# Spot Safety Project Evaluation

Spot Safety Project #s 05-00-210 & 05-00-211

**Spot Safety Project Evaluation of the Traffic Signal and Turn Lane Installation at the Intersection of SR 1010 and NC 50, the Closing of the Intersection of SR 2731 and NC 50, and The Construction of a Three-Lane Section on SR 1010 Between SR 2731 and NC 50.  
Wake County**

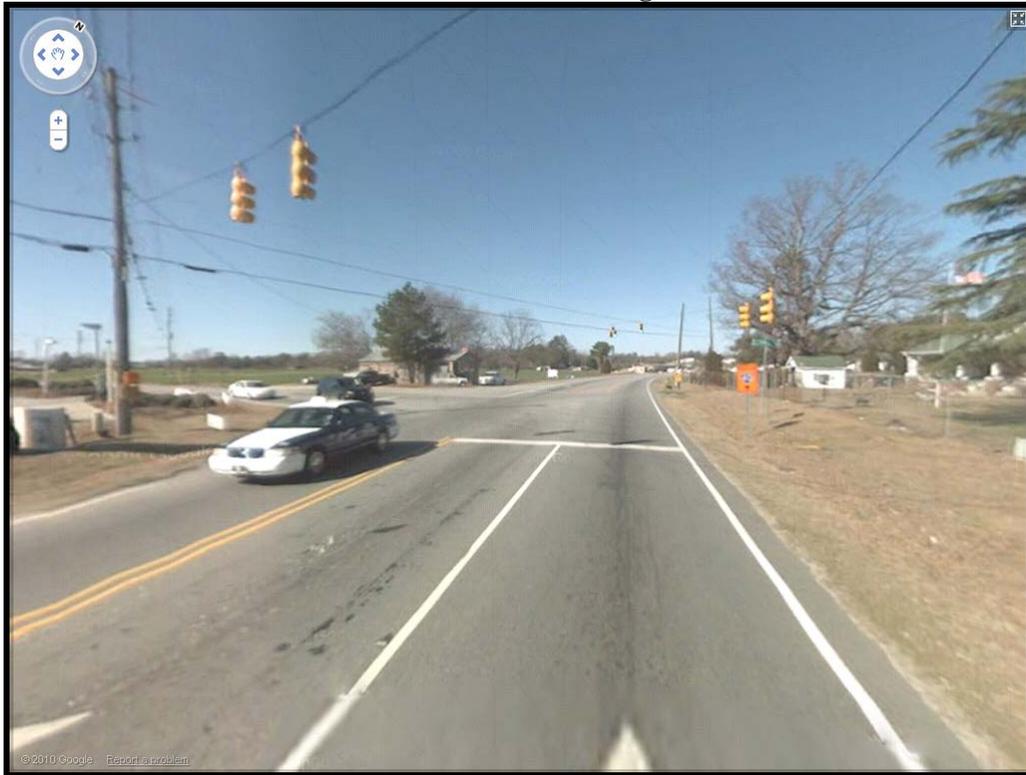
**Looking north on NC 50 at its intersection with SR 1010**

The majority of Frontal Impact Crashes in the after period (10 of 13) were Left Turn-Same Roadway Crashes involving northbound NC 50 turning left onto SR 1010. In all but one of these crashes the reporting officer faulted the left turning vehicle for failing to yield to the southbound vehicle. The signal has protected/permitted left turn phasing for this movement.

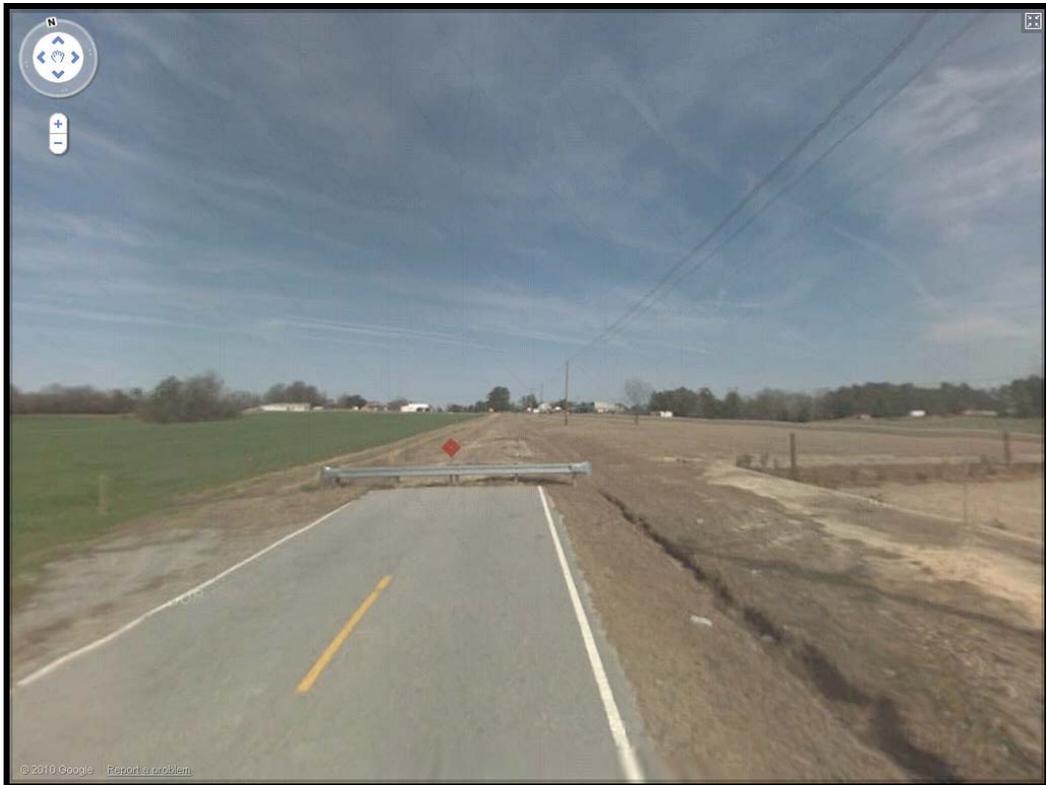
**Looking north on SR 2731 (Jordan Rd) at location where the road now ends**

Spot Safety project #05-00-210 involved closing the intersection of SR 2731 (Jordan Rd) and NC 50 and the construction of a three-lane section on SR 1010 from SR 2731 to NC 50. Spot Safety

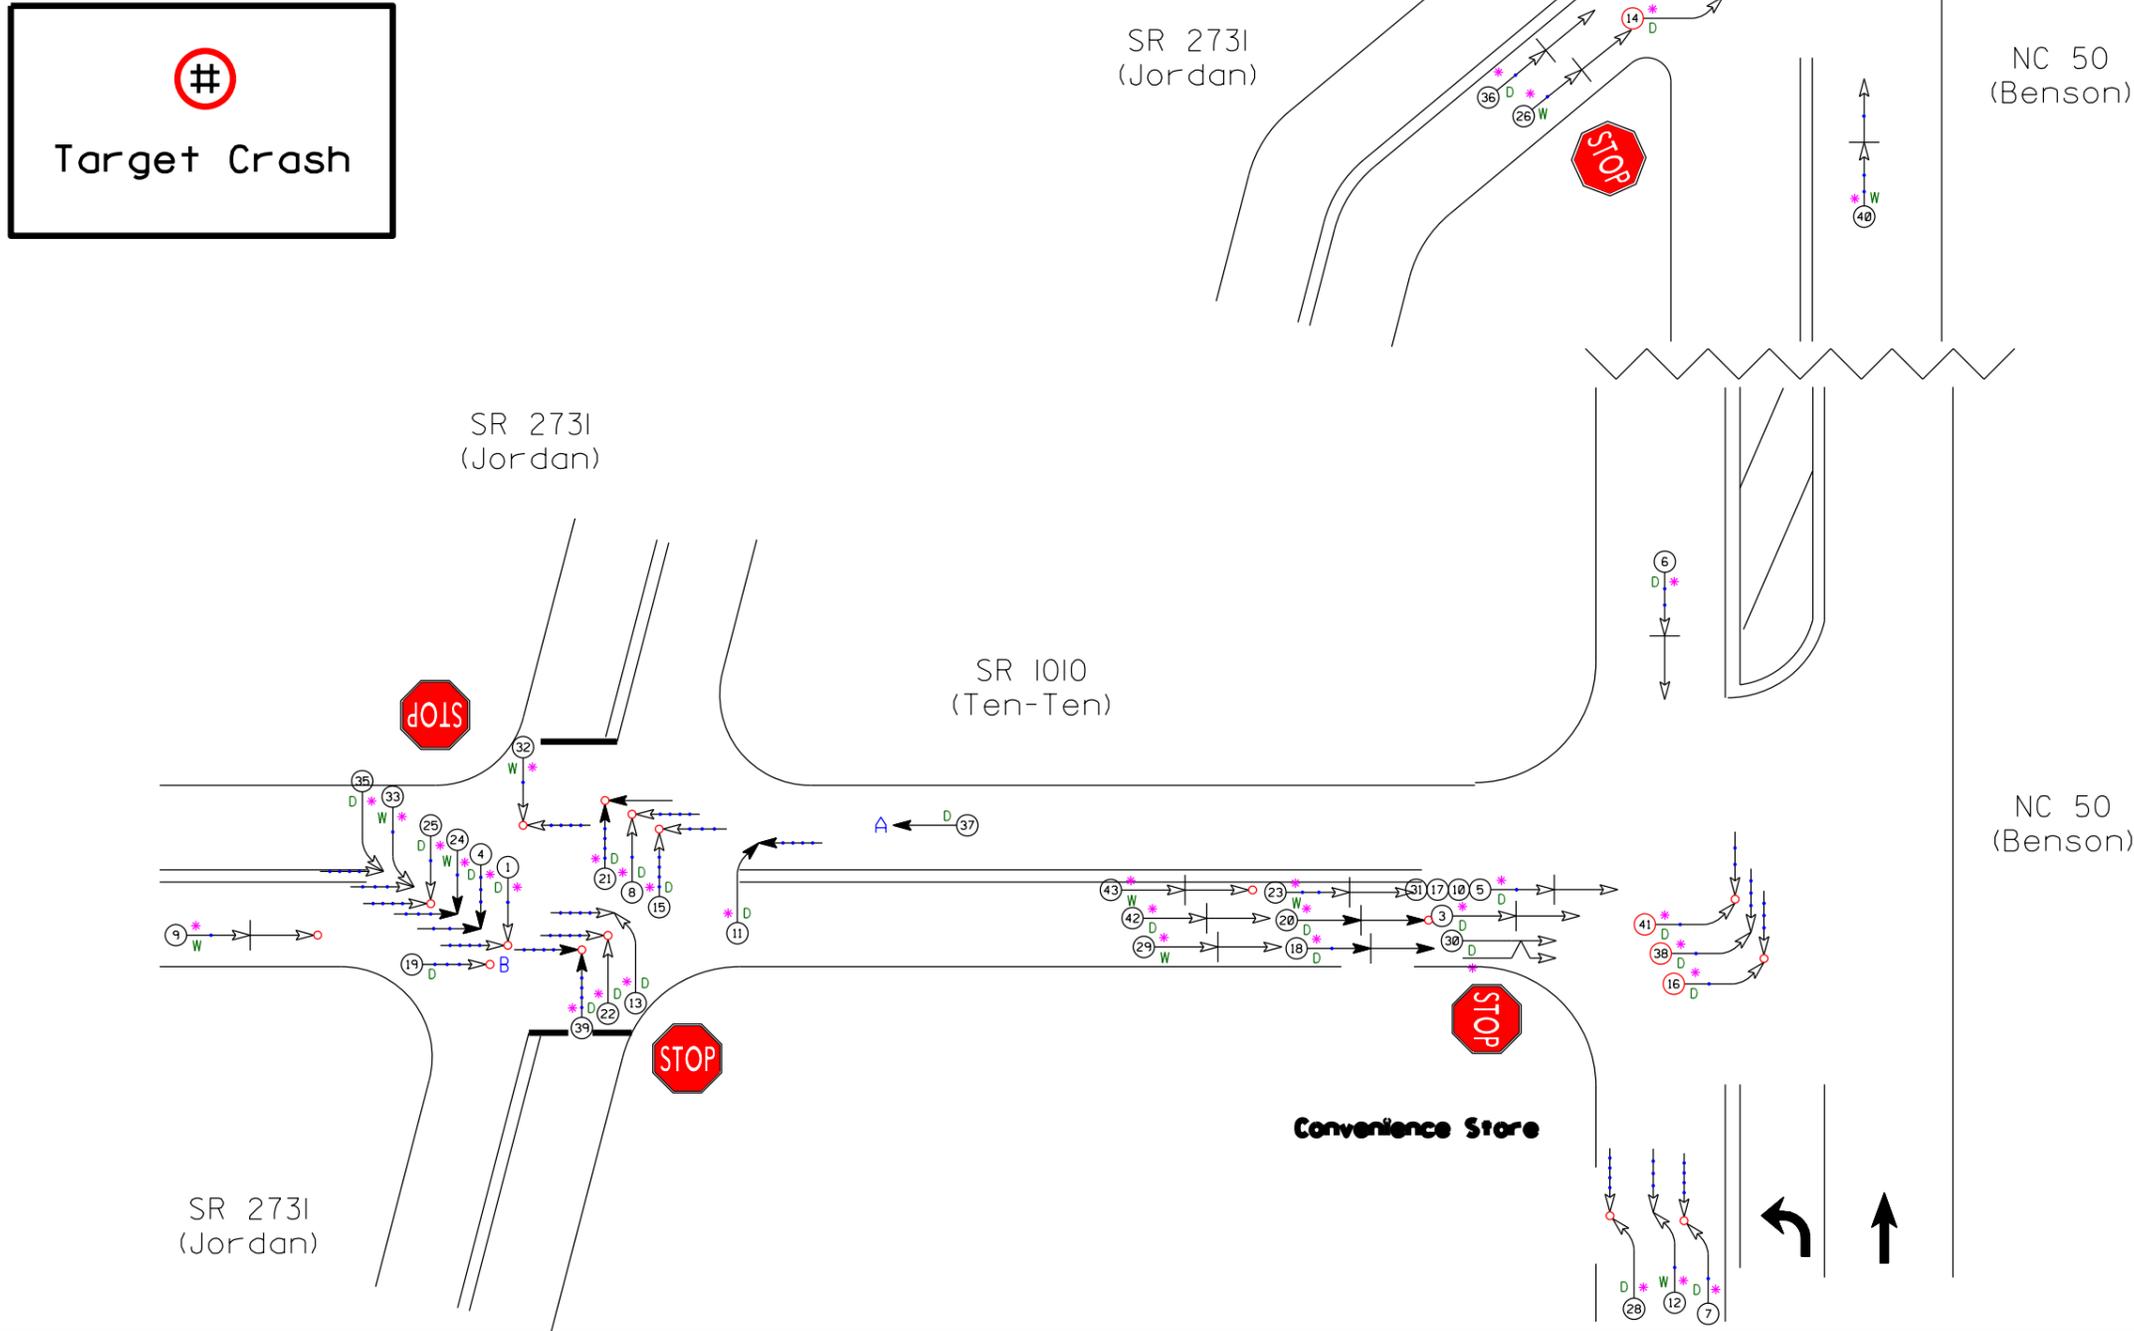
Wake County  
 NC 50 at SR 1010 and  
 SR 2731 (Jordan Rd)  
 BEFORE PERIOD  
 6/1/2000-8/31/2004

<b>COLLISION DIAGRAM</b>	
	DIVISION: 5	AREA:
	STUDY PERIOD: 4/1/99-7/31/04	
	DISTANCE: Y-LINE = 150FT	
	ANALYSIS PREPARED BY: BDR	
ANALYSIS CHECKED BY:		
DIAGRAM PREPARED BY: BDR		
DIAGRAM REVIEWED BY:		
SCALE: NOT TO SCALE		
DATE: Apr 9 2010		
LOG NUMBER: 41000005649

The treatment data consisted of all reported crashes within 150 feet of the subject intersections, in addition to any on the strip of SR 1010 between NC 50 and SR 2731. The following data table depicts the Naive Before and After Analysis for the treatment location. Please note that Frontal Impact crash types that occurred at the intersections of NC 50 and SR 1010 or NC 50 and SR 2731 were the Target Crashes for the applied countermeasure. These crash types are considered as follows: Left Turn, same roadway; Left Turn, different roadway; Right Turn, same roadway; Right Turn, different roadway; Head On and Angle. The target crashes are clearly identified in the before and after period collision diagrams.

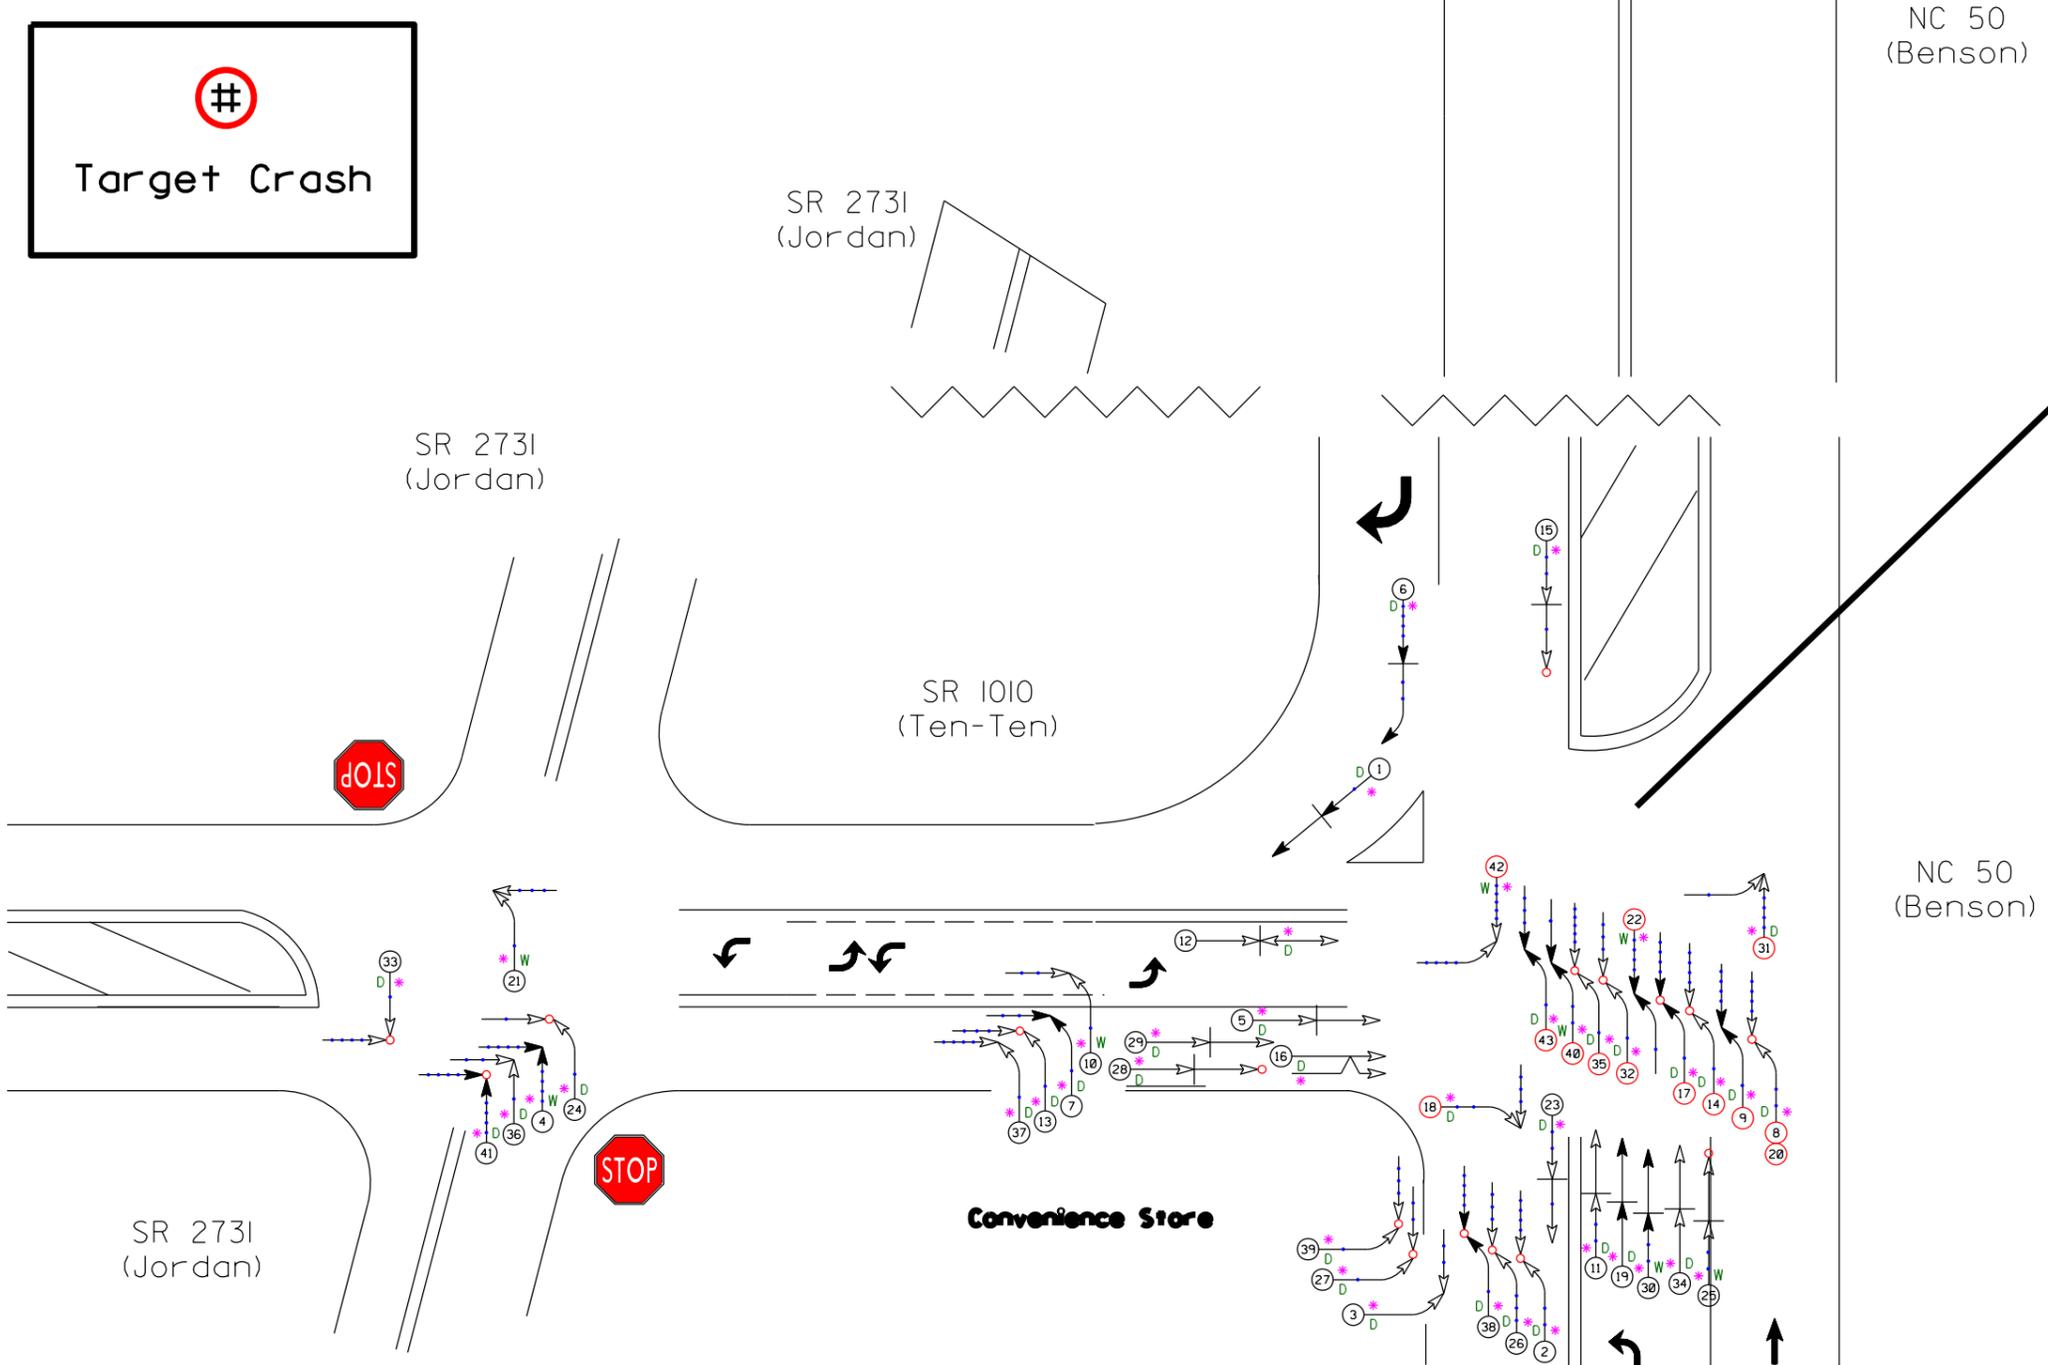
Wake County  
 NC 50 at SR 1010 and  
 SR 2731 (Jordan Rd)  
 AFTER PERIOD  
 1/1/2006-3/31/2010

COLLISION DIAGRAM	
	DIVISION: 5	AREA:
	STUDY PERIOD: 11/04-2/28/10	
	DISTANCE: Y-LINE = 150FT	
	ANALYSIS PREPARED BY: BDR	
	ANALYSIS CHECKED BY:	
	DIAGRAM PREPARED BY: BDR	
	DIAGRAM REVIEWED BY:	
SCALE: NOT TO SCALE		
DATE: April 2010		
LOG NUMBER: 4100005649
