Spot Safety Project Evaluation

Spot Safety Project # 05-04-007

**Spot Safety Project Evaluation of Intersection Changes
(Widen westbound Holden Road to accommodate dual left turn lanes and add
protected-permitted left turn phasing for northbound and southbound US 1)**

**US-1 (Capital Boulevard) at SR 1147 (Holden Road)
Franklin County**

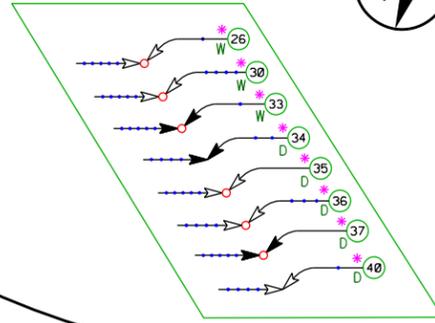
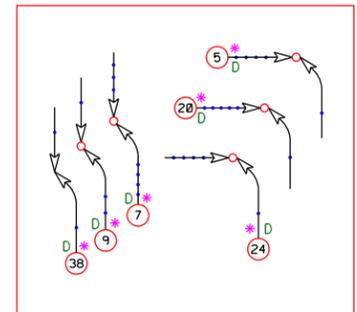
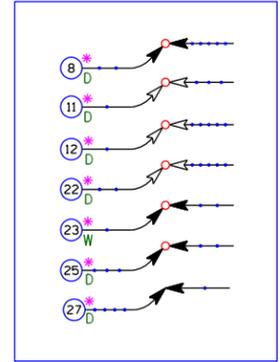
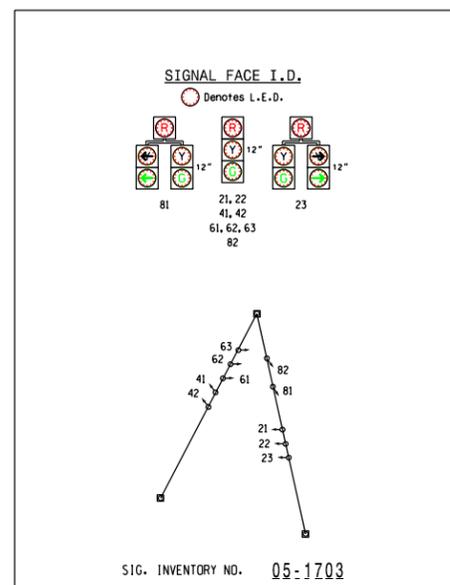
SS# 05-04-007
Franklin County
BEFORE Period
4/1/2003 - 1/31/2008

As shown on the *Before Period Collision Diagram*, three (3) crashes occurred during the before period at the traffic island on the westbound approach of SR 1147 (Holden Road). Crash #13 and crash #21 were single vehicle crashes that involved the vehicle hitting the island and traffic sign that was mounted on the island. Crash #10 involved a vehicle hitting a car that was stopped on westbound SR 1147 in addition to hitting the traffic island and sign. 100 percent of these types of crashes were eliminated after removal of the island.

- Target 1 - Westbound SR 1147 Left Turn Crashes
- Target 2 - Northbound US-1 LTSR Crashes
- Target 3 - Southbound US-1 LTSR Crashes

Referencing the *Collision Diagrams*, Target 1 Crashes (Westbound SR 1147 Left Turn Crashes) decreased from six (6) crashes during the before period to one (1) crash during the after period. That decrease is an 83.3 percent reduction in Target 1 crashes for the westbound movement. Target 2 Crashes (Northbound US-1 LTSR Crashes) increased by one (1) crash in the after period while the number of Target 3 Crashes (Southbound US-1 LTSR Crashes) remained the same.

Also noted on the *Collision Diagrams* is the occurrence of Rear-End Crashes on US-1. The northbound approach of US-1 experienced a 16.7 percent reduction in this type of crash. However, the southbound approach experienced a 37.5 percent increase in Rear-End Crashes.

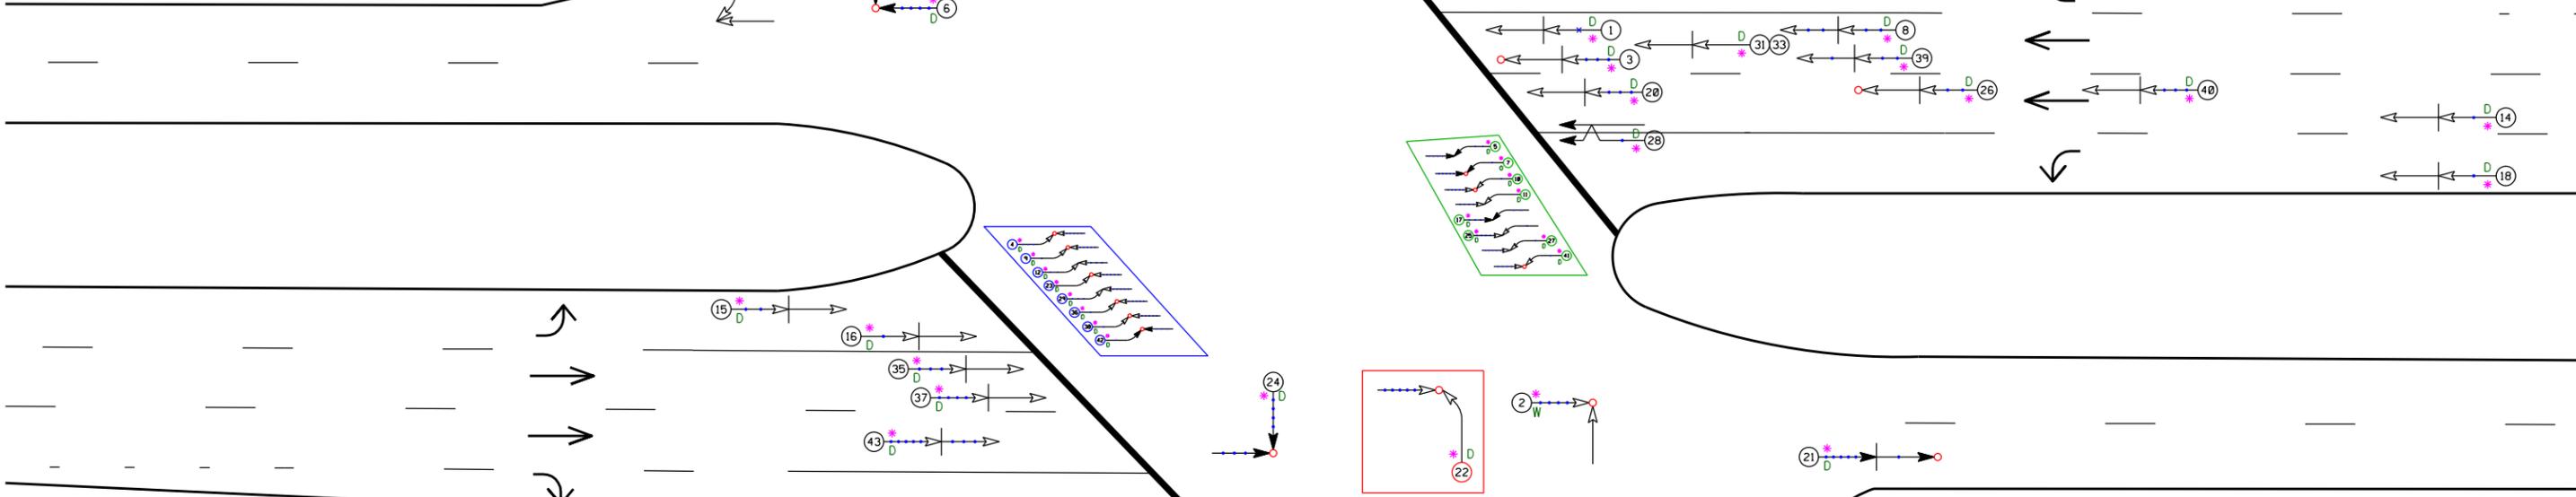
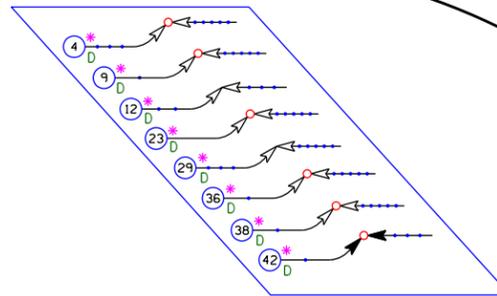
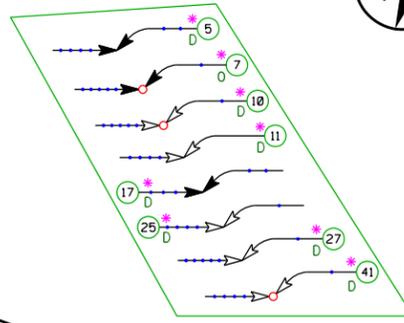
SS# 05-04-007
Franklin County
AFTER Period
5/1/2008 - 2/28/2013

- Target 1 - Westbound SR 1147 Left Turn Crashes
- Target 2 - Northbound US-1 LTSR Crashes
- Target 3 - Southbound US-1 LTSR Crashes
