# **Spot Safety Project Evaluation**

Spot Safety Project # 05-00-208

## **Preliminary Evaluation of the Construction of a Roundabout at the Intersection of NC 751 and SR 1307 - Old Erwin Road in Durham County**

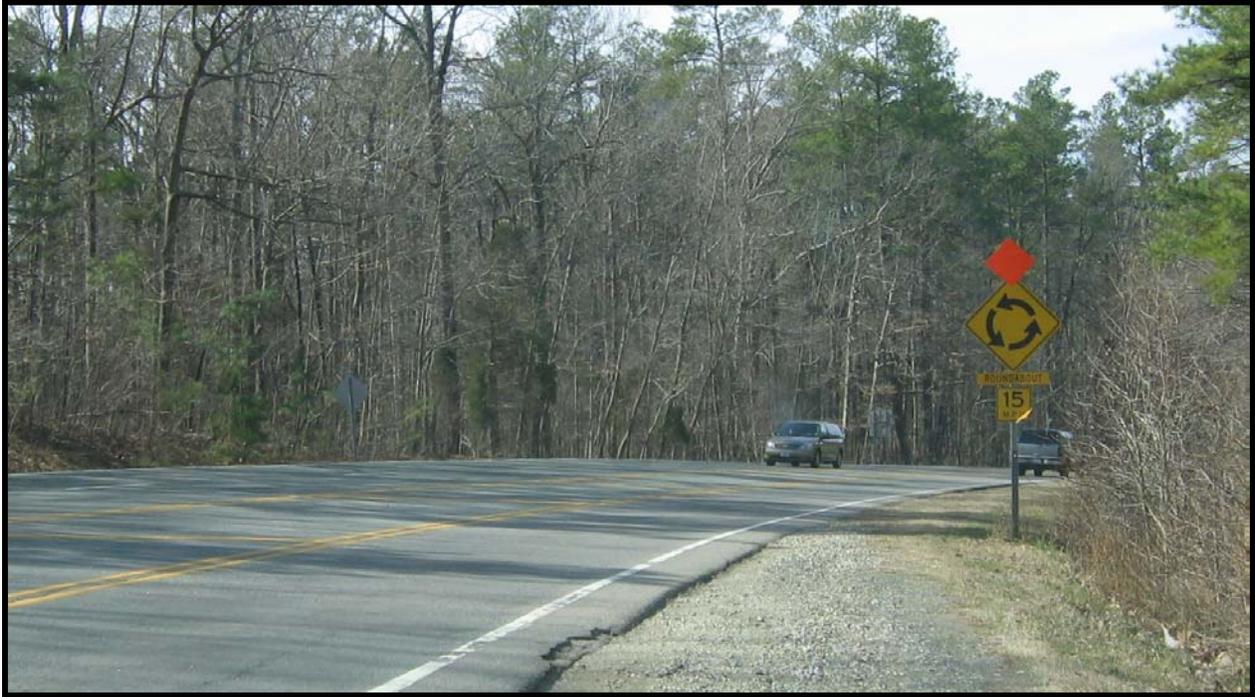
Looking west at the Roundabout Warning Sign with 15-mph Advisory Plaque.

Please see the attached Treatment Site Photos. Photos are provided for all approaches of the Treatment Intersection. Notice the Roundabout Warning Signs with 15-mph advisory plaques and the Yield Ahead Warning Signs placed on each approach.

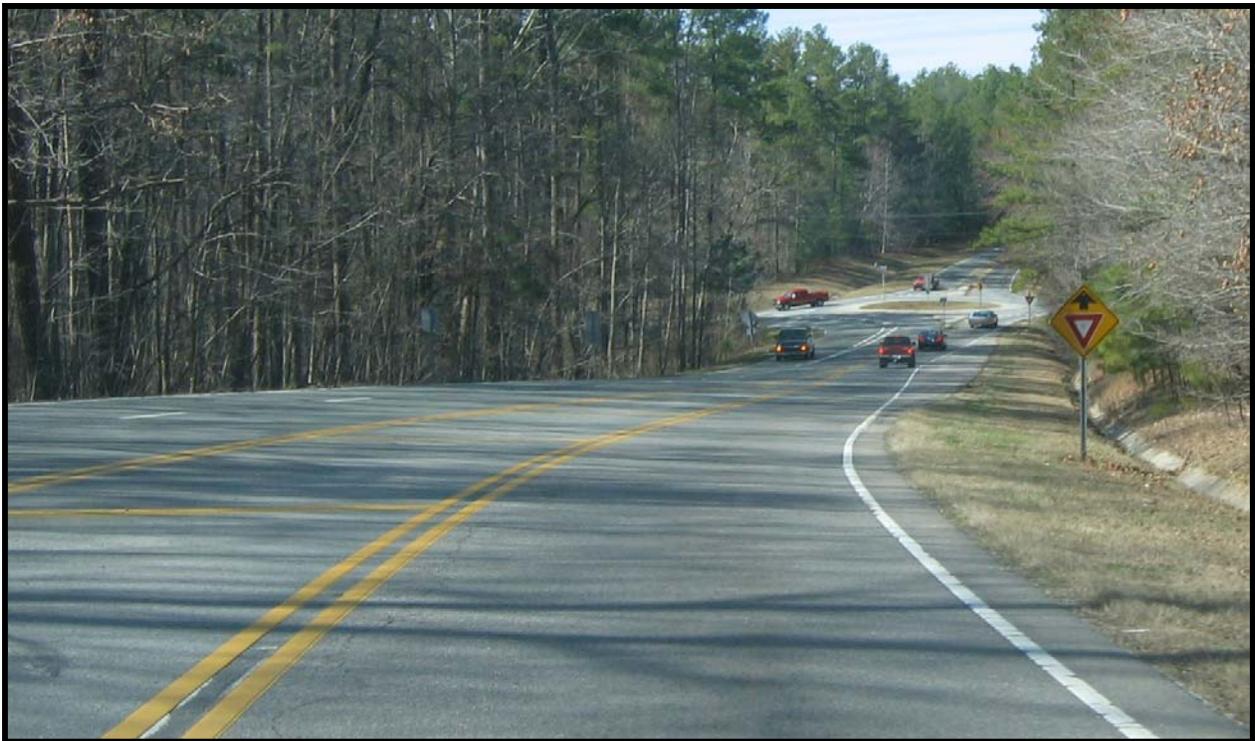
Looking west at the Yield Ahead Warning Sign in advance of the intersection.

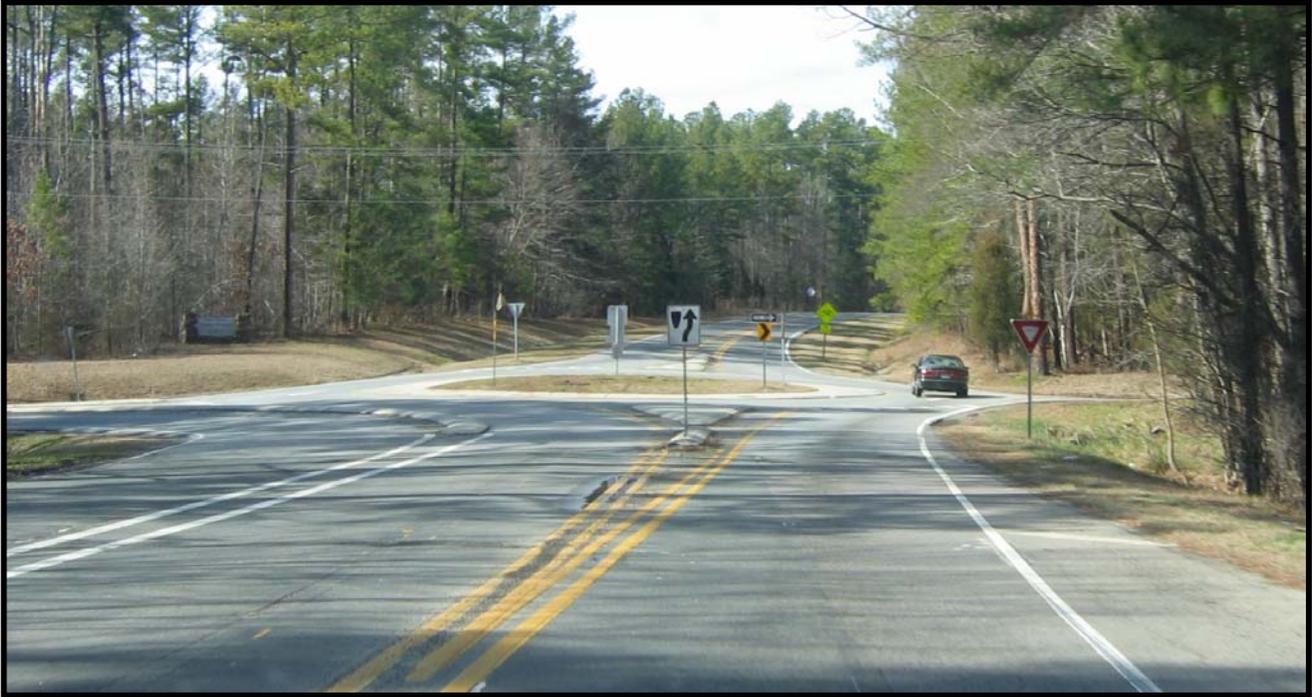
Looking west at the Treatment Intersection.

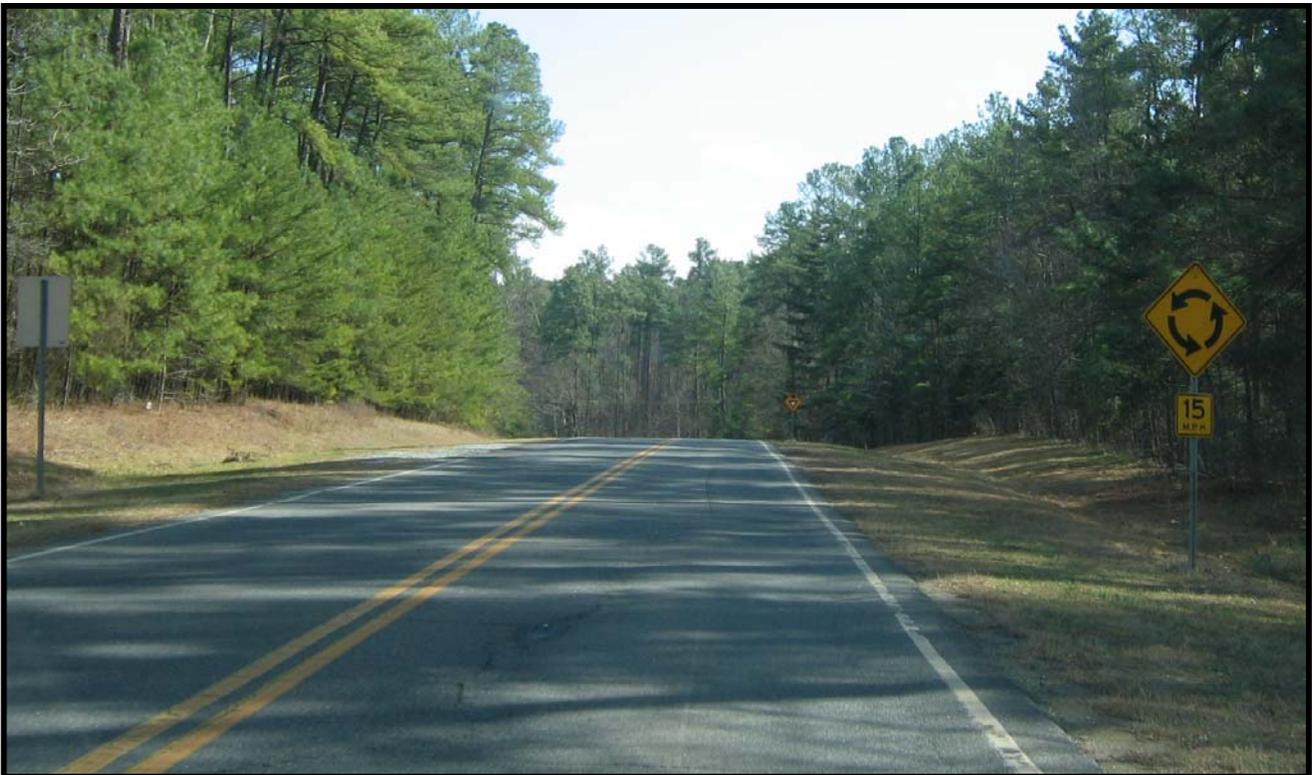
Looking east at the Roundabout Warning Sign with 15-mph Advisory Plaque.

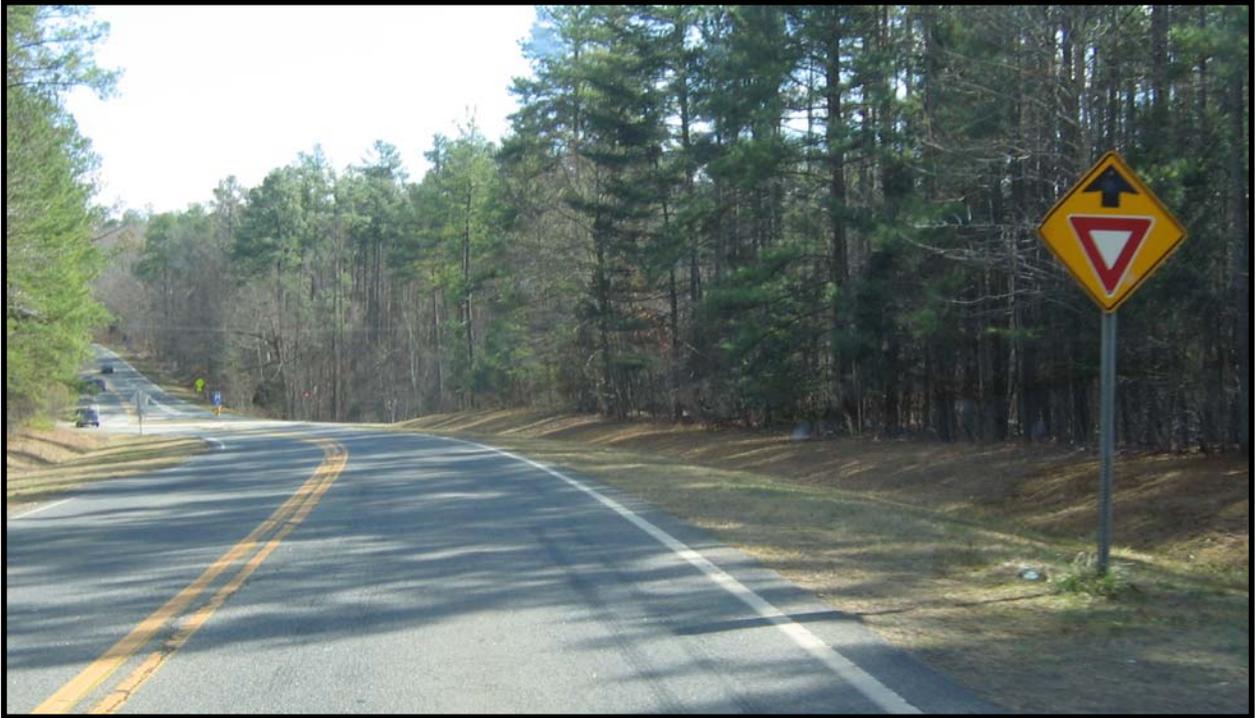
Looking east at the Yield Ahead Warning Sign in advance of the intersection.

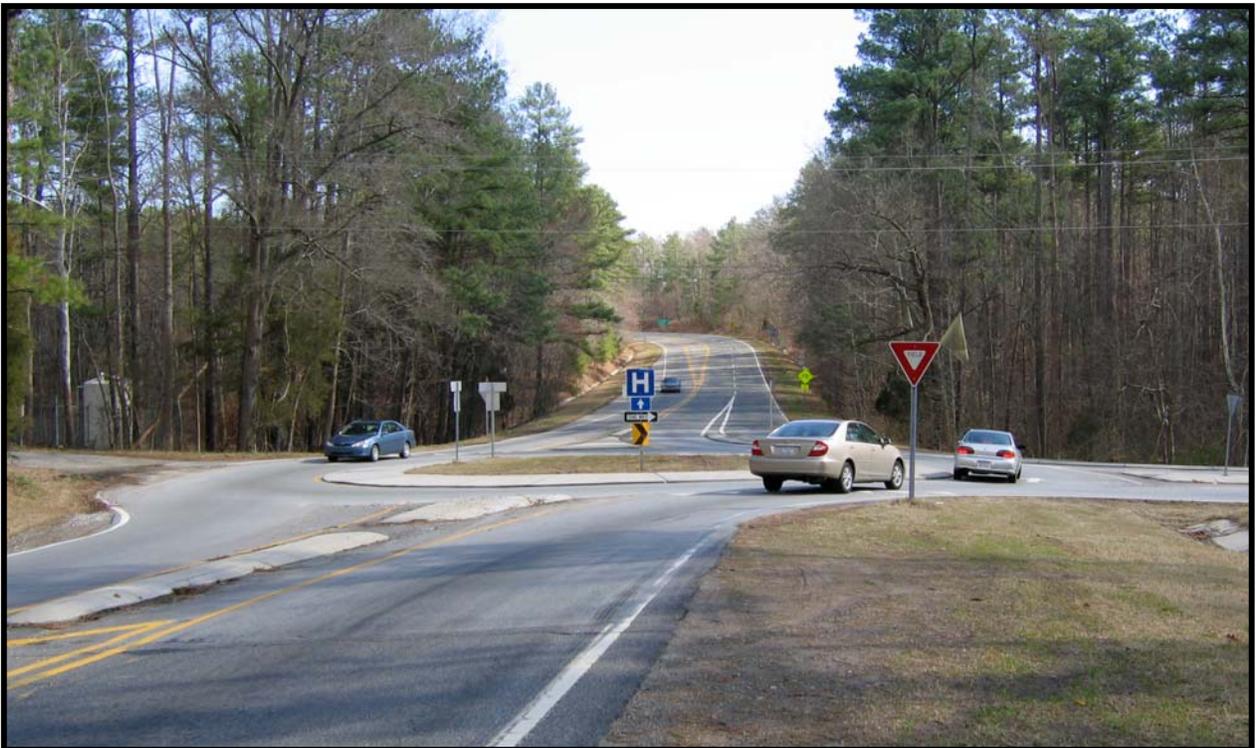
Looking east at the Treatment Intersection.

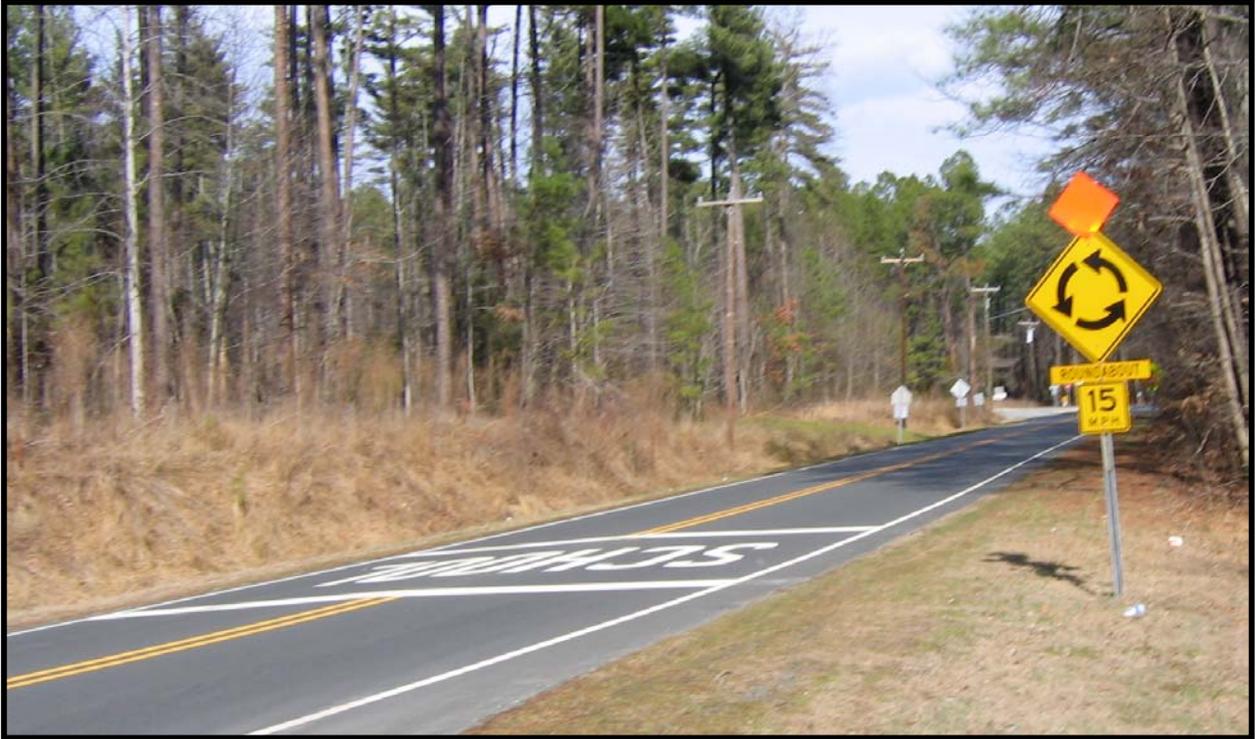
Looking north at the Roundabout Warning Sign with 15-mph Advisory Plaque.

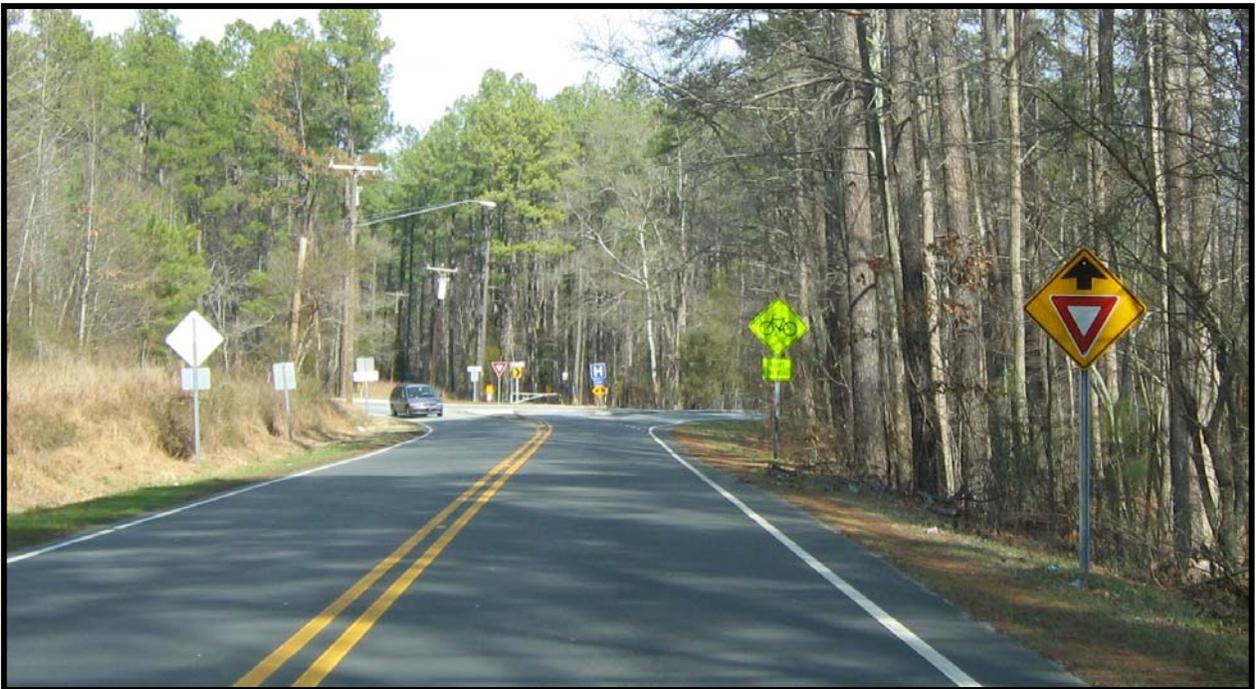
Looking north at the Yield Ahead Warning Sign in advance of the intersection.

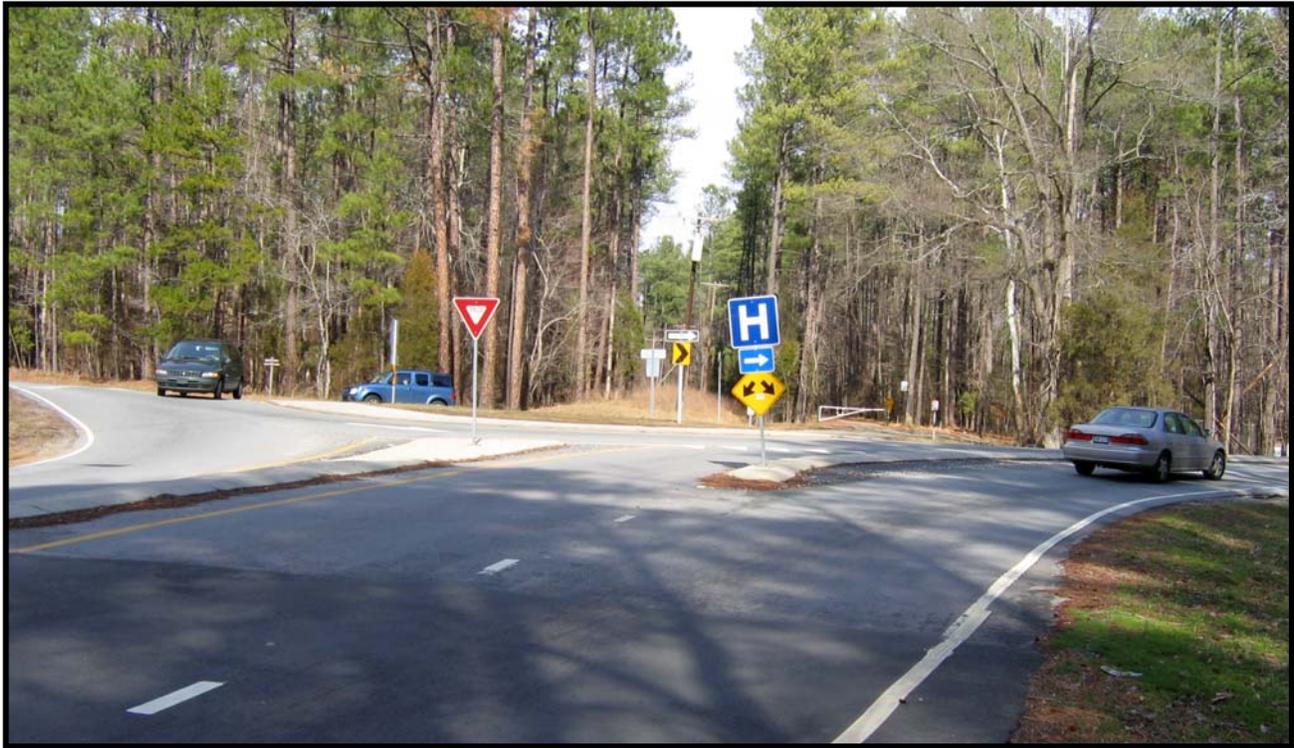
Looking north at the Treatment Intersection.

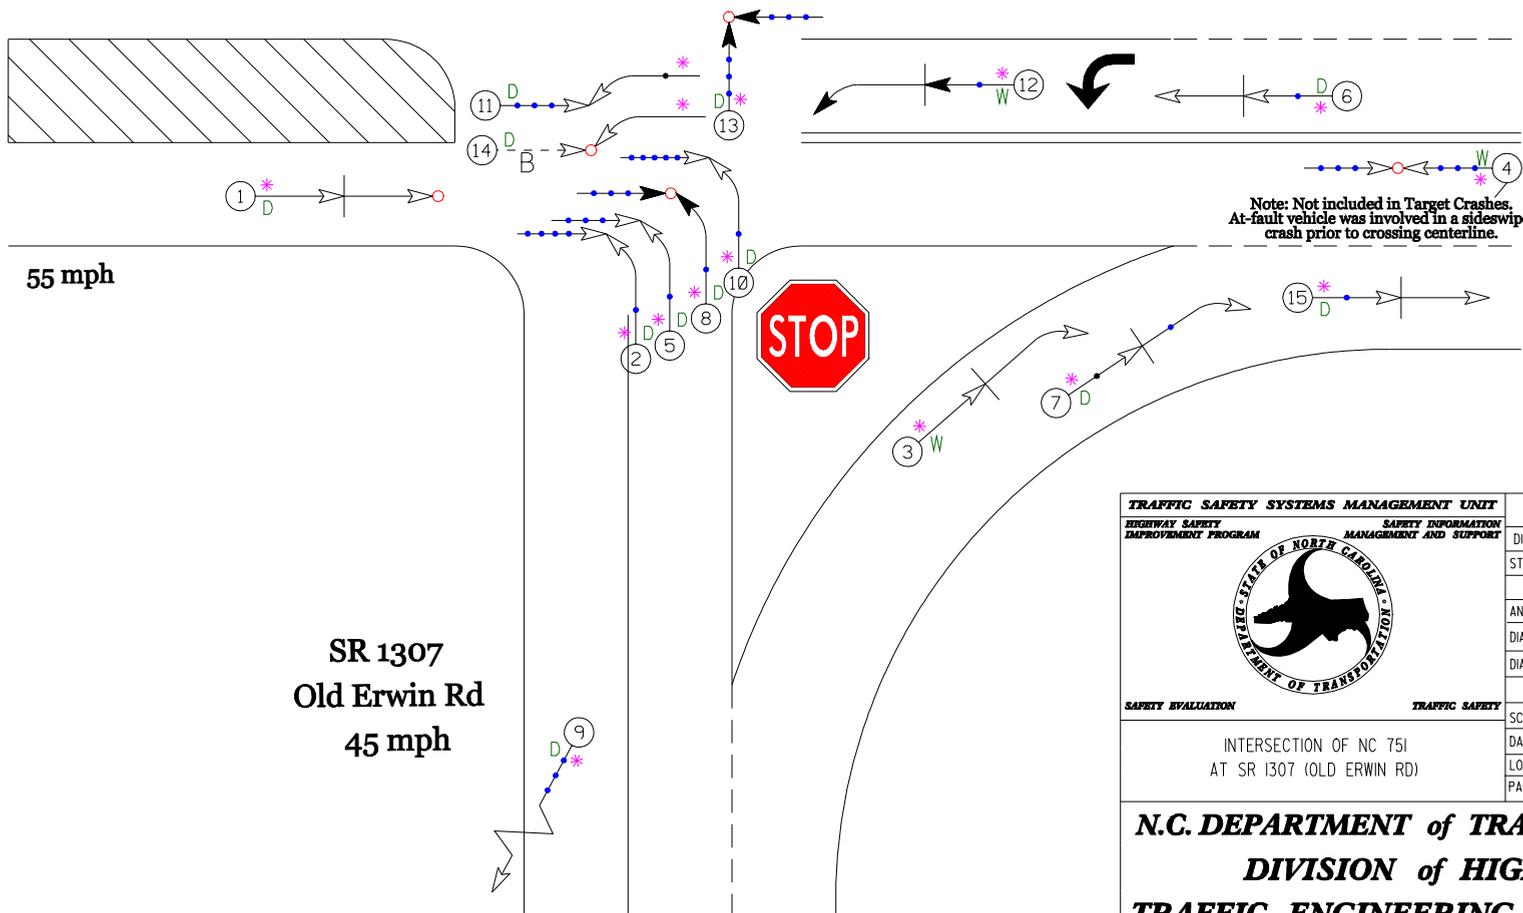
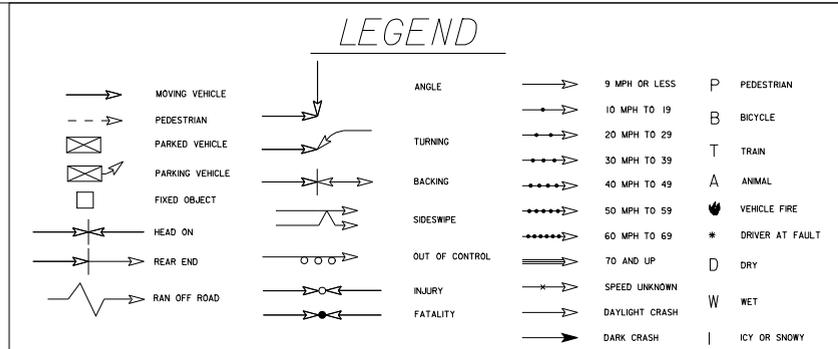
SEPTEMBER 1, 2000 - AUGUST 31, 2003

BEFORE PERIOD - TOTAL CRASHES

Six Target Crashes occurred in the entire three-year before period. The Target Crashes in the before period included one Angle Crash and five Left-Turn Crashes, resulting in one class B injury crash and one class C injury crash. The Target Severity Index in the before period was 3.47.

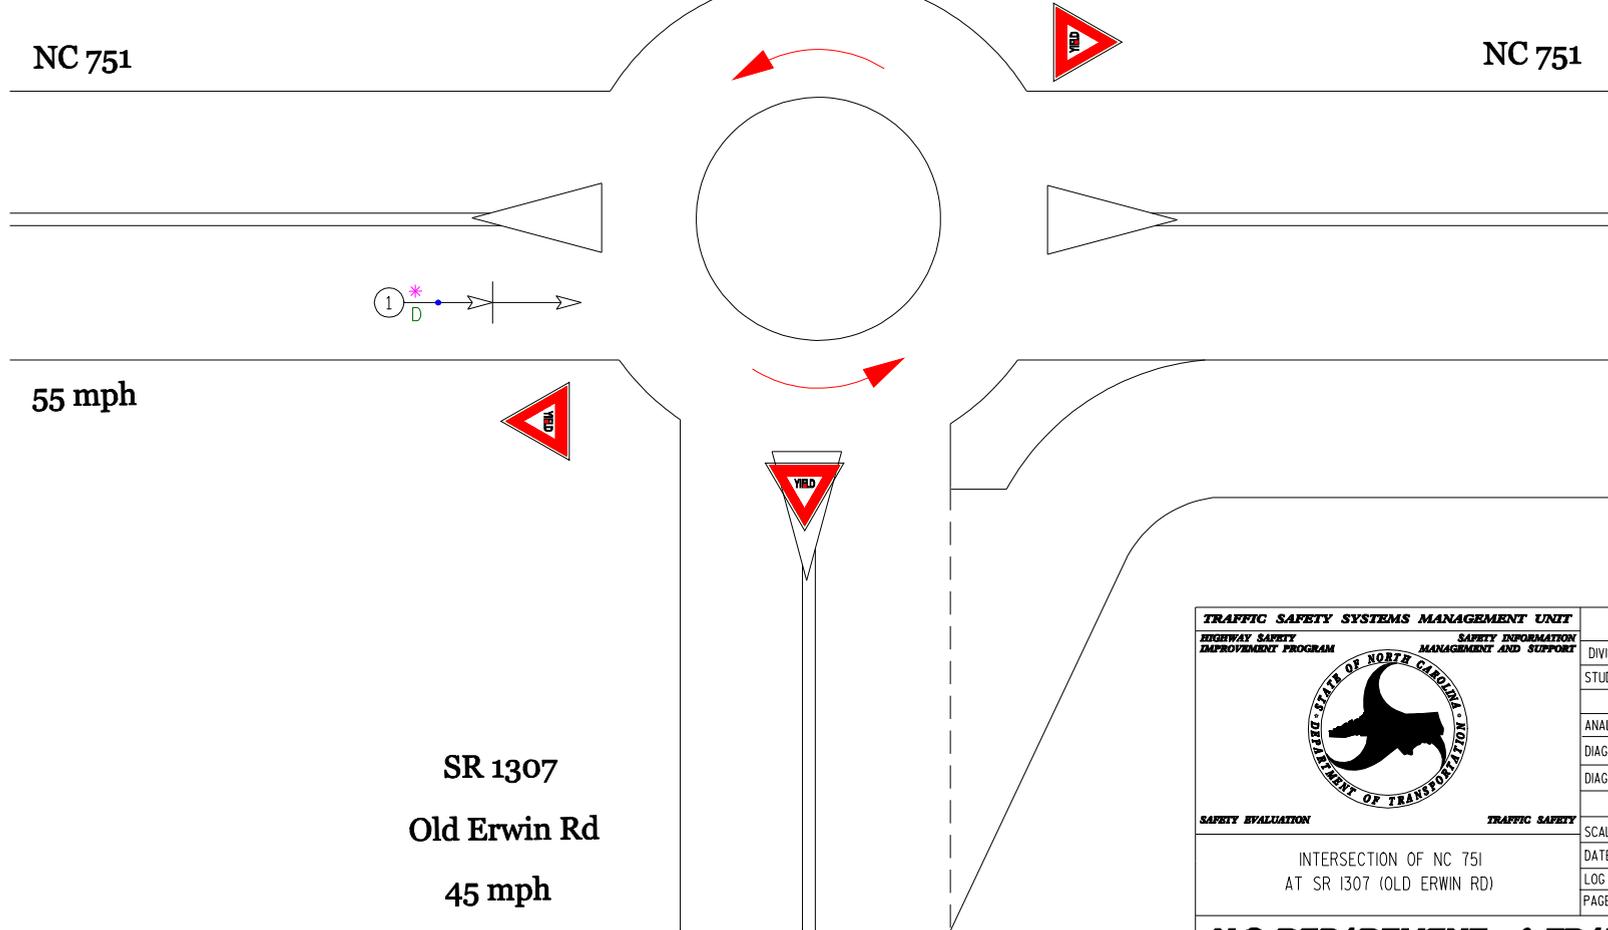
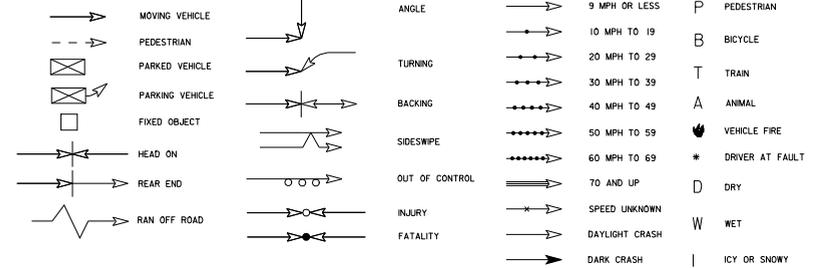
NOVEMBER 1, 2003 - JULY 31, 2006

AFTER PERIOD - TOTAL CRASHES
