Spot Safety Project Evaluation

Spot Safety Project # 05-01-205

**Spot Safety Project Evaluation of the Installation of a Traffic Signal at the Intersection of
SR 1321 (Avent Ferry Rd) and SR 1348 (Trailwood Dr)
Wake County**

Safety Evaluation Group
Traffic Safety Systems Management Section
Traffic Engineering and Safety Systems Branch
North Carolina Department of Transportation

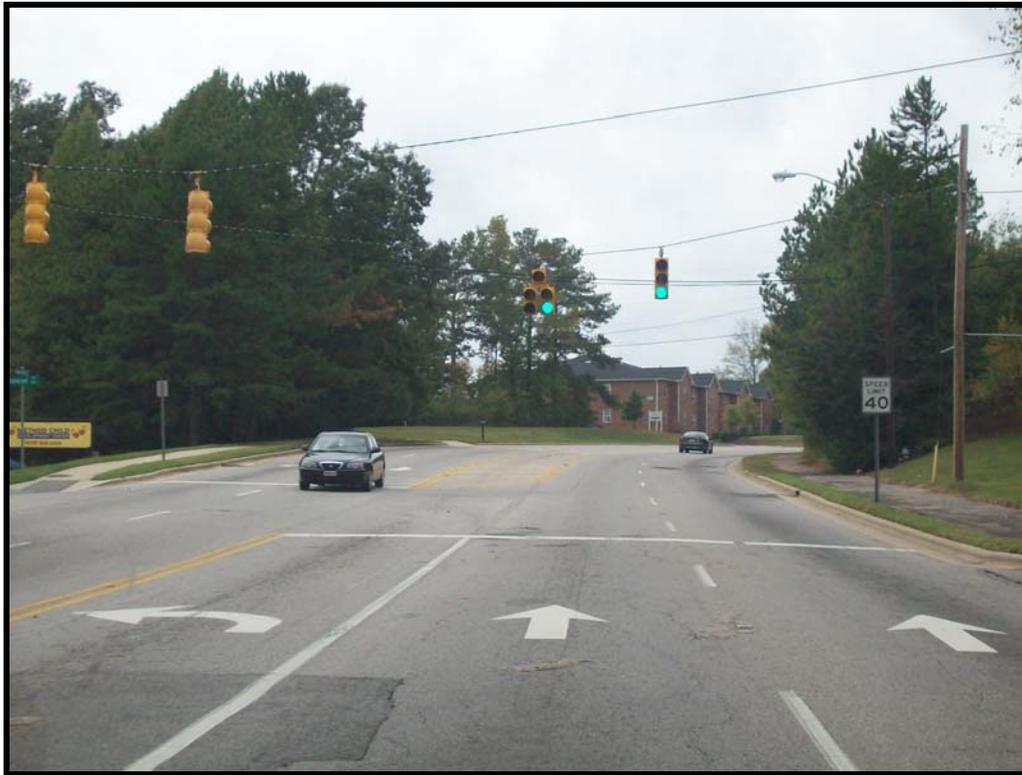
Driving Westbound on SR 1321 (Avent Ferry Rd)

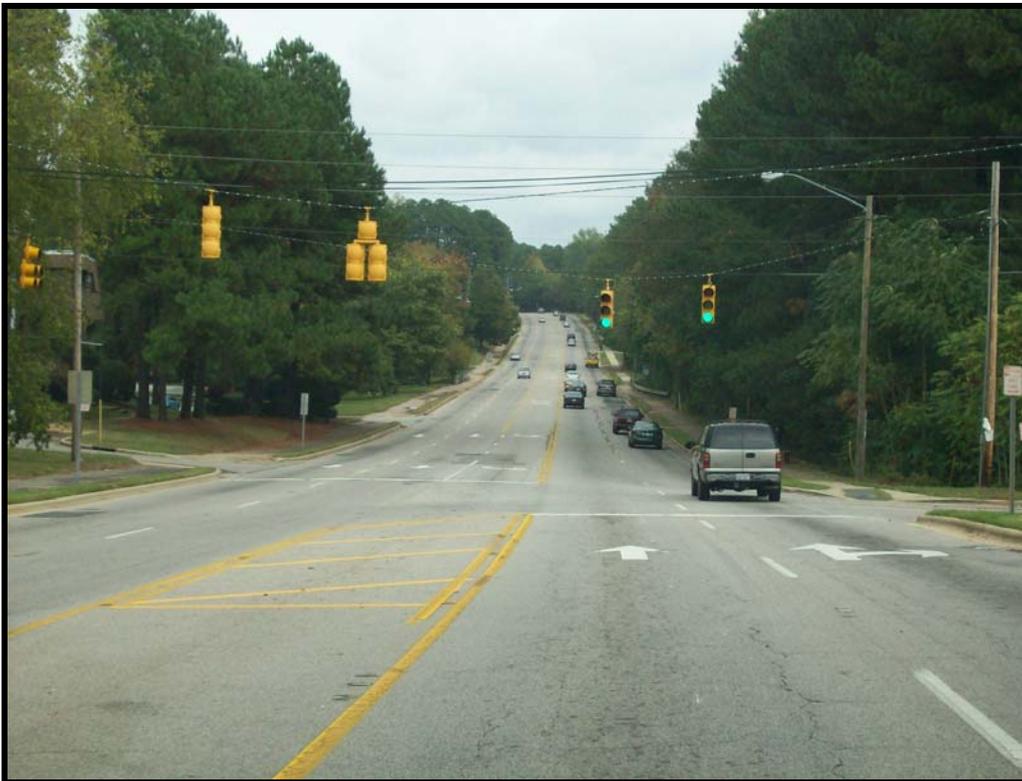
Driving Eastbound on SR 1321 (Avent Ferry Rd)

seven of the after period crashes appear to be the fault of the eastbound driver running the traffic signal. It is not clear why eastbound SR 1321 traffic is running the signal. The seven crashes took place at random times throughout the day, not following any noticeable pattern. There does not appear to be site distance issues.

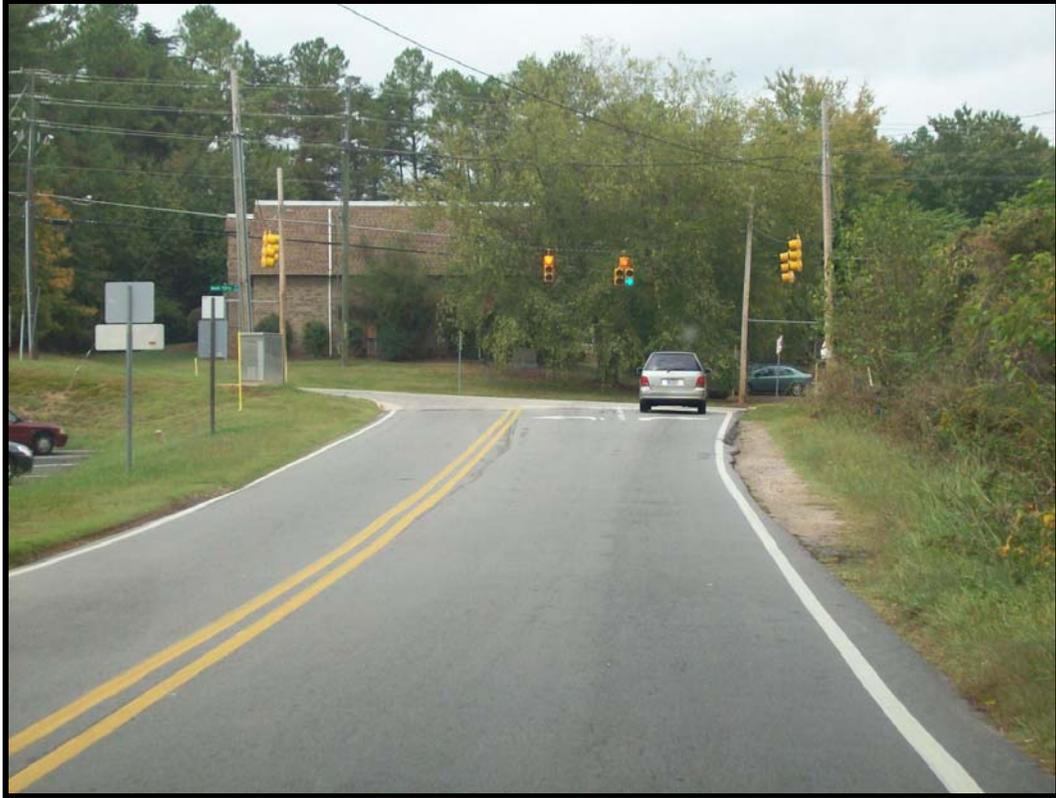
Driving Northbound on SR 1348 (Trailwood Dr)

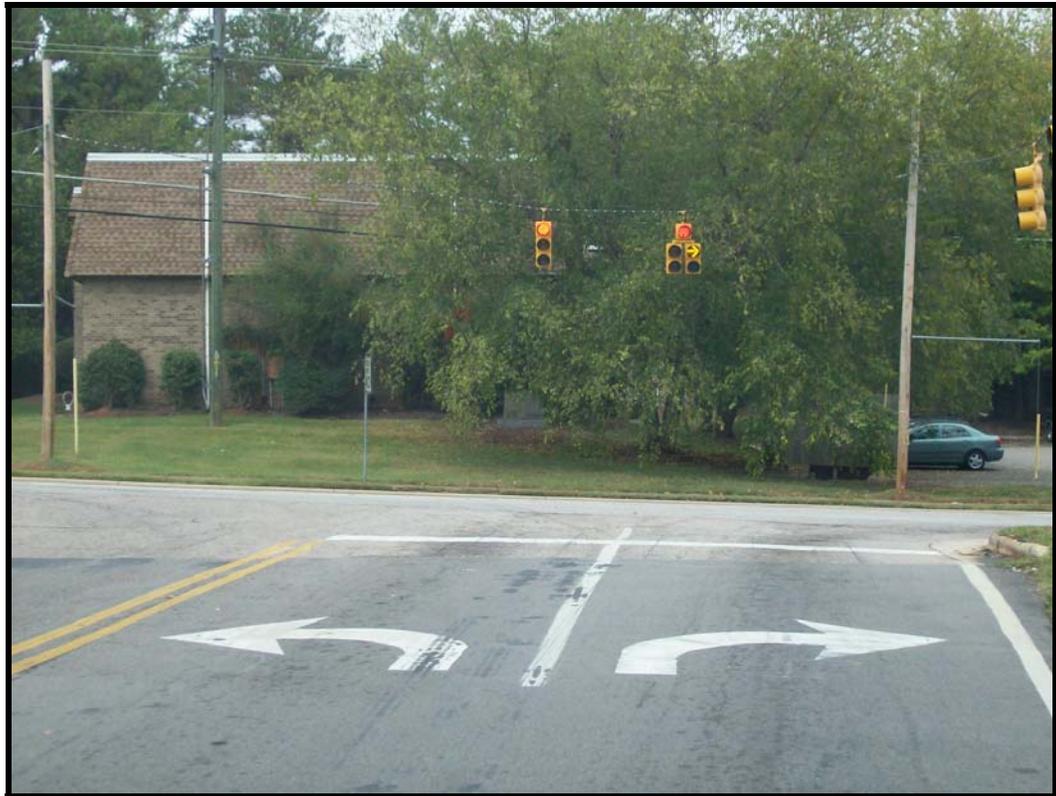
Driving Northbound on SR 1348 (Trailwood Dr)

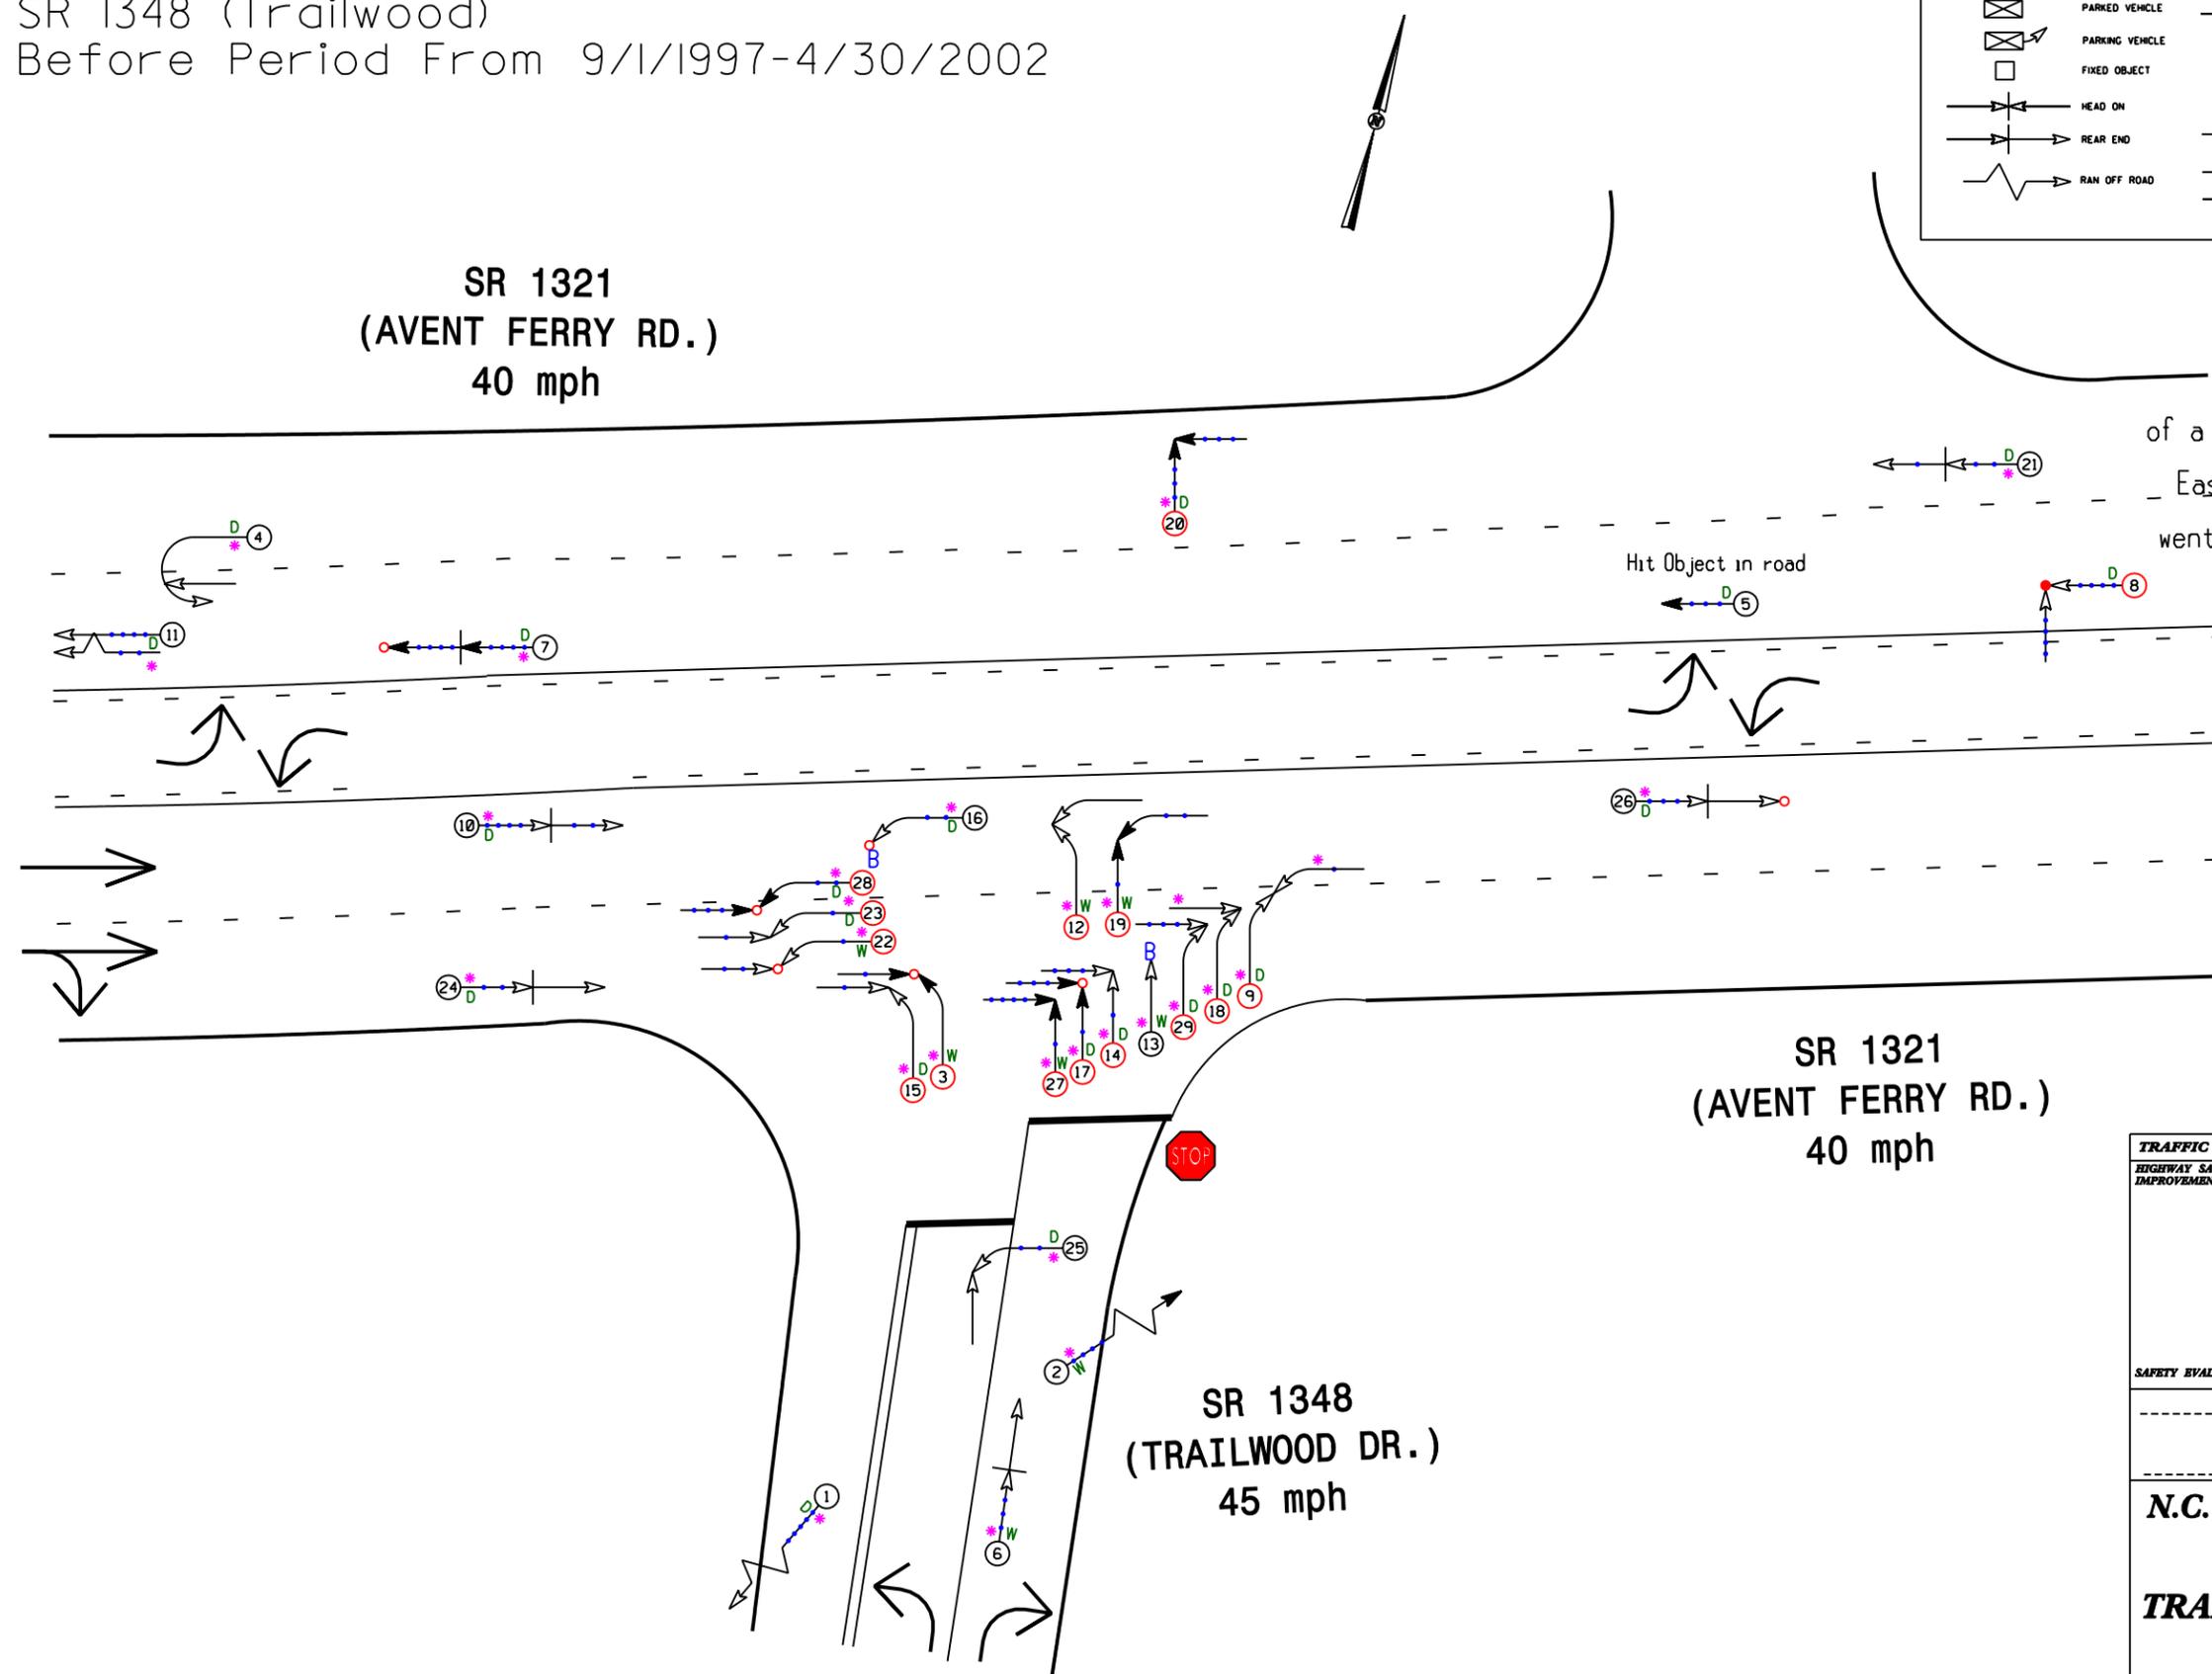
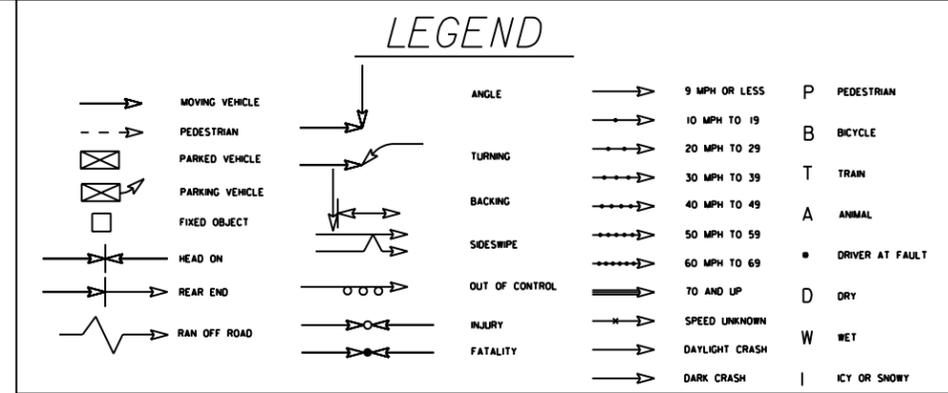
Wake County
 SR 1321(Avent Ferry) at
 SR 1348 (Trailwood)
 Before Period From 9/1/1997-4/30/2002

There was a fatality at the intersection in the before period (crash #8). A vehicle made a left turn from SR 1348 (Trailwood Dr) without yielding. An eastbound driver on SR 1321 (Avent Ferry) swerved to avoid the turning vehicle, went out of control, and struck a westbound driver.

Note: Crash #8 occurred as a result of a vehicle making a left-turn from trailwood. Eastbound driver swerved to avoid vehicle, went out of control and hit westbound vehicle.

Referencing the *Collision Diagrams*, crash patterns at the intersection have either remained constant or increased at the intersection from the before to the after period. The most notable increase appears to be Left Turn-Same Roadway Crashes involving westbound traffic on SR 1321 (Avent Ferry) turning left onto SR 1348 (Trailwood). In the before period there were three crashes of this type, in the after period there were 12 such crashes, an increase of 300 percent. Although the left turn has protected-permitted phasing, it appears that most of these crash crashes appear to be the fault of the left turning driver (9 of 12, after).

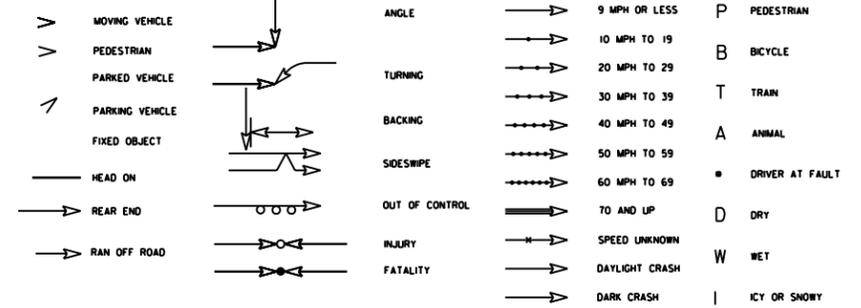
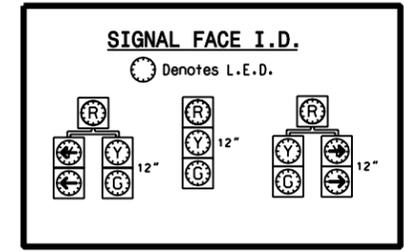
Wake County
 SR 1321(Avent Ferry) at
 SR 1348 (Trailwood)
 After Period From 10/1/2002-5/31/2007

Another notable increase is in Left Turn-Same Roadway crashes involving a left turning vehicle from SR 1348 (Trailwood) and an eastbound vehicle on SR 1321 (Avent Ferry). This pattern increased from two in the before period to seven in the after period, an increase of 250 percent. All

A pattern of Rear-End Crashes involving eastbound vehicles that had just cleared the intersection also developed in the after period. In the before period there was only 1 crash of this type, while in the after period there were 11. Some of the crash reports sited backed up traffic on SR 1321 to be the cause of the Rear-Ends. It is possible that the driveway on the northern side of SR 1321 just east of the intersection might be the reason for some of these crashes. The driveway is right next to the westbound stop bar, and the left turn lane for westbound vehicles is still clearly defined across from the driveway. In the before period there was a center turn lane in this area, so any eastbound vehicle turning into the driveway could use the center turn lane. In the after period vehicles might be stopping in the travel lane to make a left turn into the driveway instead of using the center lane, which as stated above is marked as a left turn lane for the opposite direction. Nine of the 11 crashes occurred between 1:00 p.m. and 9:00 p.m., a time period when people might be coming home to the apartment complex. It should be noted that during the field investigation no vehicles were observed making this movement.

⊕
 Target Crashes
