Spot Safety Project Evaluation

Spot Safety Project # 05-99-203

Spot Safety Project Evaluation of the Traffic Signal Installation and Construction of Left Turn Lanes At the Intersection of NC 98 (Durham Rd) and SR 1831 (Old Creedmoor Rd) Wake County

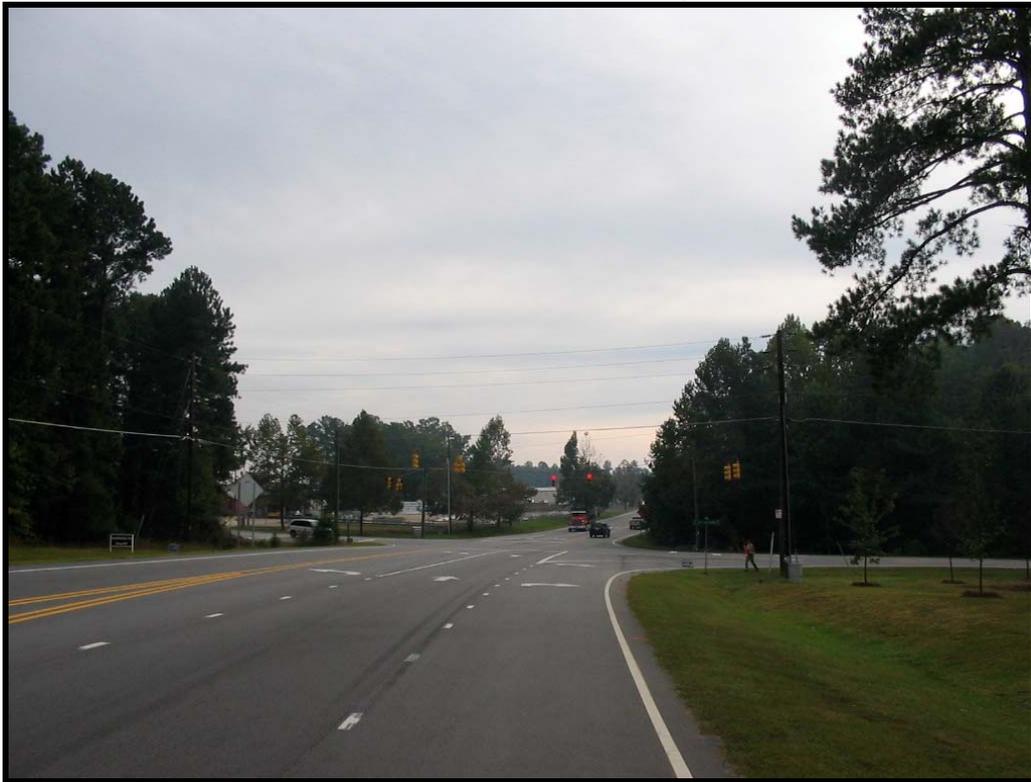
Looking EB on NC 98 (Durham Rd)

Please see the attached *Treatment Site Photos*. Photos are provided for all approaches to the treatment intersection.

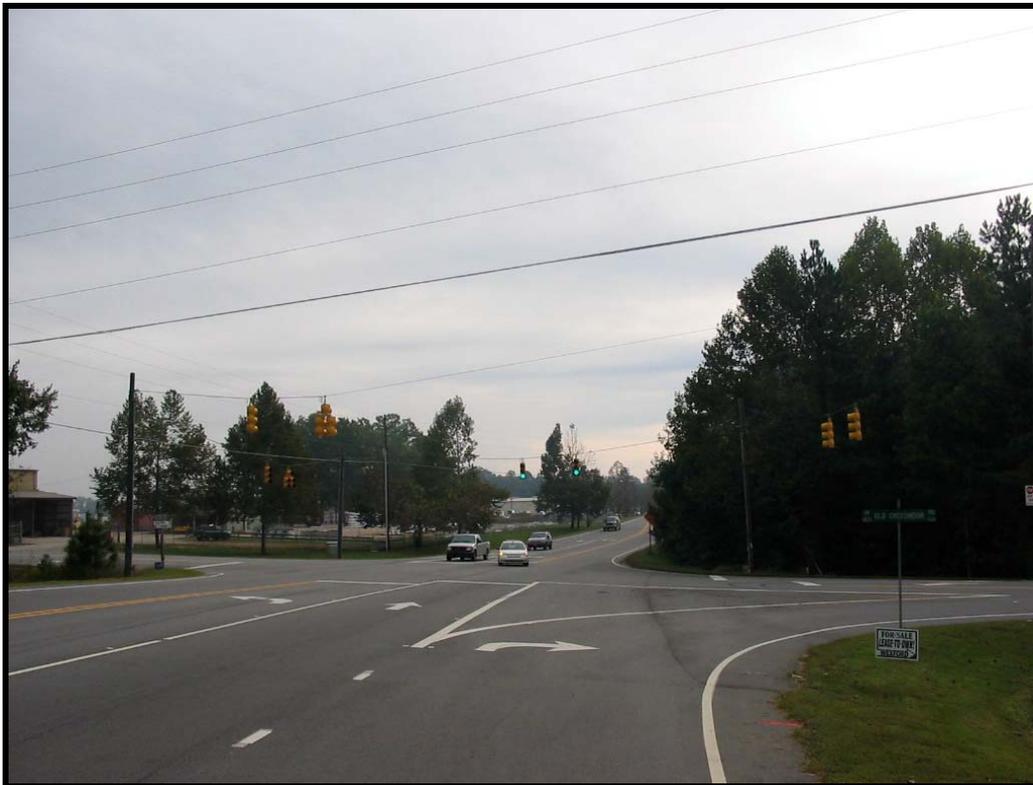
Looking EB on NC 98 (Durham Rd)

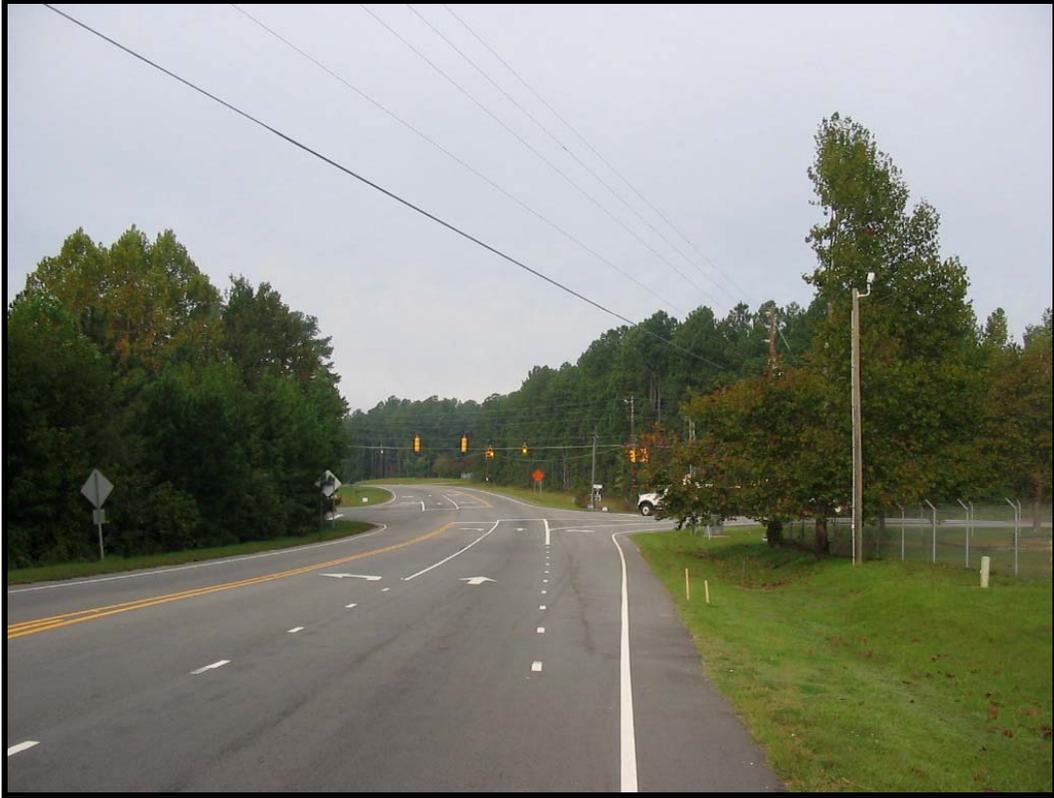
Looking WB on NC 98 (Durham Rd)

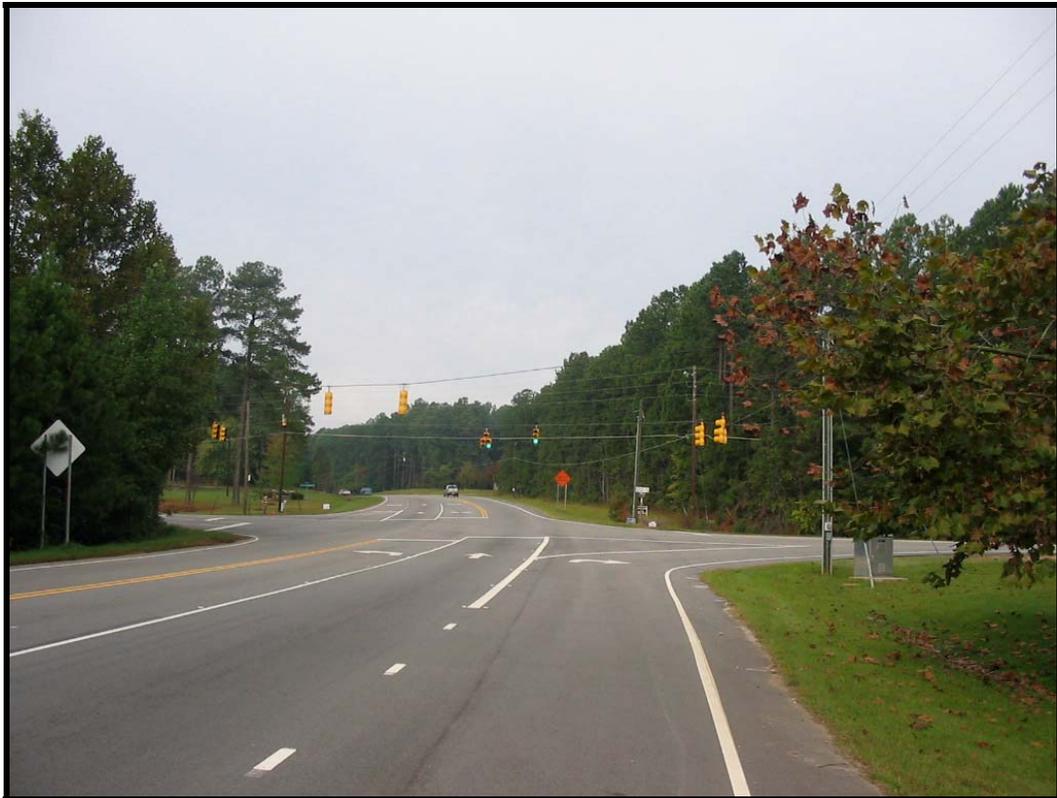
Looking WB on NC 98 (Durham Rd)

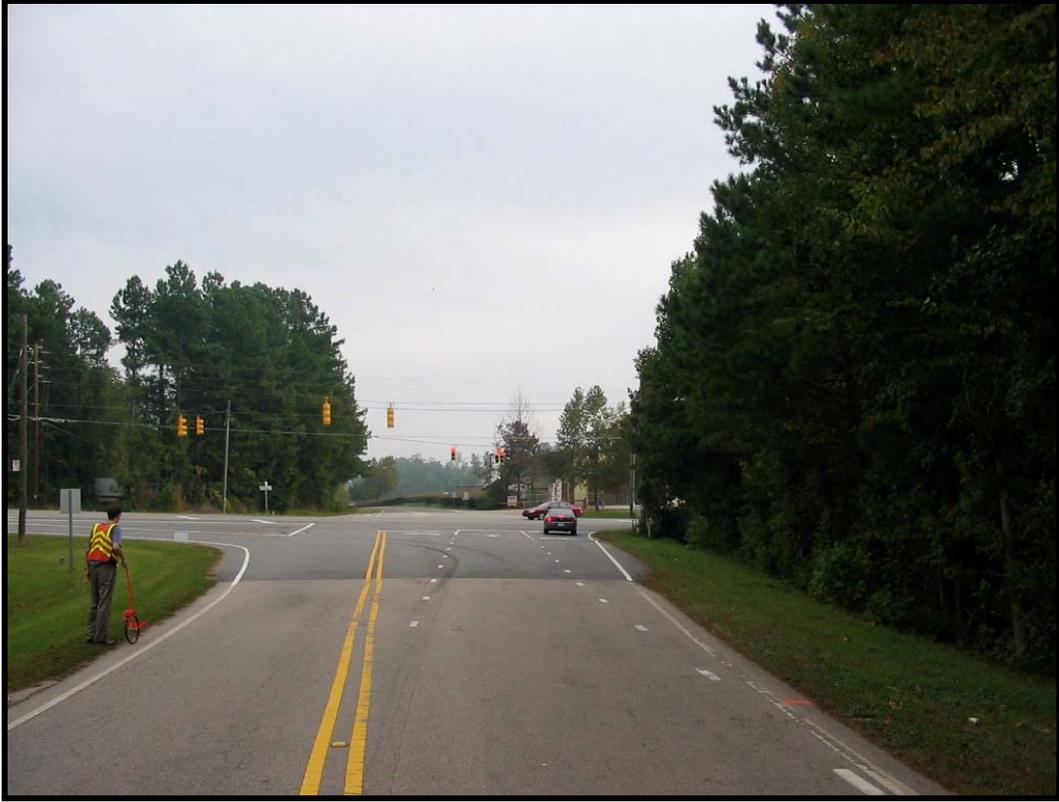
Looking NB on SR 1831 (Old Creedmoor Rd)

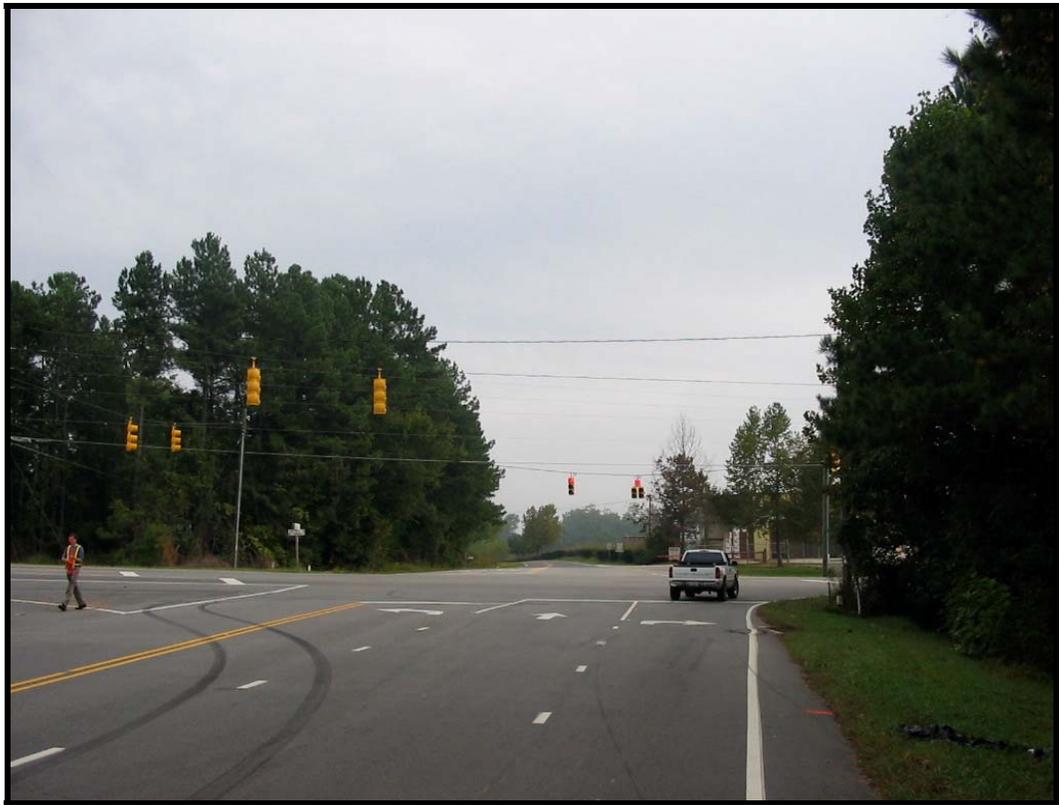
Looking NB on SR 1831 (Old Creedmoor Rd)

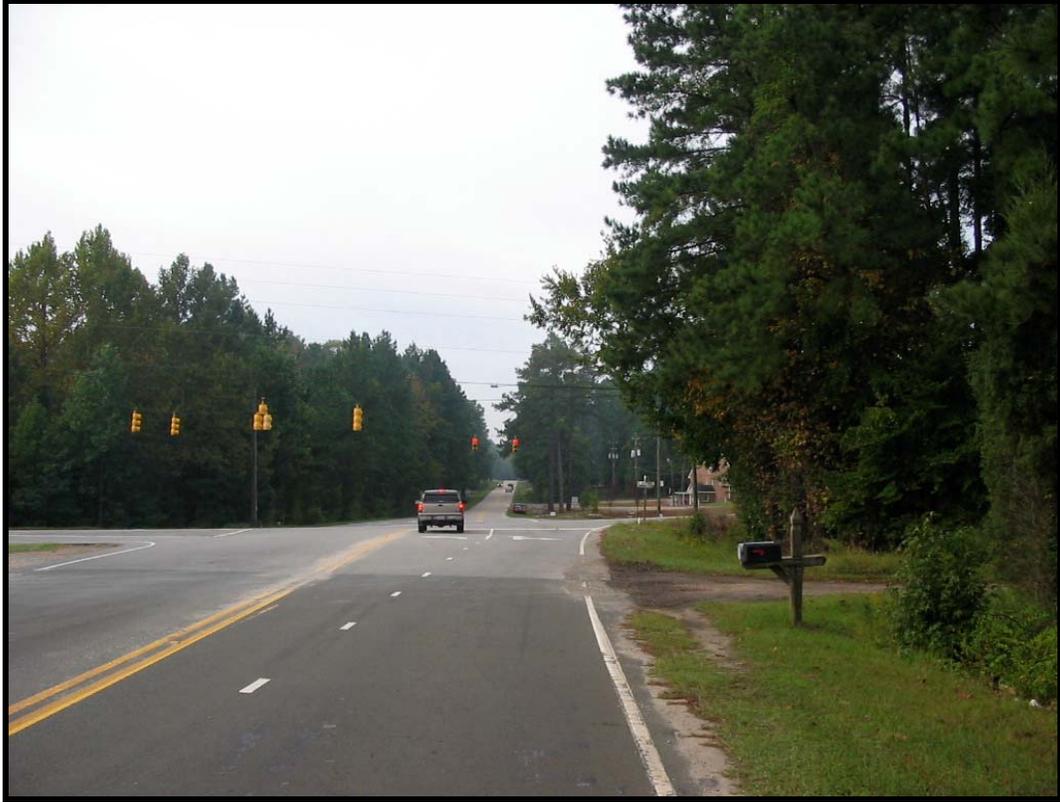
Looking SB on SR 1831 (Old Creedmoor Rd)

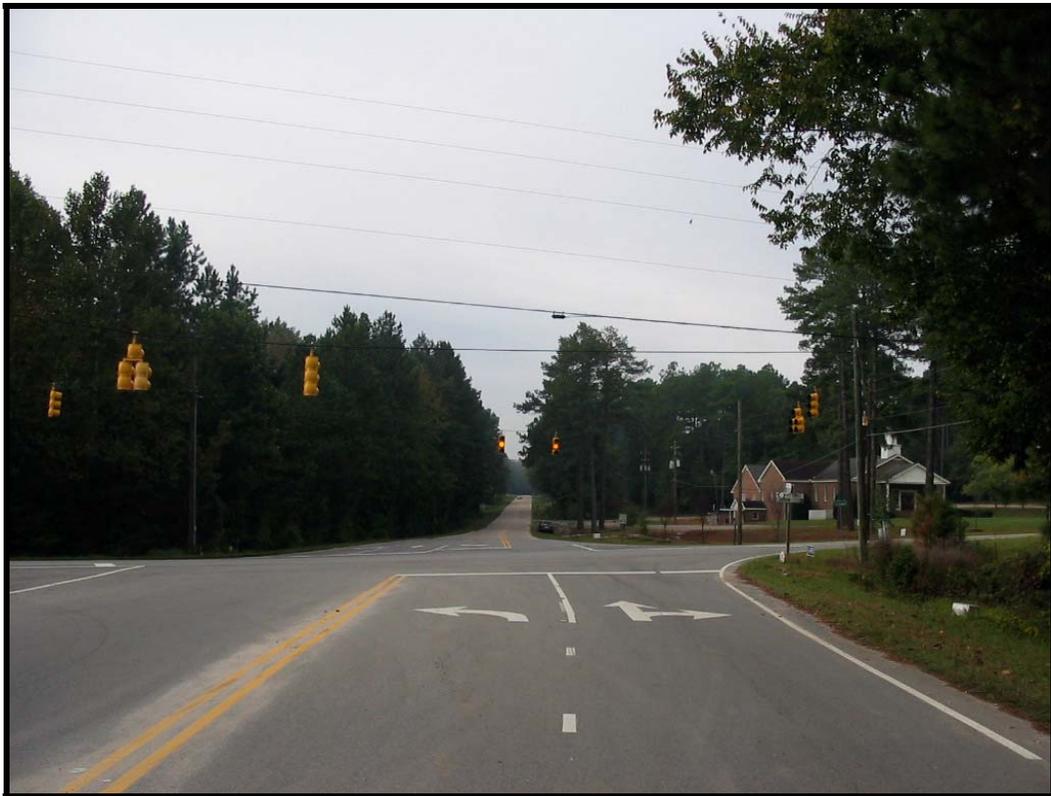
Looking SB on SR 1831 (Old Creedmoor Rd)

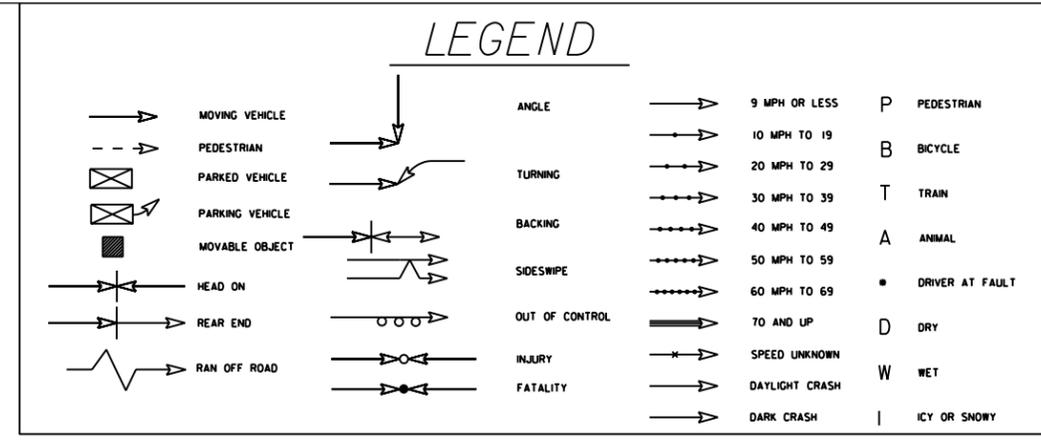
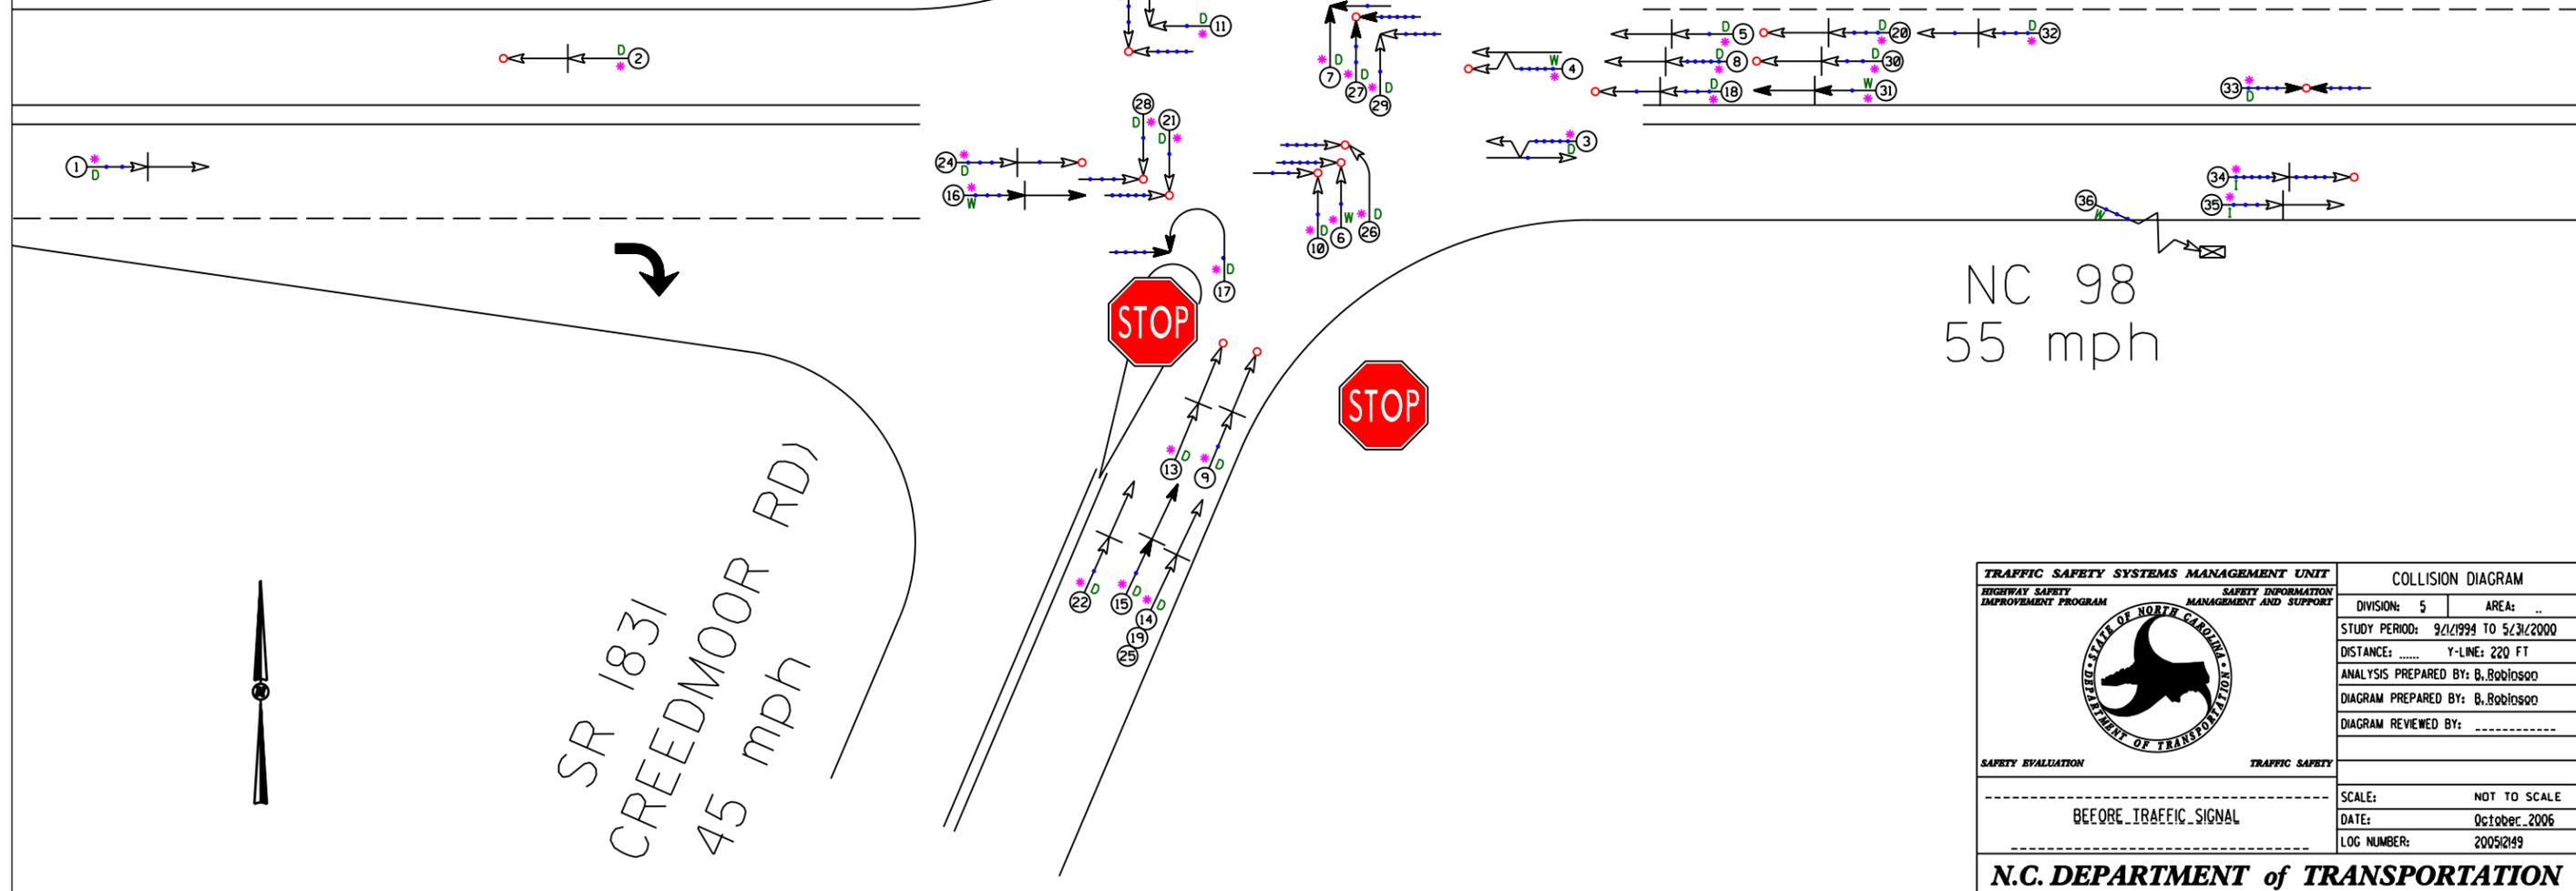
Wake County
 NC 98 (Durham Rd) at
 SR 1831 (Old Creedmoor Rd)
 Treatment Site in the
 Before Period (9/1/94-5/31/00)

Note: WB driver drove around stopped vehicle.

Referencing the *Collision Diagrams*, in the before period there was a large pattern of Rear-End Crashes for vehicles approaching the intersection from both westbound NC 98 and northbound SR 1831. Both of these patterns have disappeared in the after period, with no westbound Rear-Ends and only a single northbound Rear-End Crash in the study limits. The installation of turn lanes has provided vehicles with a refuge to wait in while vehicles traveling straight can continue uninterrupted.

Again referencing the *Collision Diagrams* and the previous table, the Frontal Impact Crashes have been almost eliminated in the after period. There was a single Left Turn, Same Roadway Crash on NC 98 in the after period and one crash involving a truck jackknifing in the intersection that was added to the Frontal Impact Crashes. The truck was traveling eastbound on NC 98 when the driver slammed on the breaks in an attempt to avoid a left turning driver from southbound SR 1831.

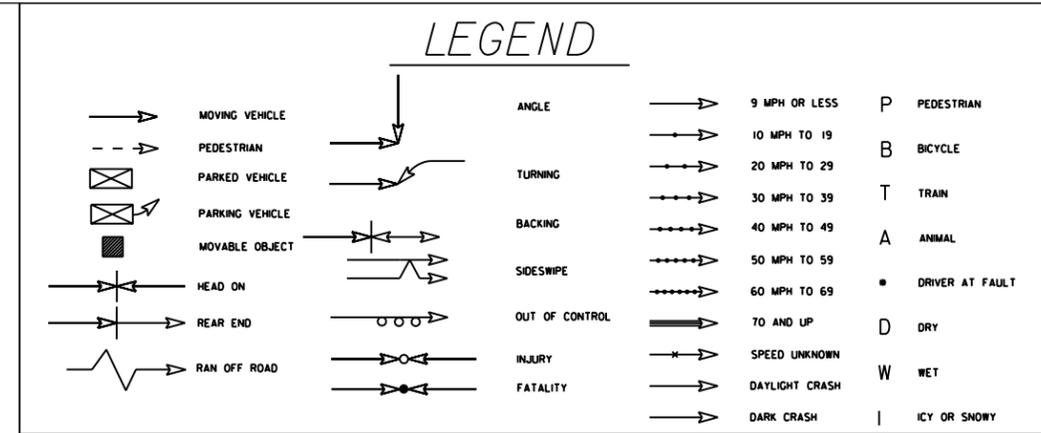
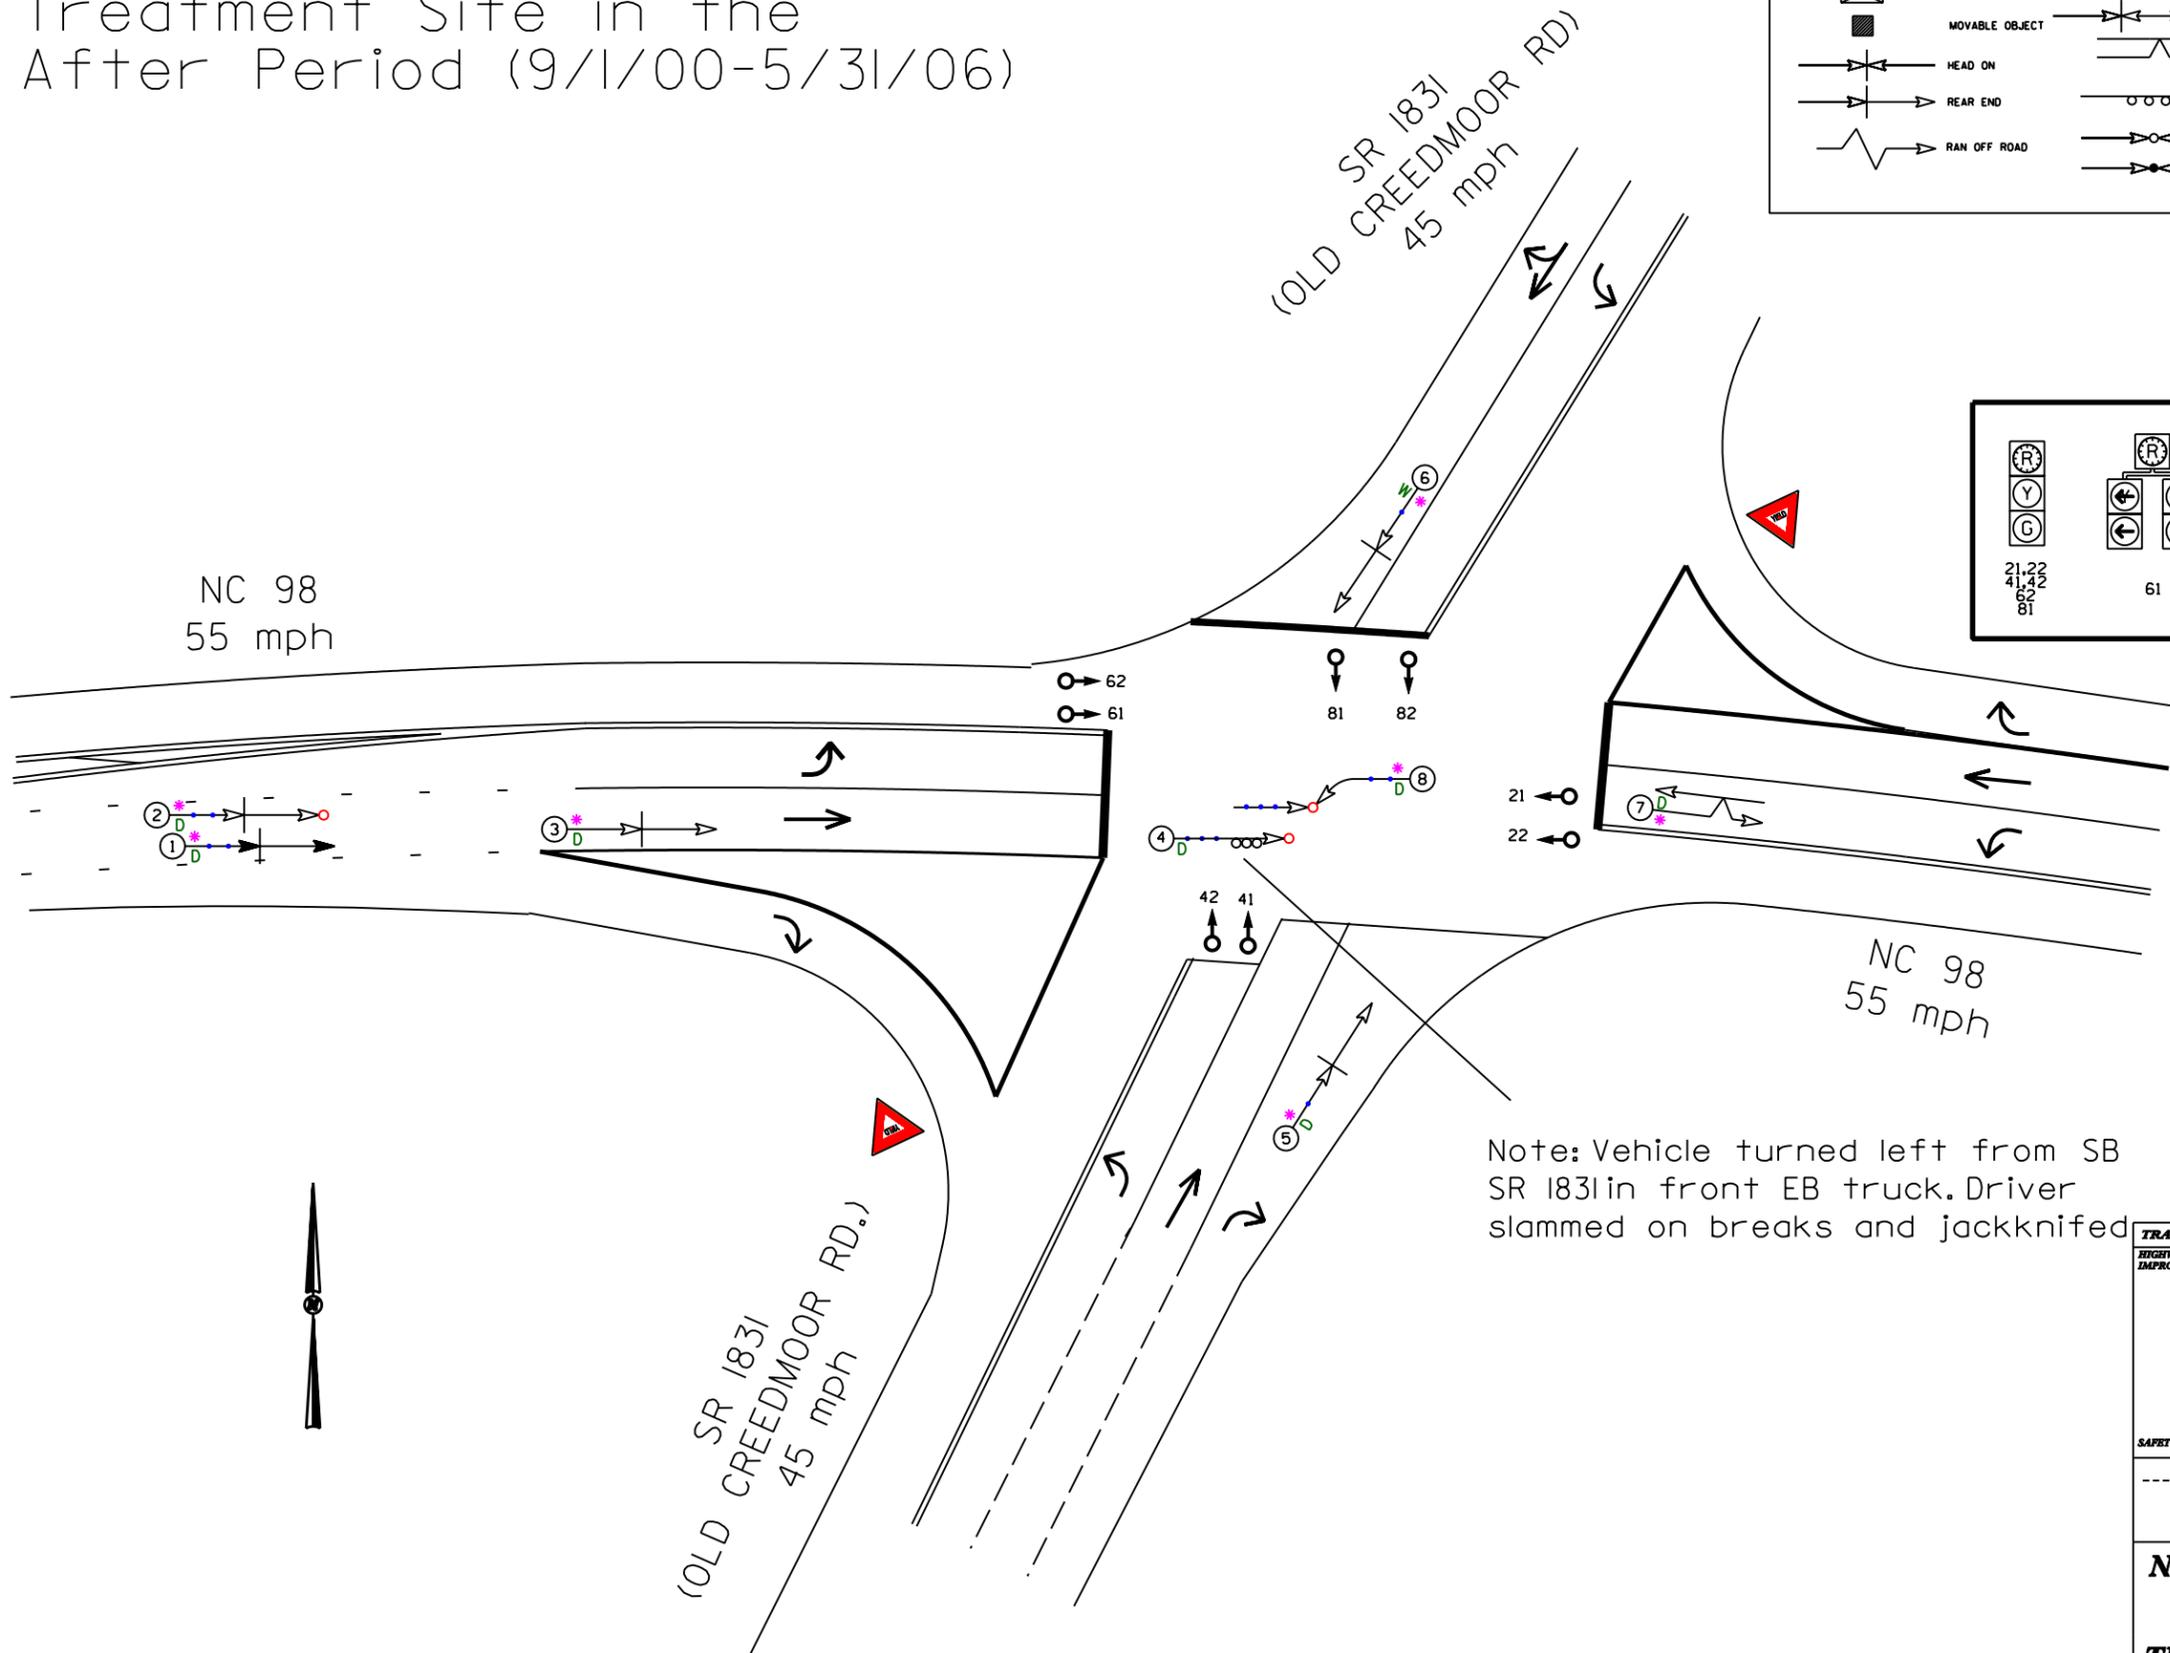
Wake County
 NC 98 (Durham Rd) at
 SR 1831 (Old Creedmoor Rd)
 Treatment Site in the
 After Period (9/1/00-5/31/06)
