# **Spot Safety Project Evaluation**

Project Log # 200512158

Spot Safety Project # 05-99-204

**Spot Safety Project Evaluation of the Traffic Signal Installation  
At the Intersection of SR 1375 (Lake Wheeler Rd) and SR 1393 (Hilltop-Needmore Rd)  
Wake County**

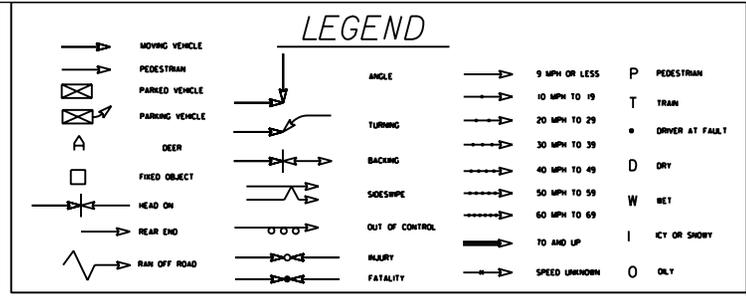
SR 1375  
 (Lake Wheeler Rd)  
 45 mph

SR 1393  
 (Hilltop-Needmore Rd)  
 45 mph

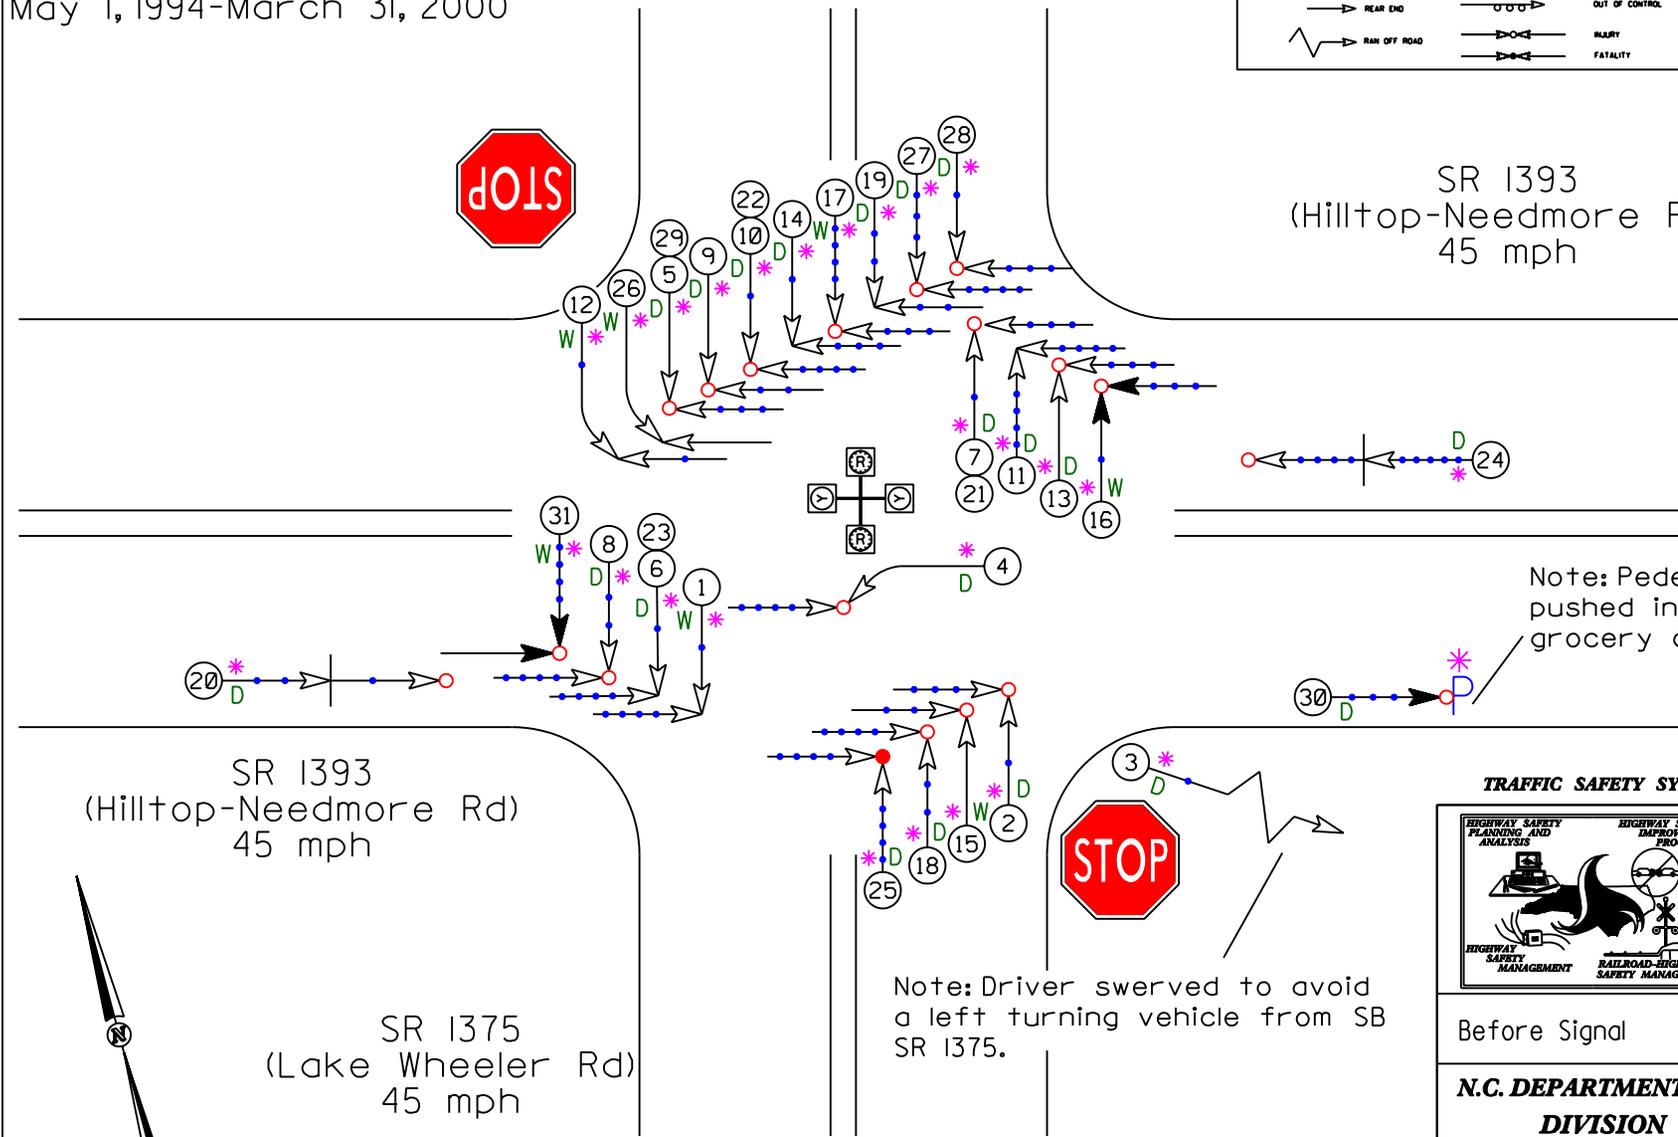
Before Signal

Wake County  
 SR 1375 (Lake Wheeler Rd) at  
 SR 1393 (Hilltop-Needmore Rd)  
 Treatment Site in the  
 Before Period  
 May 1, 1994-March 31, 2000

Note: Pedestrian was being pushed in the road on a grocery cart

Note: Driver swerved to avoid a left turning vehicle from SB SR 1375.

COLLISION DIAGRAM	
DIVISION: 5	AREA:
STUDY PERIOD: 5/1/94 - 3/31/00	
DISTANCE: Y-LINE = 150 ft	
ANALYSIS PREPARED BY: B Robinson	
ANALYSIS CHECKED BY:	
DIAGRAM PREPARED BY: B Robinson	
DIAGRAM REVIEWED BY:	
SCALE: NOT TO SCALE	
DATE: September 2006	
LOG NUMBER: 2005258

Referencing the *Collision Diagrams*, the installation of the signal greatly reduced the crash pattern between southbound SR 1375 vehicles and westbound SR 1393 vehicles (from 12 to 1), although Angle Crashes between southbound SR 1375 vehicles and eastbound SR 1393 vehicles increased by 40 percent (from 5 to 7). After conducting a field investigation it was observed that there is plenty of sight distance from both the southbound and eastbound approaches to the intersection. Referencing the *Collision Diagram, After Period*, 4 of the 7 after period crashes between southbound and eastbound vehicles involved an eastbound driver running the signal. There are no other signals within 3 miles west of the intersection, which might contribute to drivers not expecting a traffic signal at this location.
