Spot Safety Project Evaluation

Project Log # 200501266

Spot Safety Project # 05-99-205

**Spot Safety Project Evaluation of the Actuated Flashing Traffic Signal Installation with
“Vehicles Entering When Flashing” Signs at the Intersection of US 401 and
SR 1103 (Flat Rock Church Rd/Clifton Pond Rd) in Franklin County.**

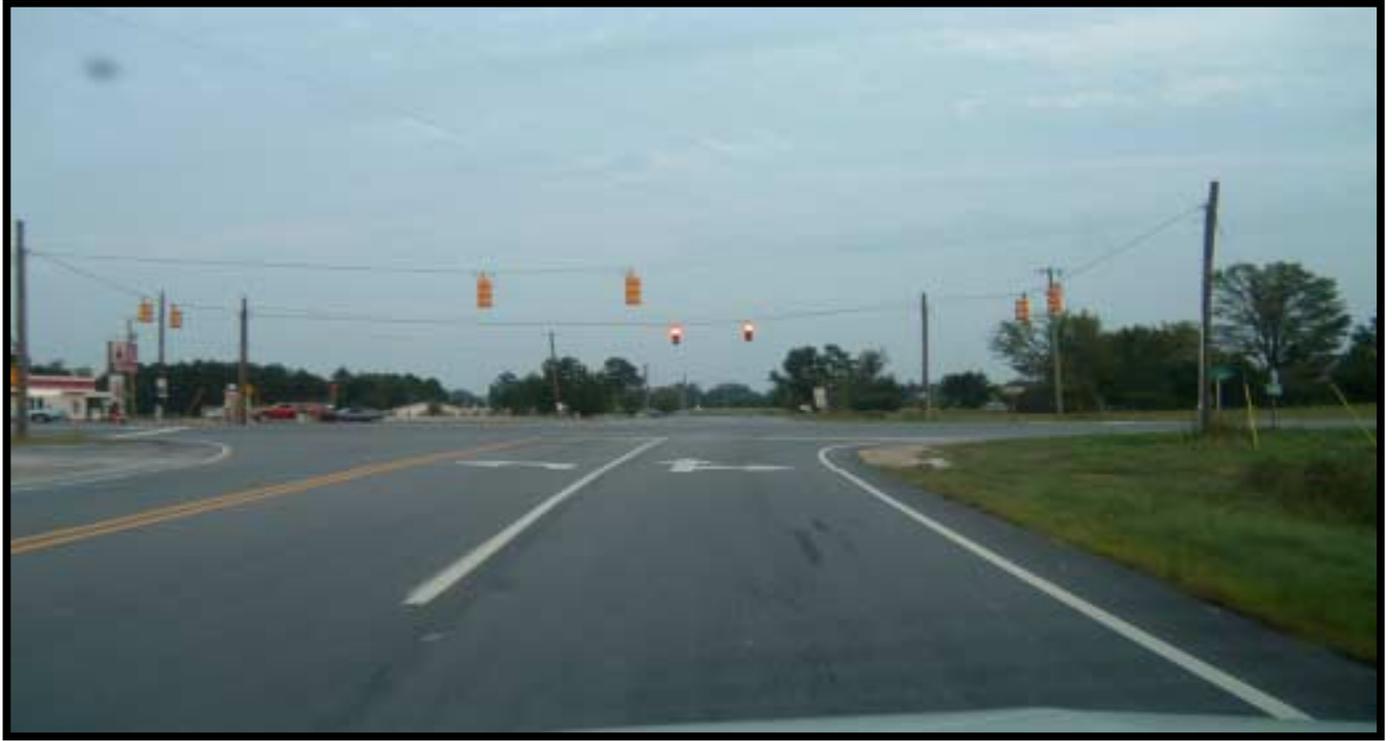
Driving East on SR 1103

A Standard traffic signal was installed in the second quarter of the year 2004. Geometric changes have also been applied to the subject intersection including removal of the islands and adding left turn lane for all approaches at the subject intersection. Additionally, a center left turn lane was added for both the SR 1103 West leg and US 401 North leg of the treatment site. *Please see attached location photos.*

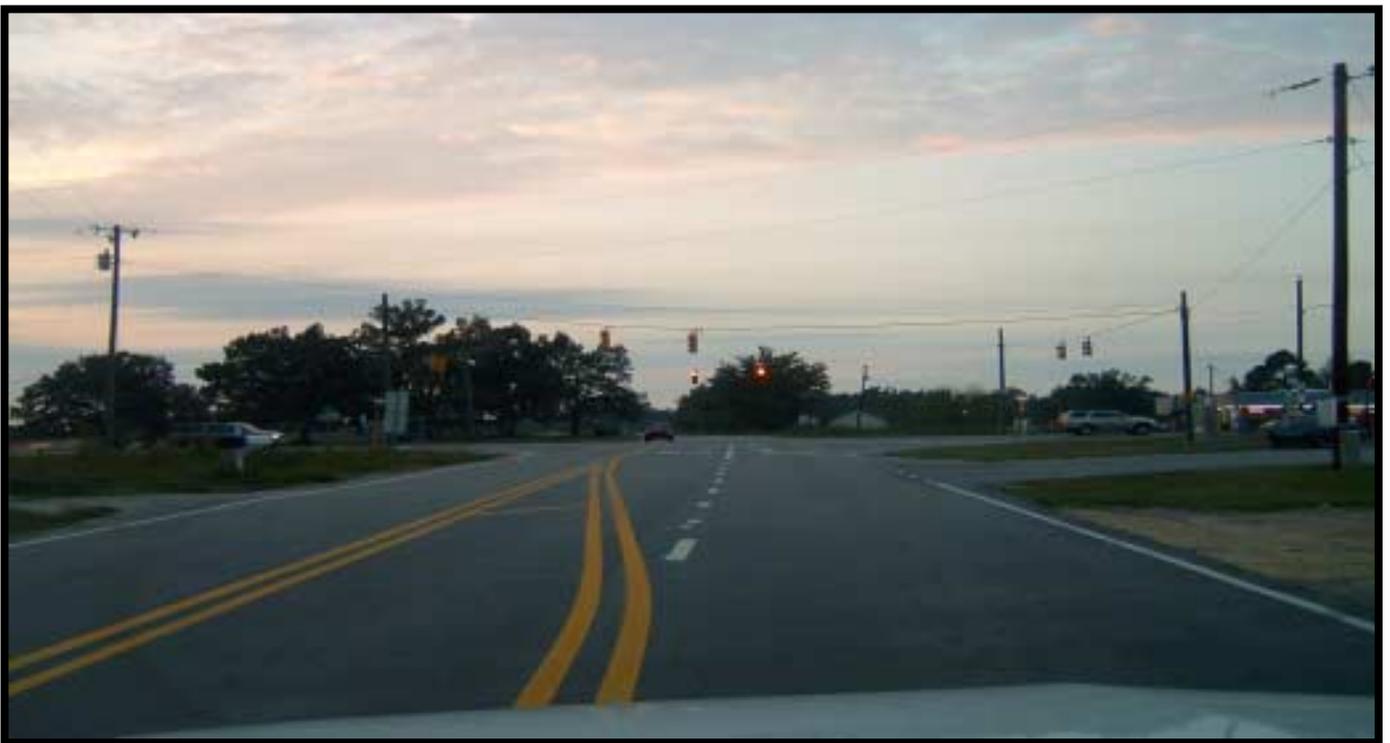
Driving West on SR 1103

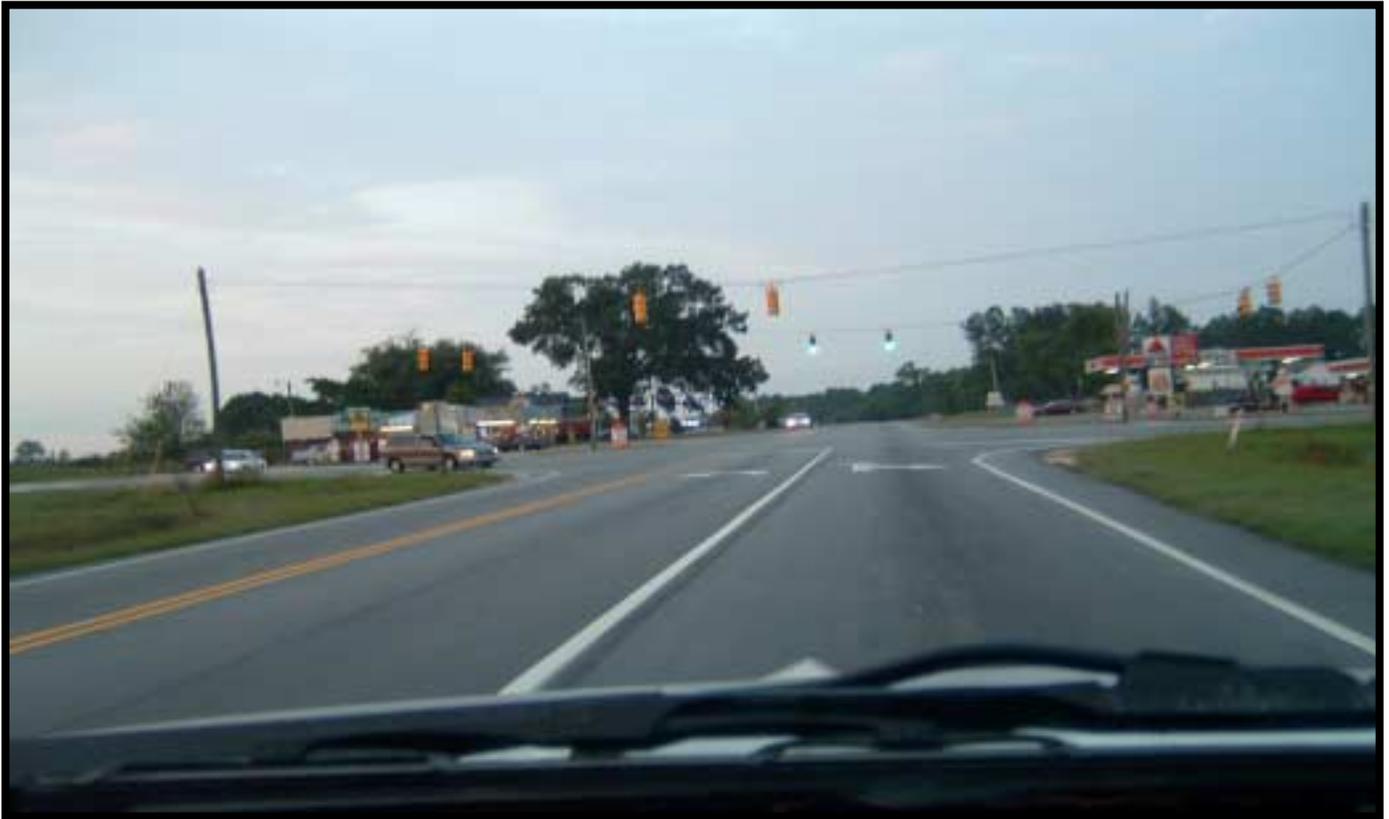
Driving North on US 401

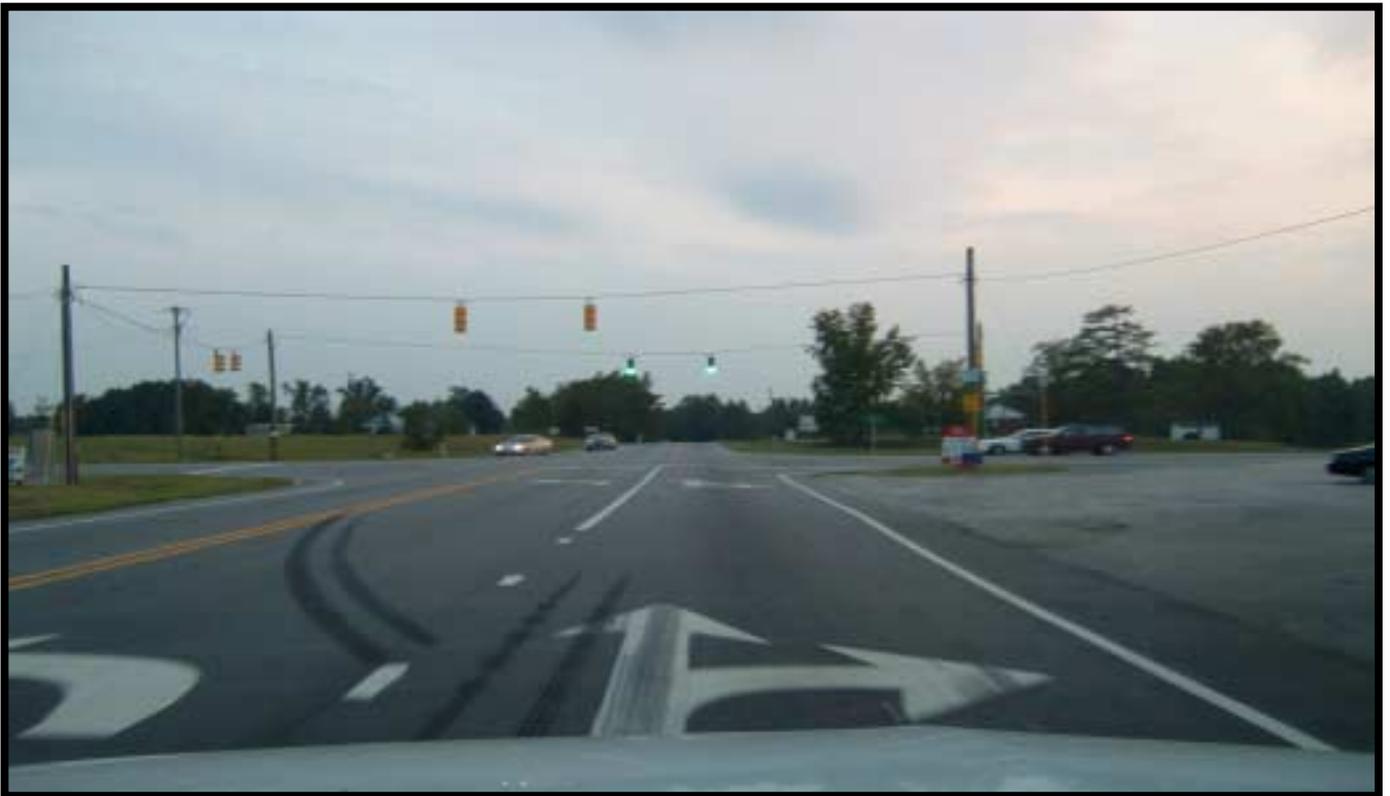
Driving South on US 401

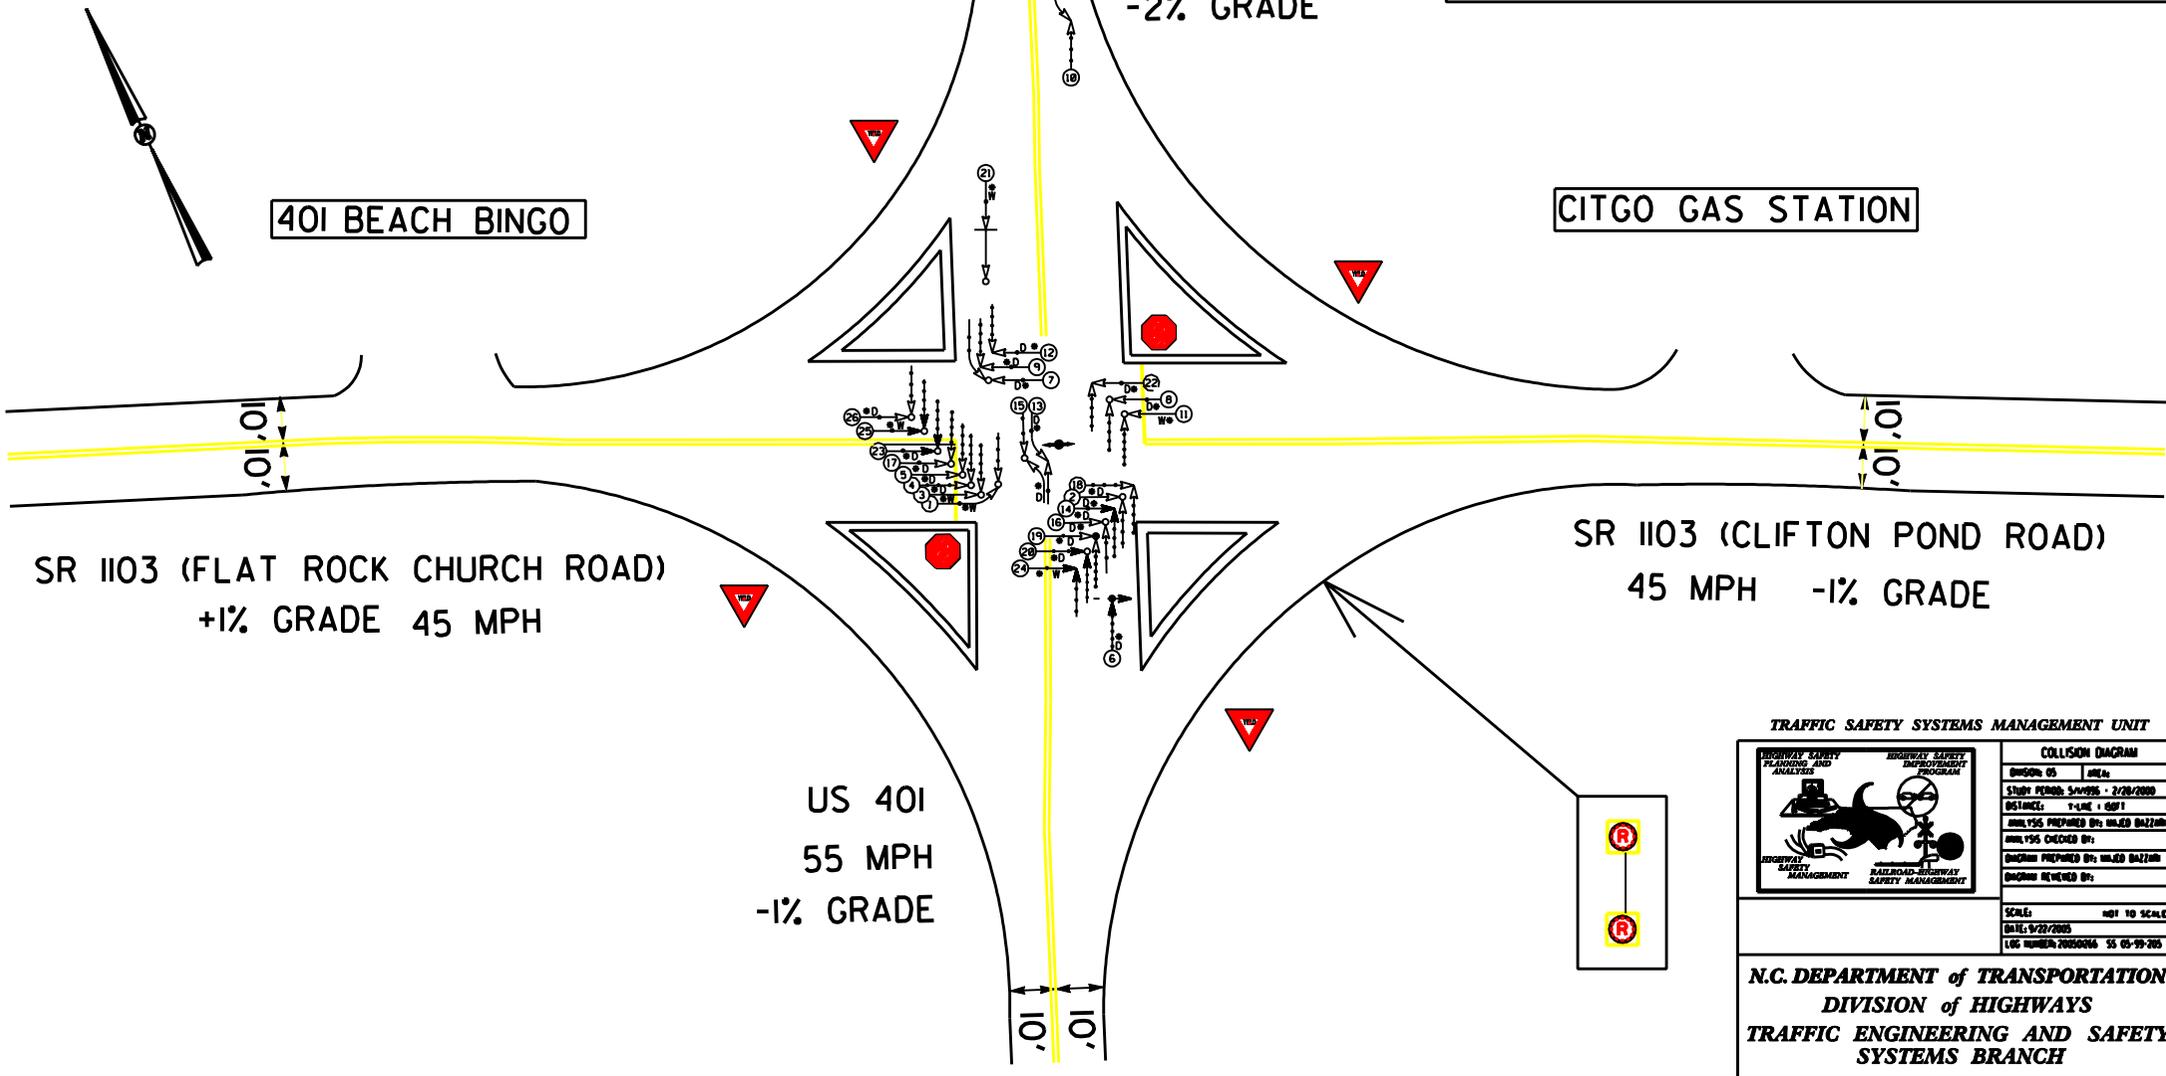
FRANKLIN COUNTY
 US 401 at SR 1103-Flat Rock Church/Clifton Pond
 Treatment Site in The Before Period
 From 5/1/1996 To 2/28/2000

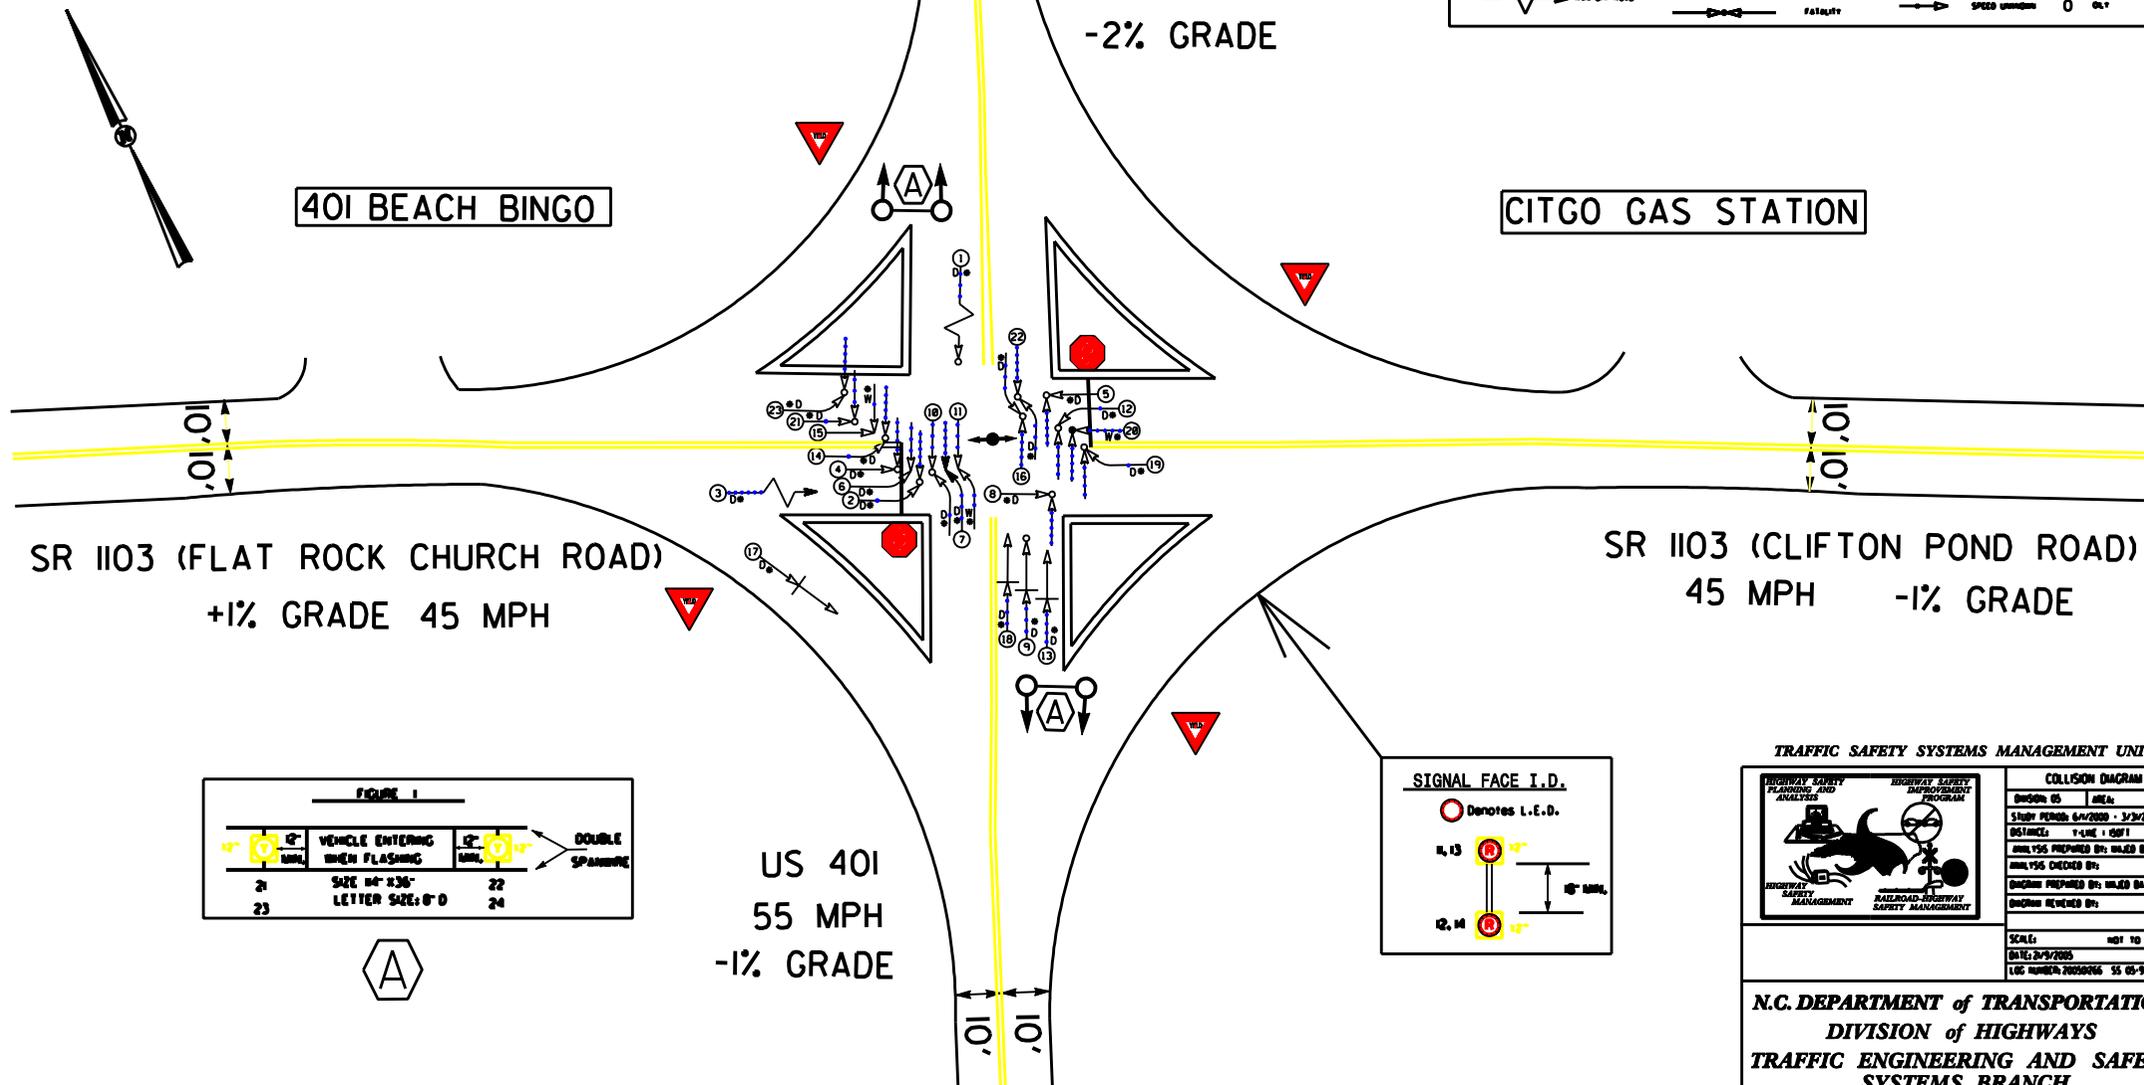
FRANKLIN COUNTY

US 401 at SR 1103-Flat Rock Church/Clifton Pond

Treatment Site in The After Period

From 6/1/2000 To 3/31/2004

COLLISION DIAGRAM	
Division: 05	Area:
Study Period: 6/1/2000 - 3/31/2004	
Distance: T-10E + 00FT	
Analysis Prepared By: WAJED BAZZAN	
Analysis Checked By: WAJED BAZZAN	
Diagram Reviewed By:	
Scale: NOT TO SCALE	
Date: 2/9/2005	
Log Number: 20050066	SS 05-99-205
