Spot Safety Project Evaluation

Spot Safety Project # 05-99-212

Spot Safety Project Evaluation of the Flashing Traffic Signal Installation at the Intersection of SR 1010-Ten Ten and SR 2727-Crowder Road/Sauls Road in Wake County.

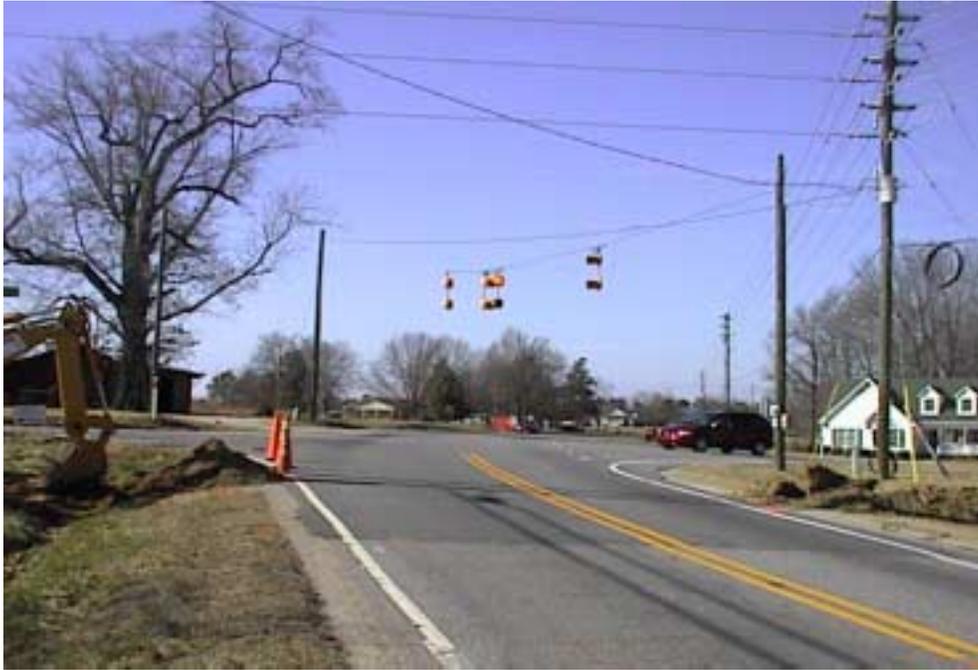
Looking West

More specifically southbound/eastbound combinations were prominent in both study periods (11 in the before period and 10 in the after period). These facts suggest that there is a problem with drivers making a sound judgement when crossing SR 1010 southbound on SR 2727. In the pictures attached, the intersection sits on a vertical crest at a skew with eastbound traffic approaching while in a curve, if positioned southbound on SR 2727 at SR 1010. These physical attributes may make it difficult to distinguish a passable gap in the traffic on SR 1010.

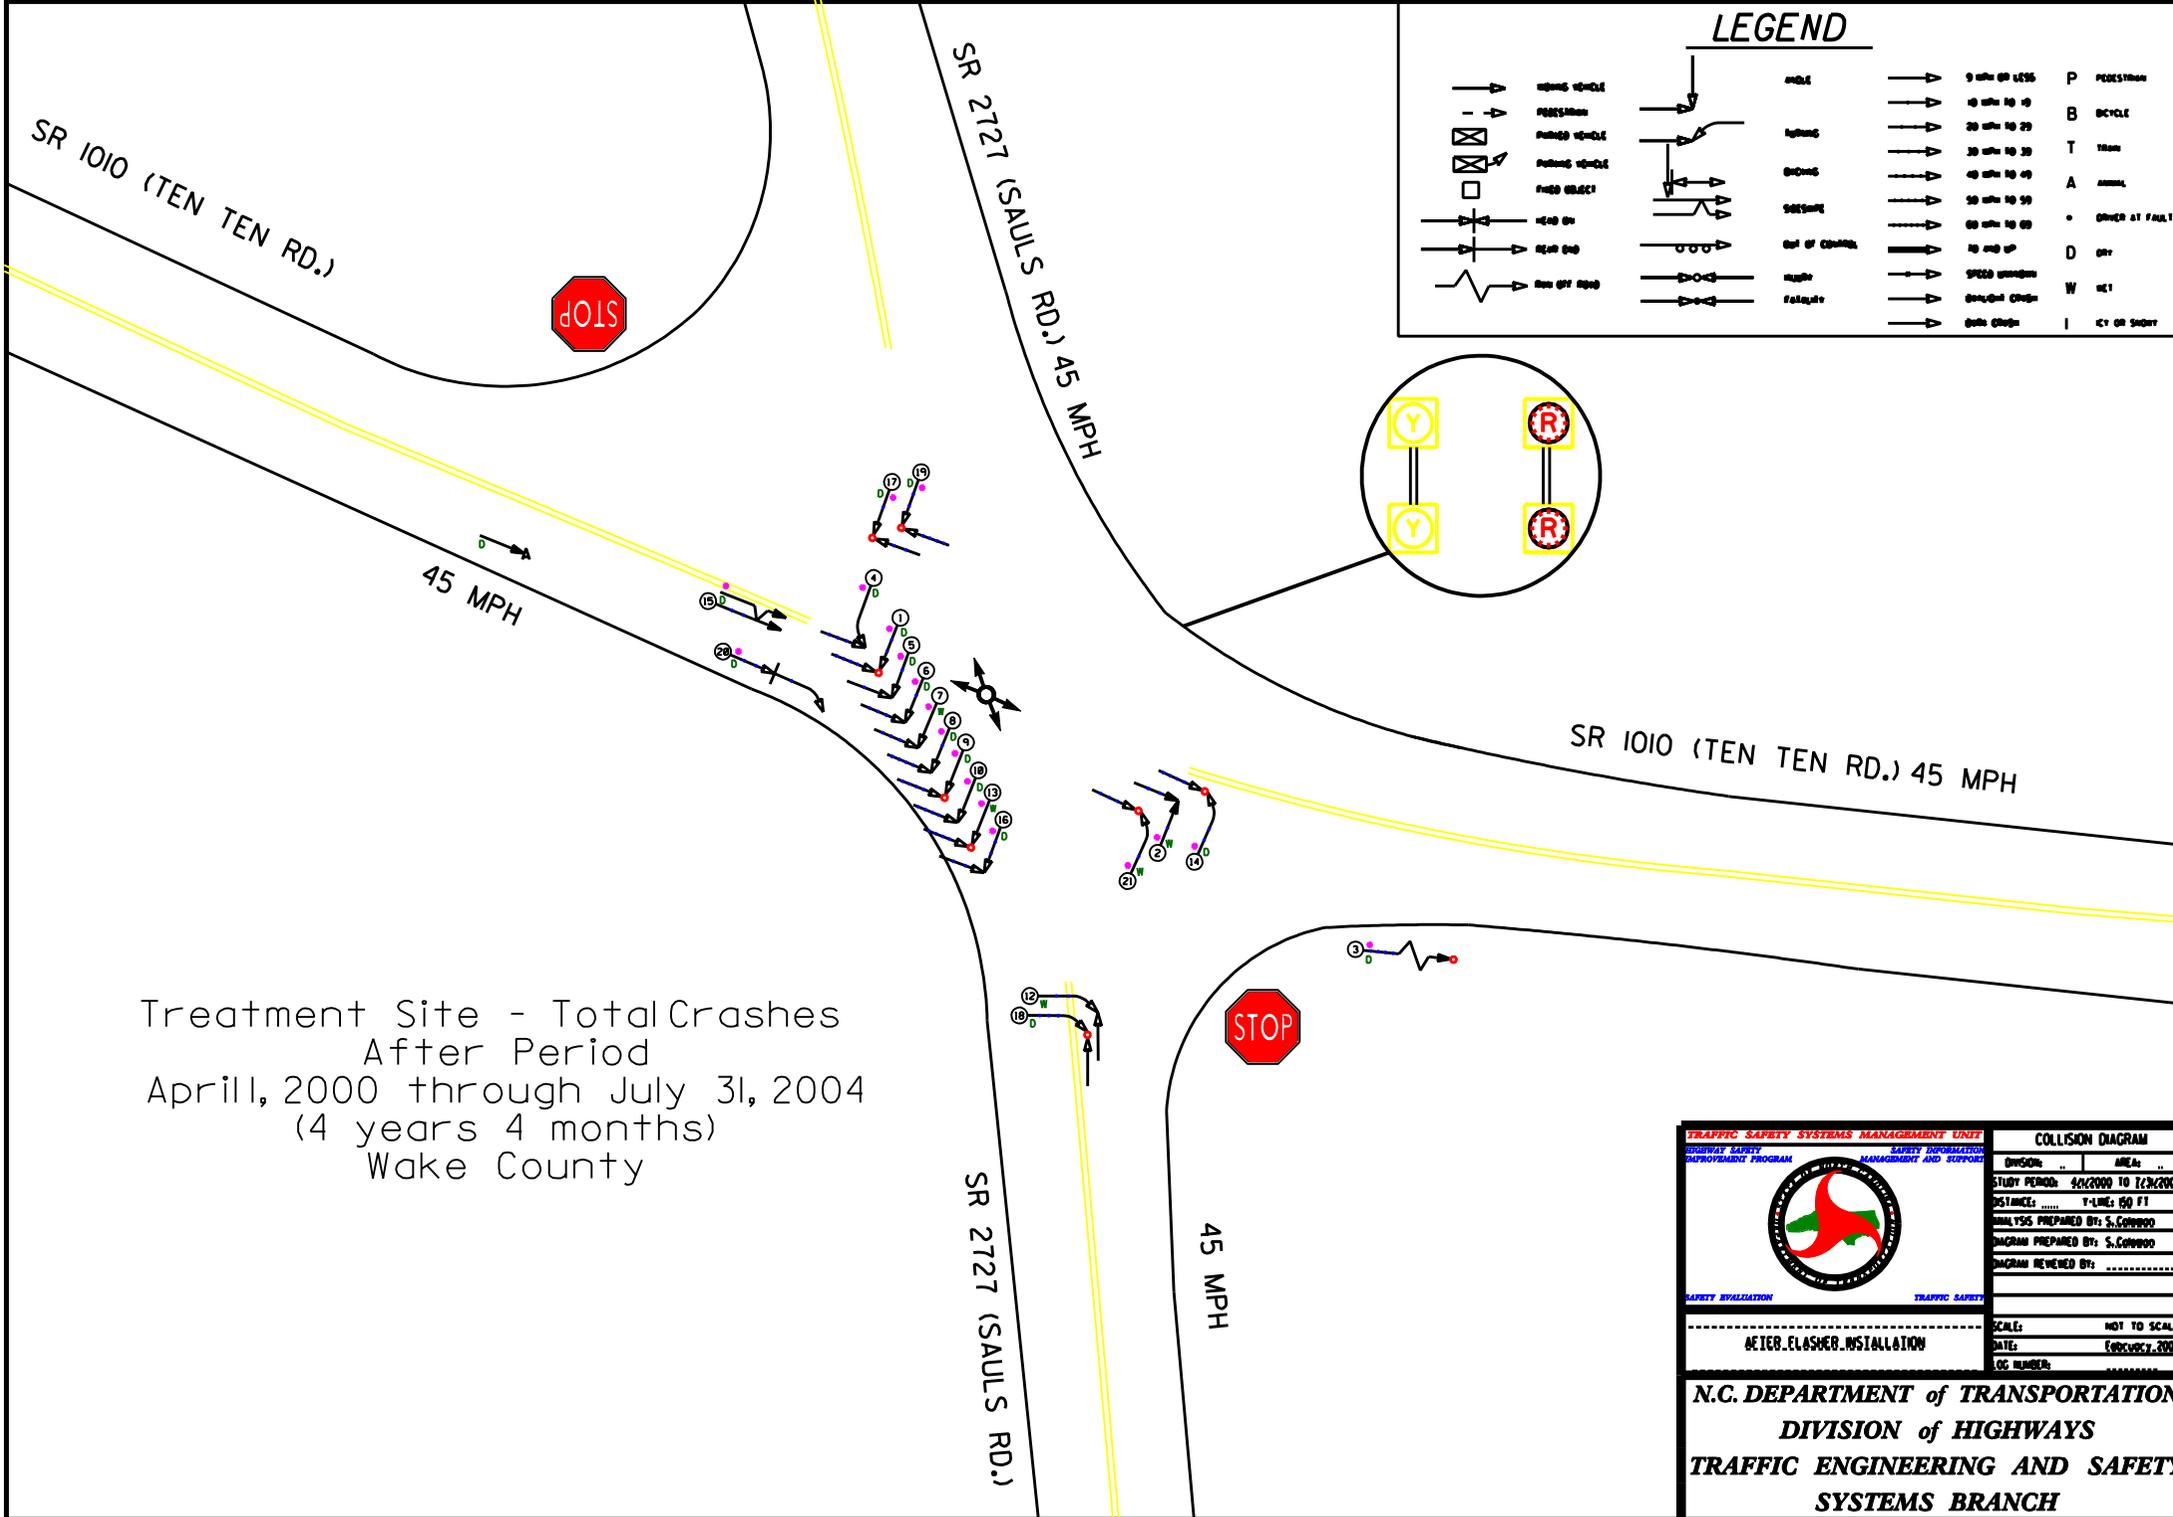
Treatment Site - TotalCrashes
 After Period
 April, 2000 through July 31, 2004
 (4 years 4 months)
 Wake County

TRAFFIC SAFETY SYSTEMS MANAGEMENT UNIT		COLLISION DIAGRAM	
SAFETY INVESTIGATION	SAFETY REPAIRS	DIVISION:	AREA:
		STUDY PERIOD:	4/1/2000 TO 7/31/2004
		DISTANCE:	Y-LINE: 150 FT
METER FLASHER INSTALLATION		ANALYSIS PREPARED BY:	S. CONWOOD
		DIAGRAM PREPARED BY:	S. CONWOOD
		DIAGRAM REVIEWED BY:	
		SCALE:	NOT TO SCALE
		DATE:	FEBRUARY, 2005
		LOG NUMBER:

Peak distribution for the crash data in the after period occurred from 4pm to 7pm (4 crashes, 4:00p-5:00p; 4 crashes, 5:00p-6:00p; 3 crashes, 6:00p-7:00p). For the 4 and 5 o'clock hour, 3 of the 4 crashes were a result of the southbound vehicle failing to stop. For the 6 o'clock hour, all 3 of the crashes were a result of the southbound vehicle failing to stop. As a result 9 out of the 11 crashes (81.8 percent) from 4p to 7p were from a southbound error. A total of 15 after crashes were angle types, 12 of them occurred from southbound error (80.0 percent). A total of 14 before crashes were angle types, 11 of them occurred from southbound error (78.5 percent).
