# **Spot Safety Project Evaluation**

Spot Safety Project # 06-96-207

**Spot Safety Project Evaluation of the Resurface – Wedge and Overlay, along US 401 from SR 2019 to SR 2035 in Harnett County**

Evaluation of Spot Safety Project Number 06-96-207 – along US 401 from SR 2019 to SR 2035 in Harnett County.

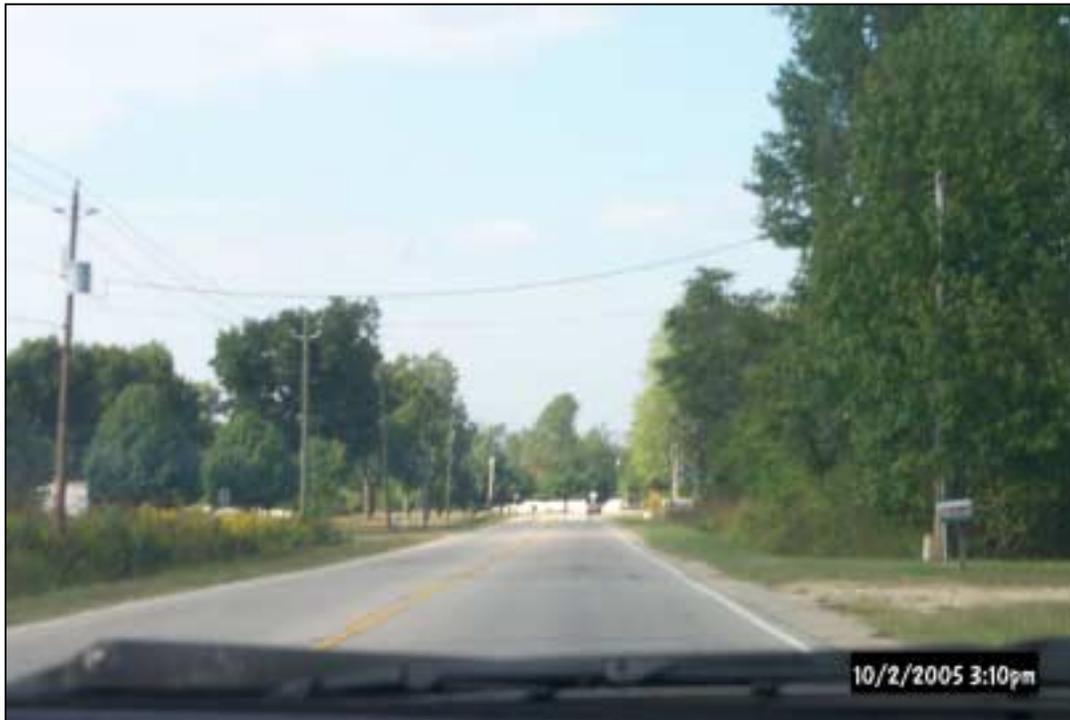
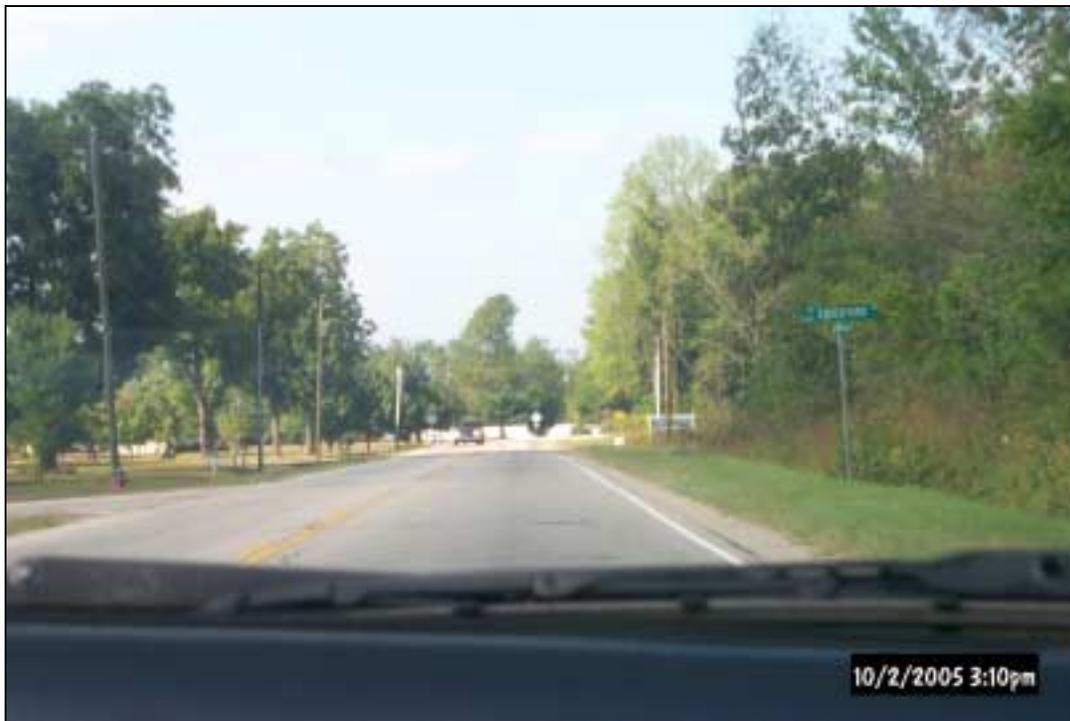
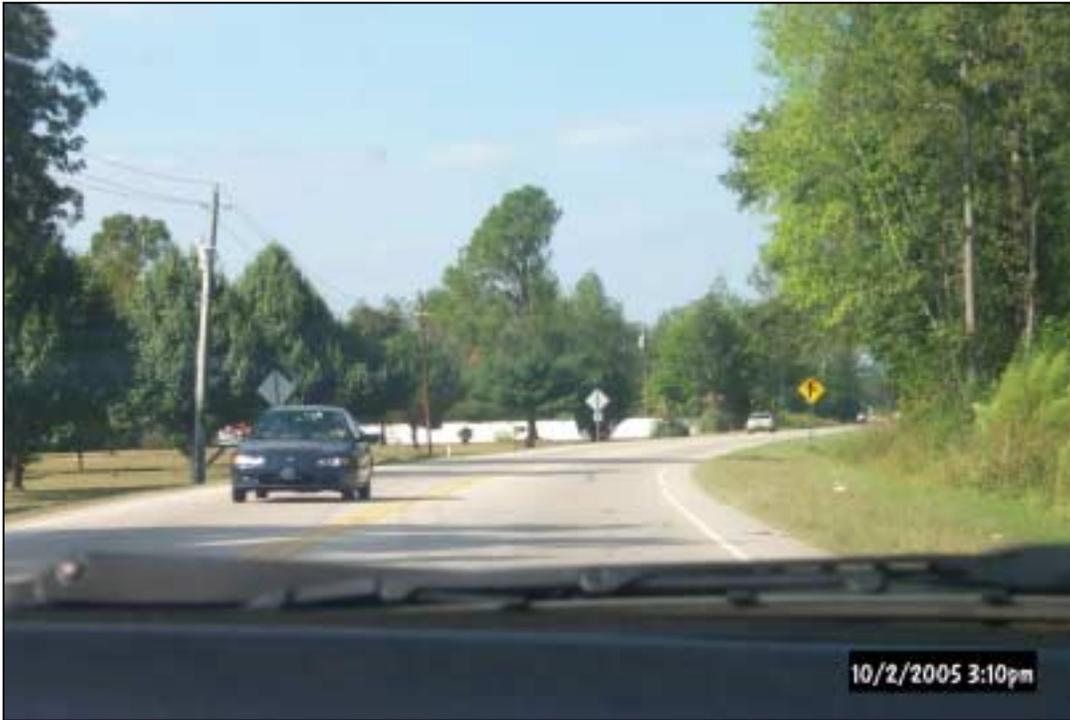
Treatment Strip Photos Taken October 2, 2005

Driving North on NC 401

With these factors included, there were a total of 22 wet crashes in the before period. After resurfacing US 401 with skid resistant materials, the wet crash total was reduced to 0. Referencing the included photos, there is a super-elevation in the curve that may help with drainage, helping to reduce the number of wet crashes. In the after period there is also a speed advisory for the slight curve that exists along this road which may contribute to the lower speeds for the after period crashes decreasing the severity.

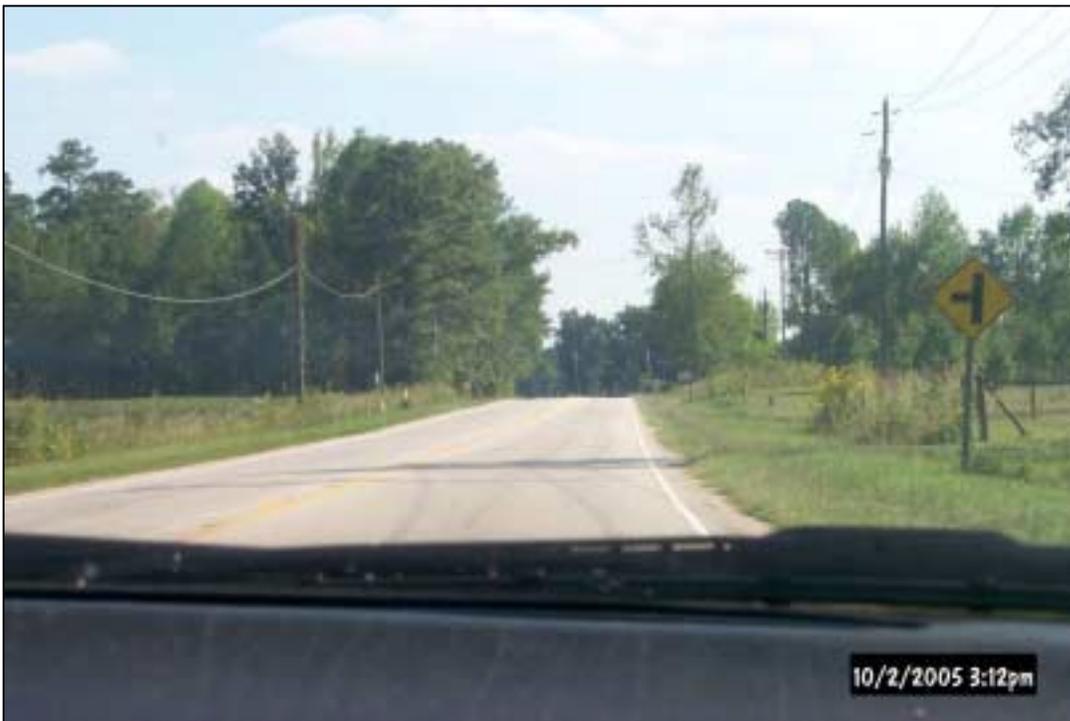
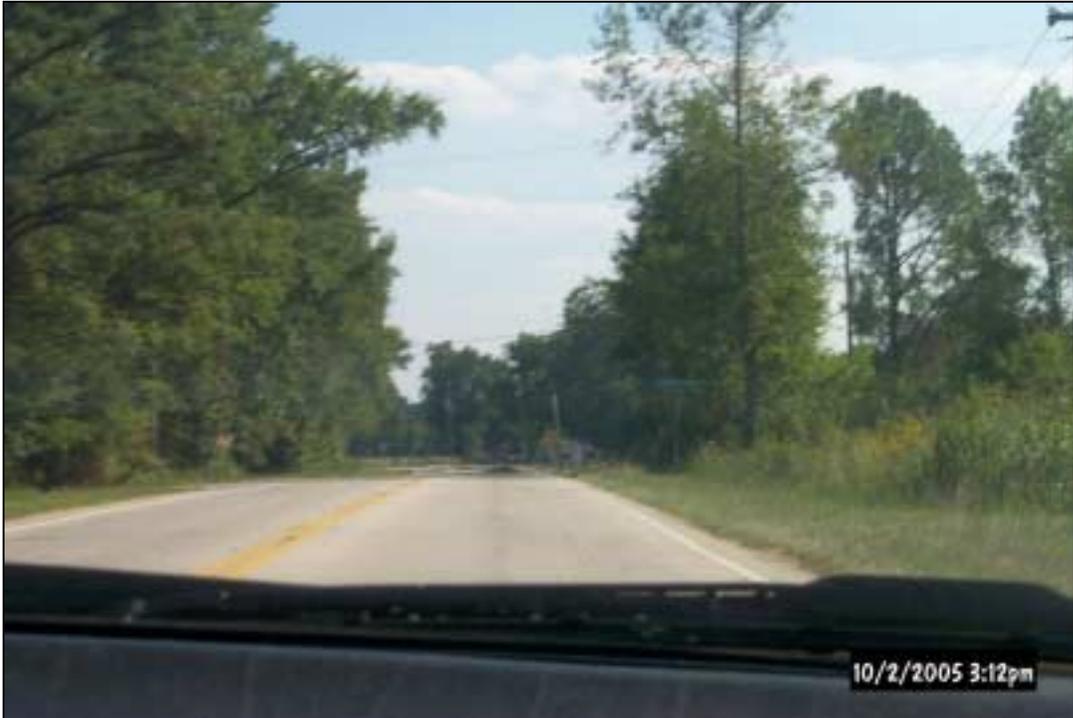
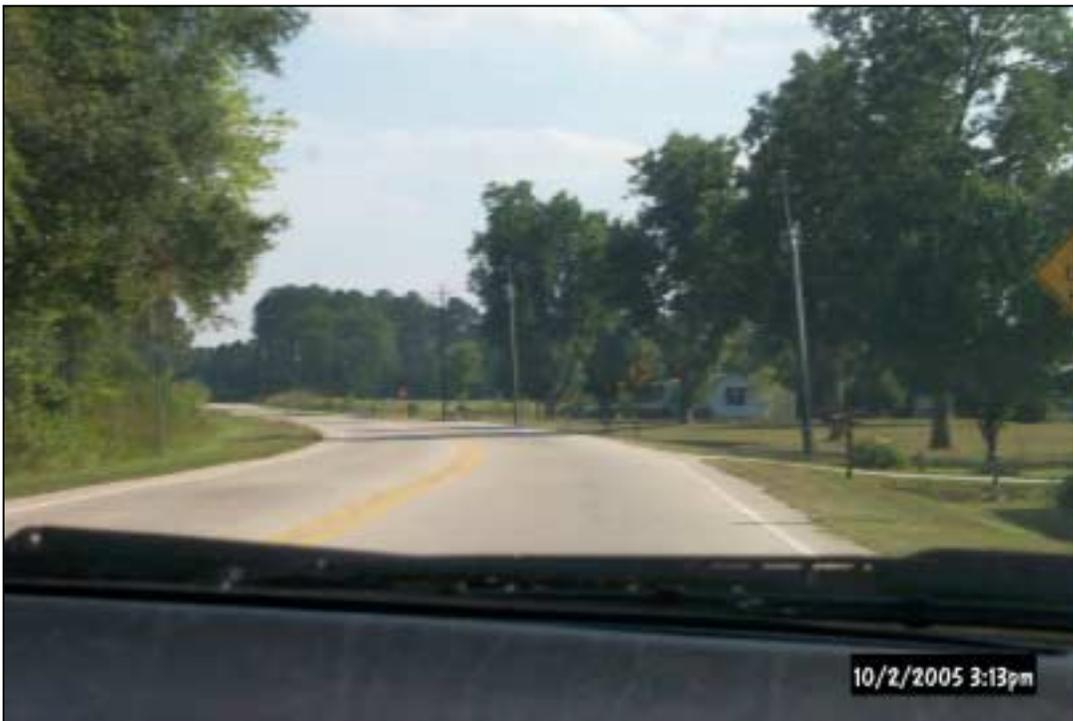
Driving South on NC 401

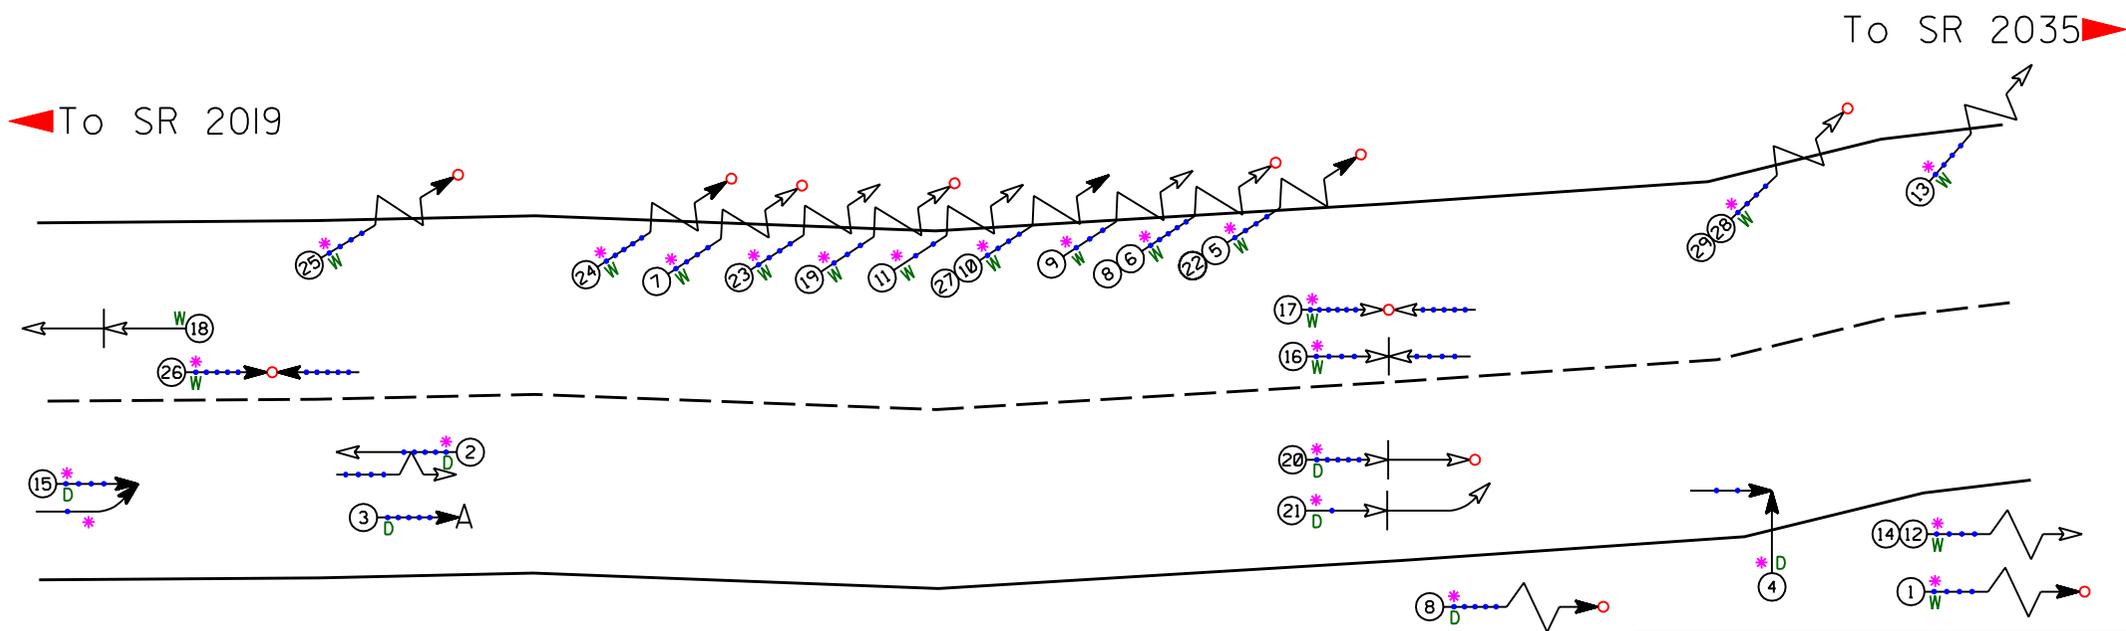
Treatment Site - Total Crashes  
 Before Period  
 February 1, 1990 - July 31, 1997  
 (7 years 6 months)  
 Harnett County

US 401  
 55 mph  
 (45 mph speed advisory for curve)

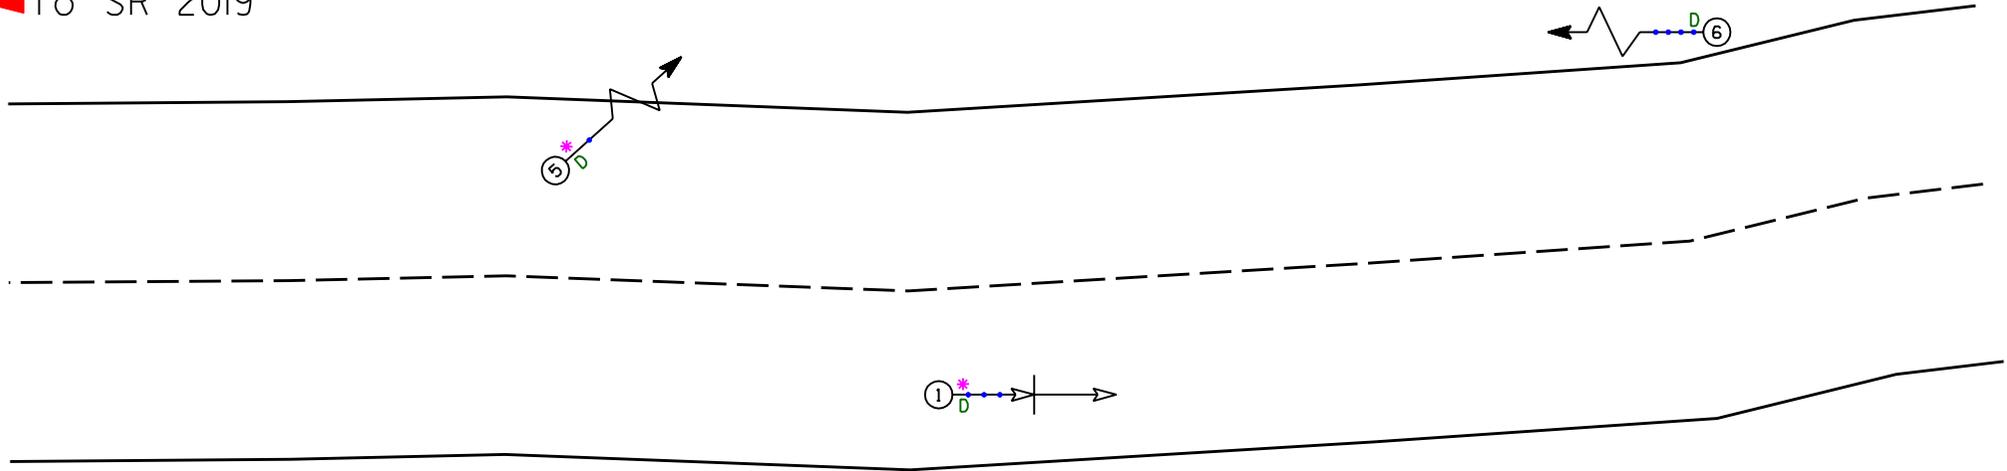
Treatment Site - Total Crashes  
 After Period  
 November 1, 1997 - April 30, 2005  
 (7 years 6 months)  
 Harnett County

US 401  
 55 mph  
 (45 mph speed advisory for curve)
