# **Spot Safety Project Evaluation**

Project Log # 200610098

Spot Safety Project # 06-97-204

**Spot Safety Project Evaluation of the Standard Flasher Installation at the Intersection of NC 210 at SR 1006 (Old Stage Road) in Harnett County**

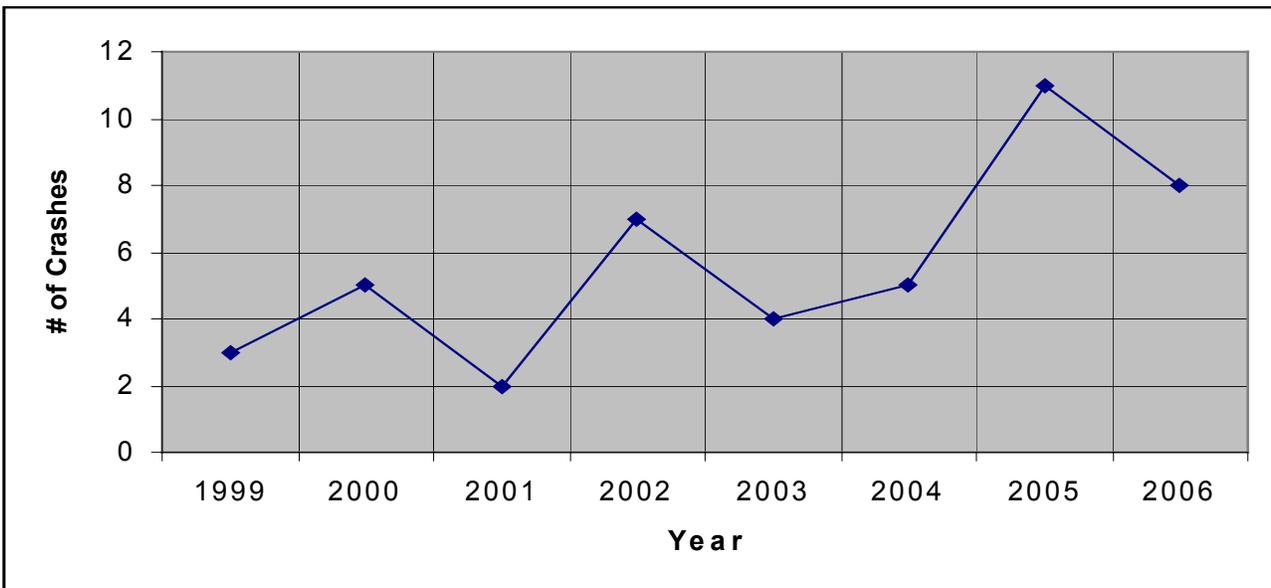
Table 2.

Table 2 shows a distribution of crashes over the study period of this evaluation. Notice crashes peaked just before the installation of the flasher, then were reduced and remained consistent for the next two years before peaking again. This information shows that the flasher may have had little to no effect on the decisions made by motorists.

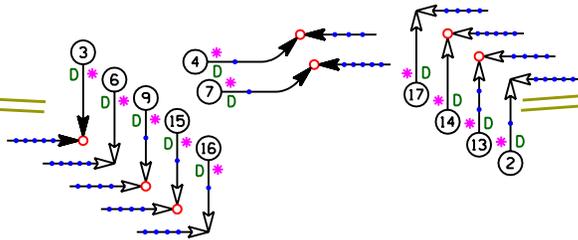
Harnett County  
 Treatment Site - Total Crashes  
 Before Period  
 January 1, 1999 - September 30, 2002  
 (3 years, 9 months)

SR 1006  
 55 MPH

NC 210  
 55 MPH

Referencing the collision diagrams and the background information it is apparent that some motorists are still having problems traversing the intersection safely. In the before period there are two angle crashes with the “at fault” vehicle showing a speed of 20 mph or greater. In the after period there are eight angle crashes with the “at fault” vehicle showing a speed of 20 mph or greater. This data may indicate some vehicles are running the stop condition.

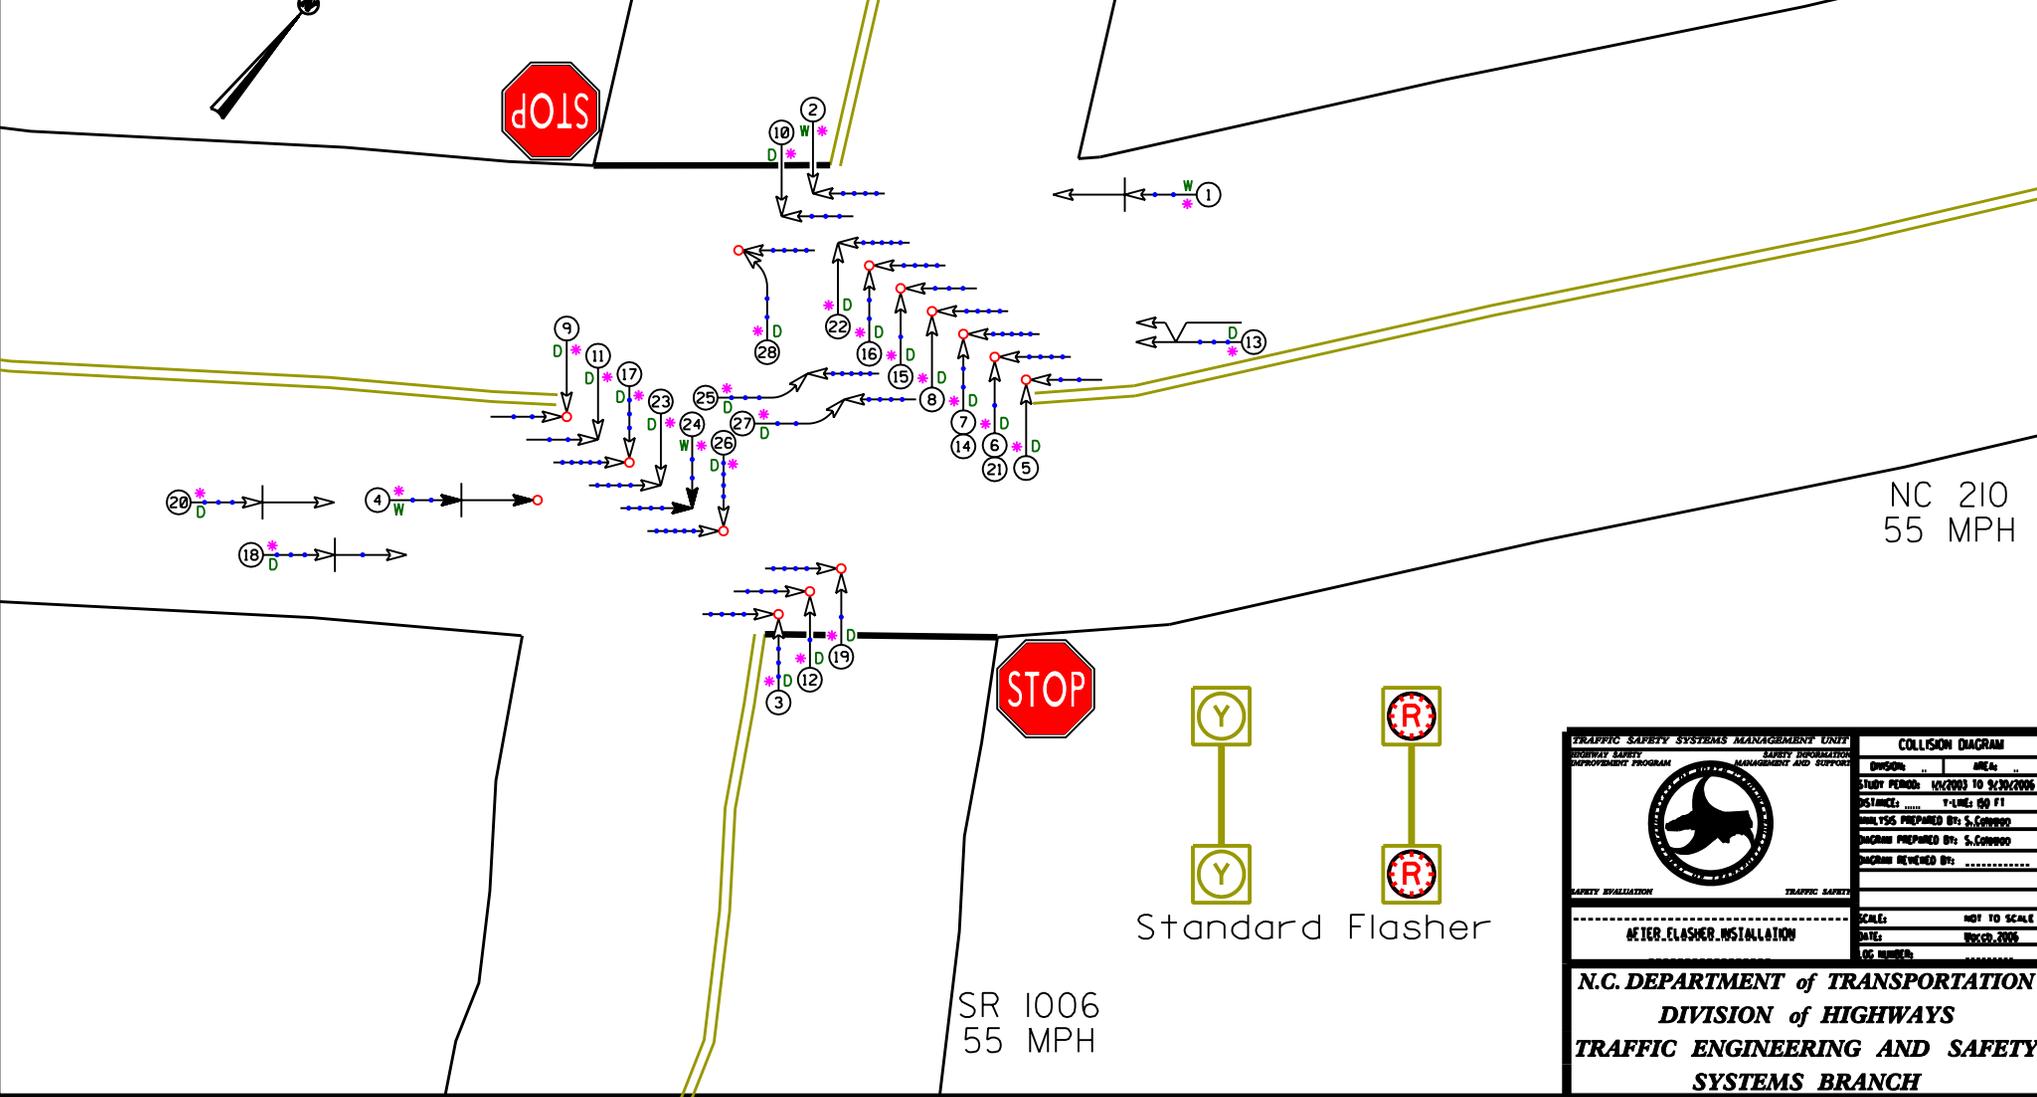
Harnett County  
Treatment Site - Total Crashes  
After Period  
January 1, 2003 - September 30, 2006  
(3 years, 9 months)

NC 210  
55 MPH

SR 1006  
55 MPH

Standard Flasher
