Spot Safety Project Evaluation

Project Log # 200505125

Spot Safety Project # 06-98-205

**Spot Safety Project Evaluation of the Guardrail Installation,
On SR 1527-Pine Log Road at the Raft Swamp Bridges
Near Lumberton, Robeson County**

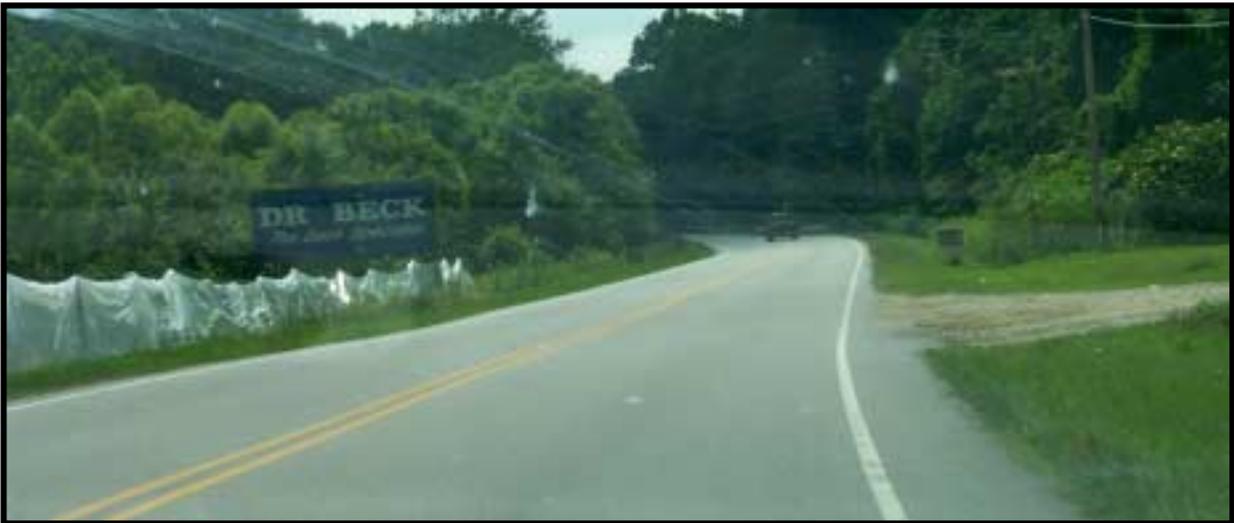
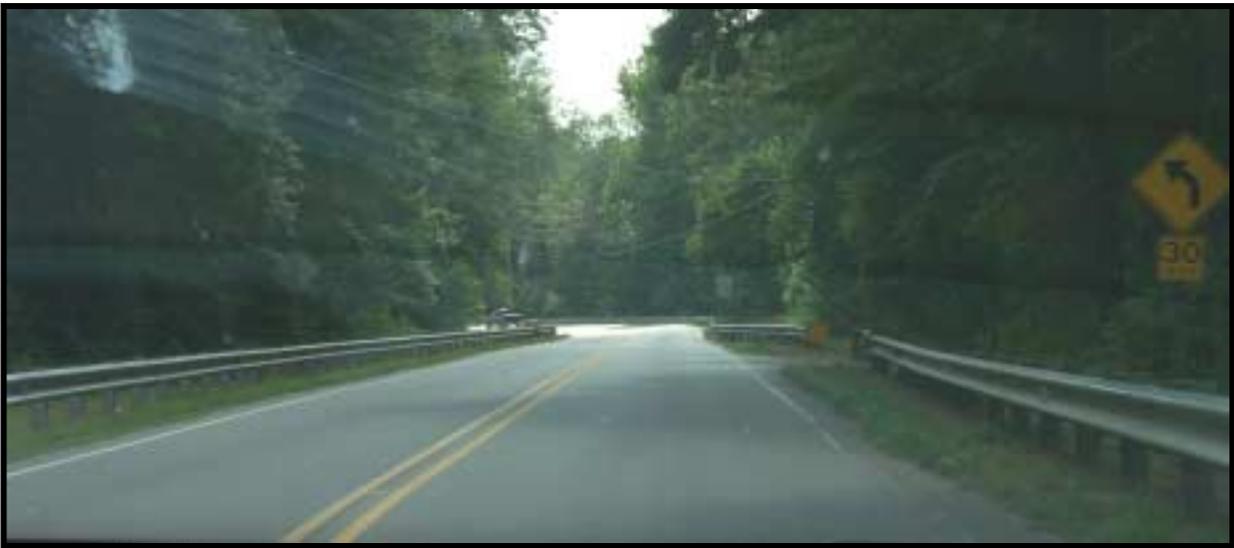
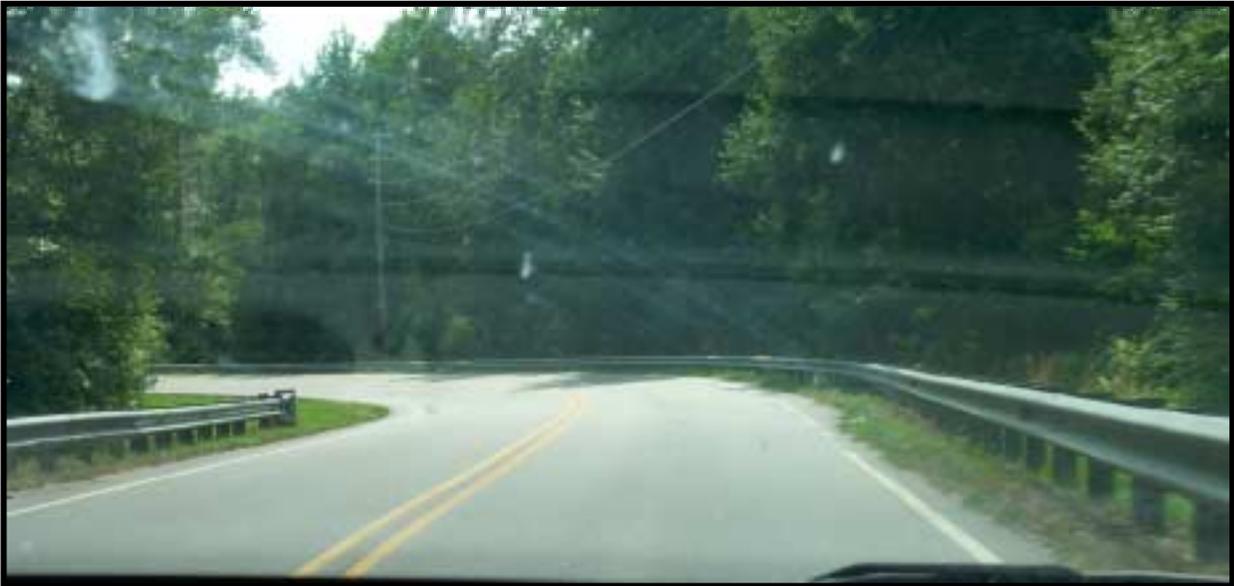
Treatment Site Photos (Taken on June 13, 2005)

Driving southwest on SR 1527-Pine Log Road

In order to mitigate the problem at the treatment site, countermeasures should be taken to prevent motorists from leaving the roadway. Possible countermeasures include installing centerline and shoulder rumble strips and improving delineation through the use of Chevrons in the curves. Better delineation will help to position vehicles correctly through the curves and provide more information in poor visibility conditions. In the after period, 40.0 percent of Target Crashes occurred at night and 45.0 percent occurred in wet pavement conditions, both circumstances are a possibility of poor visibility. Note that the pavement and shoulders appeared to be in good condition during the site visit for this evaluation. It is recommended that a site investigation be performed to identify the best possible alternative. Please see the attached Treatment Site Photos for additional visual information.

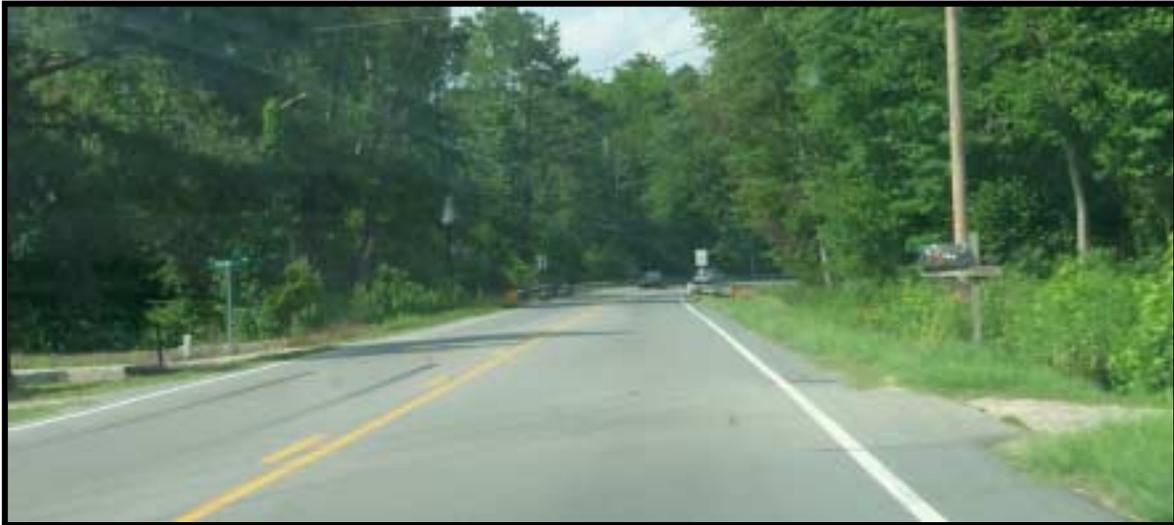
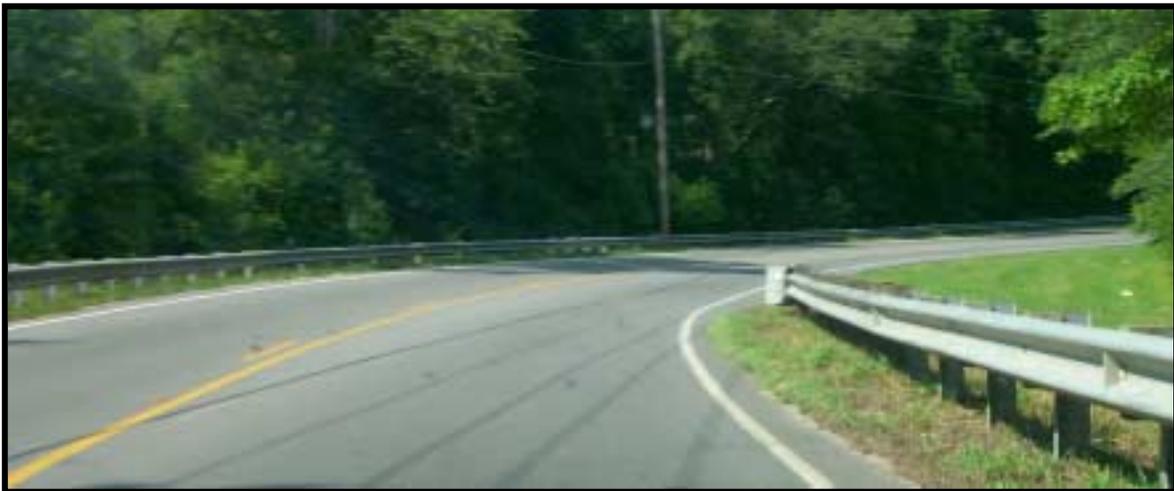
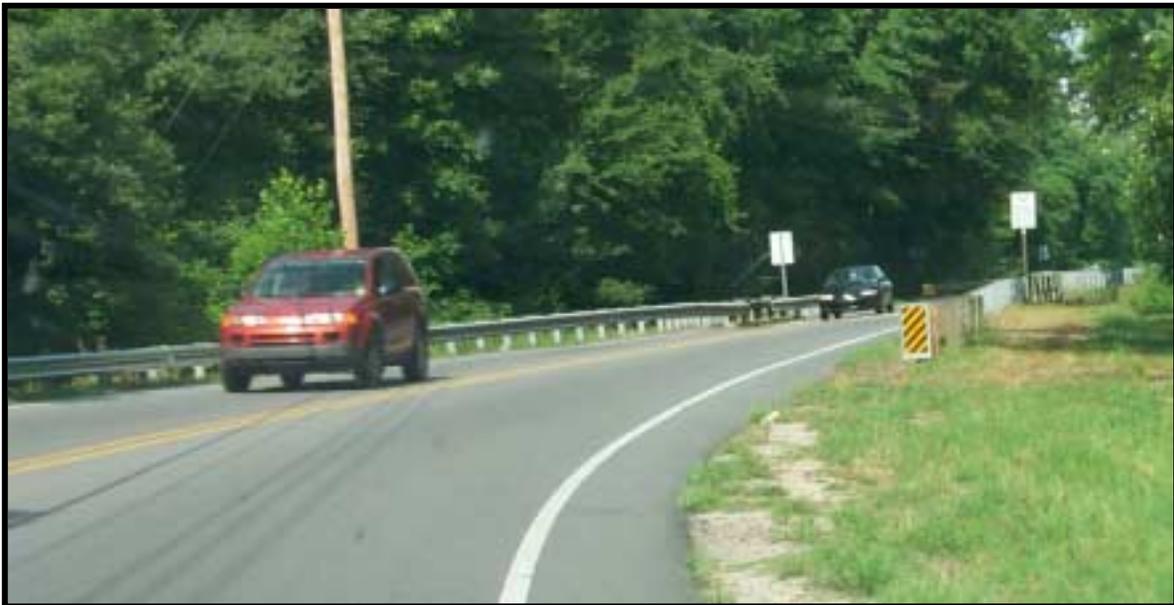
Treatment Site Photos (Taken on June 13, 2005)

Driving northeast on SR 1527-Pine Log Road

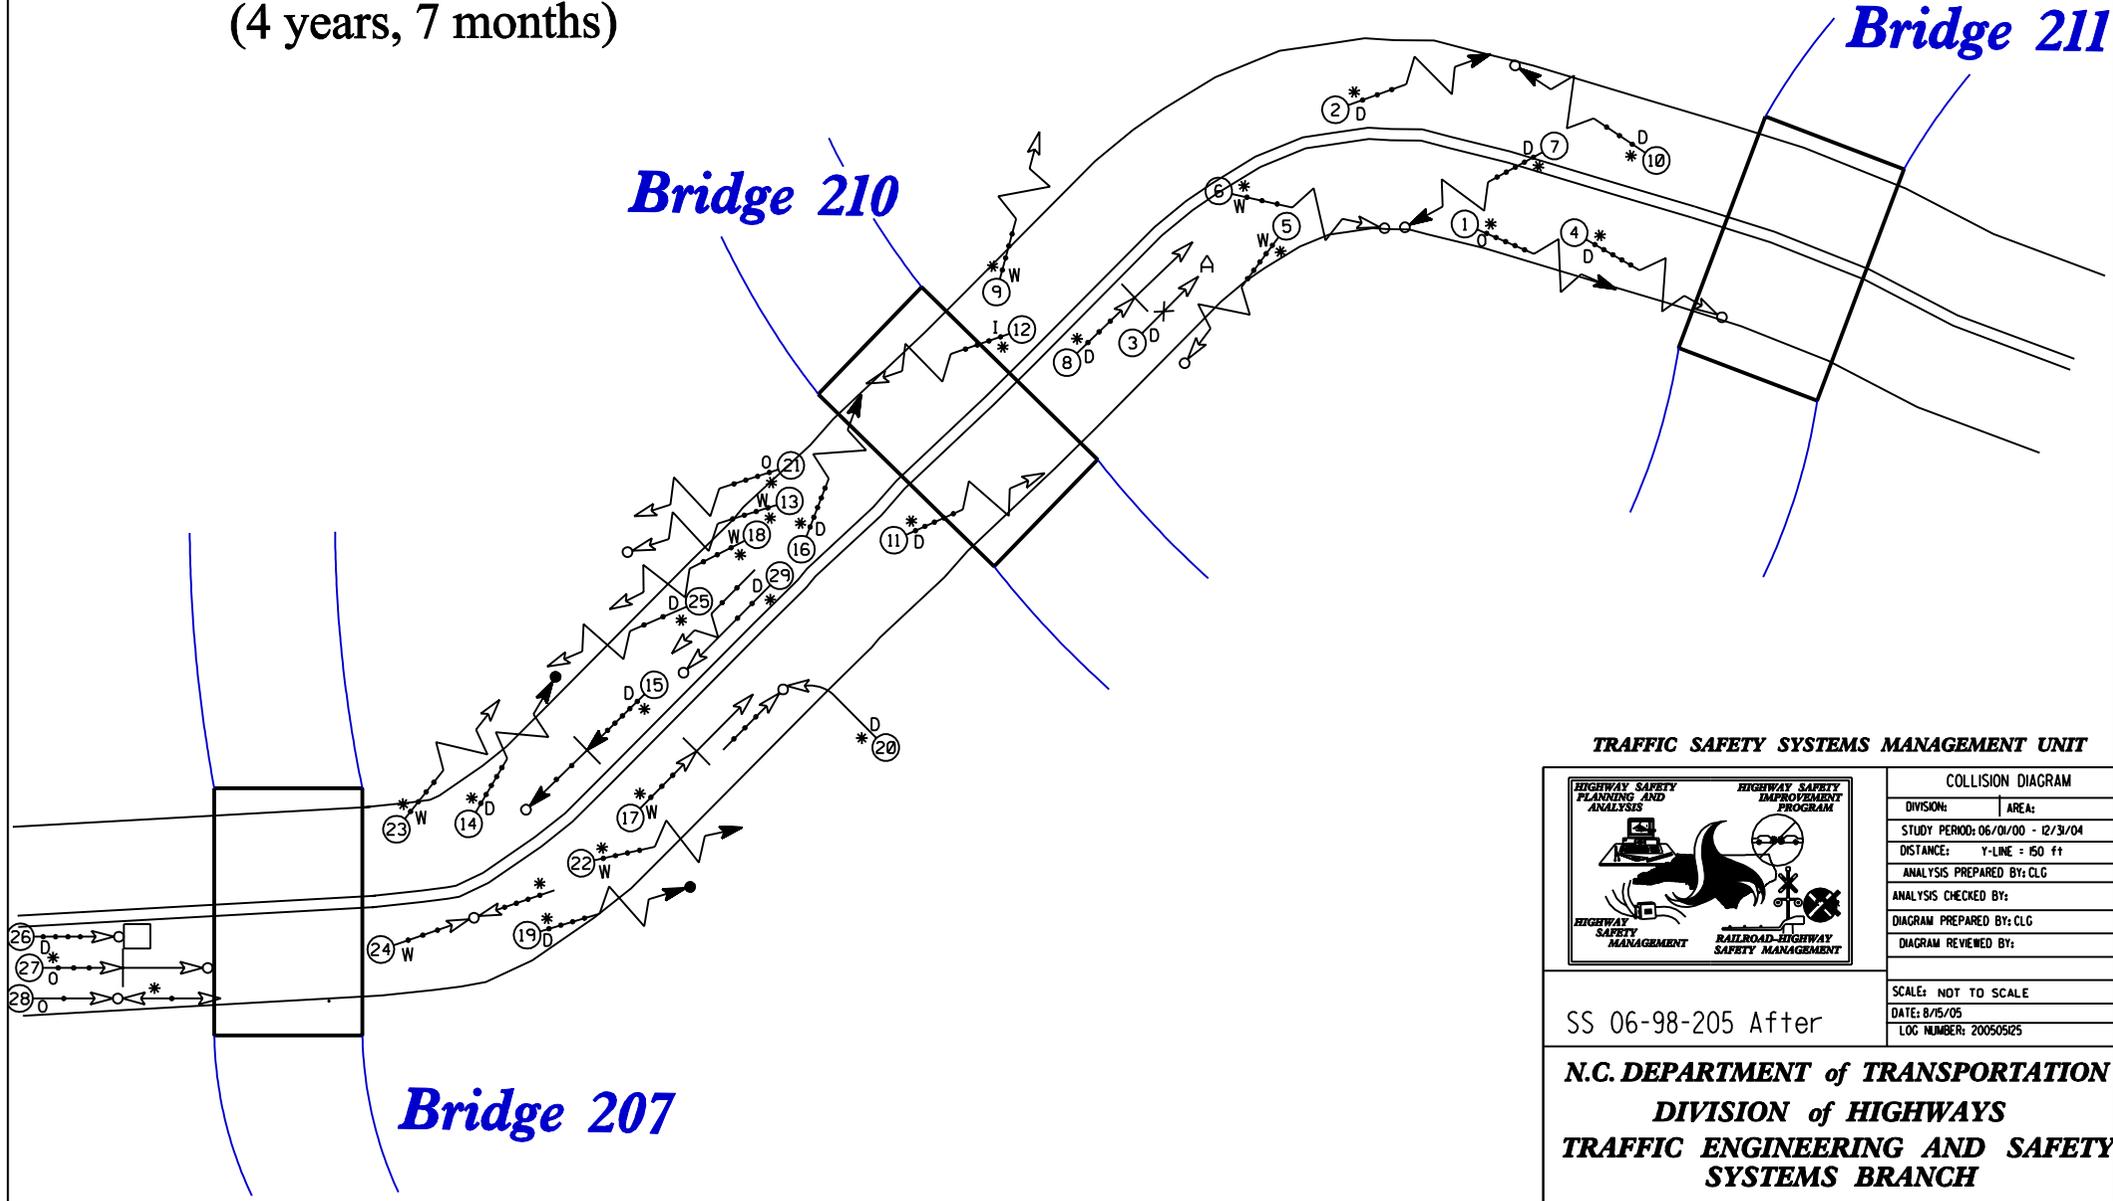
SS 06-98-205 After
 SCALE: NOT TO SCALE
 DATE: 8/15/05
 LOG NUMBER: 20050525

Treatment Site - Total Crashes

After Period

6/1/2000 - 12/31/2004
