Spot Safety Project Evaluation

Spot Safety Project # 07-00-209

**Spot Safety Project Evaluation of the Traffic Island and
Dual Posted Stop Sign Installations at the Intersection of
SR 1120 (Simpson Rd) and SR 1129 (Gideon Grove Church Rd)
Rockingham County**

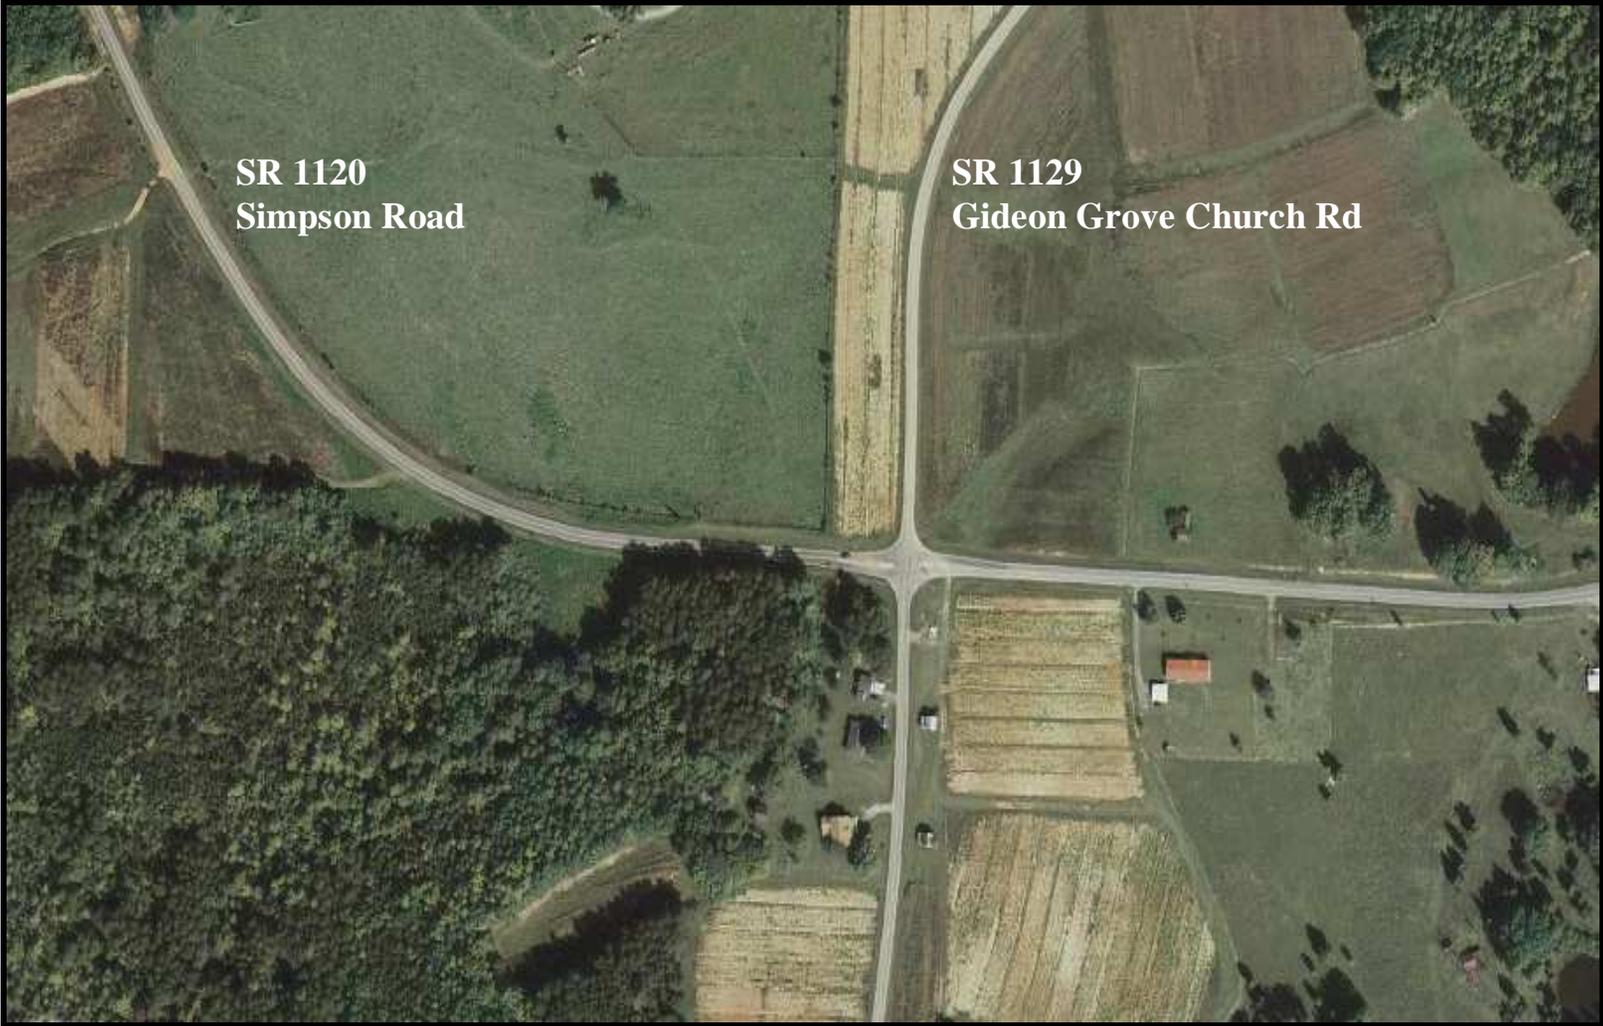
**SS# 07-00-209 Aerial Map
Rockingham County**

**SR 1120
Simpson Road**

**SR 1129
Gideon Grove Church Rd**

The treatment data consisted of all crashes within 150 feet of the subject intersection. *Please see attached location map, aerial map, and photos for further details.*

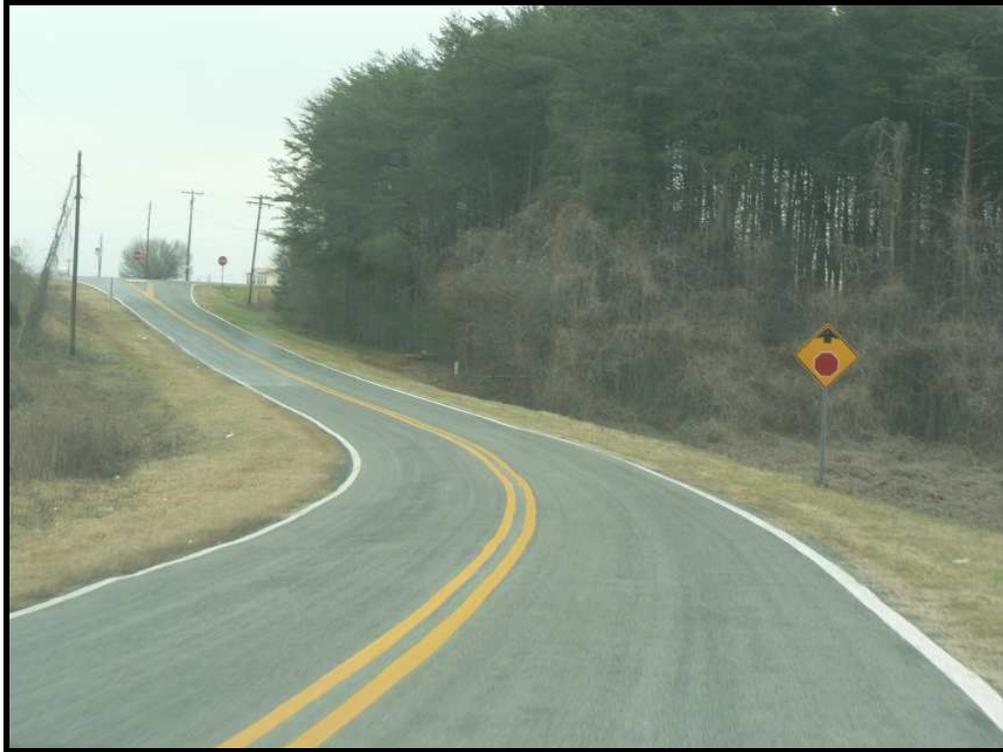
Traveling East on SR 1120 (Simpson Rd)

Please see the attached *Treatment Site Photos*. Photos are provided for all approaches to the treatment intersection. As the Safety Evaluation Group completes additional spot safety reviews for this type of countermeasure, we will be able to provide objective and definite information regarding actual crash reduction factors for this type of intersection.

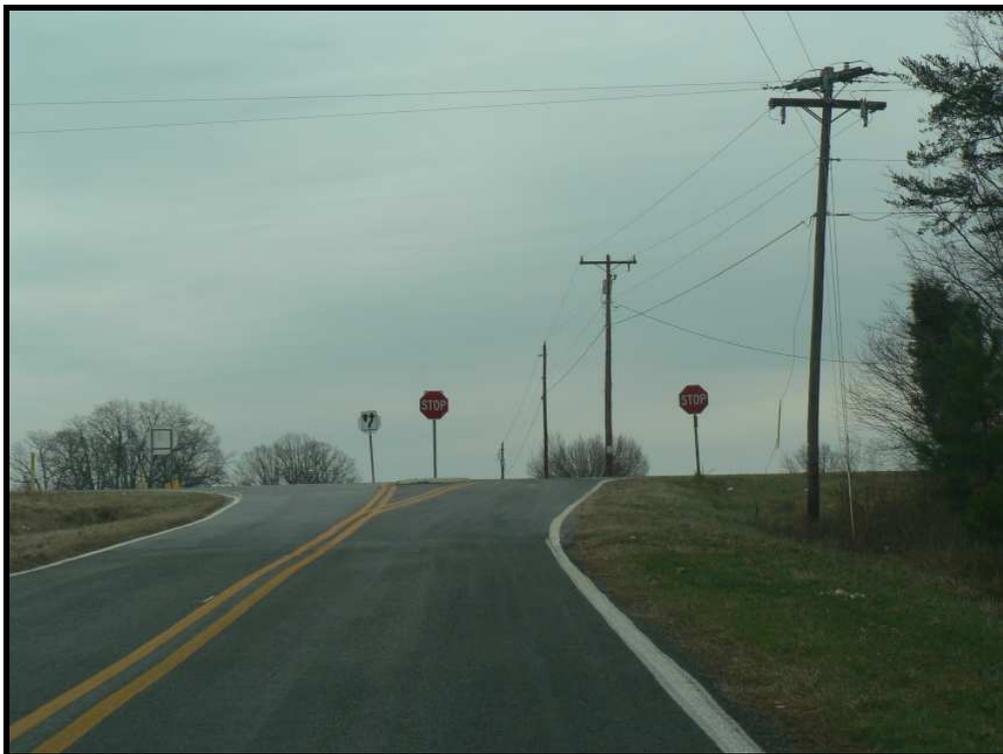
Traveling East on SR 1120

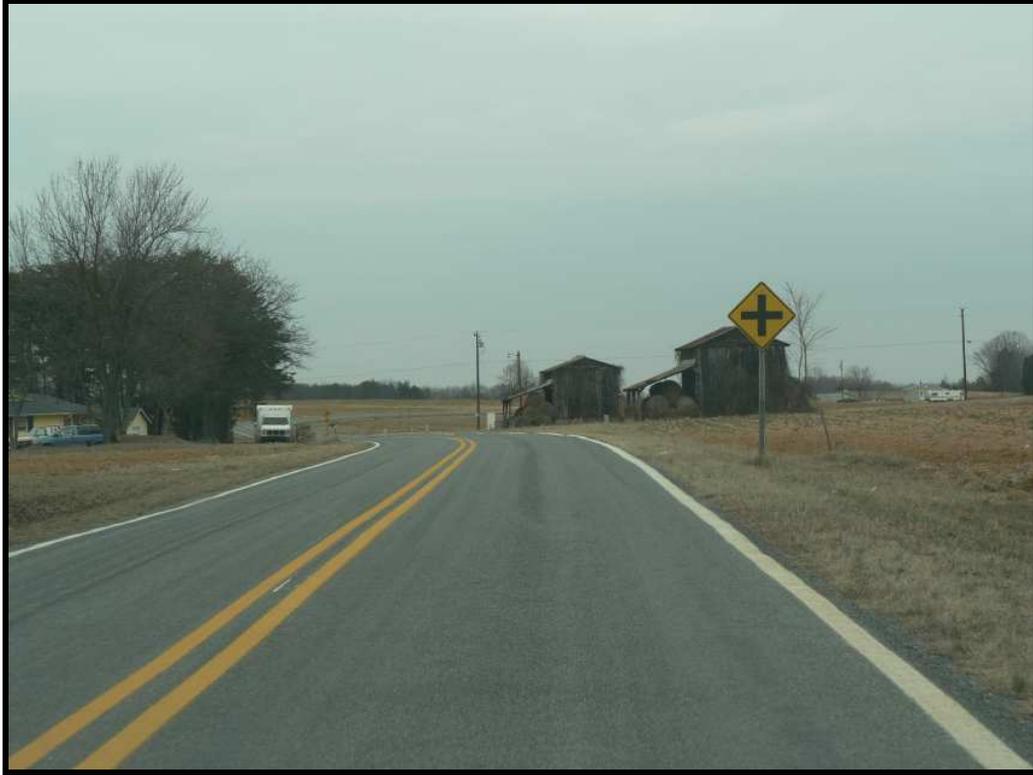
Traveling North on SR 1129 (Gideon Grove Church Road)

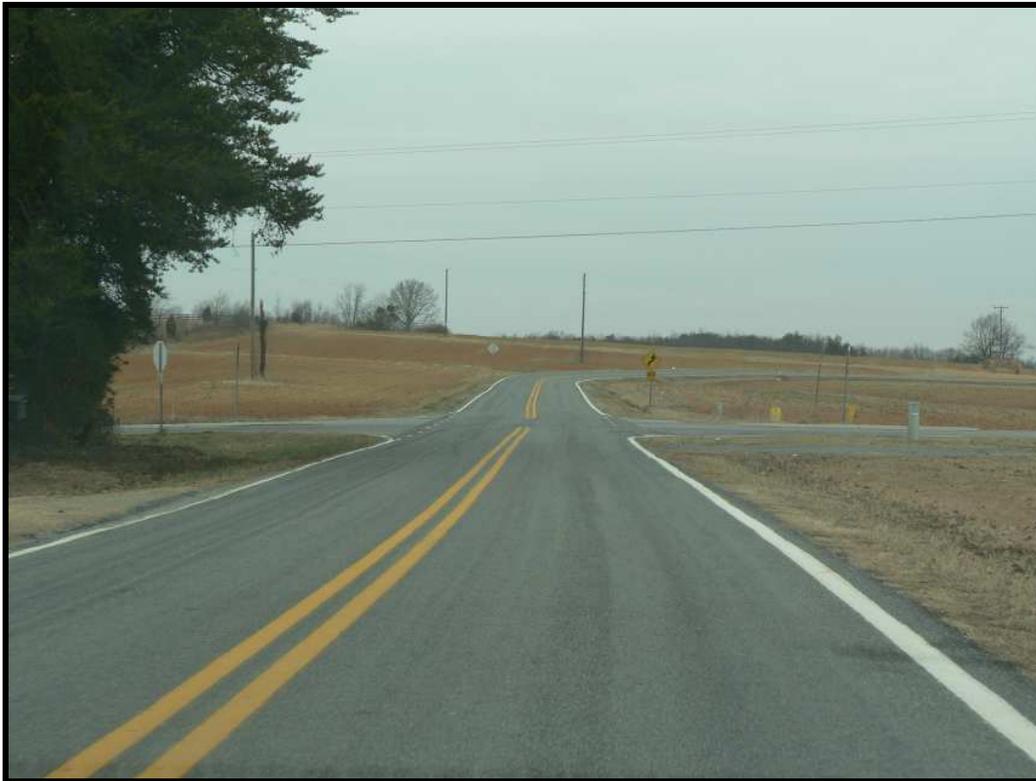
Traveling North on SR 1129

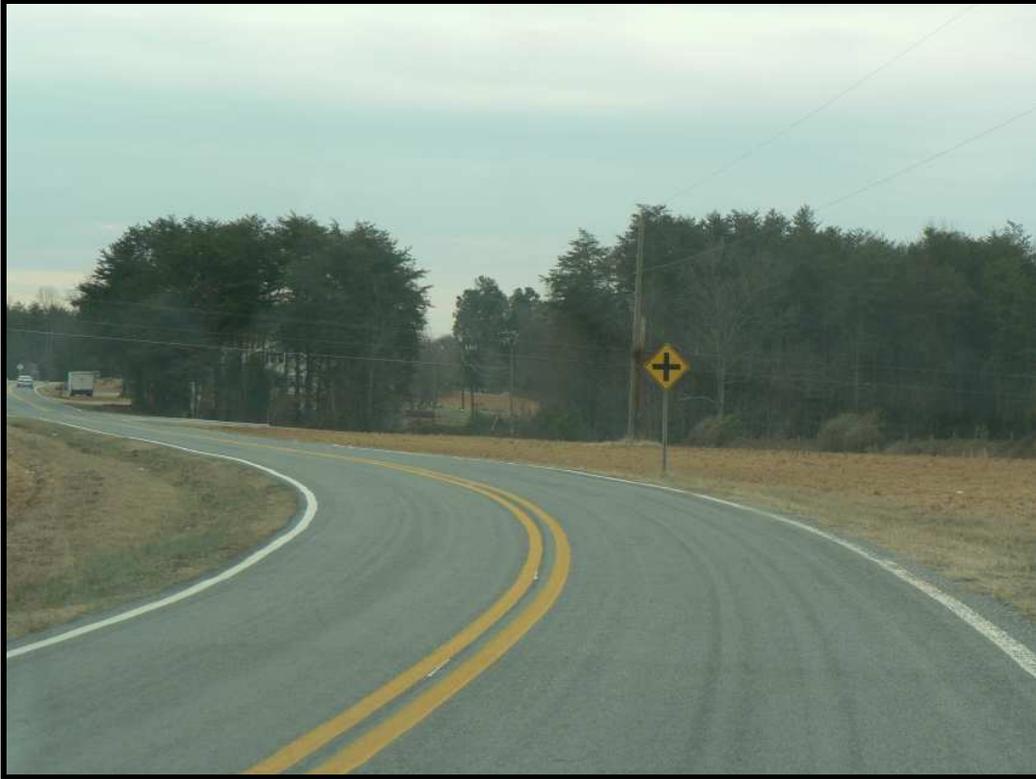
Traveling South on SR 1129 (Gideon Grove Church Road)

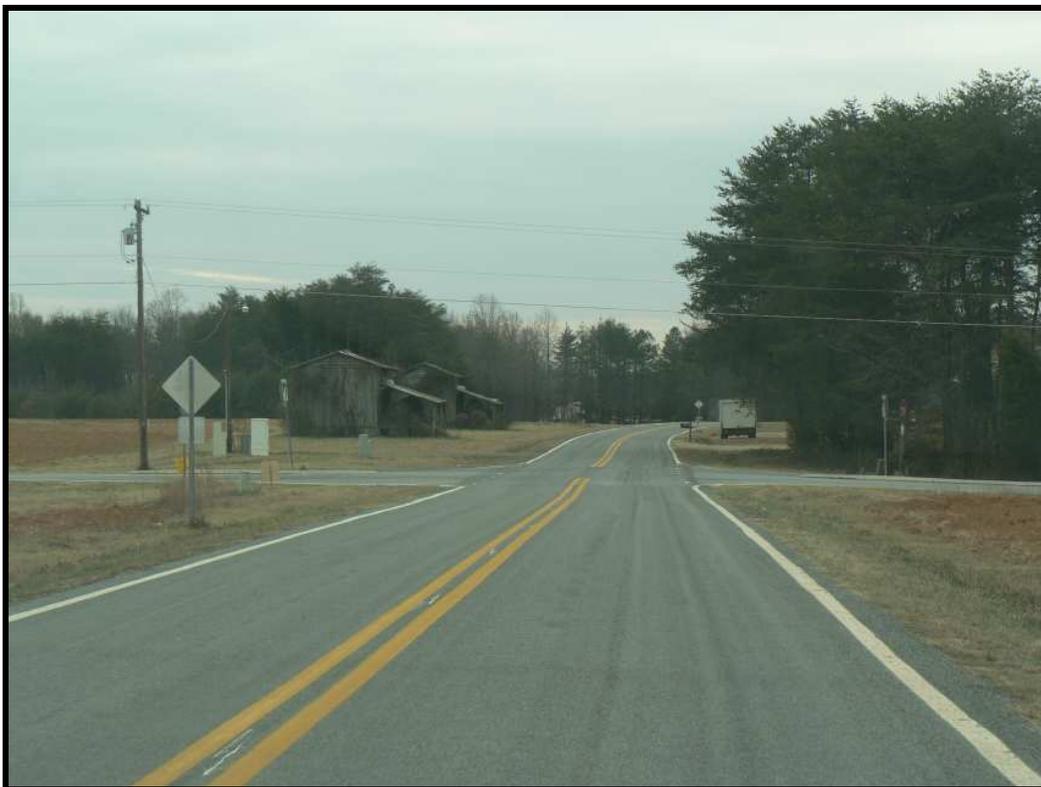
Traveling South on SR 1129

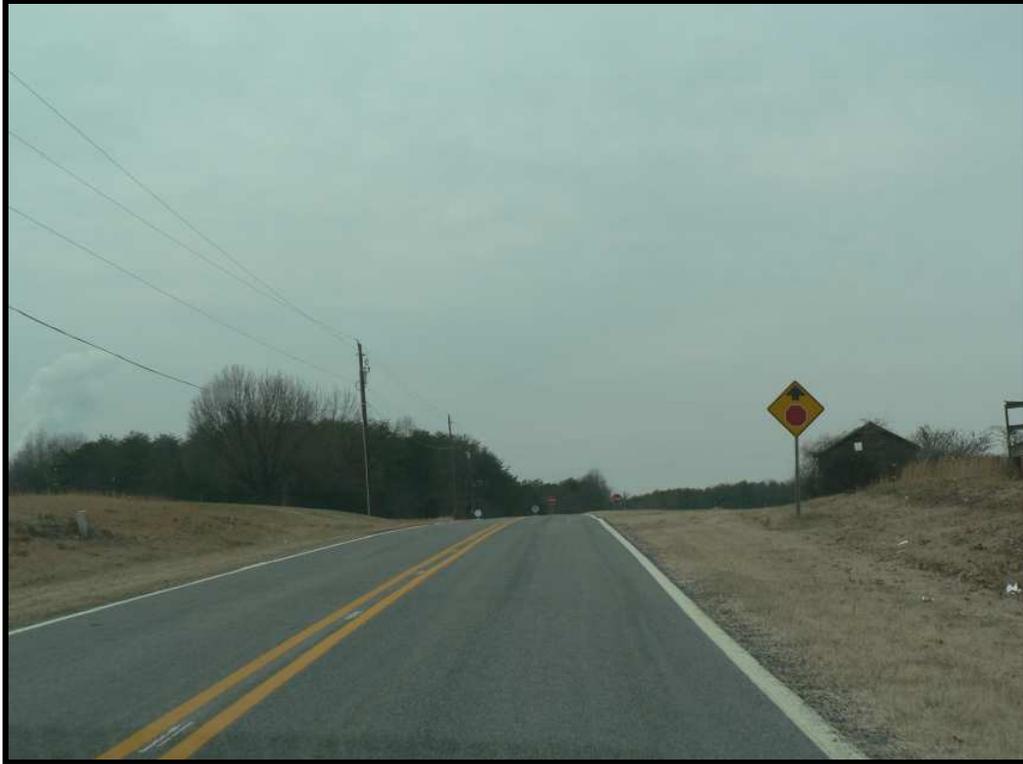
Traveling West on SR 1120 (Simpson Road)

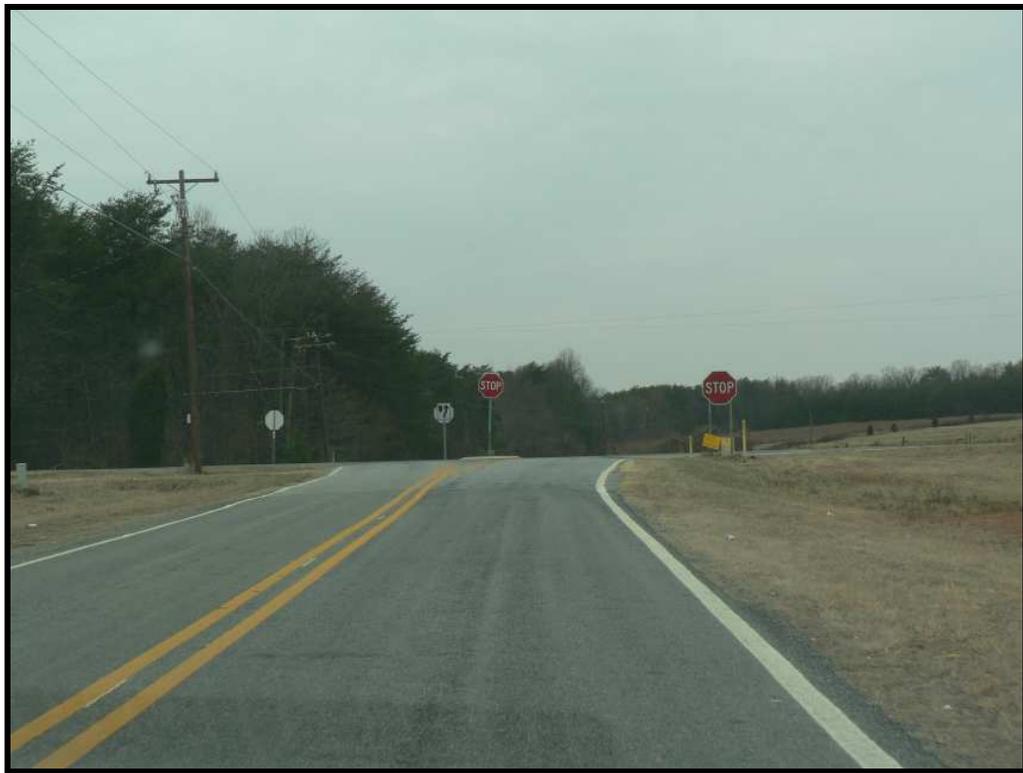
Traveling West on SR 1120

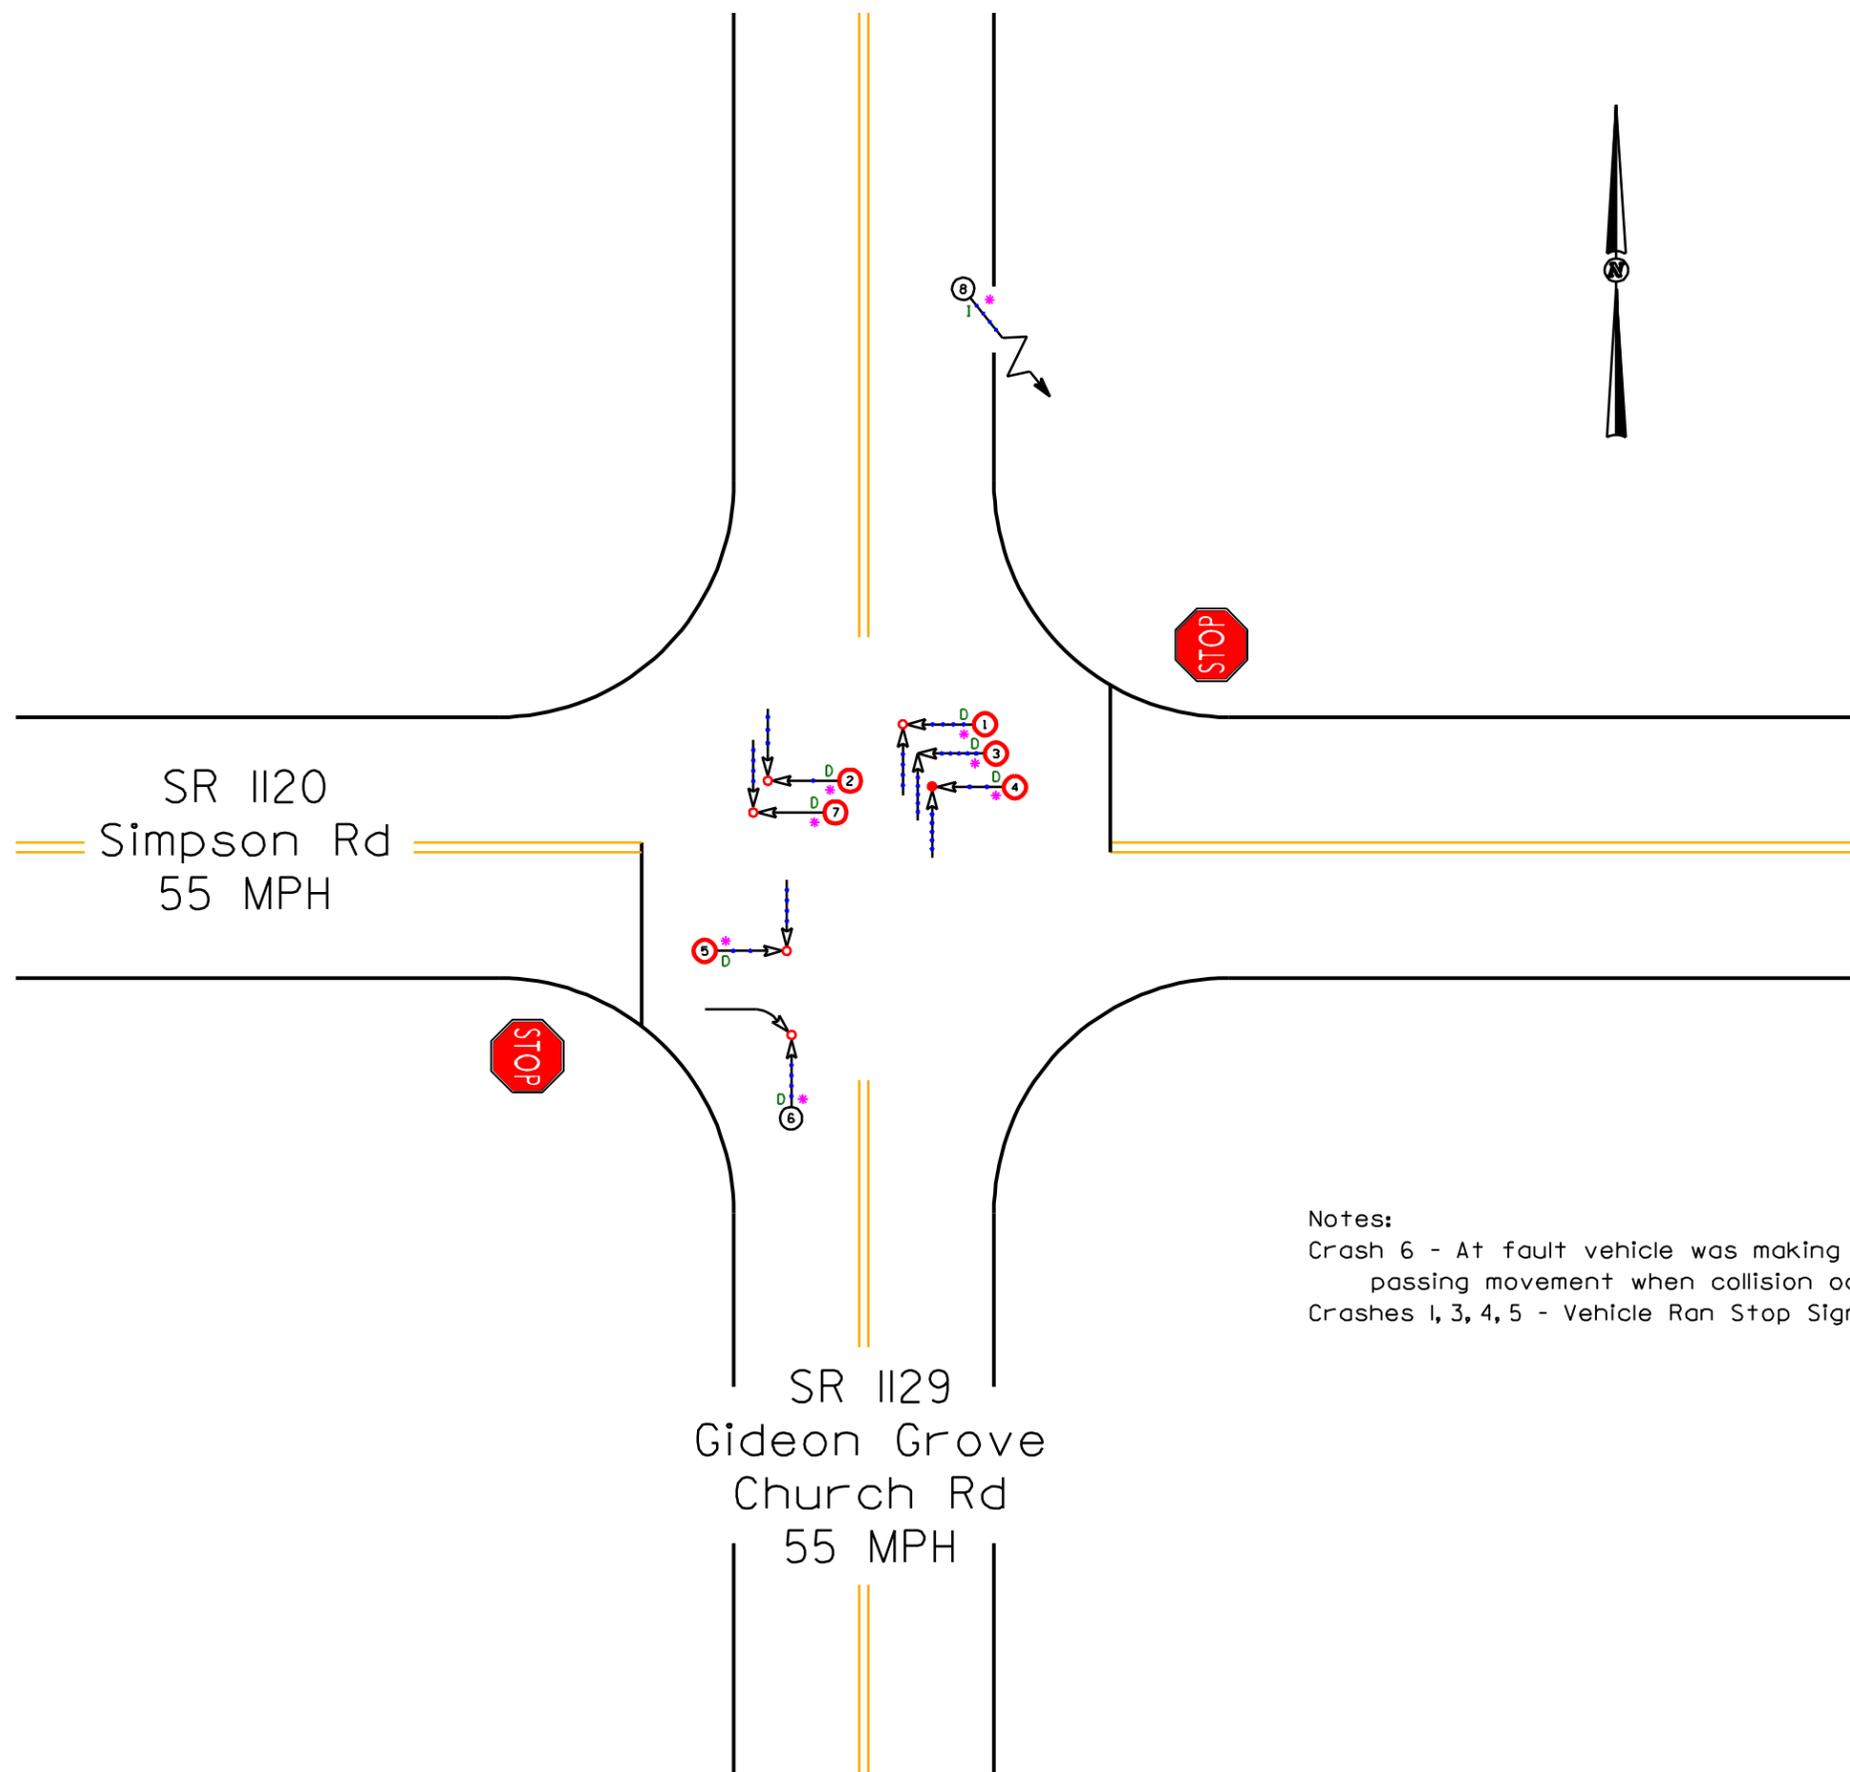
SS# 07-00-209
 Rockingham County
 near Gold Hill
 BEFORE Period
 6/1/98 - 7/31/03
 SR 1120 at SR 1129

Notes:
 Crash 6 - At fault vehicle was making an illegal passing movement when collision occurred
 Crashes 1, 3, 4, 5 - Vehicle Ran Stop Sign

Target Crashes

Referencing the *Collision Diagrams*, high speed angle collisions at this location reduced from six (6) in the before period to one (1) in the after period. The significant benefit of this countermeasure improvement was the elimination of severe injury collisions, both fatalities and A-injury crashes. The total and target severity indexes were reduced by nearly 80 percent which have yielded very significant benefit-cost ratios as seen below.

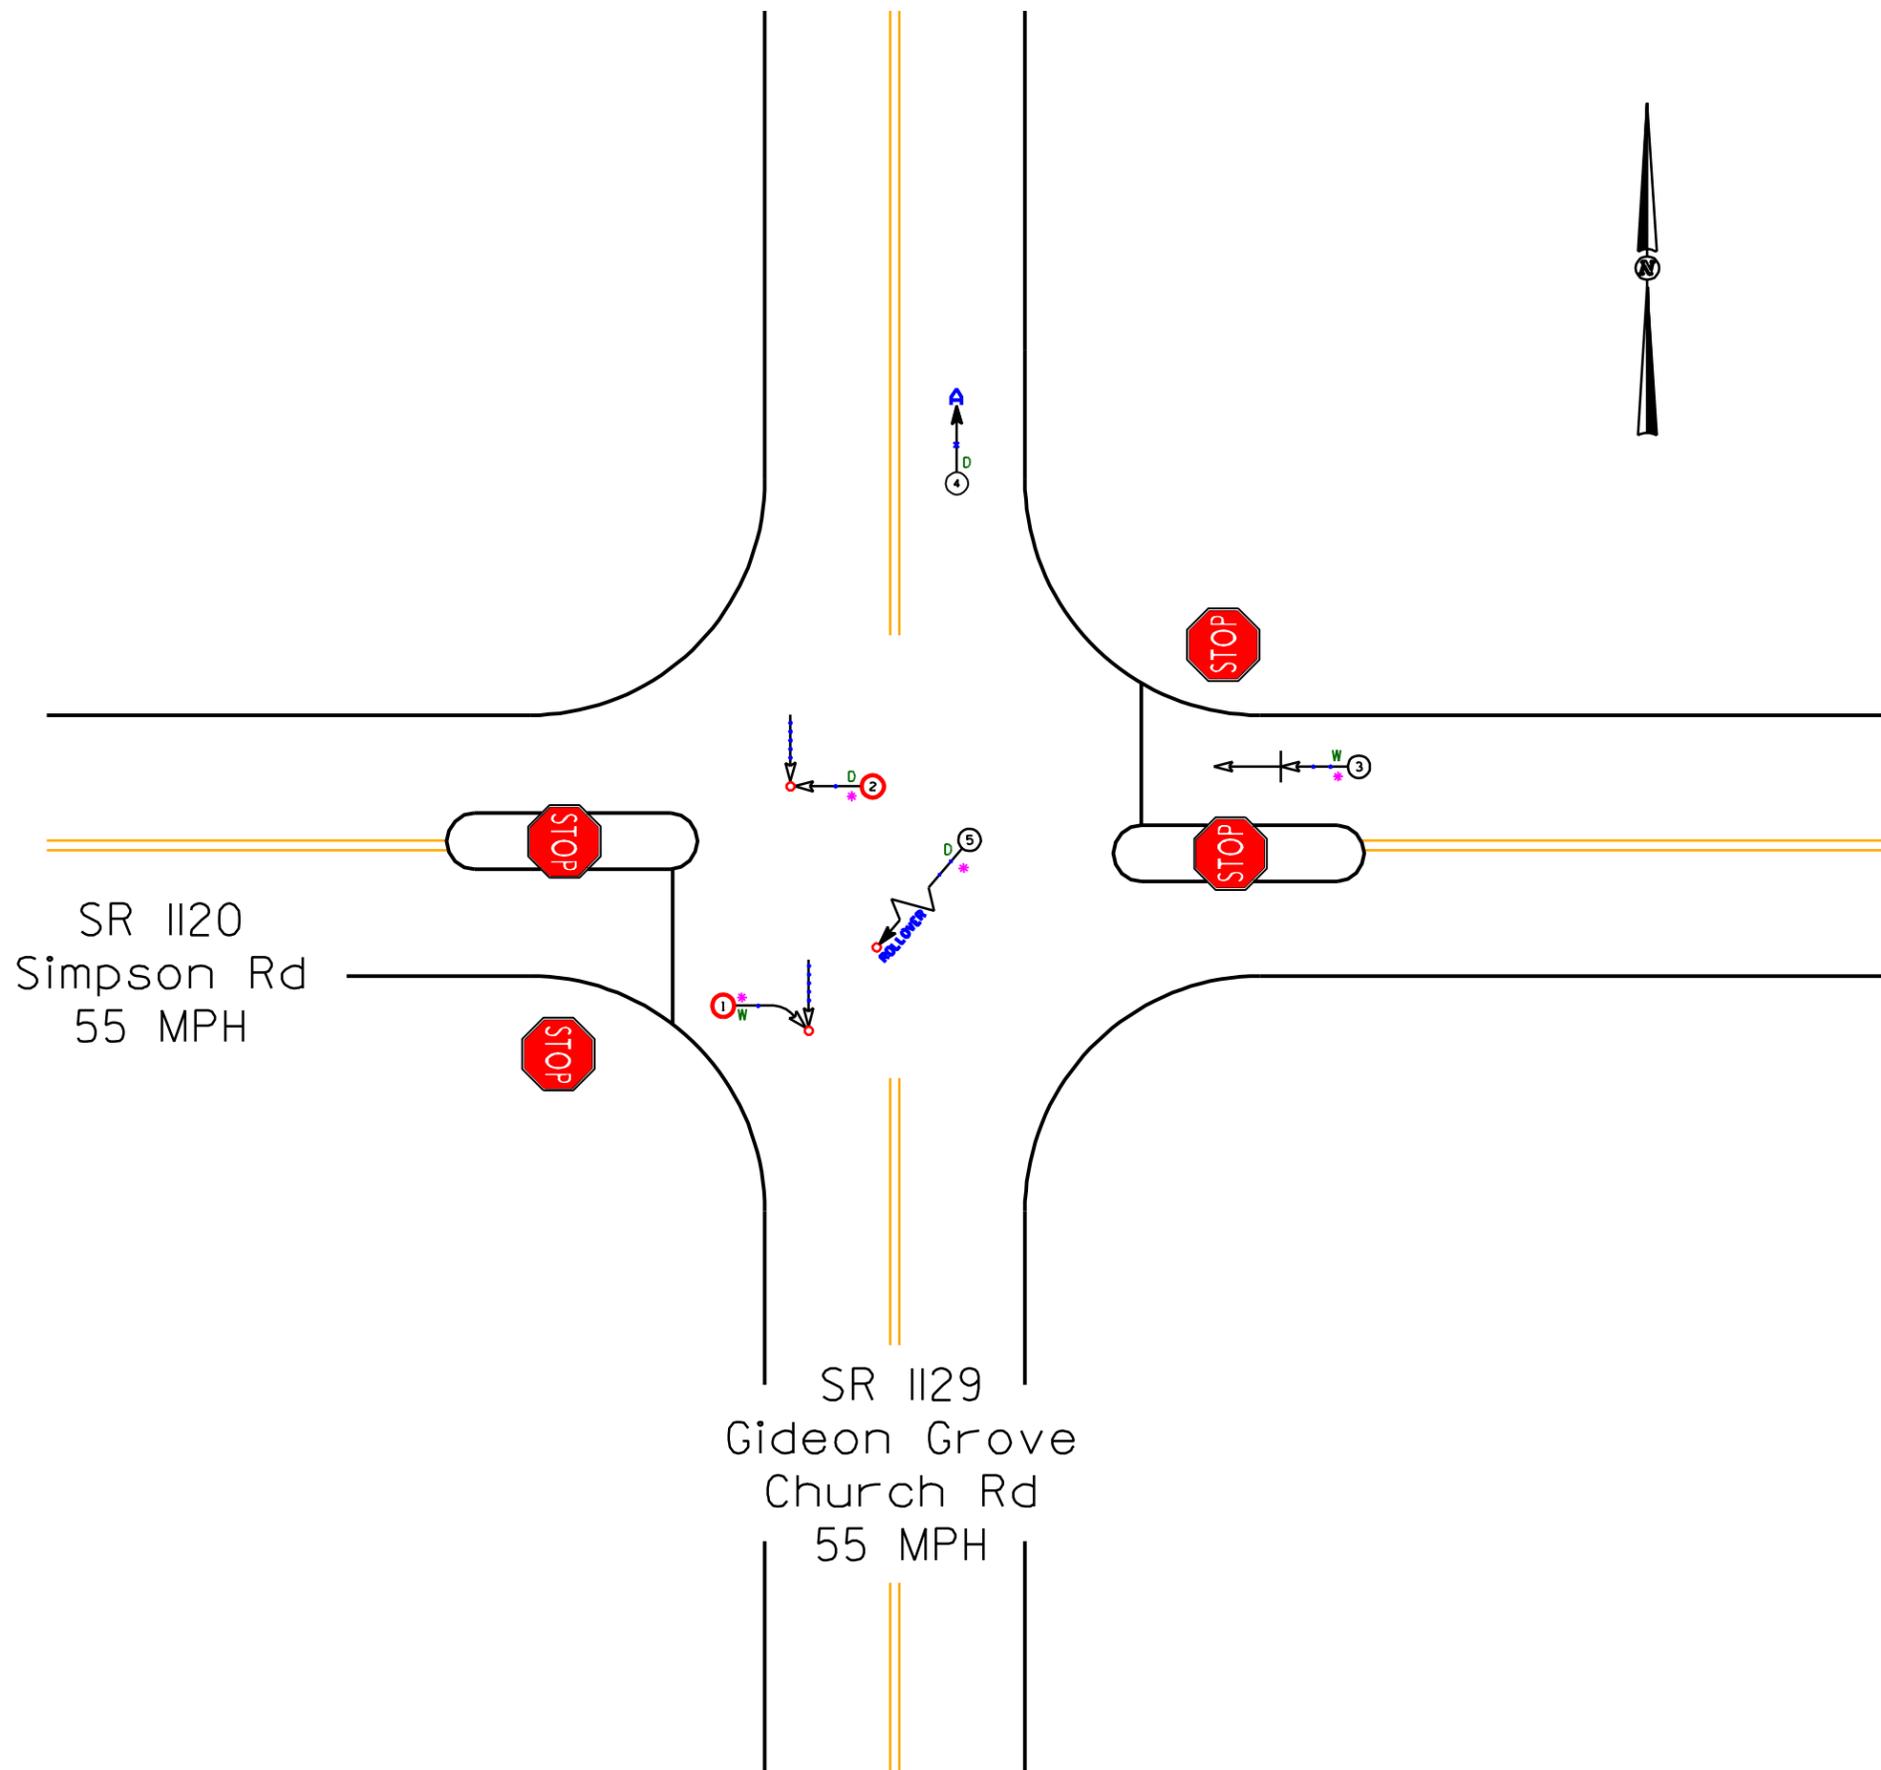
SS# 07-00-209
 Rockingham County
 near Gold Hill
 AFTER Period
 10/1/03 - 11/30/08
 SR 1120 at SR 1129

Target Crashes
