Spot Safety Project Evaluation

Spot Safety Project # 08-05-204

**Spot Safety Project Evaluation of the Directional Crossover with Median U-Turns Installation
US 74 at SR 1321 (Elmore Road/Laurel Hill Church Road)
Scotland County**

Evaluation of Spot Safety Project Number 08-05-204 located at the Intersection of US 74 at SR 1321 (Elmore Road/Laurel Hill Church Road) in Scotland County, West of Laurinburg.

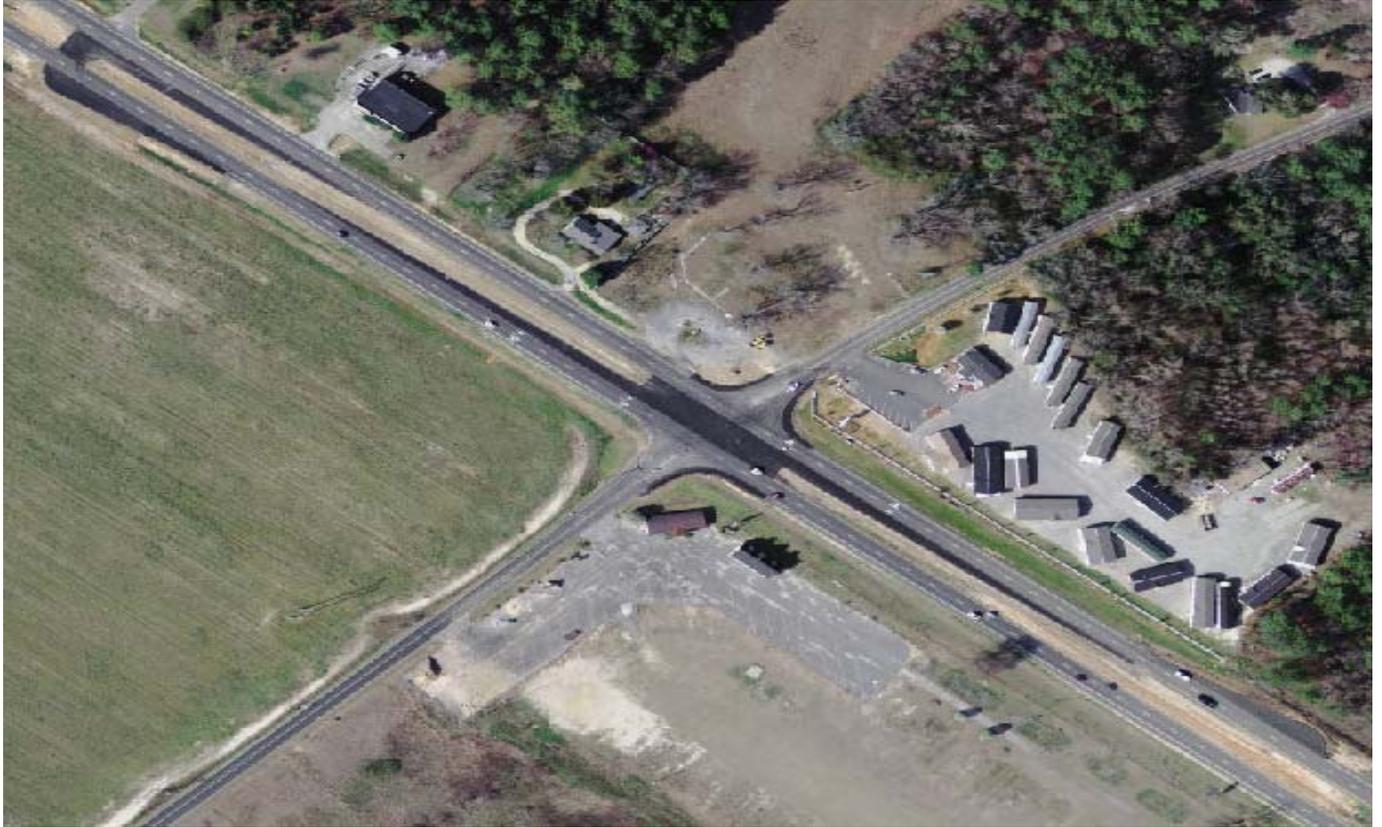
Before Period

Aerial Photo provided from Scotland County GIS Web Map

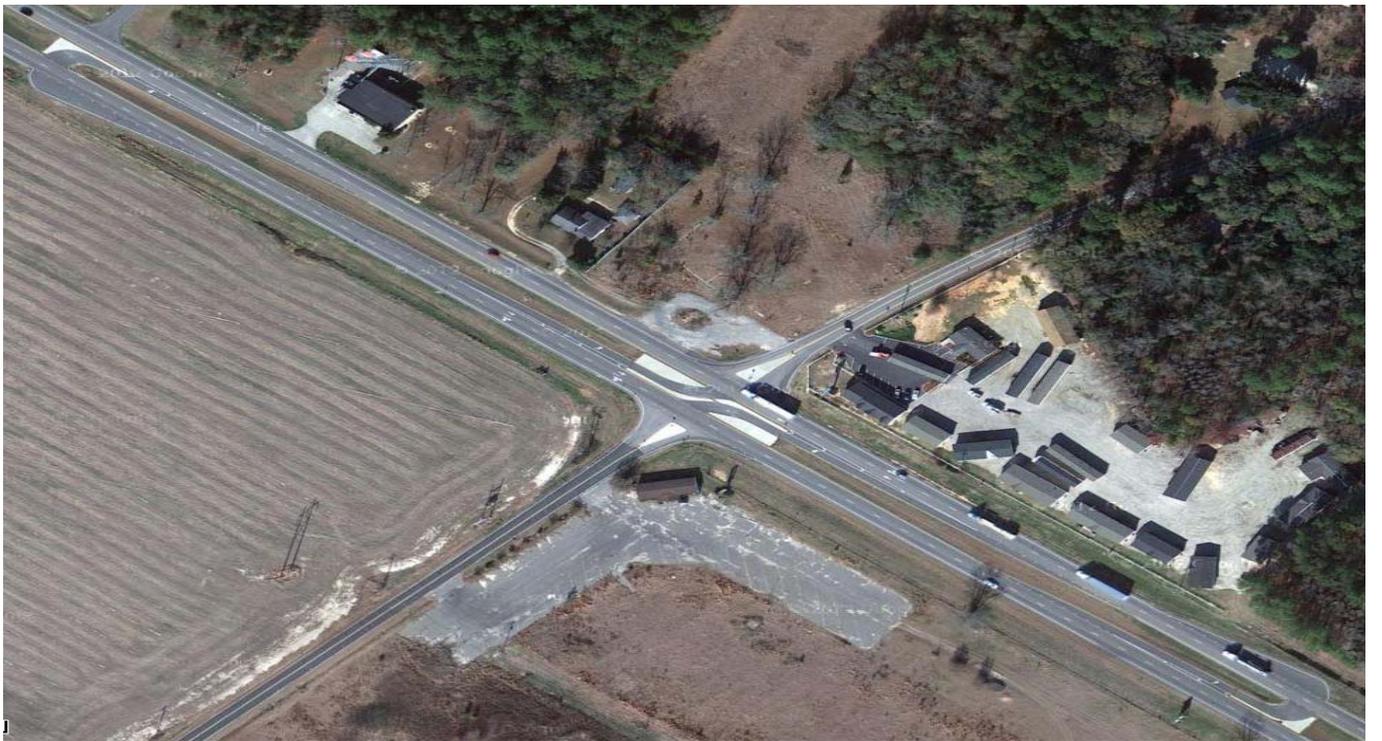
After Period

Aerial Photo provided from Google Maps

The spot safety project improvement countermeasure chosen for the subject location was the installation of a limited movement directional crossover with median U-Turn concrete dividers. US 74 is a four-lane divided facility under partial control access. SR 1321 is a two lane roadway under stop sign control which intersects US 74 at grade. The speed limit on US 74 and SR 1321 is 55 mph.

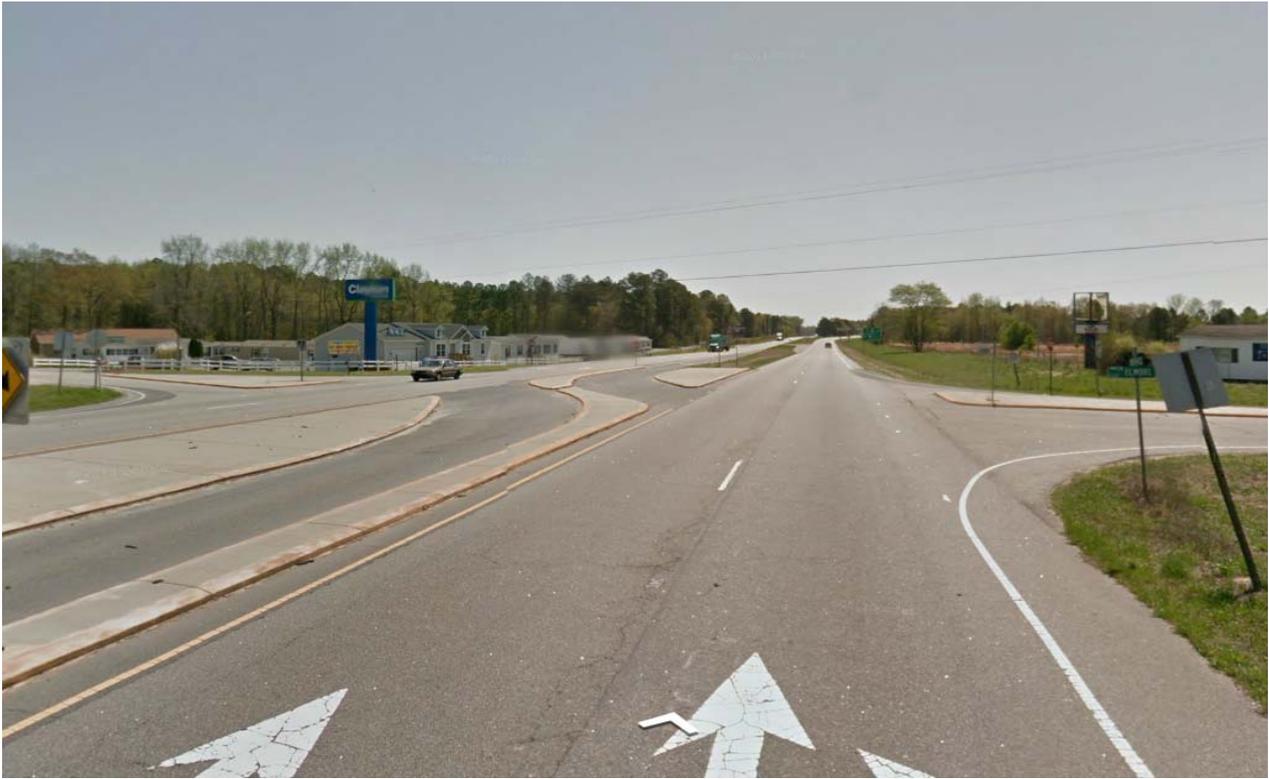
Looking East on US-74 (Image Date: April 2013)

Please see the attached *Treatment Site Photos*. Photos are provided from Google Street View for all four approaches to the treatment intersection. As the Safety Evaluation Group completes additional spot safety reviews for this type of countermeasure, we will be able to provide objective and definite information regarding actual crash reduction factors for this type of intersection.

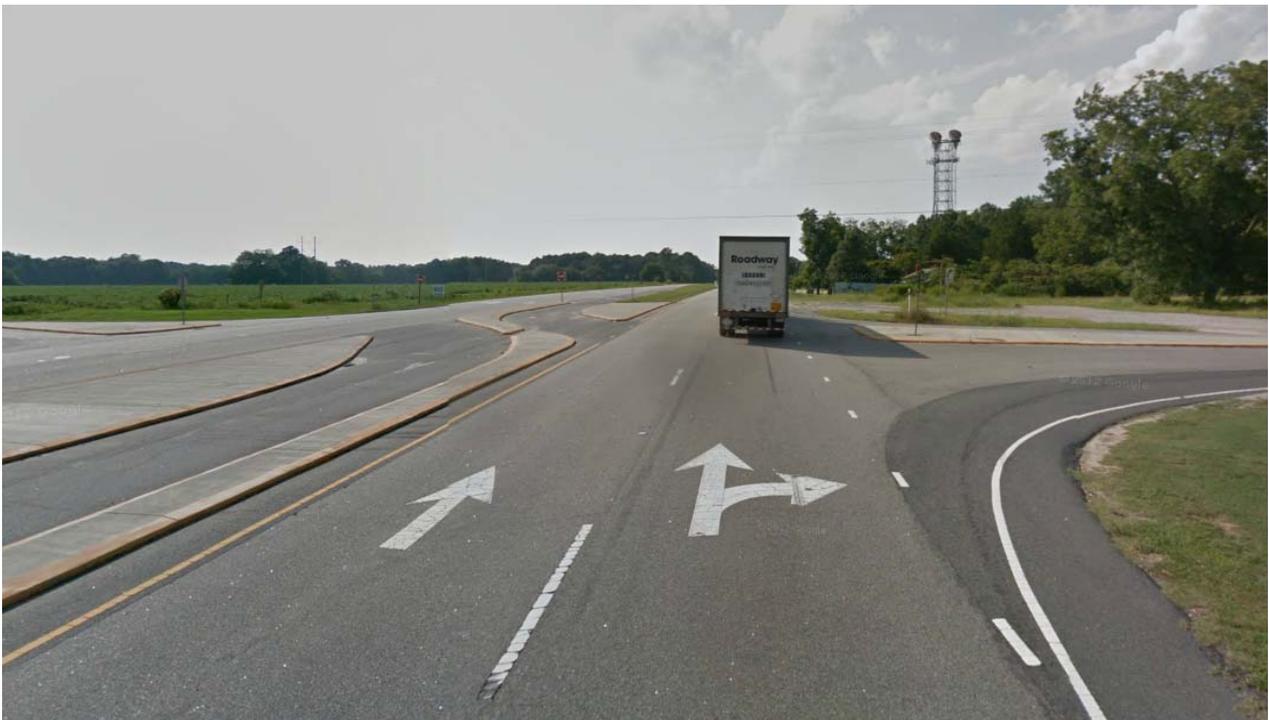
Looking West on US-74 (Image Date: August 2011)

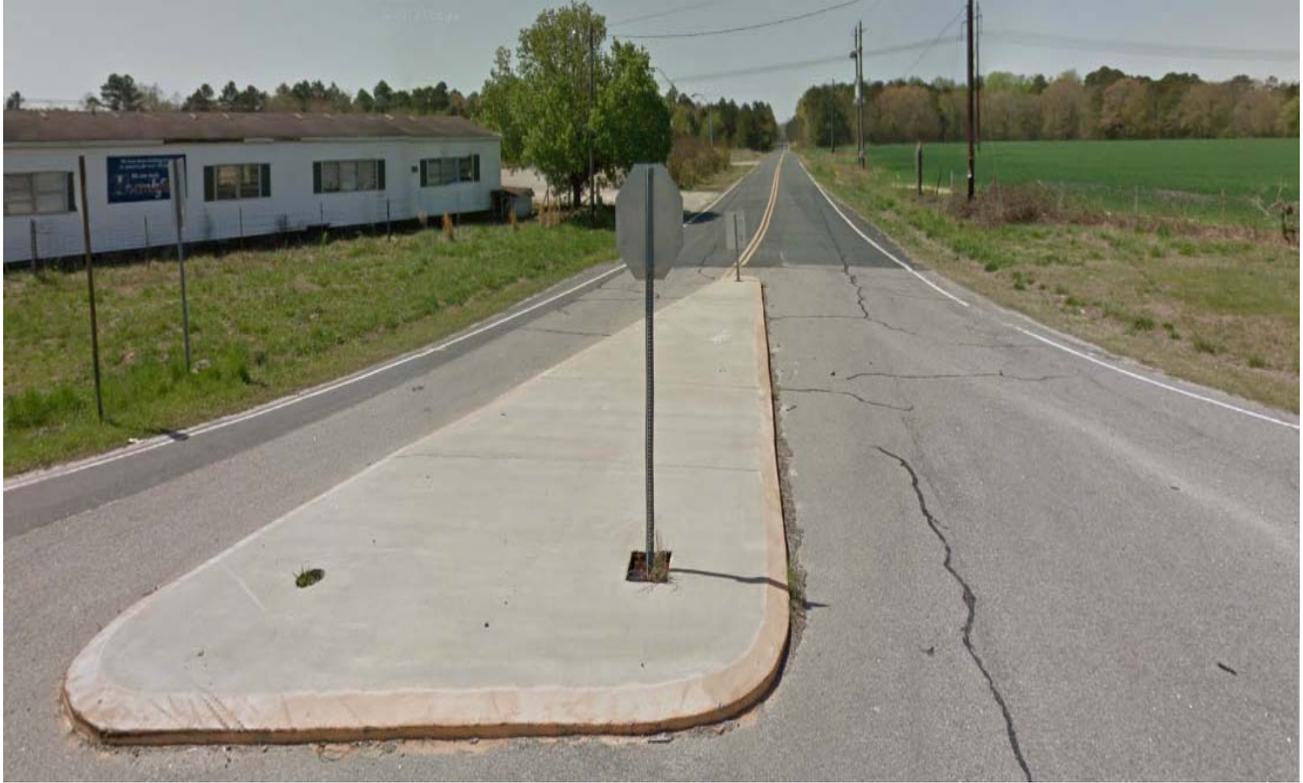
Looking South onto SR 1321 (Elmore Road) (Image Date: April 2013)

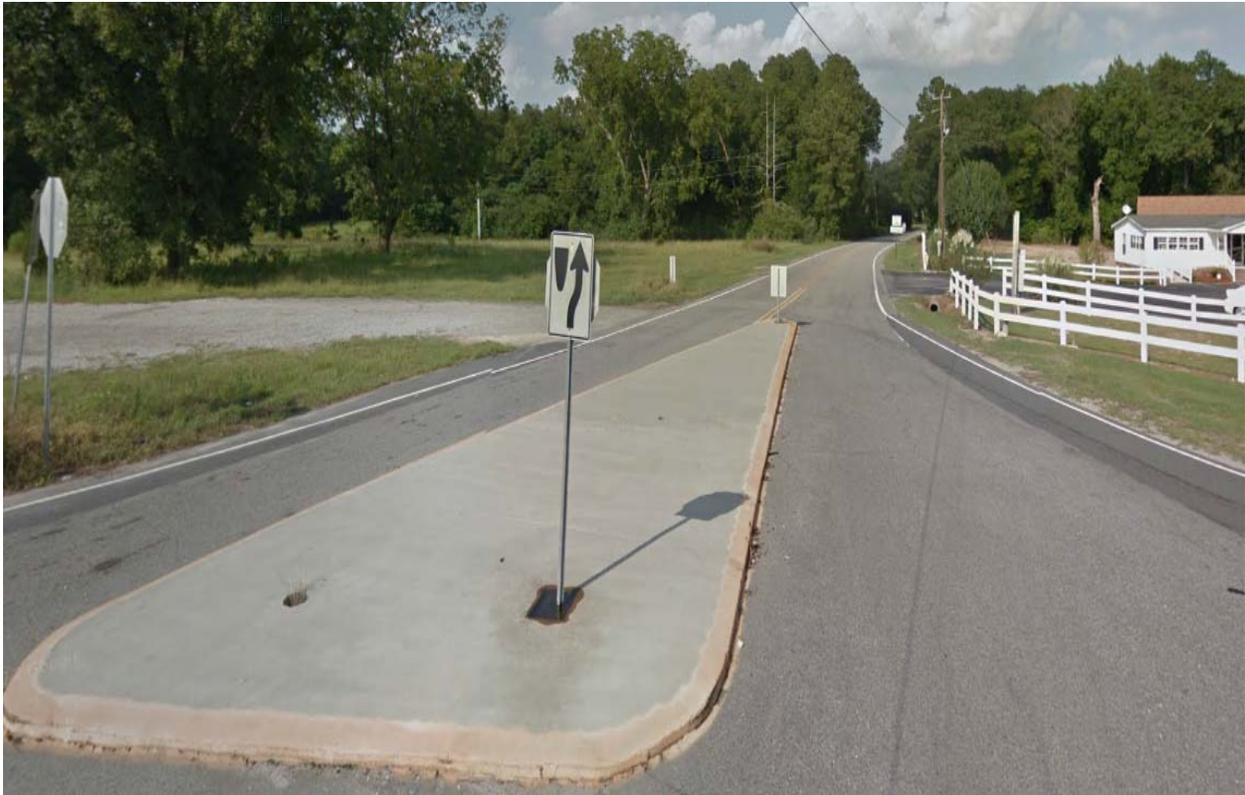
Looking North onto SR 1321 (Laurel Hill Road) (Image Date: August 2011)

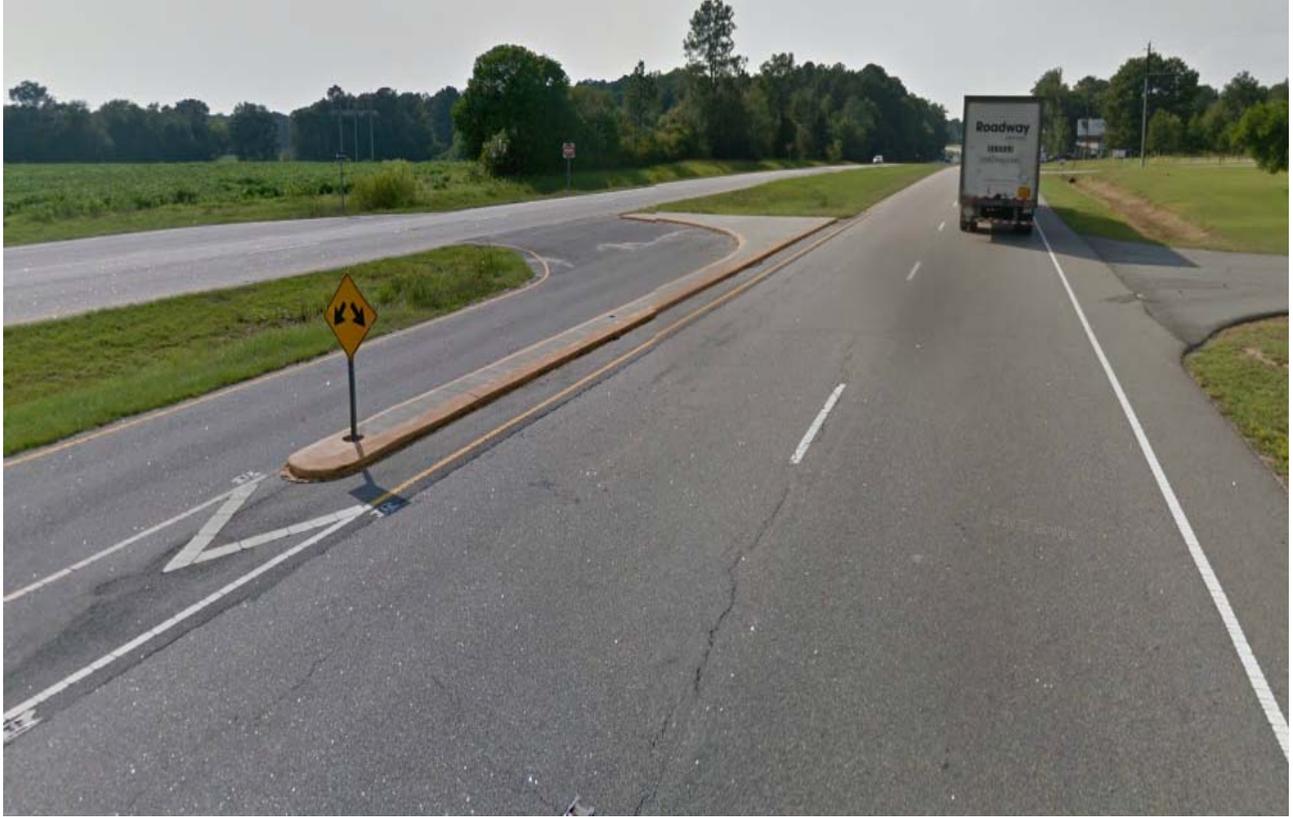
Western Most U-Turn on US 74 (Image Date: August 2011)

Typically, crossover installations occur on median divided roadways and the Safety Evaluation Group evaluates the closest u-turn locations for crash migration. However, with this installation, motorists have the ability to u-turn at the end of the concrete medians. A general search analyzing for u-turn related crashes was completed for the after period and no crashes were found.

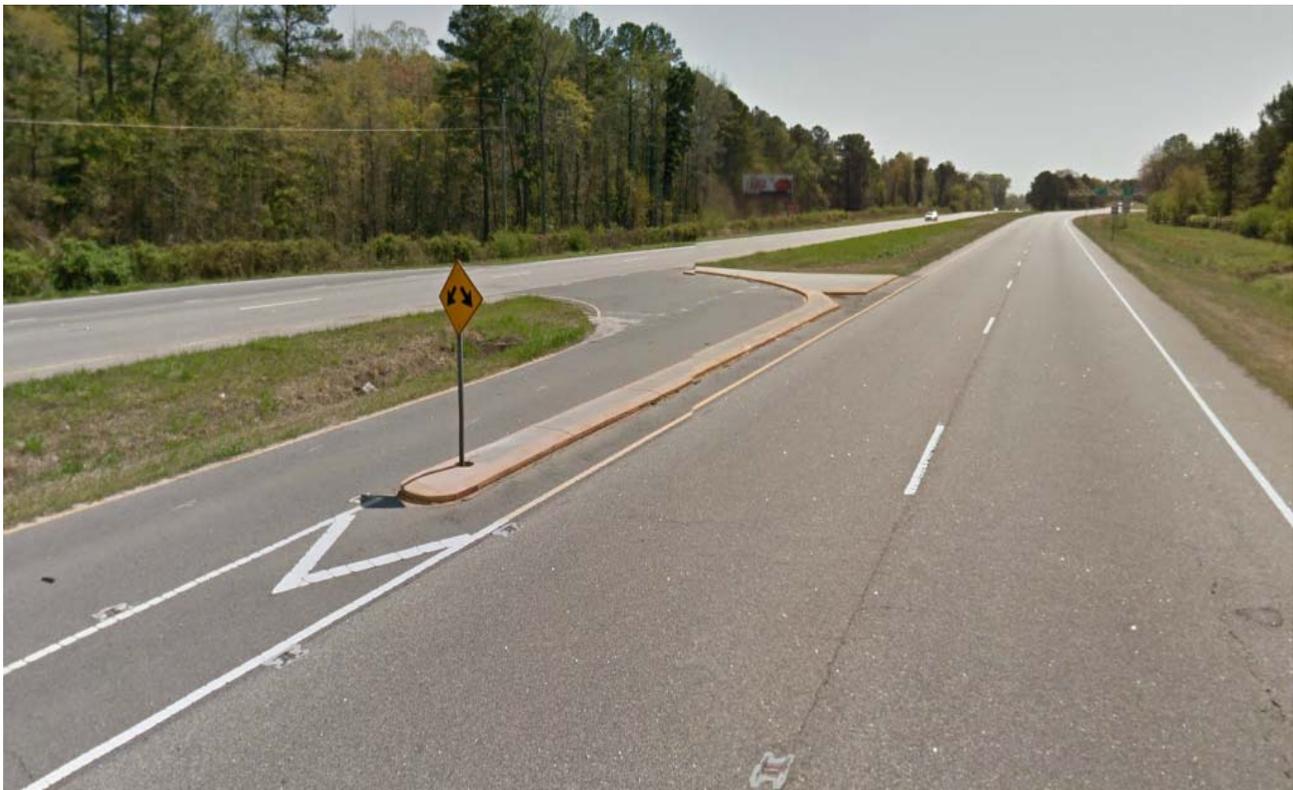
Eastern Most U-Turn on US 74 (Image Date: April 2013)

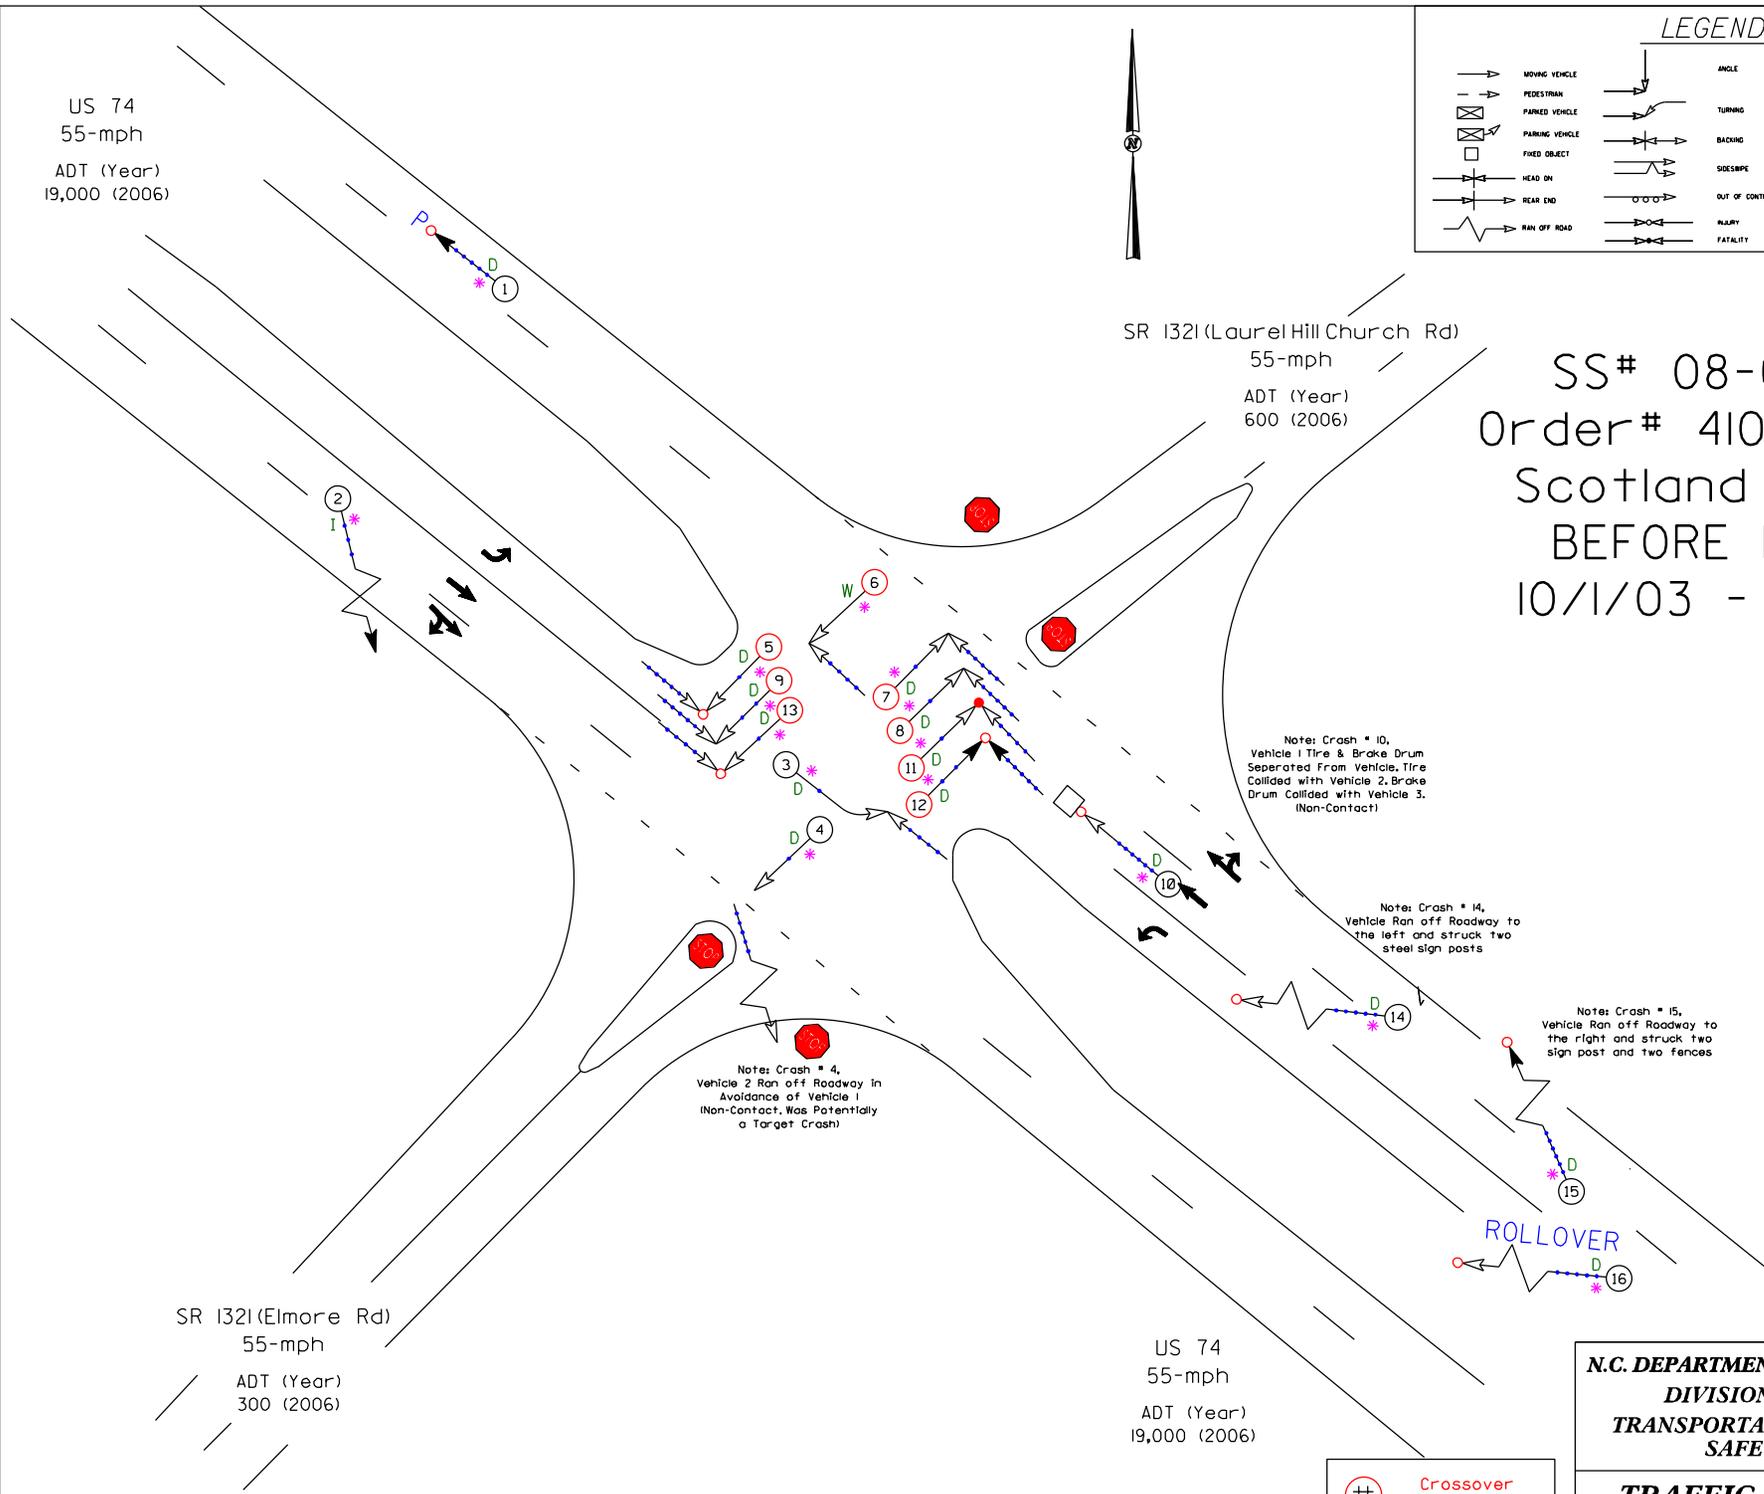
SS# 08-05-204
Order# 41000025426
Scotland County
BEFORE Period
10/1/03 - 5/31/08

Note: Crash # 10,
Vehicle 1 Tire & Brake Drum
Separated From Vehicle. Tire
Collided with Vehicle 2, Brake
Drum Collided with Vehicle 3.
(Non-Contact)

Note: Crash # 14,
Vehicle Ran off Roadway to
the left and struck two
steel sign posts

Note: Crash # 4,
Vehicle 2 Ran off Roadway in
Avoidance of Vehicle 1
(Non-Contact, Was Potentially
a Target Crash)

Note: Crash # 15,
Vehicle Ran off Roadway to
the right and struck two
sign post and two fences

Crossover
Target Crashes

Referencing the *Collision Diagrams*, the before period indicated eight (8) angle roadway crashes at the studied intersection including a fatality crash in August 2006. After the crossover installation all of these crashes were eliminated by the removal of the through movement option at the intersection for SR 1321 motorists.

The before period included Crash 4 (ID- 101067533) where vehicle 1 traveling Eastbound on US 74 ran off the roadway to the right in avoidance of vehicle 2 traveling Southbound on SR 1321. This was a non-contact collision which follows the target angle crash pattern. Three (3) other crashes in the before period follow this crash pattern. The other angle crash pattern discovered during the before period was, vehicles traveling Northbound on SR 1321 were colliding with vehicles traveling Westbound on US 74. It is conclusive that vehicles traveling Northbound/Southbound on SR 1321 failed to yield the right of way to vehicles traveling Eastbound/Westbound on US 74.
