Spot Safety Project # 08-06-215

**Spot Safety Project Evaluation of the
“Vehicle Entering When Flashing” Overhead Actuated Flasher
US 401 at SR 1207 (John Russell Rd)
Hoke County**

Spot Safety Project Evaluation Documentation

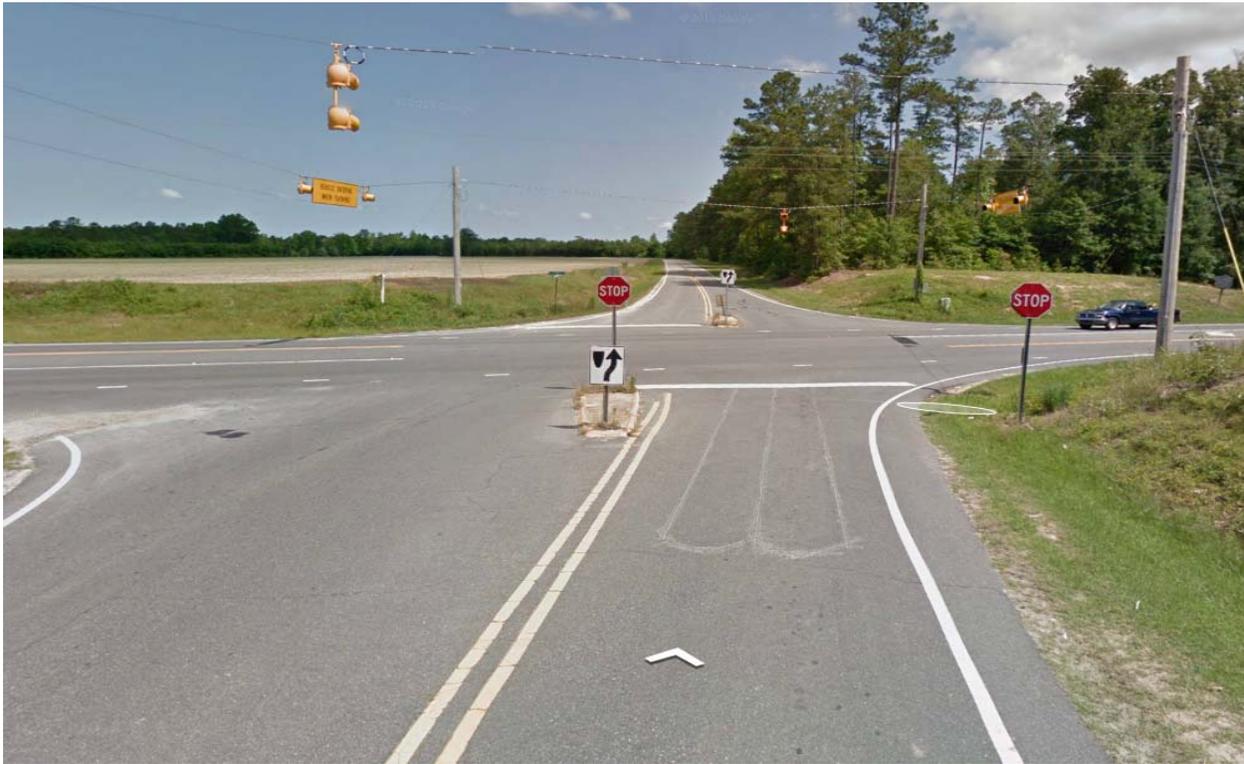
Google Maps (May 2012) – Looking North from SR 1207

Please see the attached *Treatment Site Photos*. Photos are provided from Google Street View for all four approaches to the treatment intersection. As the Safety Evaluation Group completes additional spot safety reviews for this type of countermeasure, we will be able to provide objective and definite information regarding actual crash reduction factors for this type of intersection.

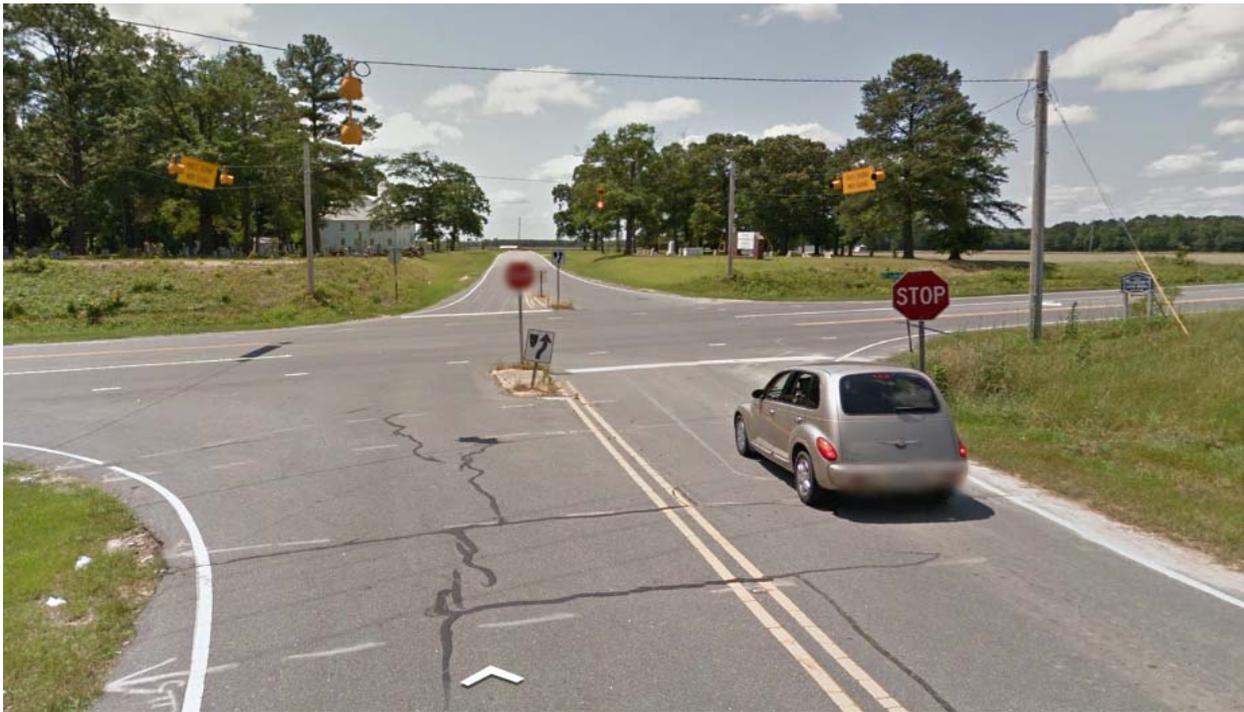
Google Maps (May 2012) – Looking South from SR 1207

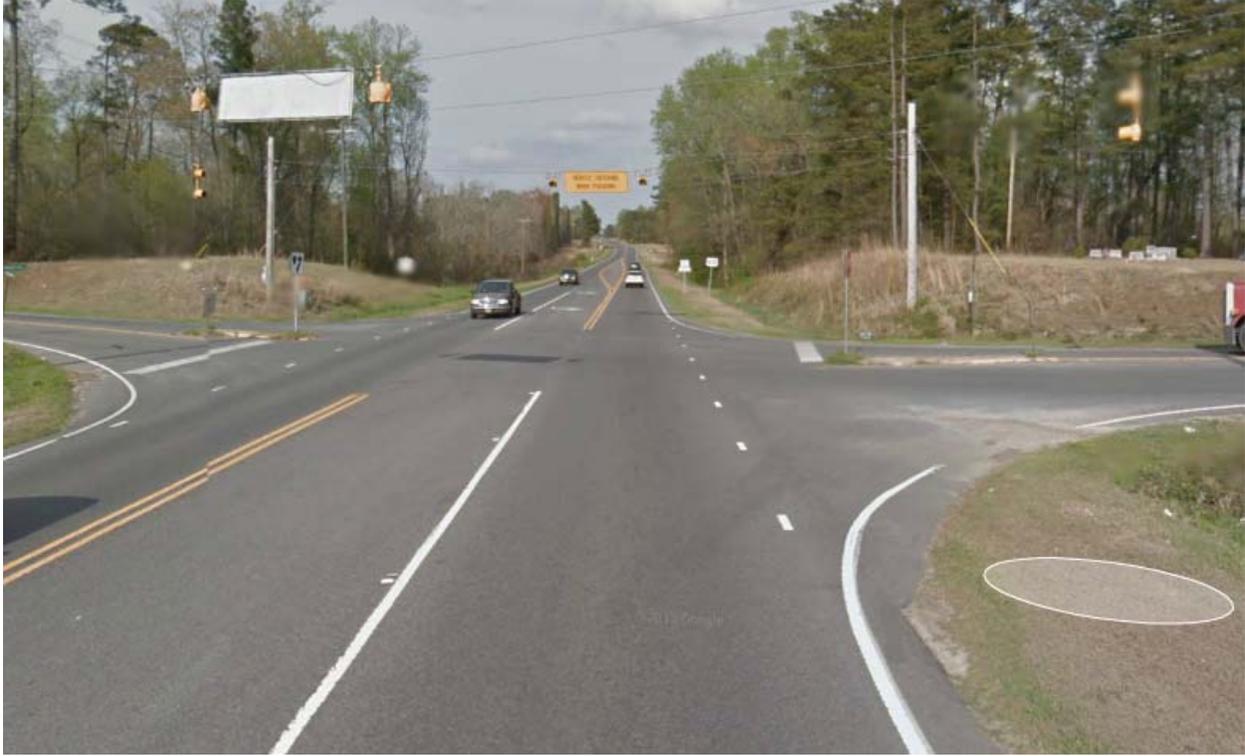
Google Maps (April 2013) – Looking East from US 401

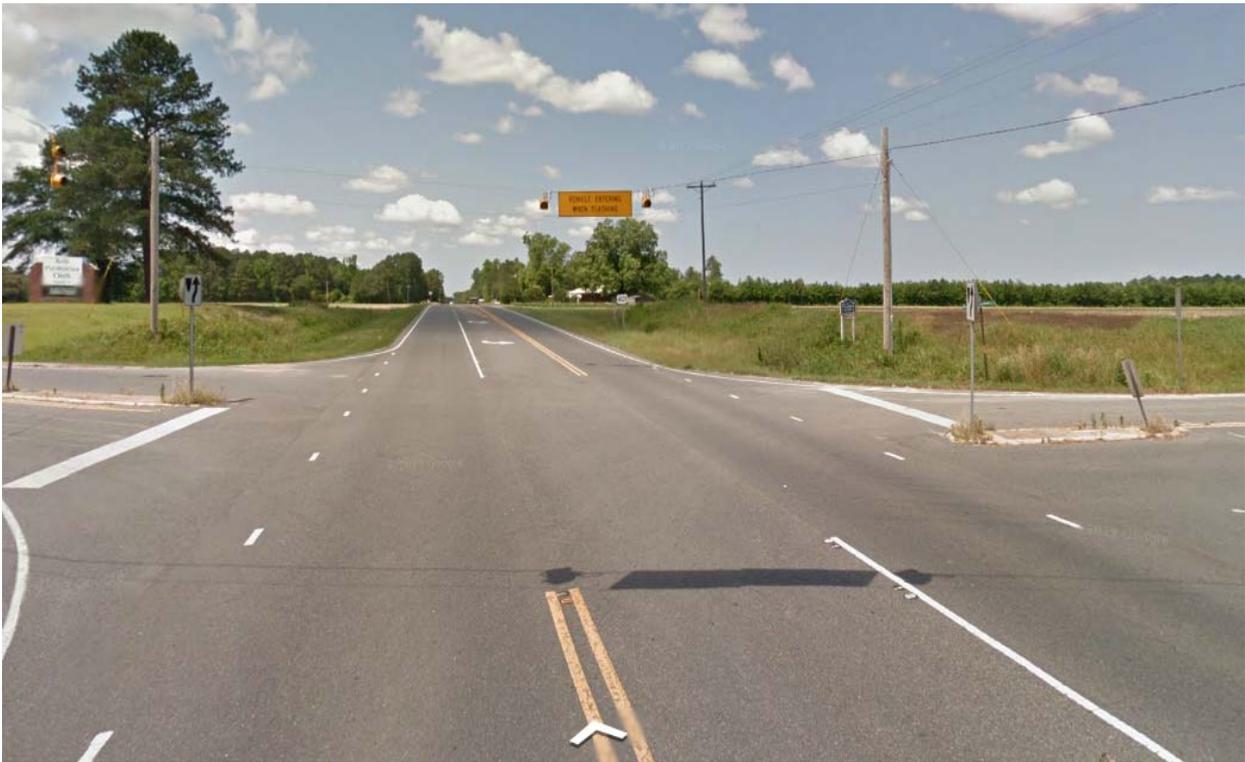
Google Maps (May 2012) – Looking West from US 401

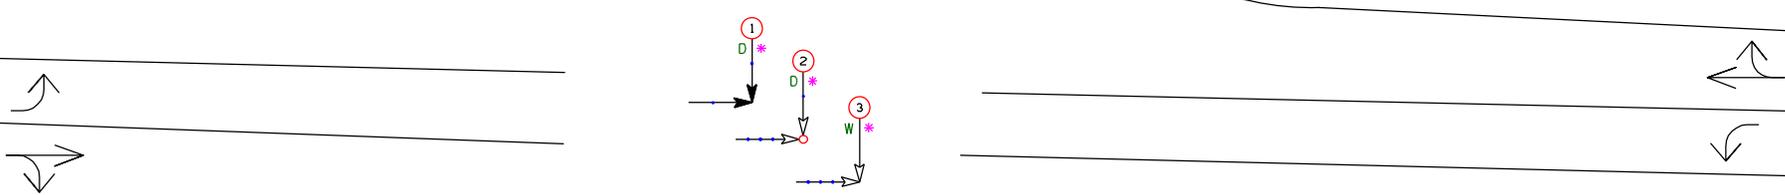
FIGURE 1

SIG ID 08-0801 (Actuated Flasher)

Denotes L.E.D.

TABLE OF OPERATION		
SIGNAL FACE	INTERVAL	
	1	2
11,12	ON	OFF
13,14	OFF	ON
21,23	ON	OFF
22,24	OFF	ON
