Spot Safety Project Evaluation

Spot Safety Project # 09-07-202

Spot Safety Project Evaluation for Installation Left-Turn Lanes on the Northbound and Southbound Approaches of NC 109

NC 109 at SR 2266 (Clarksbury Church Road/Hannerville Road)
Davidson County

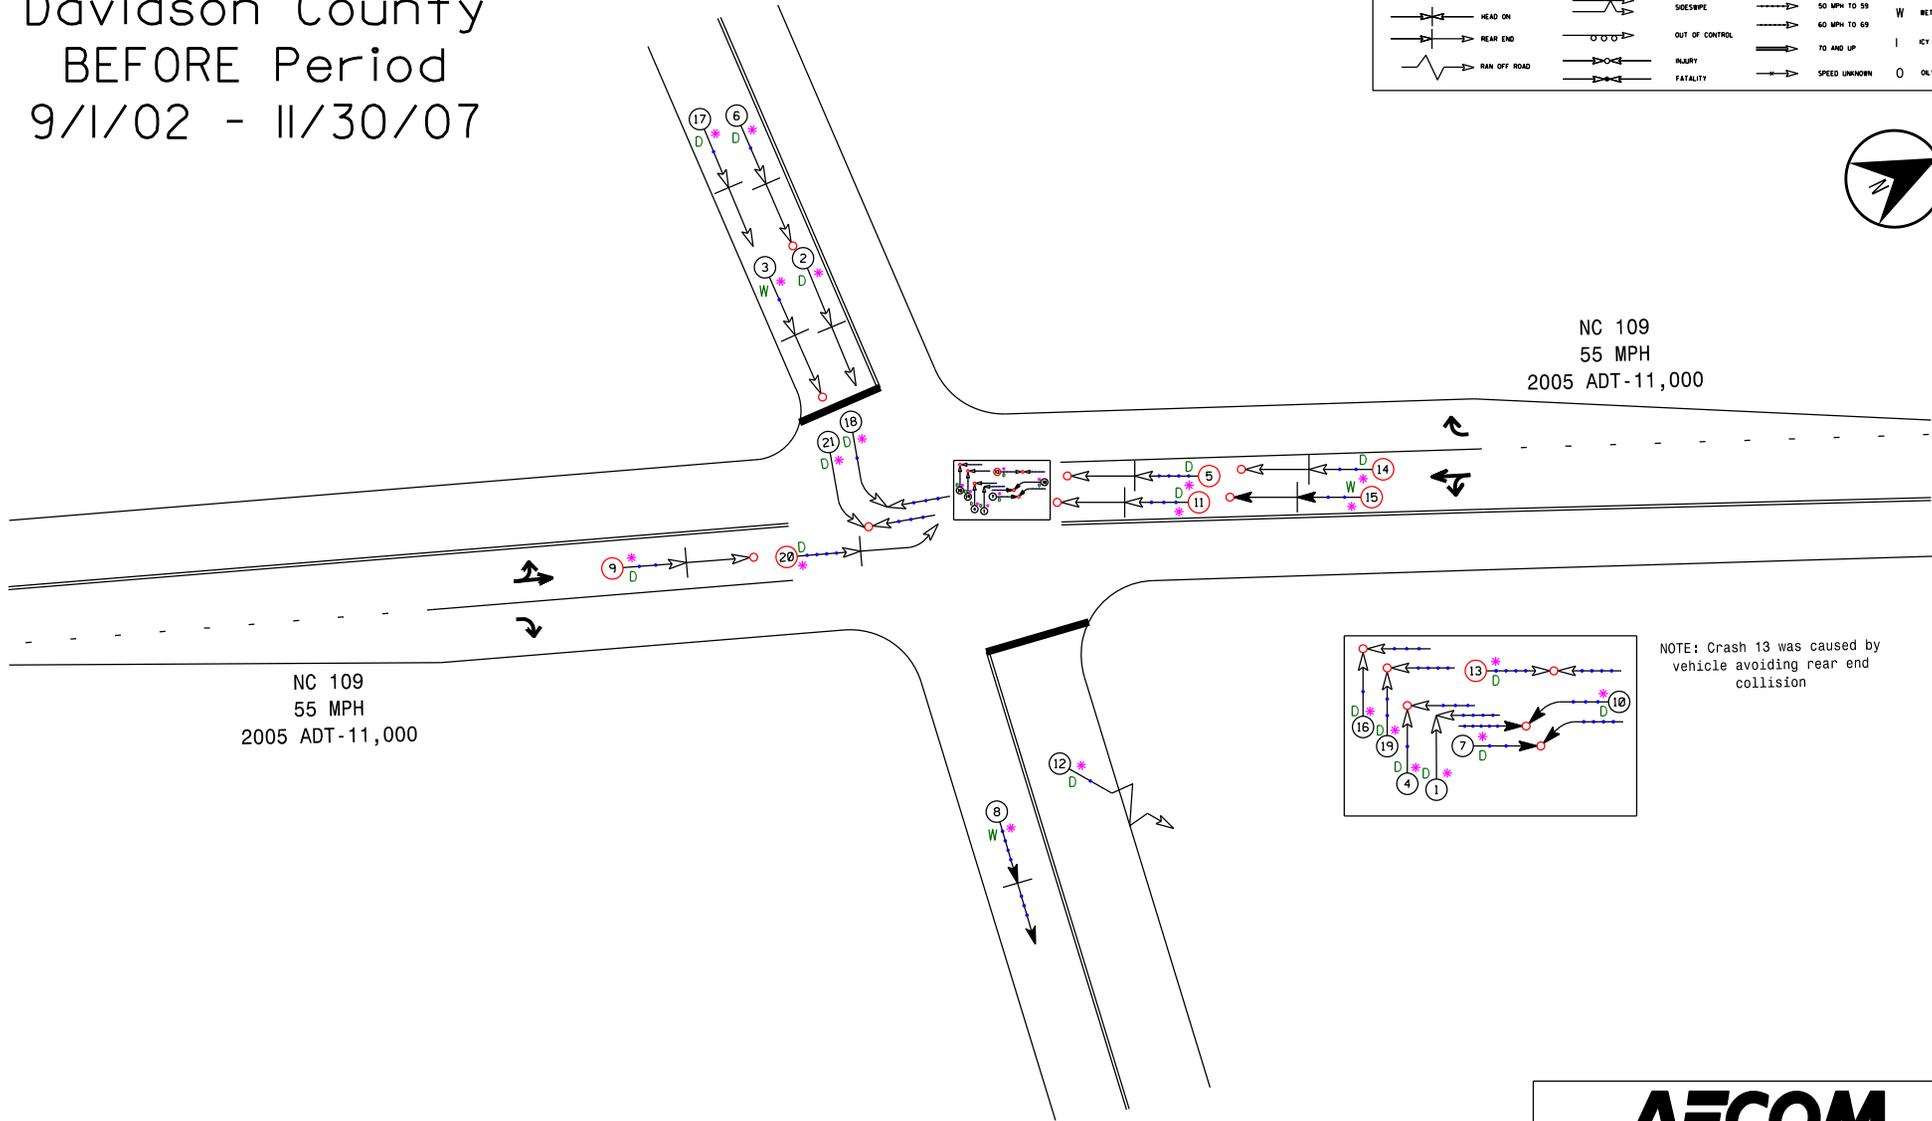
SS# 09-07-202
 Davidson County
 BEFORE Period
 9/1/02 - 11/30/07

SR 2266 (Clarksbury Church Road)
 55 MPH
 2005 ADT-1,900

NC 109
 55 MPH
 2005 ADT-11,000

SR 2266 (Hannerville Road)
 55 MPH
 2005 ADT-1,100

NOTE: Crash 13 was caused by vehicle avoiding rear end collision

NB and SB Rear End Crashes

Referencing the *Collision Diagrams*, target crashes (Northbound and Southbound Rear End Crashes) experienced a reduction from 7 crashes in the before period to 0 crashes in the after period. The installation of the left-turn lanes on both approaches was beneficial in reducing the target crashes at this location during the after period.

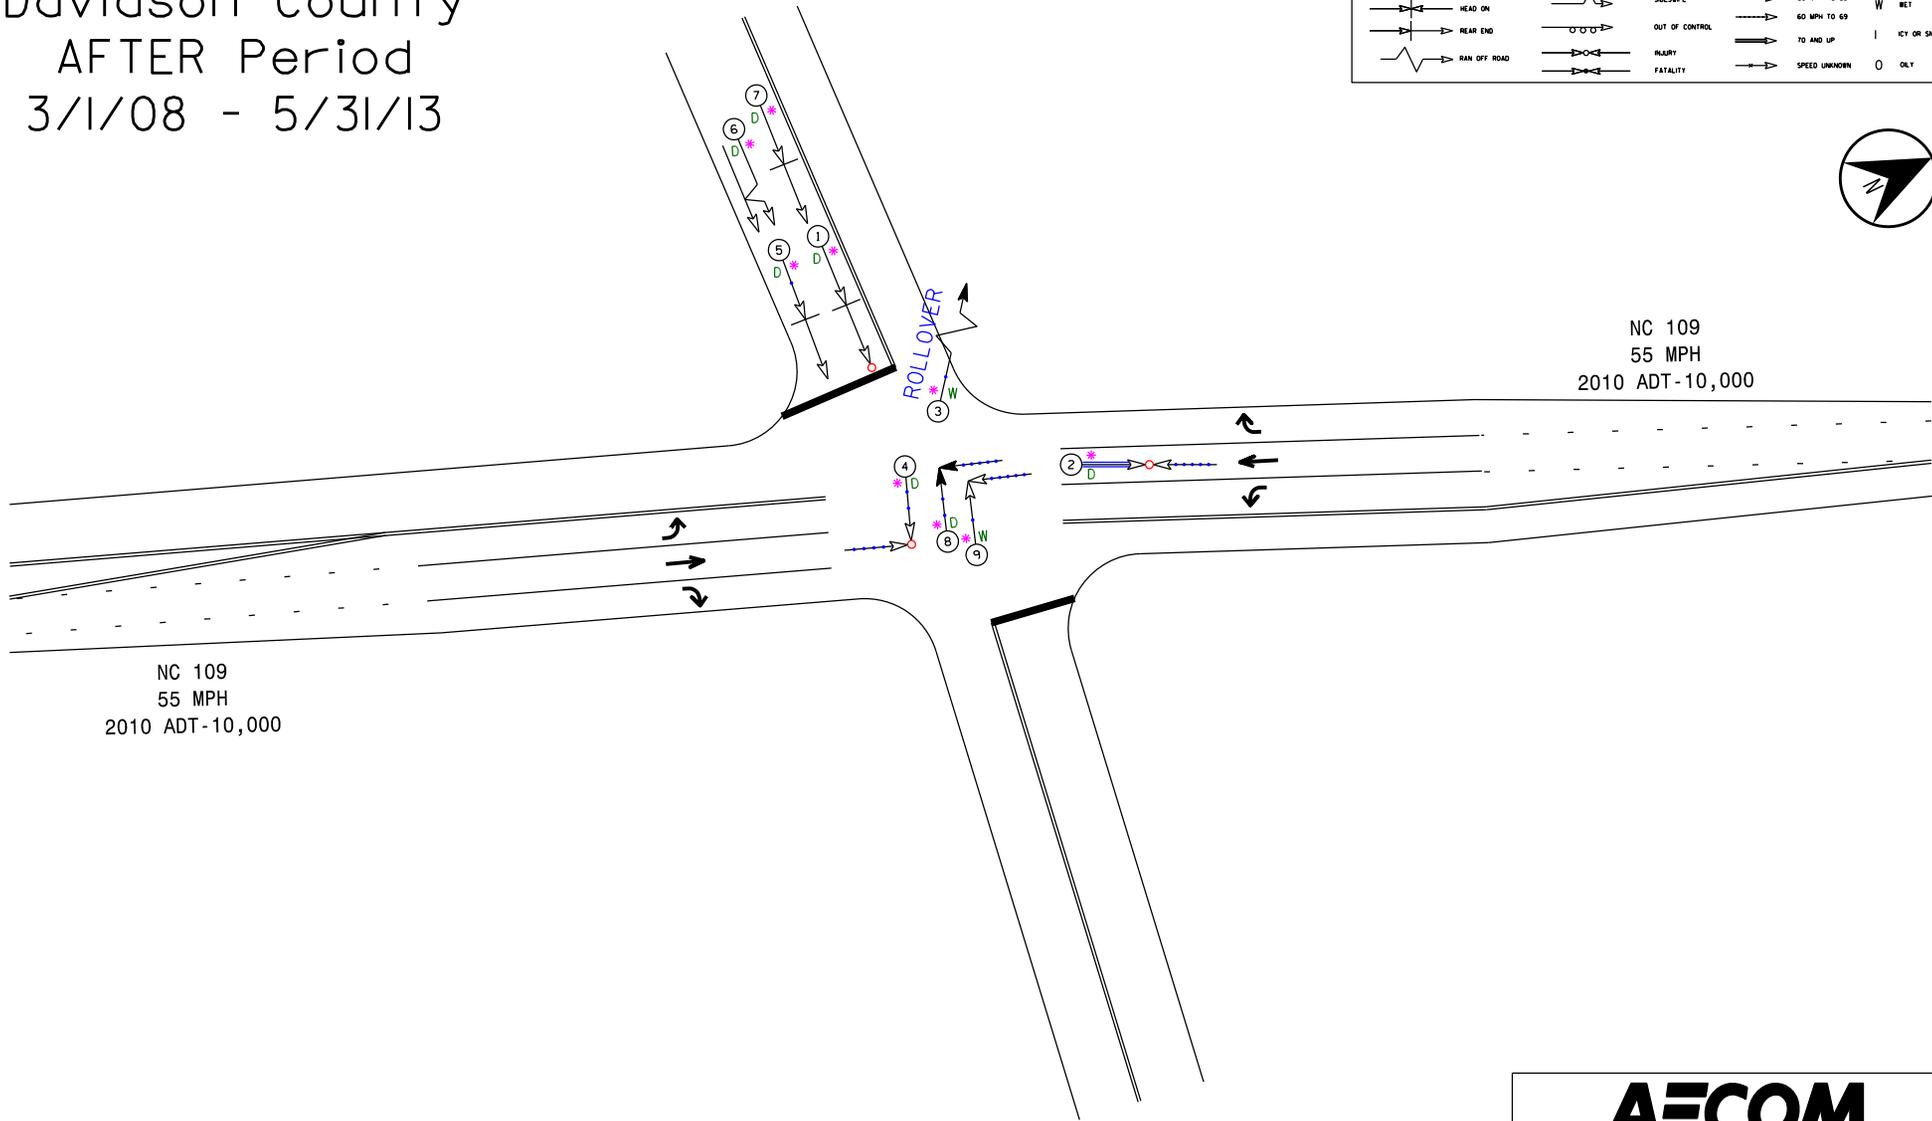
SS# 09-07-202
 Davidson County
 AFTER Period
 3/1/08 - 5/31/13

SR 2266 (Clarksbury Church Road)
 55 MPH
 2010 ADT-1,800

NC 109
 55 MPH
 2010 ADT-10,000

SR 2266 (Hannerville Road)
 55 MPH
 2010 ADT-1,200

NB and SB Rear End Crashes
