Spot Safety Project Evaluation

Spot Safety Project # 10-03-211

Spot Safety Project Evaluation for Installation of Traffic Signal

**SR 2475 (Prosperity Church Road) and SR 2601 (Ridge Road)
Mecklenburg County**

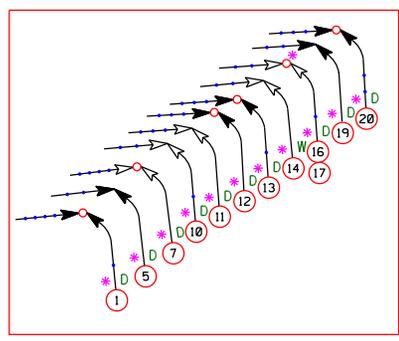
Frontal Impact
 Crashes

SS# 10-03-211
 Mecklenburg County
 BEFORE Period
 10/1/02 - 9/30/05

SR 2475 (Prosperity Church Road)
 45 MPH
 2004 ADT-9,000

SR 2601 (Ridge Road)
 45 MPH
 2004 ADT-4,900

Referencing the *Collision Diagrams*, target crashes per year (Frontal Impact Crashes) experienced a reduction from 6.33 crashes per year in the before period to 1.95 crashes per year in the after period. The installation of the signal was beneficial in reducing the target crashes per year at this location during the after period.

Left turn, different roadway crashes decreased from 4.00 crashes per year in the before period to 0.14 crashes per year in the after period. Left-turn, same roadway crashes increased from 0.33 crashes per year in the before period to 1.53 crashes per year in the after period.

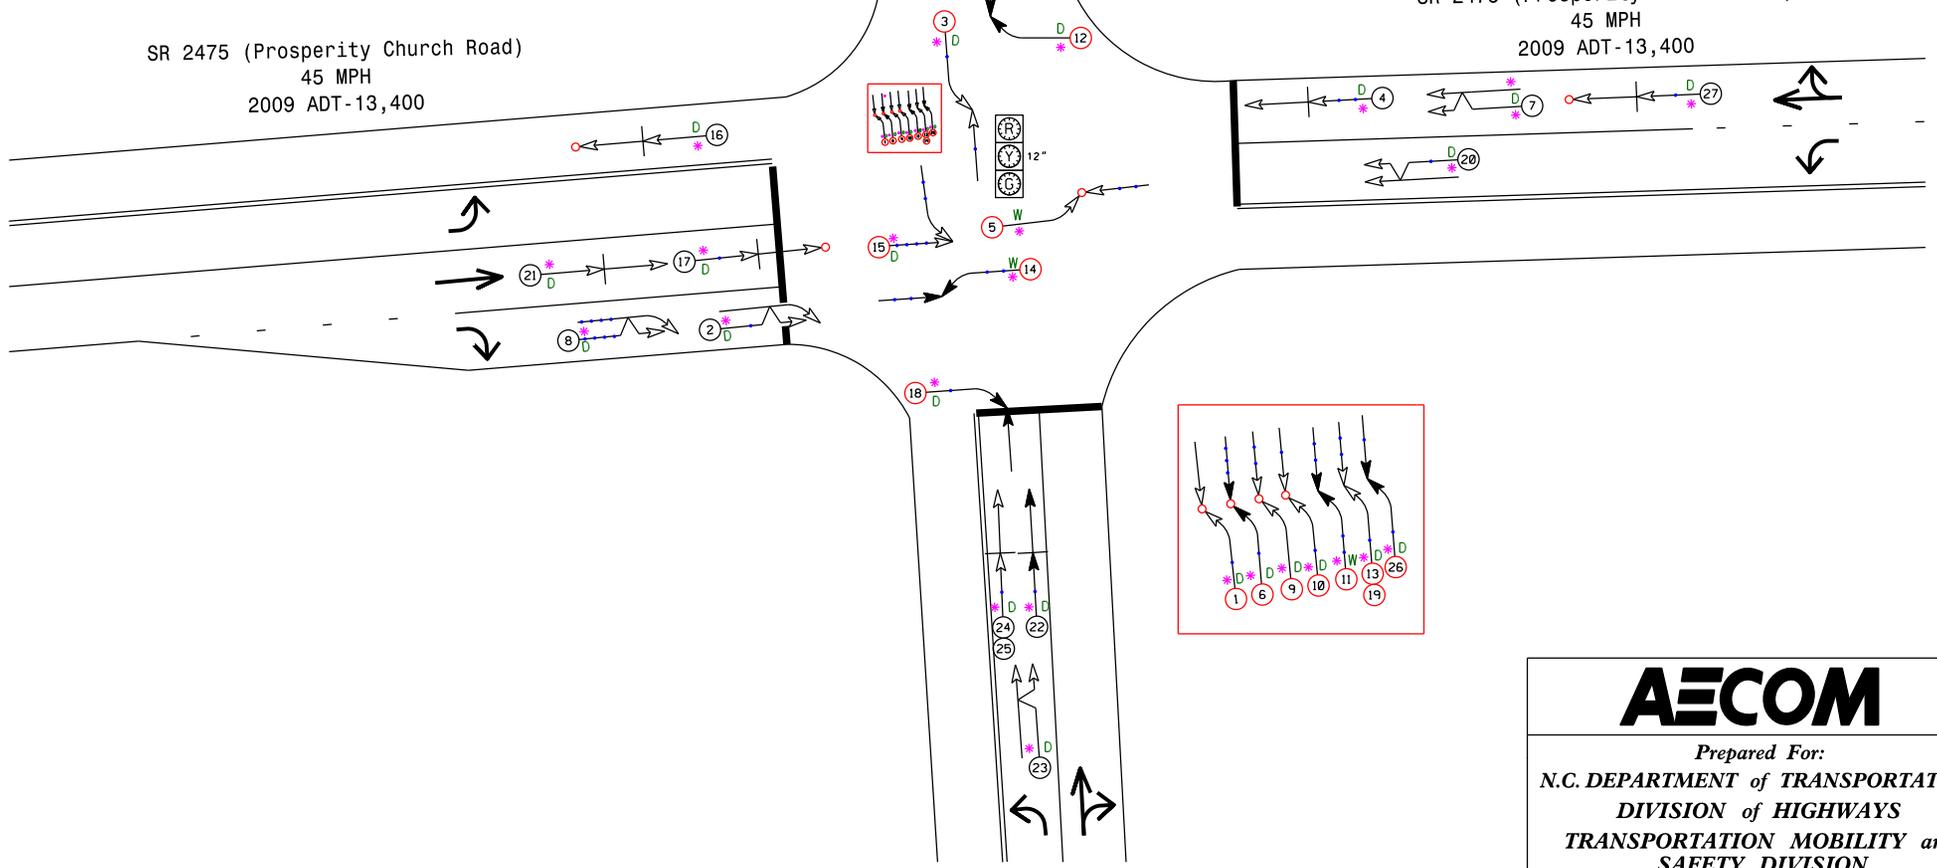
Frontal Impact Crashes

SS# 10-03-211
 Mecklenburg County
 AFTER Period
 1/1/06 - 2/28/13

SR 2475 (Prosperity Church Road)
 45 MPH
 2009 ADT-13,400

SR 2601 (Ridge Road)
 45 MPH
 2009 ADT-4,700

Although the target crashes were reduced, the number of rear end crashes and sideswipe crashes per year at the intersection increased. Rear end crashes increased from 0.33 crash per year in the before period to 1.12 crashes per year in the after period. Sideswipe crashes also increased from 0 crashes per year in the before period to 0.70 crashes per year in the after period.
