Spot Safety Project Evaluation

Spot Safety Project # 10-99-217

**Spot Safety Project Evaluation of the Traffic Signal and
Left Turn Lane Installation at the Intersection of
NC 73 and SR 2408 (Goldhill Rd)
Cabarrus County**

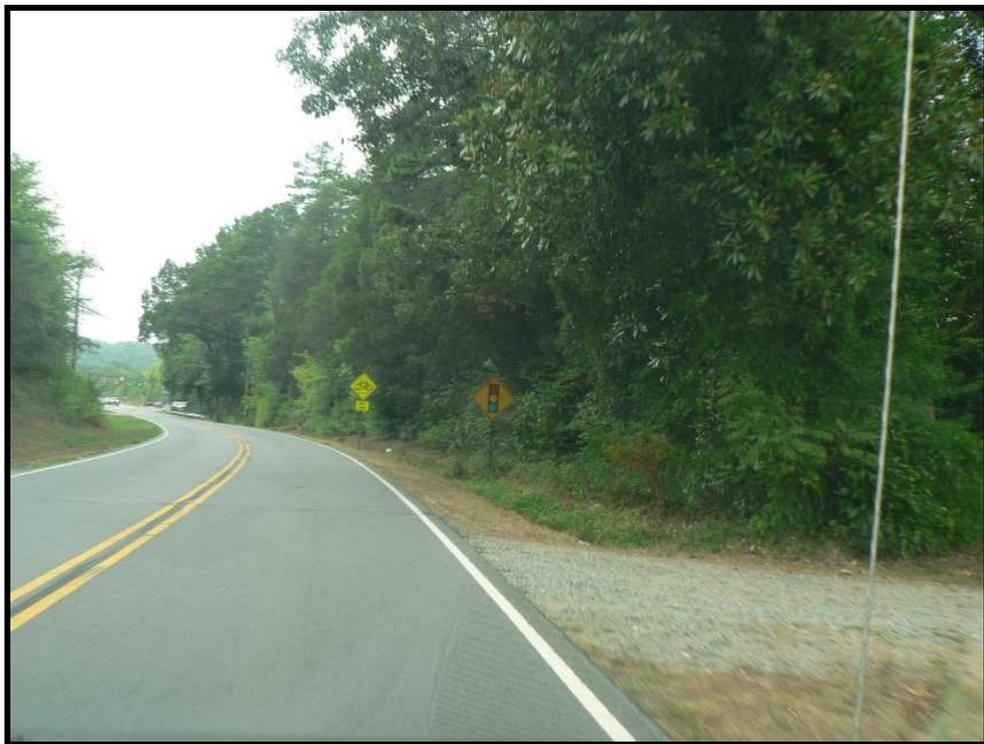
Traveling West on NC-73

(Observe Signal Ahead Warning Sign and curve leading into the intersection)

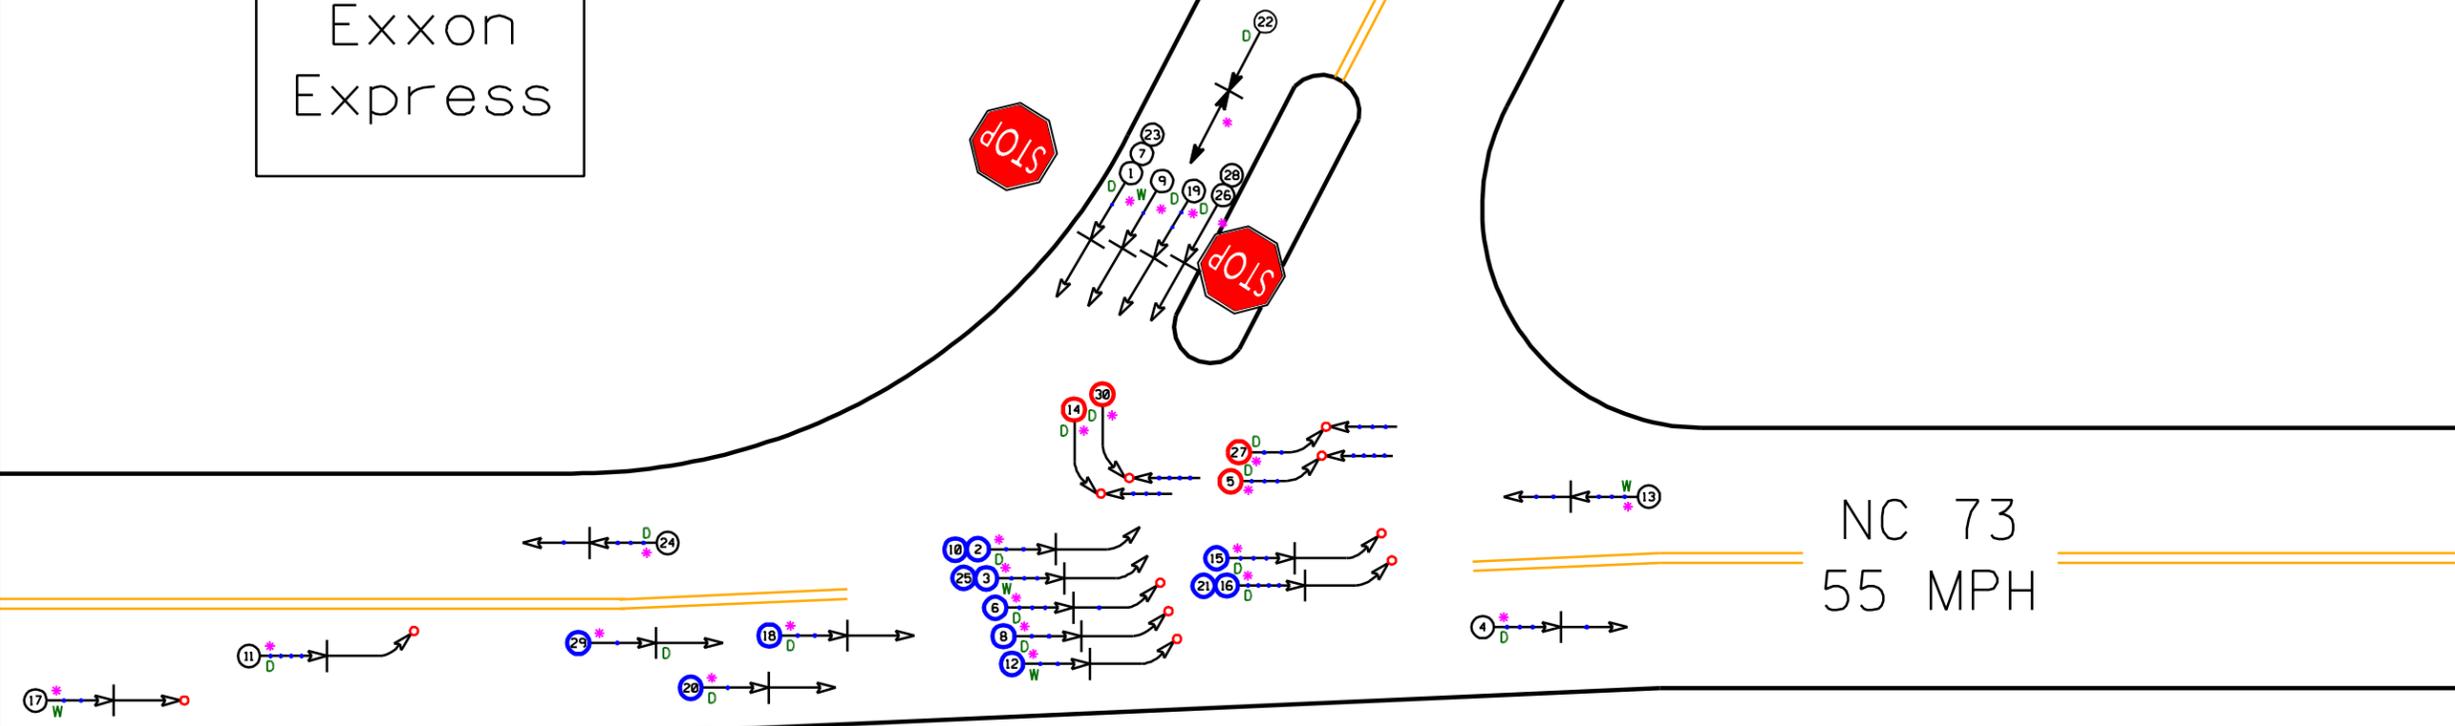
SS# 10-99-217
Cabarrus County
Before Period
12/1/92 - 4/30/00
NC-73 at SR 2408

New Signal
 Target Crashes

Left Turn Lane
Target Crashes

COLLISION DIAGRAM	
	DIVISION: 10	AREA:
	STUDY PERIOD: 12/1/1992 - 4/30/2000	
	DISTANCE: Y-LINE = 150 FT	
ANALYSIS PREPARED BY: JBS		
ANALYSIS CHECKED BY: BR		
DIAGRAM PREPARED BY: JBS		
DIAGRAM EXAMINED BY: ST		
SCALE: NOT TO SCALE		
DATE: 2-24-2009		
LOG NUMBER: SS* 10-99-217 BEFORE

Referencing the *Collision Diagrams*, three patterns of crashes exist at the intersection in the before period. The eastbound NC 73 rear-end pattern of 13 collisions (Target Crash 2) was completely eliminated by the installation of the left turn lane. The southbound SR 2408 rear-end crash pattern was also positively impacted by the installation of the signal. This pattern reduced from seven (7) collisions in the before period to just one (1) in the after period.

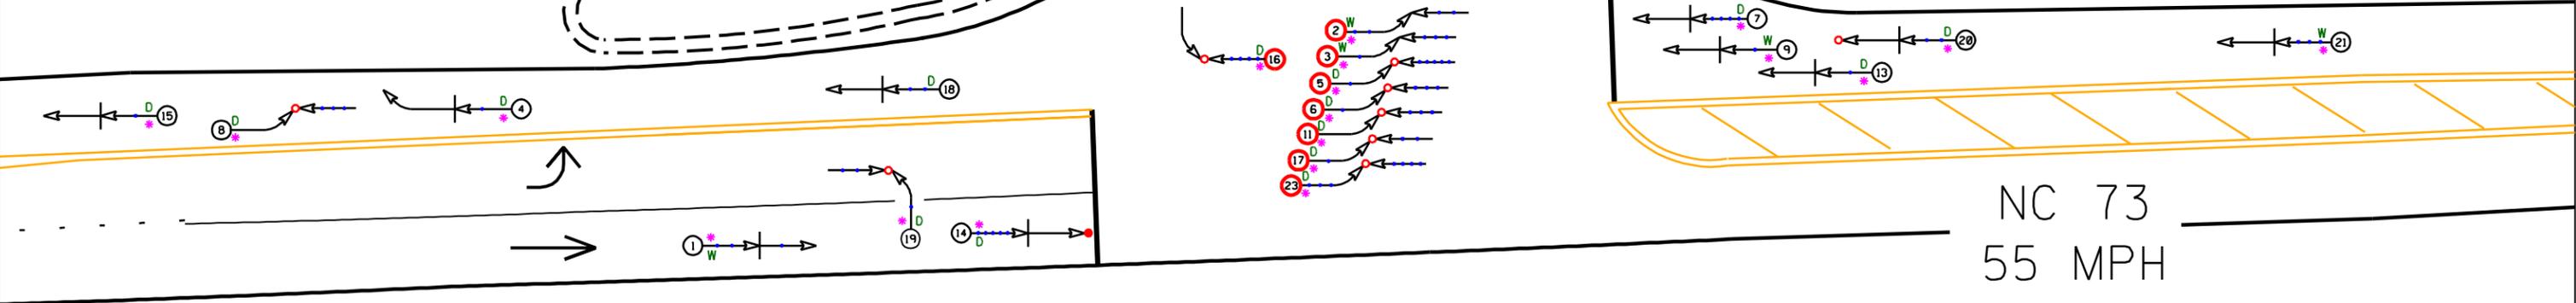
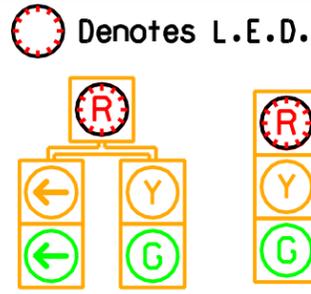
SS# 10-99-217
 Cabarrus County
 After Period
 6/1/01 - 10/31/08
 NC-73 at SR 2408

New Signal
 Target Crashes

Left Turn Lane
 Target Crashes

COLLISION DIAGRAM	
	DIVISION: 10	AREA:
	STUDY PERIOD: 6/1/2008 TO 10/31/2008	
	DISTANCE: Y-LINE = 150FT	
ANALYSIS PREPARED BY: JBS		
ANALYSIS CHECKED BY: BR		
DIAGRAM PREPARED BY: JBS		
DIAGRAM REVIEWED BY: ST		
SCALE: NOT TO SCALE		
DATE: 2-24-2009		
LOG NUMBER: SS* 10-99-217 AFTER

However, after the signal installation, the frontal impact pattern (Target Crash 1) doubled through the analysis. Left turn same roadway crashes increased from two (2) to seven (7) with eastbound NC 73 motorists improperly accessing the permissive signal phase. The after period also had one (1) vehicle on westbound NC 73 run the red light resulting in a frontal impact crash.
