Spot Safety Project Evaluation

Spot Safety Project # 10-96-220

**Spot Safety Project Evaluation, of the Flashing Traffic Signal Installation,
At the Intersection of NC 24/ 27/ 73 and SR 1720-Valley Drive-Stony Gap Road
Near Albemarle, Stanly County**

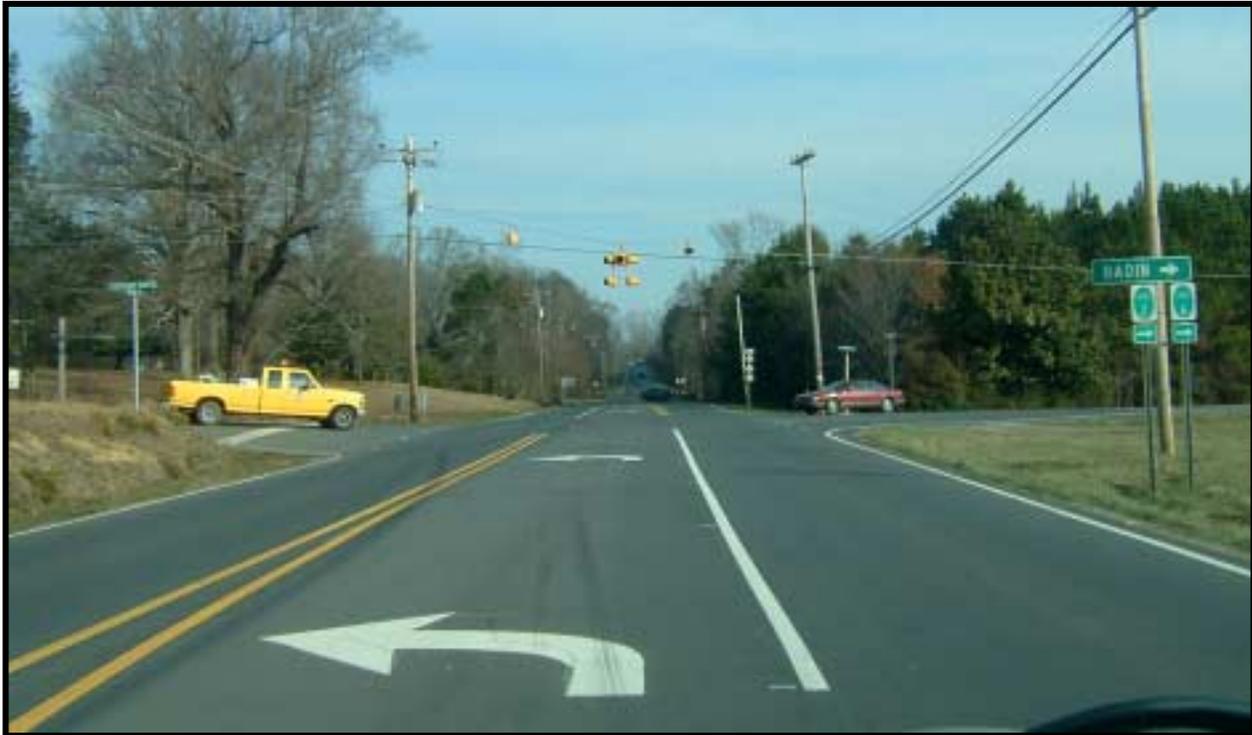
Looking north on NC 24/ NC 27/ NC 73.

Please see the attached Treatment Site Photos. Photos are provided for each leg of the intersection. In addition, photos are included to show the advance warning signs on each intersection approach.

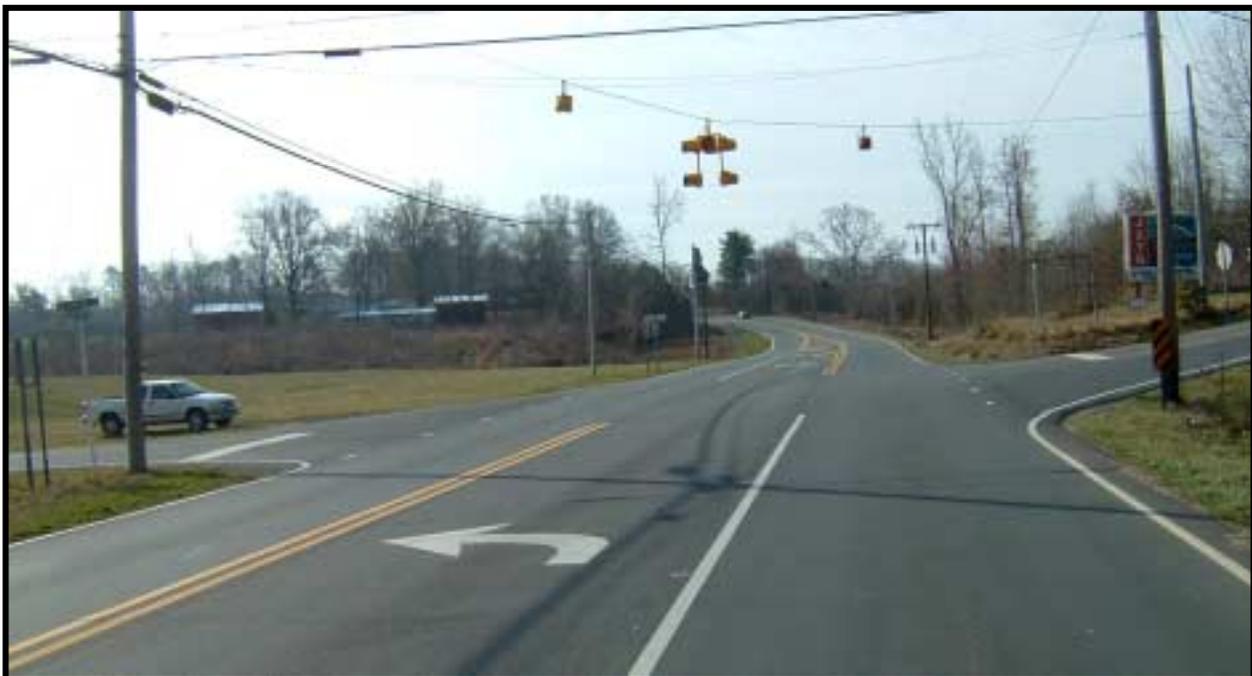
Looking south on NC 24/ NC 27/ NC 73.

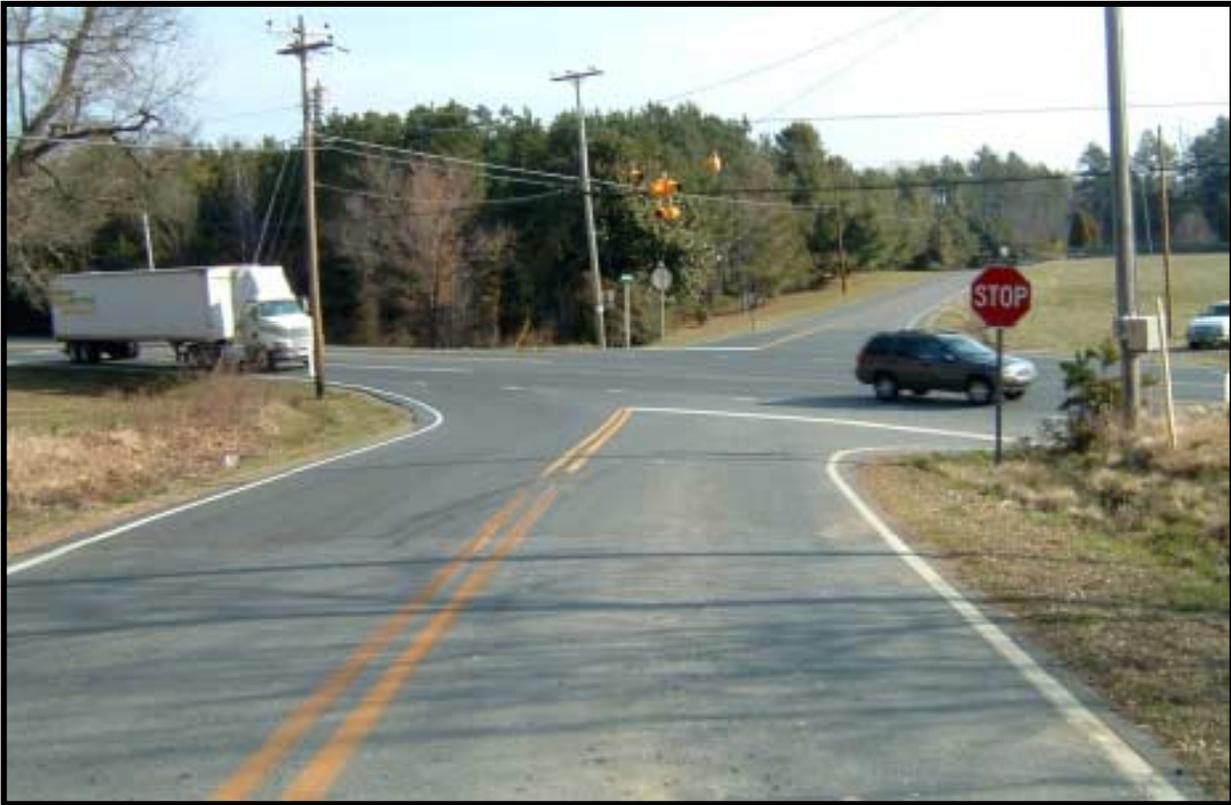
Looking east on SR 1720 – Valley Road – Stony Gap Road.

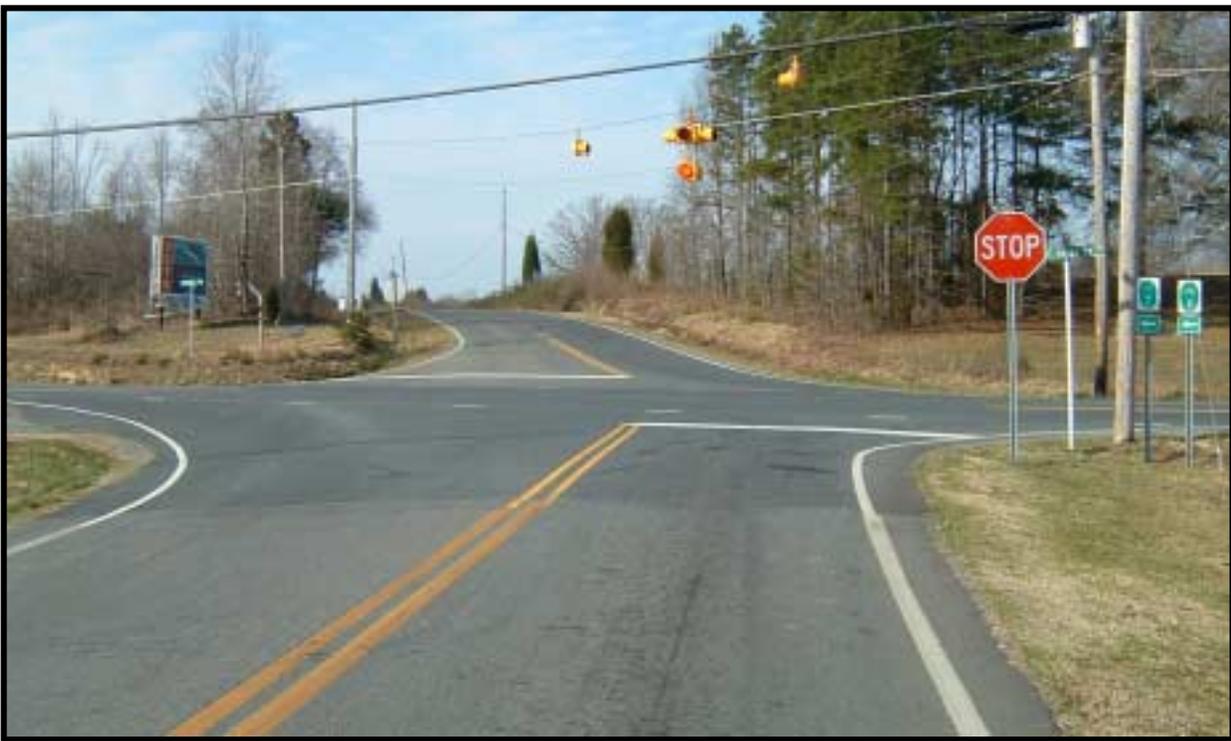
Looking west on SR 1720 – Valley Road – Stony Gap Road.

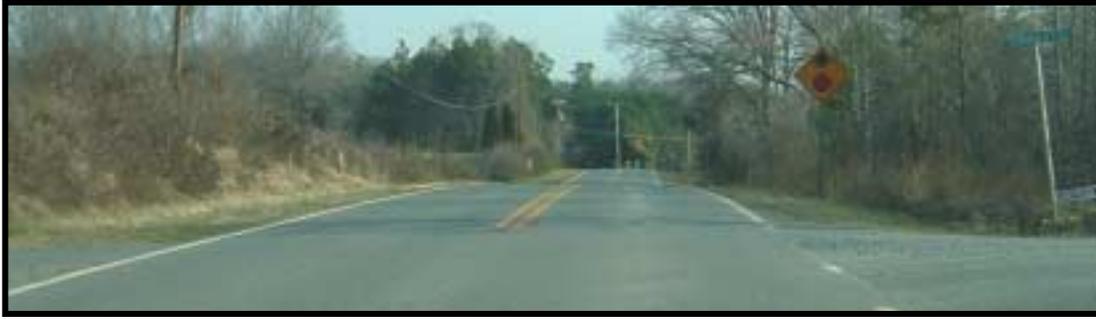
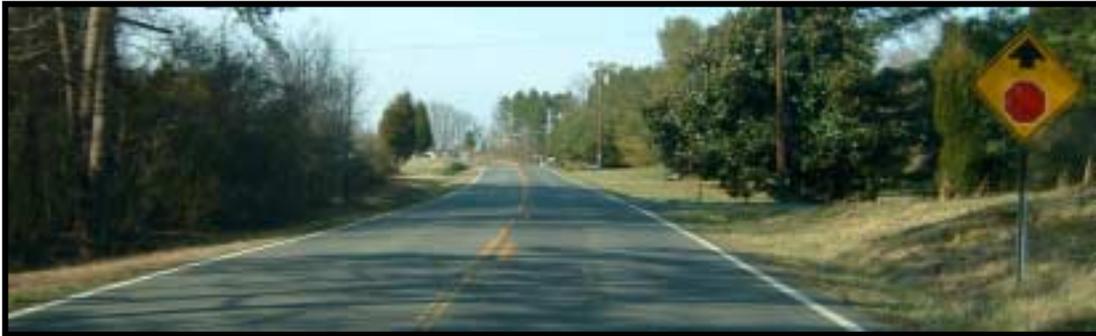
Photos taken while driving east (above, top) and west (above, bottom) towards treatment intersection. Notice the Stop Ahead Warning signs.

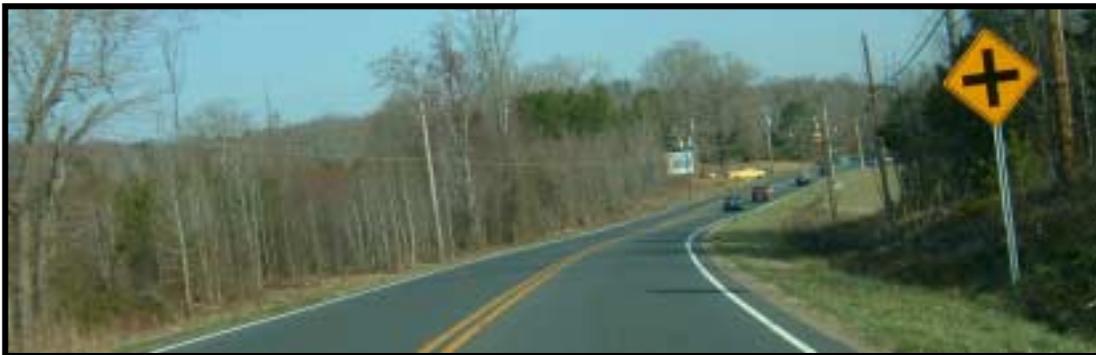
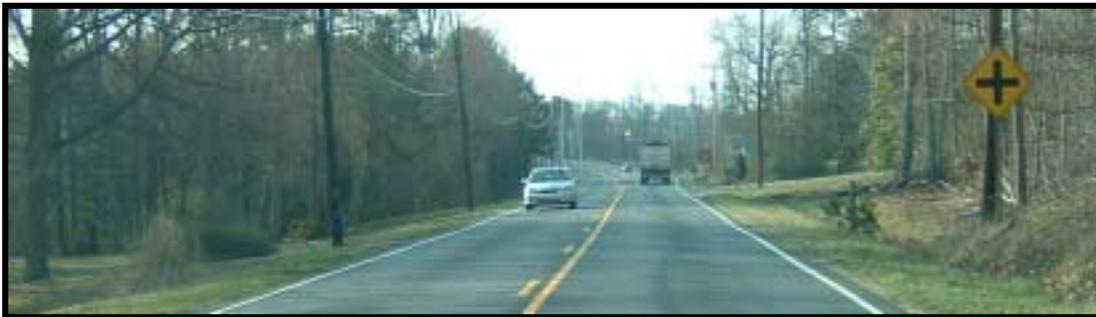
Photos taken while driving north (above, top) and south (above, bottom) towards treatment intersection. Notice the Intersection Warning signs.

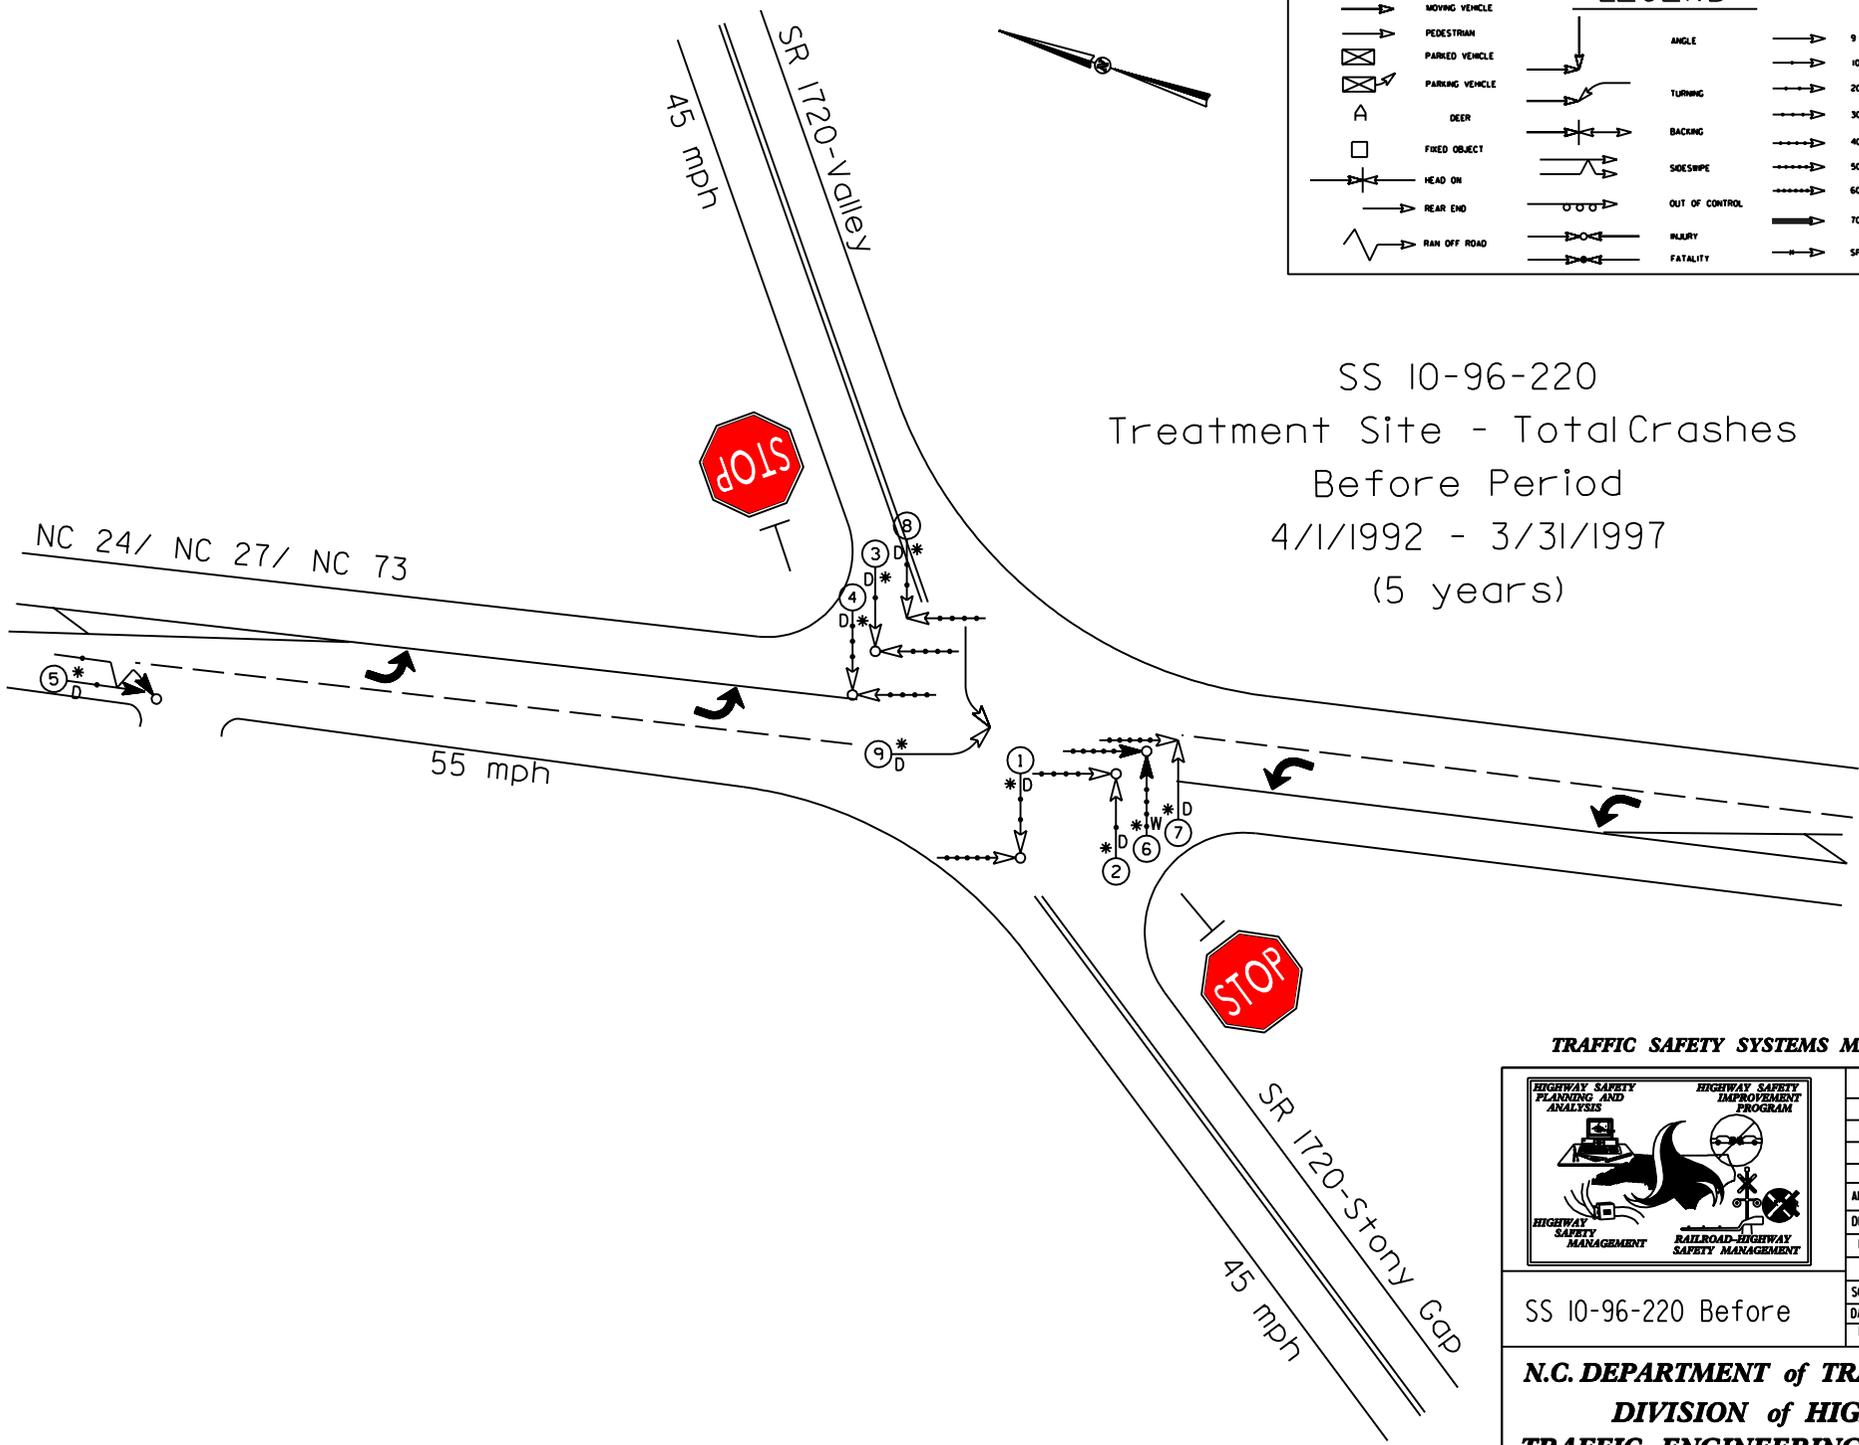
SS 10-96-220 Before

SS 10-96-220
 Treatment Site - Total Crashes
 Before Period
 4/1/1992 - 3/31/1997
 (5 years)

COLLISION DIAGRAM	
DIVISION:	AREA:
STUDY PERIOD: 4/1/1992 - 3/31/1997	
DISTANCE: T-LINE = 150 ft	
ANALYSIS PREPARED BY: CLG	
ANALYSIS CHECKED BY:	
DIAGRAM PREPARED BY: CLG	
DIAGRAM REVIEWED BY:

Flashing traffic signals are generally installed to help motorists better identify the existing traffic control. Analysis of the crash data in the before period reveals that at least four out of the nine crashes (44.4 percent) at the treatment intersection were caused by a vehicle running through the stop signs located on SR 1720-Valley Drive-Stony Gap Road. In the after period, none of the crashes at the subject location appeared to be caused by a vehicle running through the stop signs. Therefore the problem of intersection recognition appears to have been corrected by the treatment.

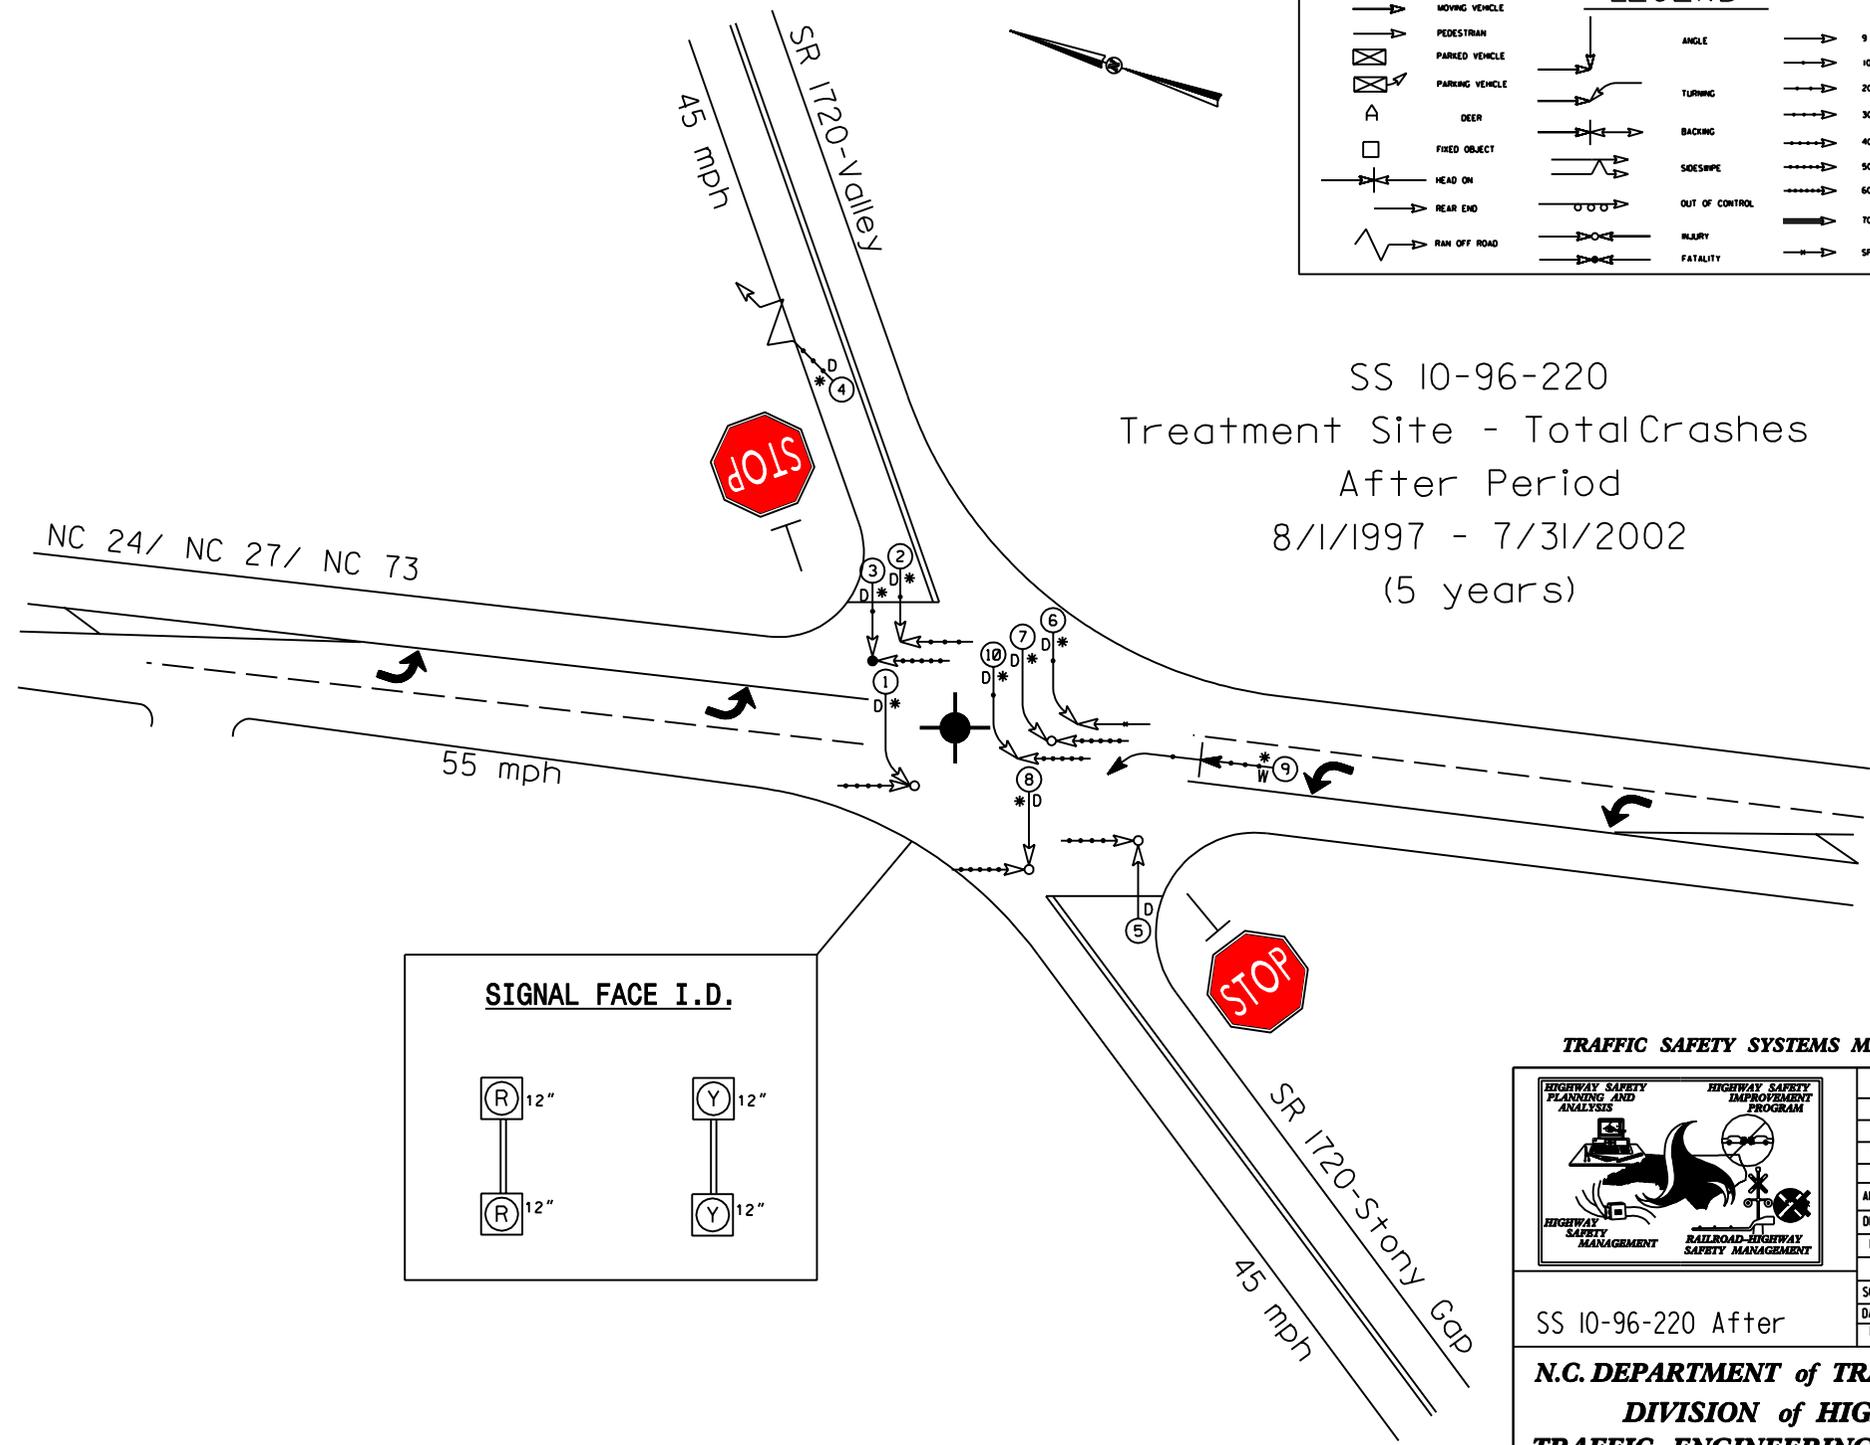
SS 10-96-220 After

SS 10-96-220
 Treatment Site - Total Crashes
 After Period
 8/1/1997 - 7/31/2002
 (5 years)

COLLISION DIAGRAM	
	DIVISION:	AREA:
	STUDY PERIOD: 8/1/1997 - 7/31/2002	
	DISTANCE: Y-LINE : 150 ft	
	ANALYSIS PREPARED BY: CLG	
ANALYSIS CHECKED BY:		
DIAGRAM PREPARED BY: CLG		
DIAGRAM REVIEWED BY:		
SCALE: NOT TO SCALE		
DATE: 3/1/2004		
LOG NUMBER: 20050245
