Spot Safety Project Evaluation

**Spot Safety Project Evaluation, of the Flashing Traffic Signal Installation,
At the Intersection of NC 268 and SR 1003-Siloam Rd., Surry County**

Evaluation of Spot Safety Project Number 11-00-200 – The Intersection of NC 268 and SR 1003-Siloam Rd., Surry County

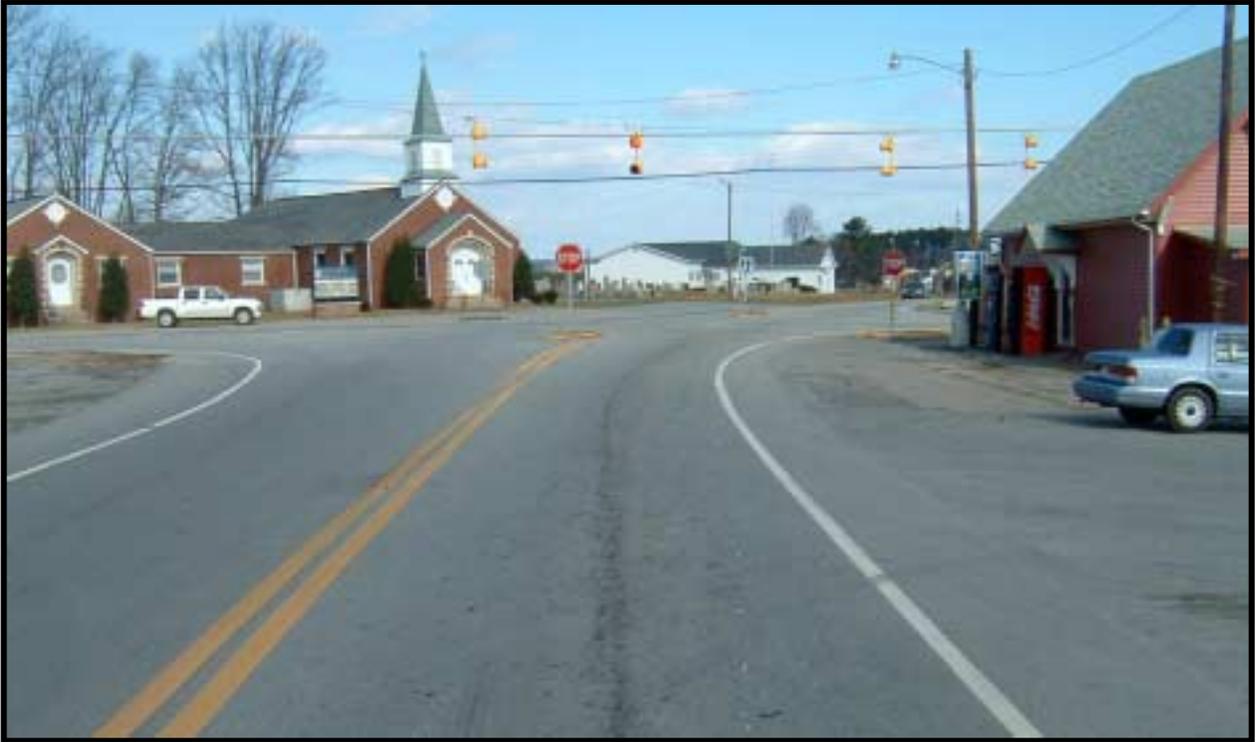
Looking north on SR 1003-Siloam Rd

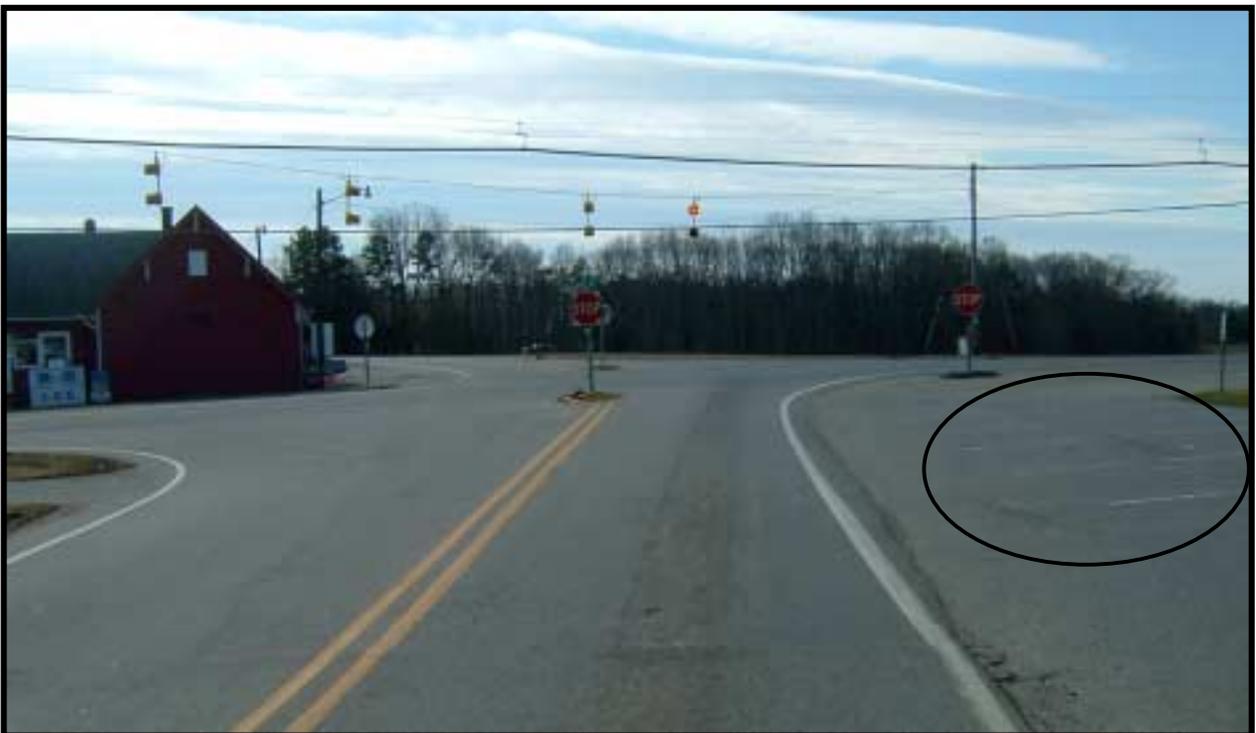
Looking south on SR 1003-Siloam Rd.
Notice the lack of channelization at the church parking lot adjacent to the roadway.

The naive before and after analysis involving the comparison of treatment actual before data versus treatment actual after data resulted in a 45.5 percent decrease in Total Crashes and a 50.0 percent decrease in Frontal Impact Crashes. Using the Odds Ratio to calculate the treatment effect resulted in a 50.3 percent decrease in Total Crashes at the Treatment Intersection. The summary results above demonstrate that the treatment location appears to have had a decrease in the number of Total Crashes and a decrease in the number of Frontal Impact Crashes from the before to the after period. Please see the attached Treatment Site Photos. Photos are provided for each leg of the intersection. In addition, a photo is included which depicts the poor driveway channelization at the treatment location.

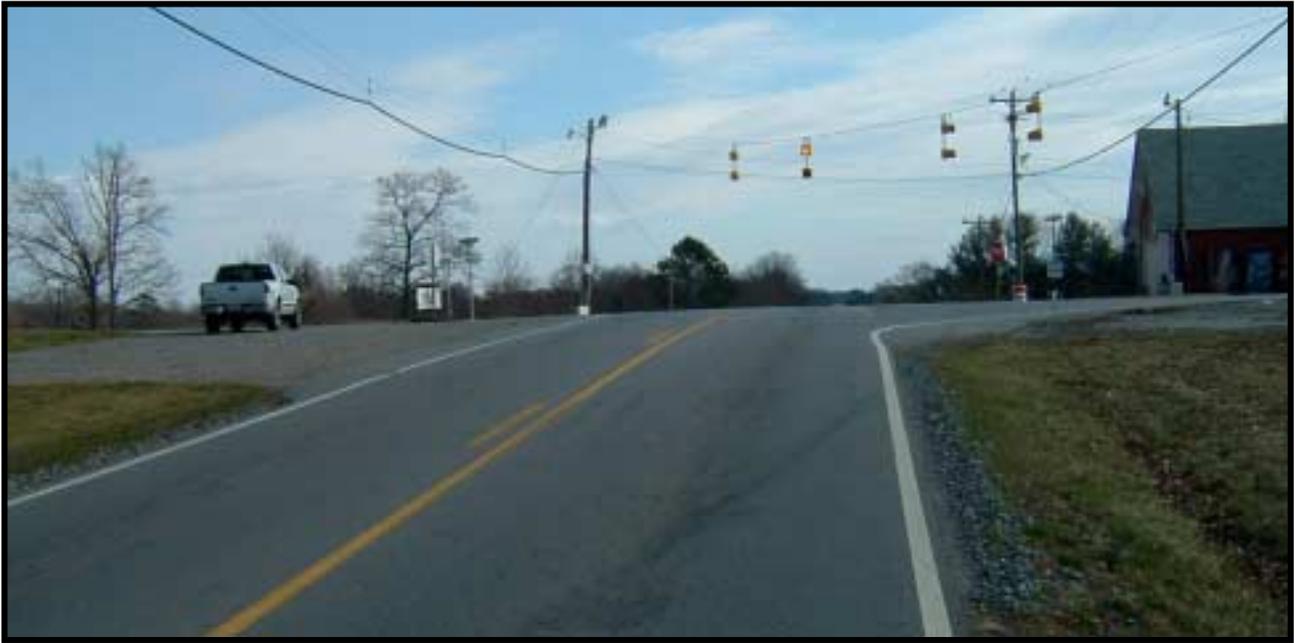
Looking east on NC 268

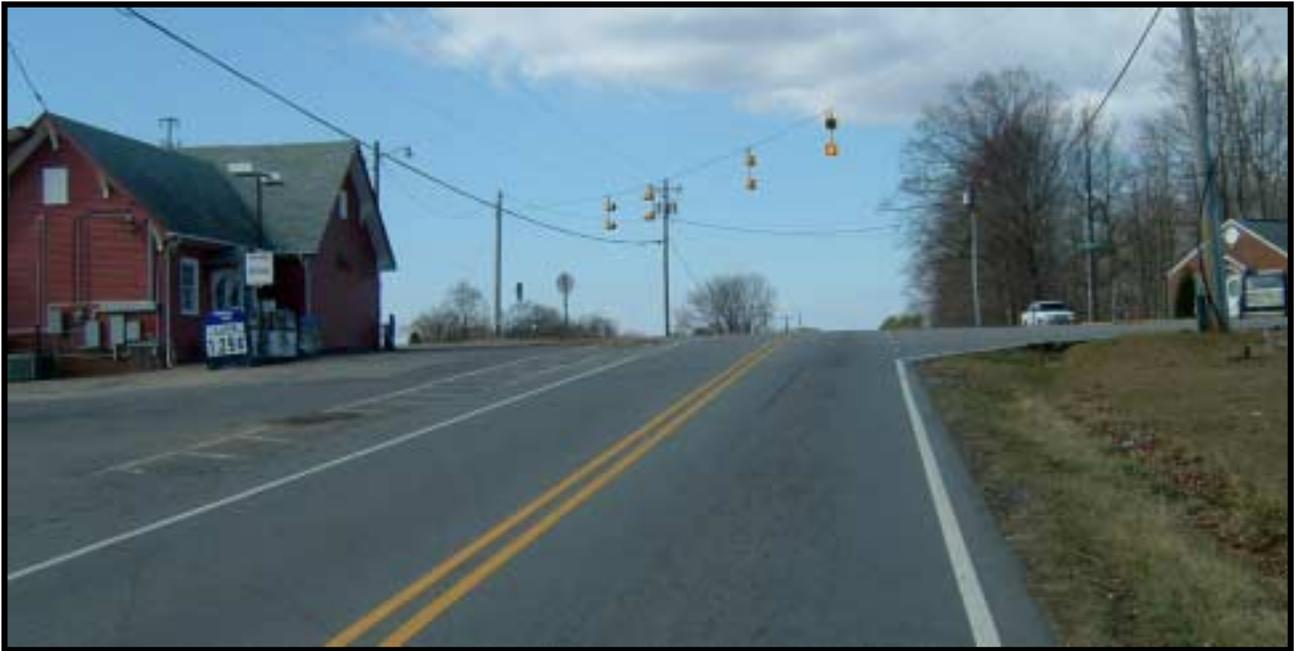
Looking west on NC 268

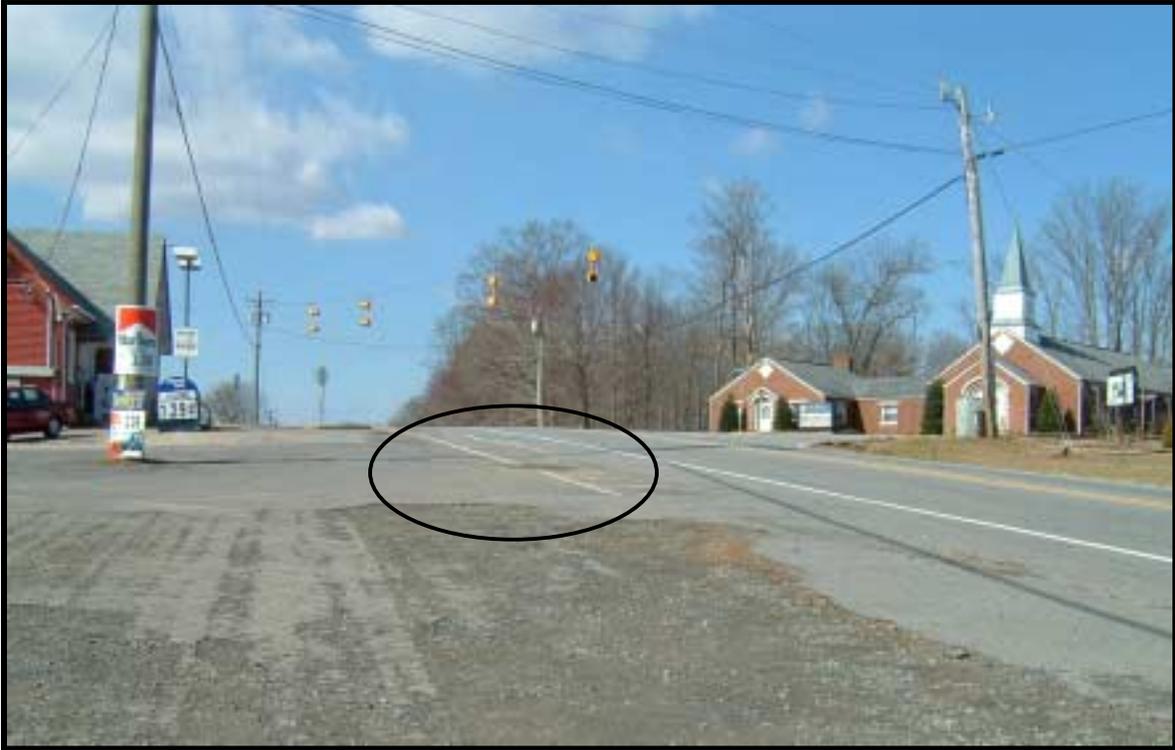
Another photo (looking west) taken from Level Cross General Store parking lot.
Notice the “No Parking” pavement markings in front of the store.

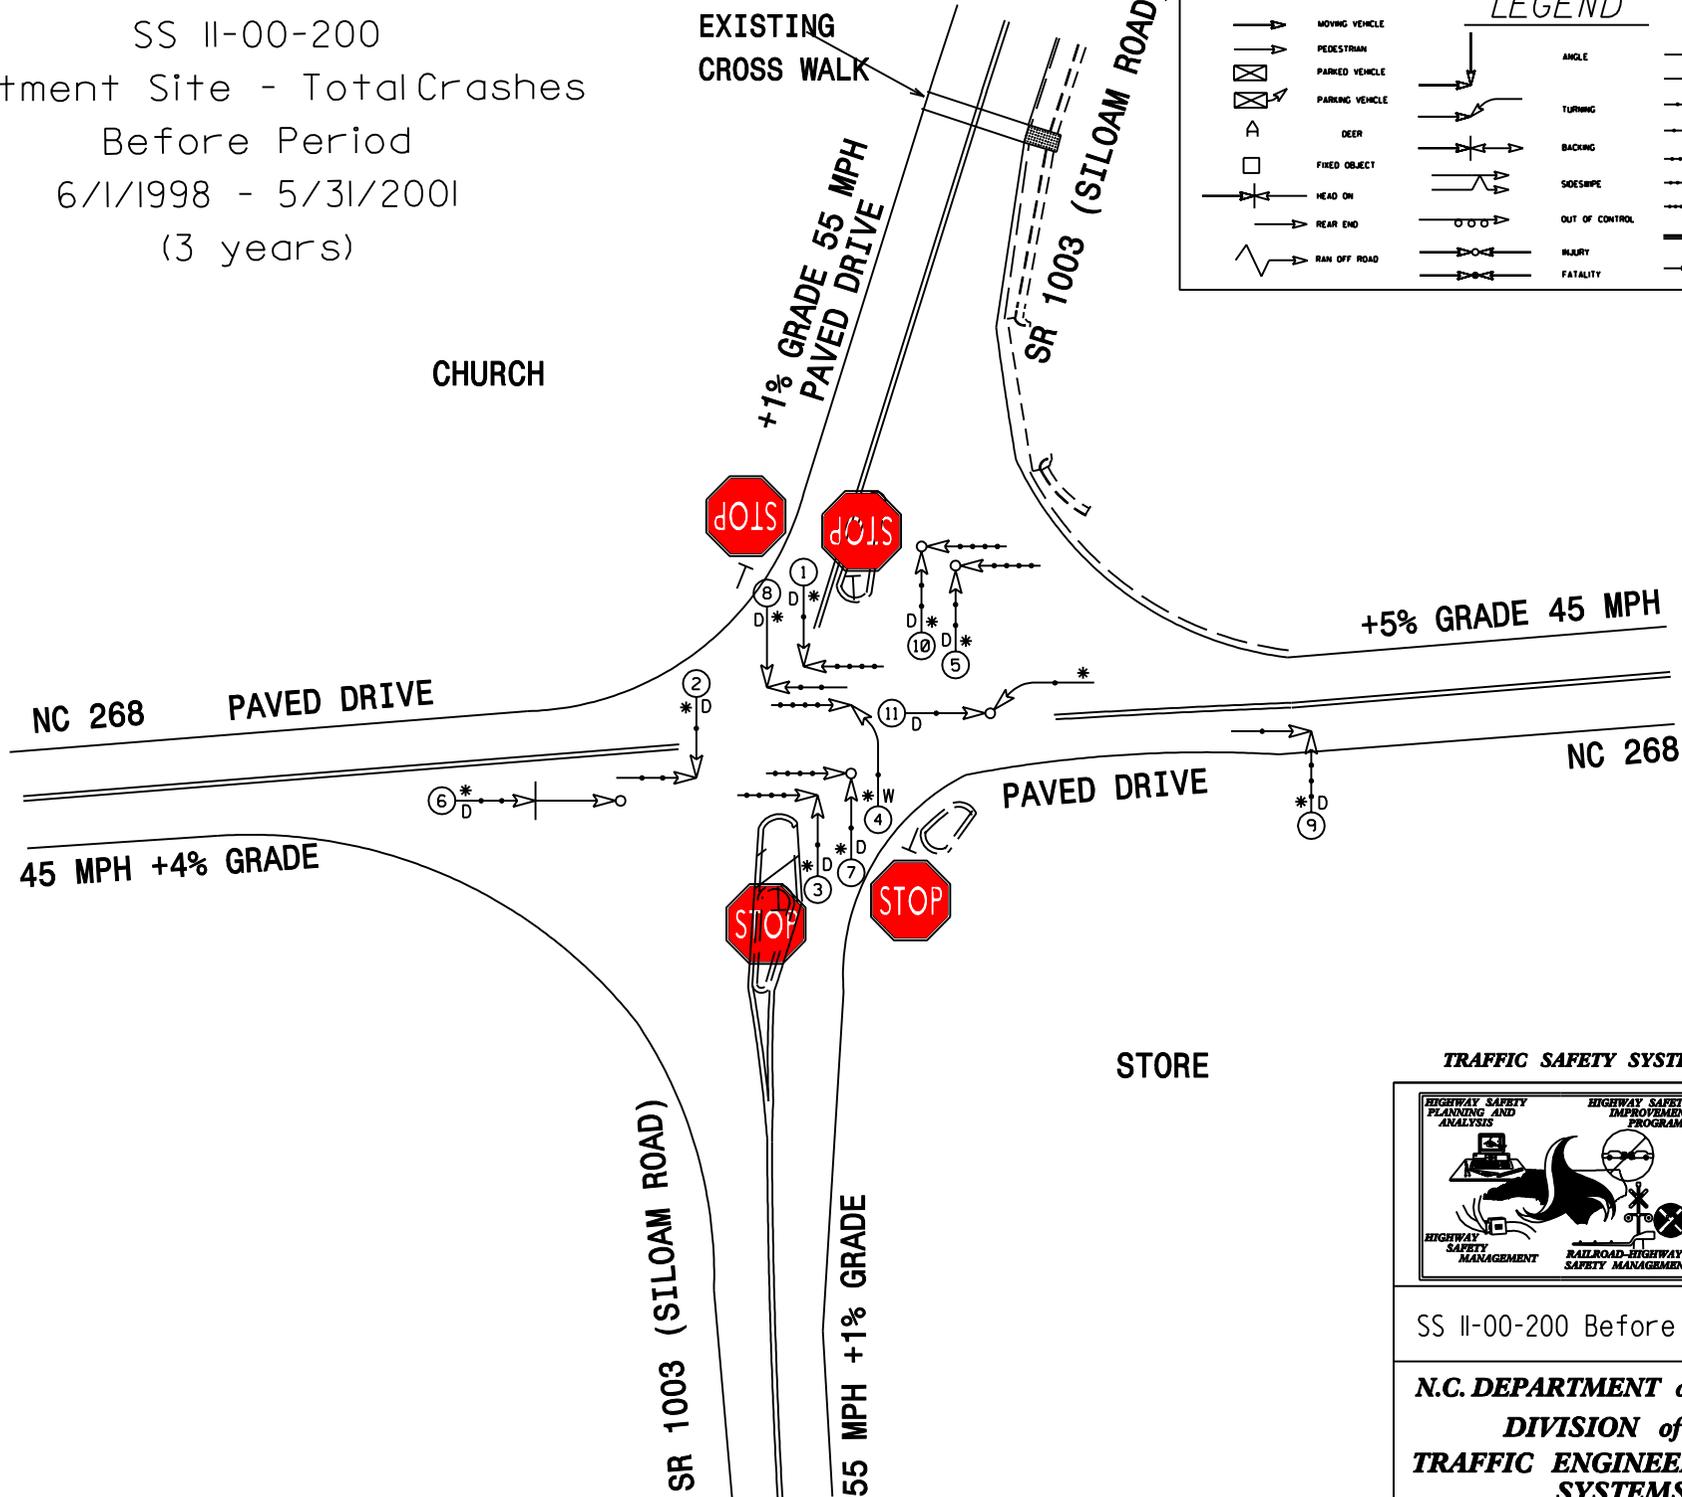
SS II-00-200 Before

SS II-00-200
 Treatment Site - TotalCrashes
 Before Period
 6/1/1998 - 5/31/2001
 (3 years)

COLLISION DIAGRAM	
	DIVISION:	AREA:
	STUDY PERIOD: 06/01/1998 - 05/31/2001	
	DISTANCE: Y-LINE : 150 ft	
	ANALYSIS PREPARED BY: CLG	
ANALYSIS CHECKED BY:		
DIAGRAM PREPARED BY: CLG		
DIAGRAM REVIEWED BY:

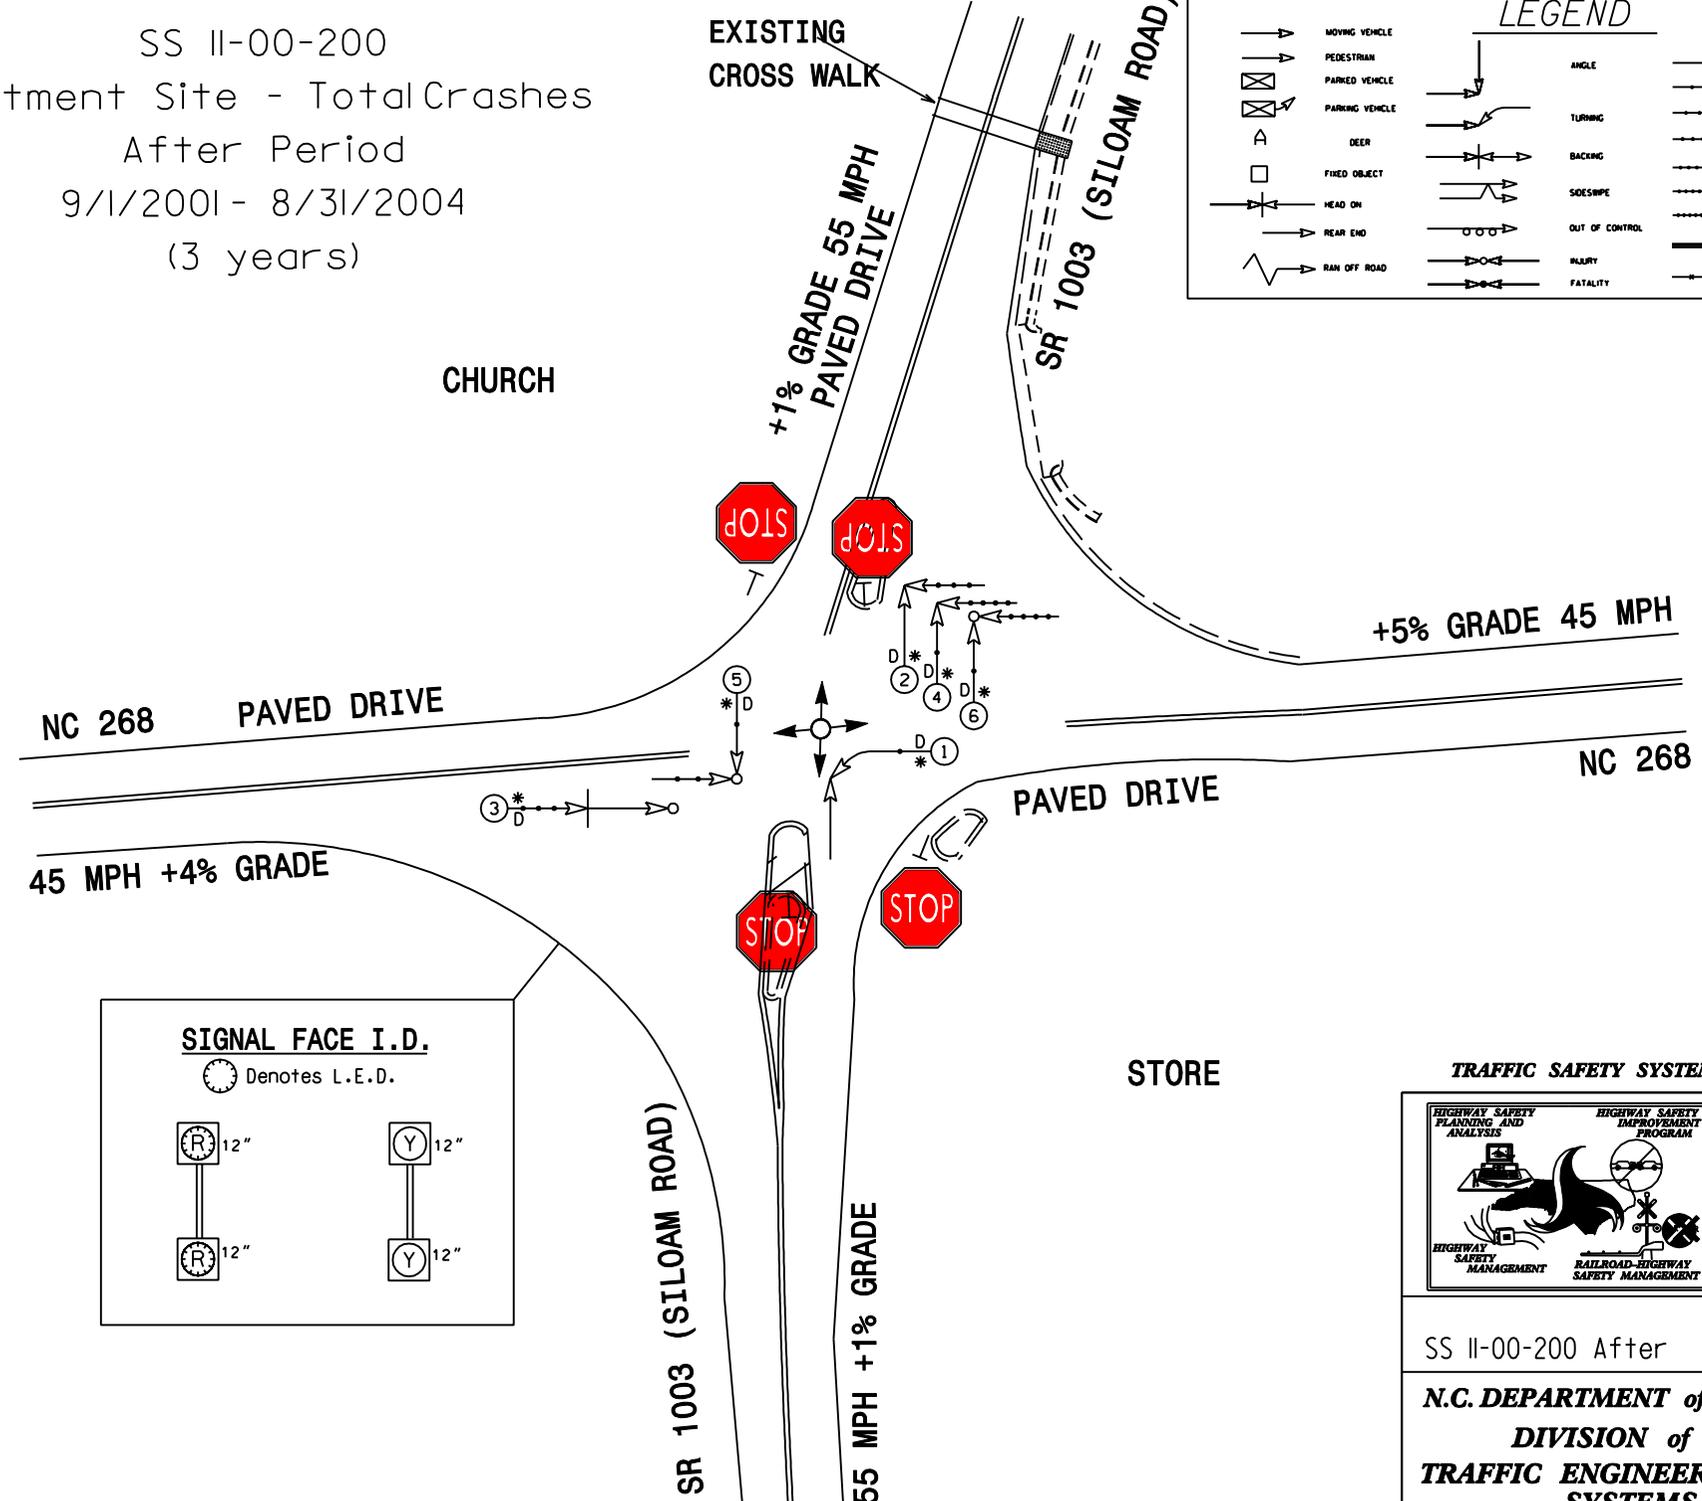
SS II-00-200 After

SS II-00-200
 Treatment Site - TotalCrashes
 After Period
 9/1/2001 - 8/31/2004
 (3 years)

COLLISION DIAGRAM	
DIVISION:	AREA:
STUDY PERIOD: 09/01/2001 - 08/31/2004	
DISTANCE: Y-LINE = 150 ft	
ANALYSIS PREPARED BY: CLG	
ANALYSIS CHECKED BY:	
DIAGRAM PREPARED BY: CLG	
DIAGRAM REVIEWED BY:	
SCALE: NOT TO SCALE	
DATE: 3/14/05	
LOG NUMBER: 20050243
