Spot Safety Project Evaluation

Spot Safety Project # 12-07-211

**Spot Safety Project Evaluation of the Signal Changes
(Doghouse Heads Replaced with Flashing Yellow Arrow)
US-70 (Conover Blvd) at SR 1709 / 1713
Catawba County**

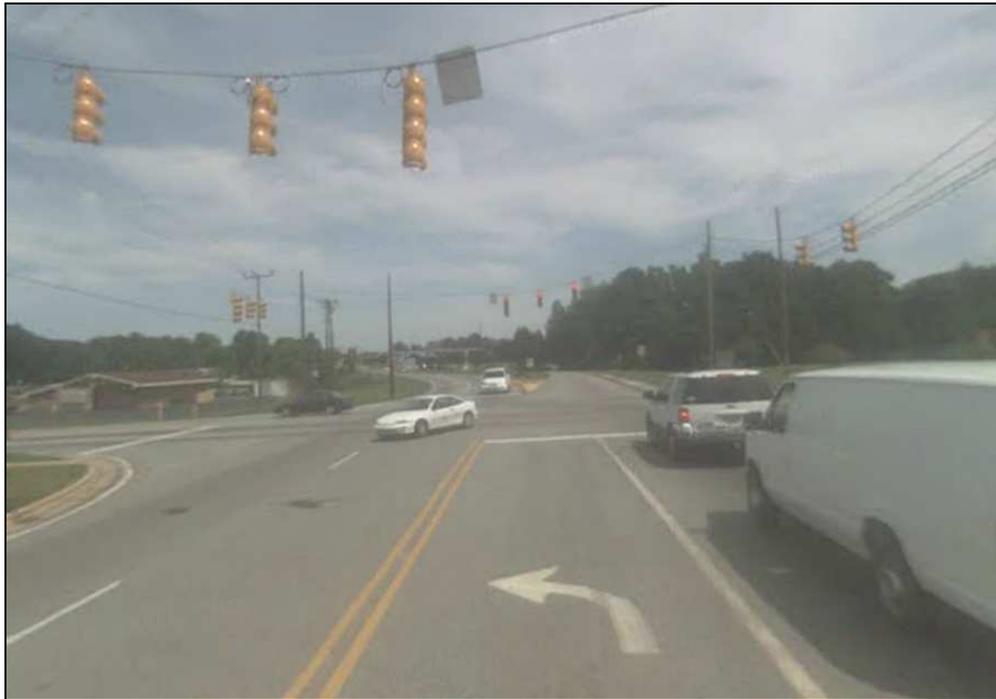
Google Maps – Looking East on SR 1713 Approach

The spot safety project improvement countermeasure chosen for the subject location was the replacement of the pre-existing 5-section (doghouse) signal heads with the new Flashing Yellow Arrow design for northbound and westbound US-70 approaches. Also, the signal was modified to add a Flashing Yellow Arrow protected/permissive phase to the eastbound SR 1713 approach.

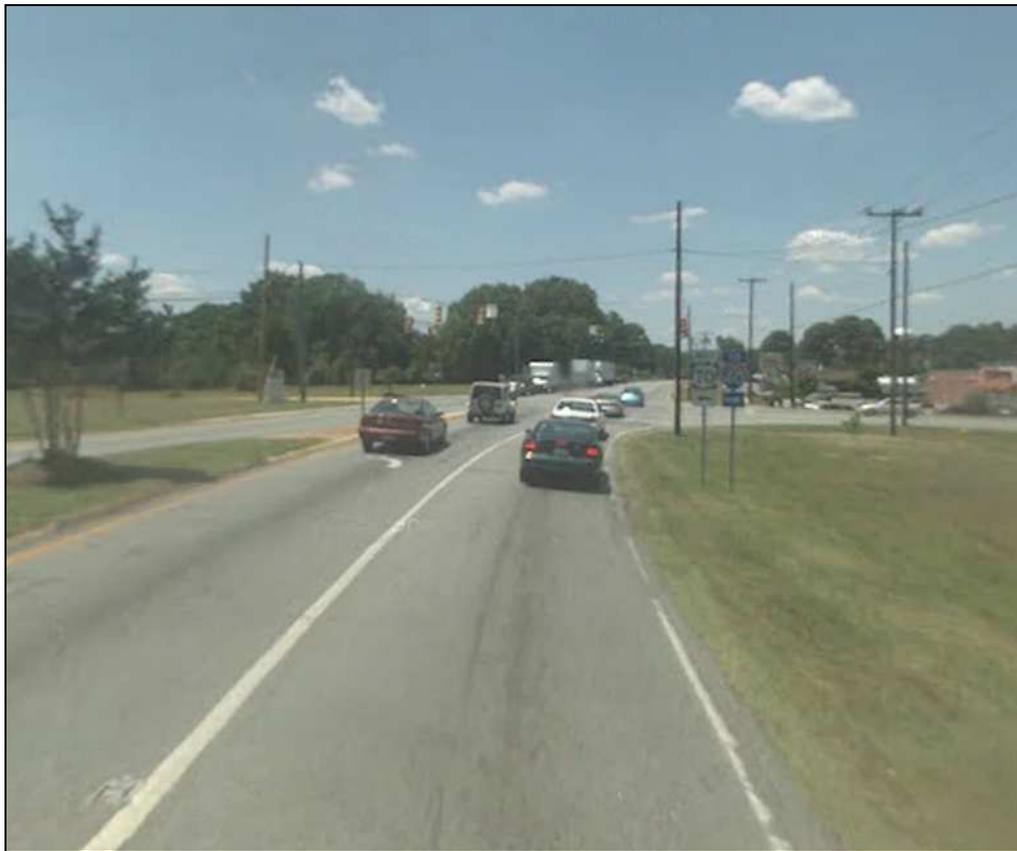
Google Maps – Looking West on US-70 Approach

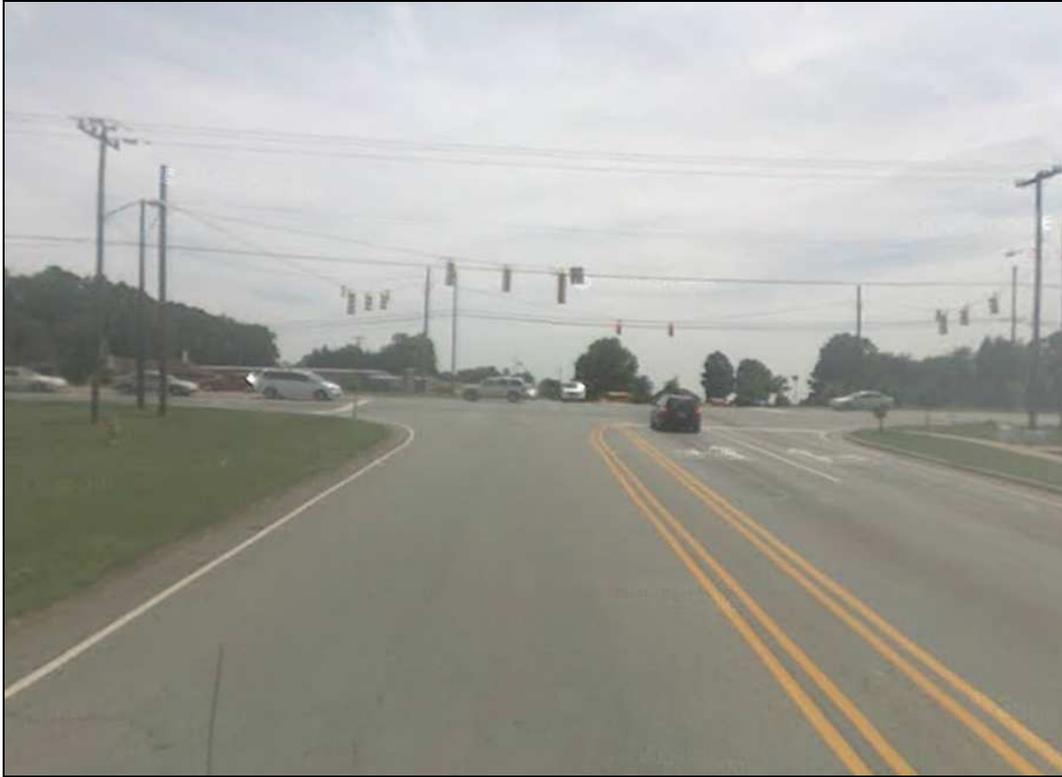
Google Maps – Looking South from SR 1709 Approach

However, the left turn same roadway crashes for southbound SR 1709 increased from two (2) to six (6) throughout the evaluation period. Also, the rear-end and sideswipe crash pattern on the US-70 slip ramp and yield movement stayed consistent throughout the analysis.

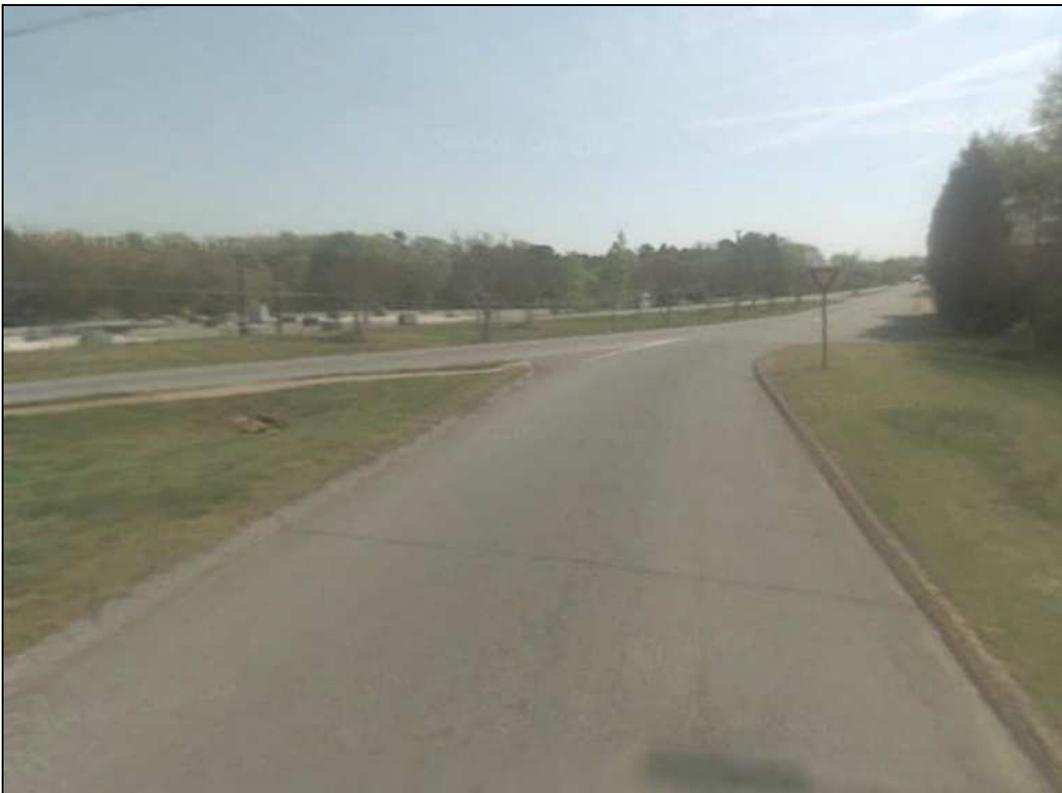
Google Maps – US-70 Eastbound Merge Location
