# **Hazard Elimination Project Evaluation**

Hazard Elimination Project W-2909

## **Evaluation of the Installation of Left Turn Lanes at Nine Median Crossovers on US 29 from Heathway Drive to SR 2679 (US 29 Access Road) In Mecklenburg County**

## ***Spot Safety Project Evaluation Documentation***

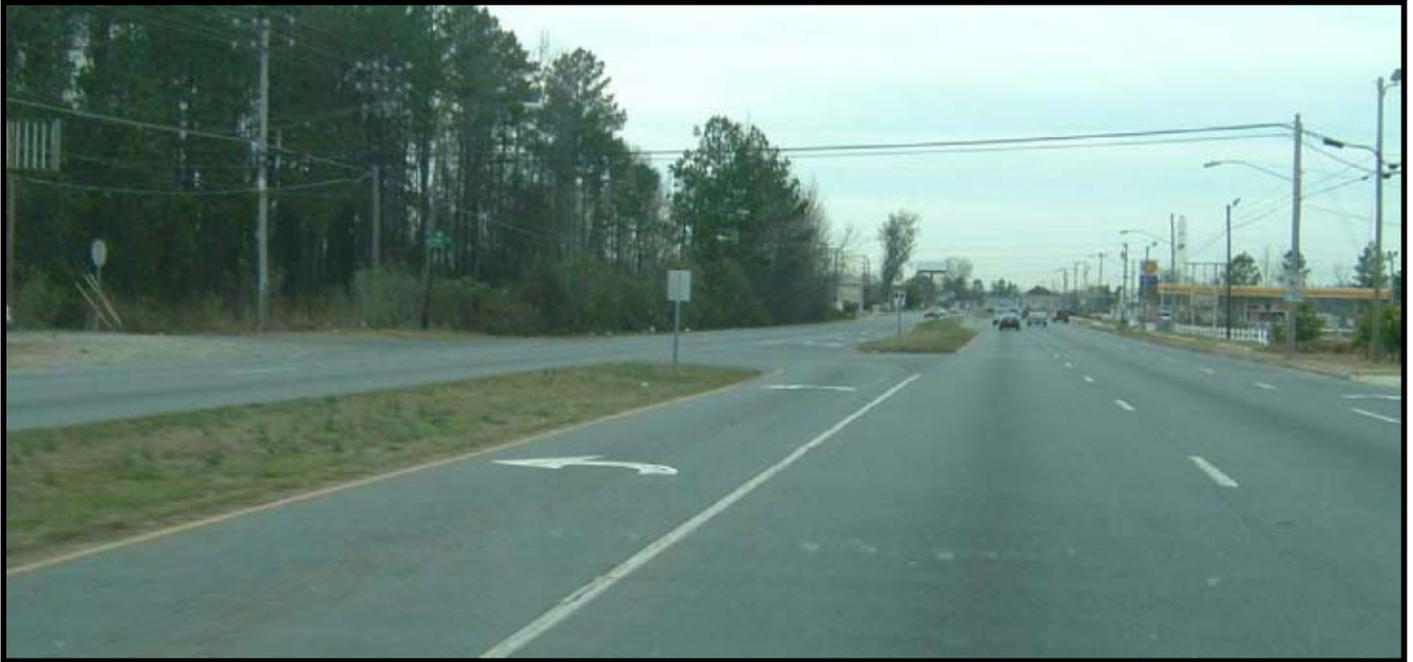
Driving southbound at Location 1

- Location 1: Heathway Drive, Three-Leg Intersection, MP 15.71  
NB Left Turn Lane Added
- Location 2: Owen Blvd, Three-Leg Intersection, MP 15.81  
NB and SB Left Turn Lanes Added

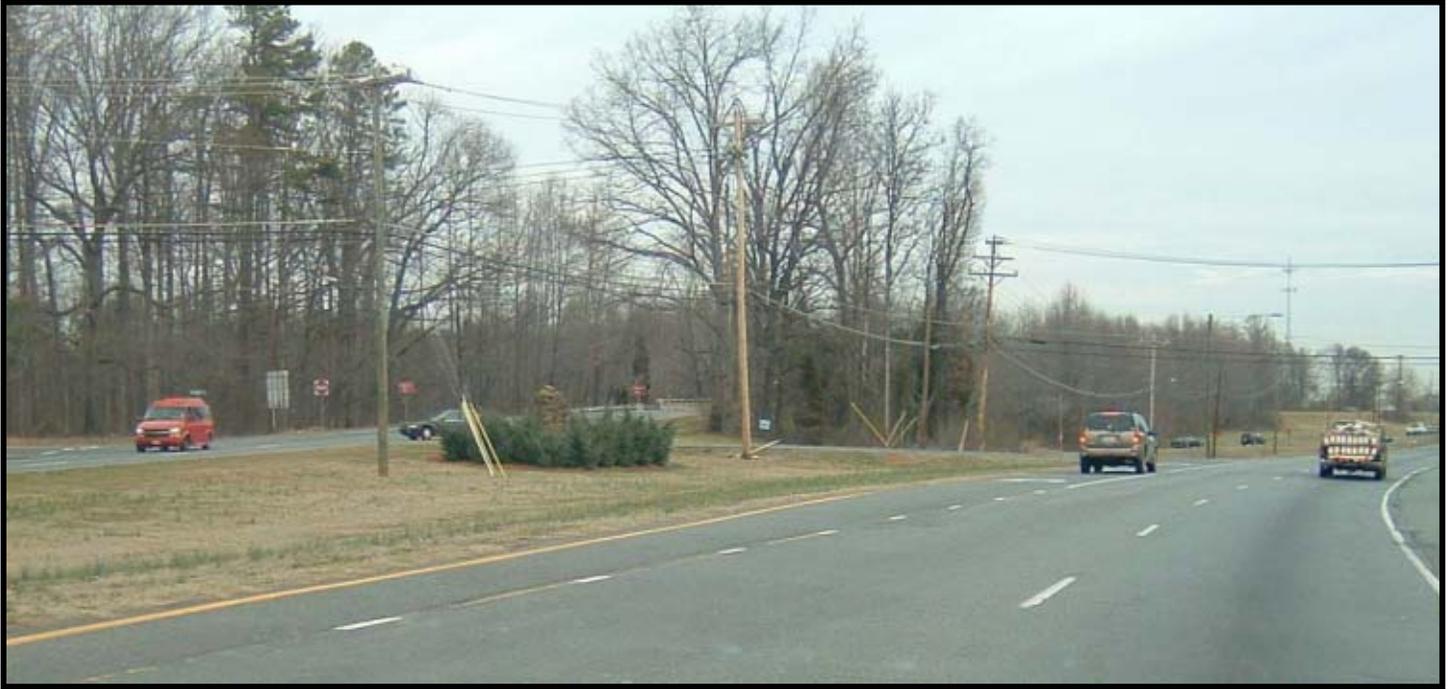
Driving northbound at Location 3

- Location 3: Kemp Street, Four-Leg Intersection, MP 16.46  
NB and SB Left Turn Lanes Added
- Location 4: Stetson Drive, Three-Leg Intersection, MP 16.90  
SB Left Turn Lane Added

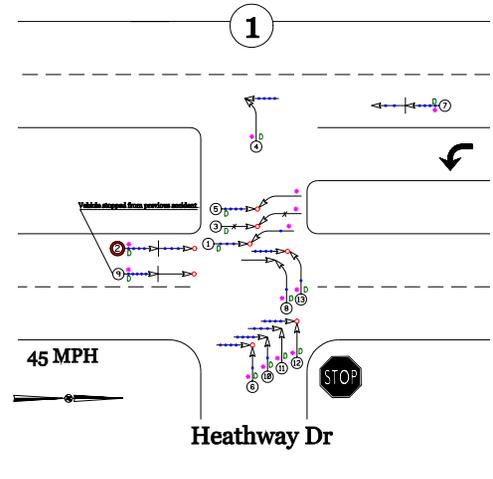
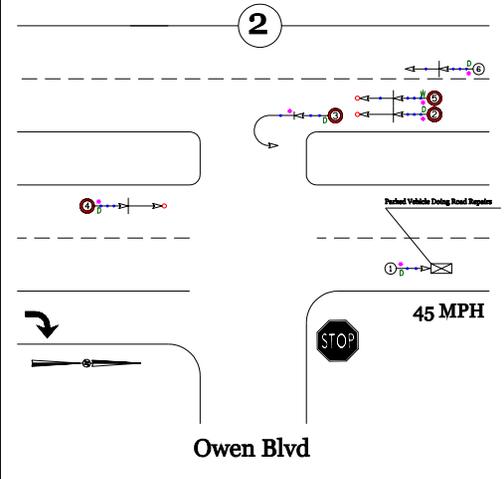
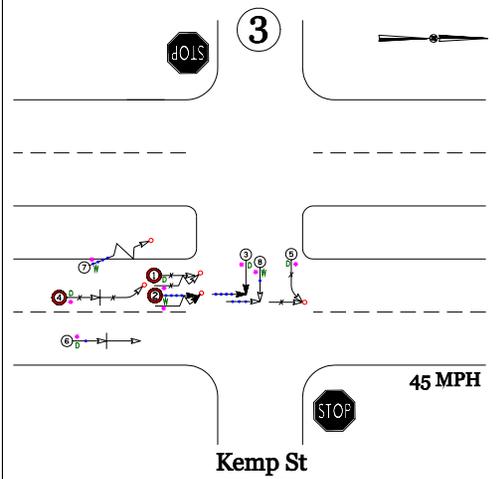
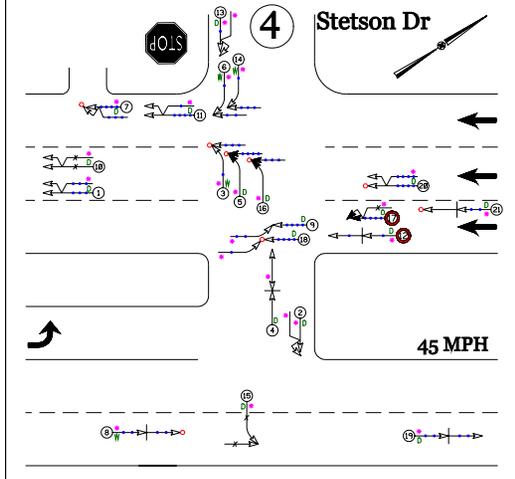
### BEFORE PERIOD - TOTAL CRASHES

Please see the attached Collision Diagrams for a visual representation of Total and Target Crashes. Note that the crash numbers for Target Crashes are circled in red on the diagrams.

### January 1, 1994 - December 31, 1996 (3 Yrs)

Although the left turn treatments appear to have addressed a portion of the Rear End crash pattern, other crash patterns appear to have increased in the after period. The number of Frontal Impact Crashes have increased dramatically from the before period to the after period. Specifically, at Locations 1, 2, and 3 there appears to be a concentration of Angle and Left Turn-Different Roadway crashes occurring between westbound cross street vehicles and northbound US 29 vehicles. These crash types have increased (by 250 percent) from 6 crashes in the before period to 21 crashes in the after period at these three locations. At Location 4, the number of Frontal Impact Crashes have increased (by 125 percent) from 8 crashes in the before period to 18 crashes in the after period. Please see the Before and After Collision Diagrams provided for Locations 1-4.

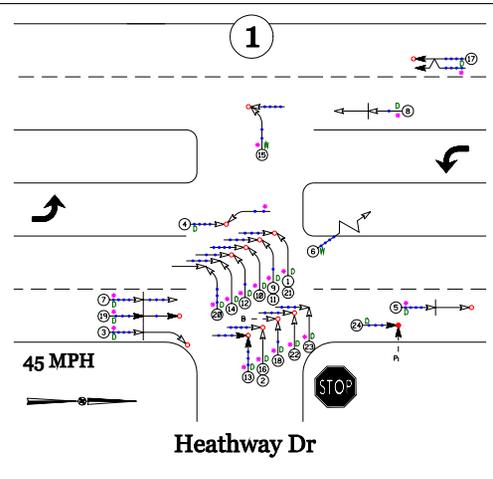
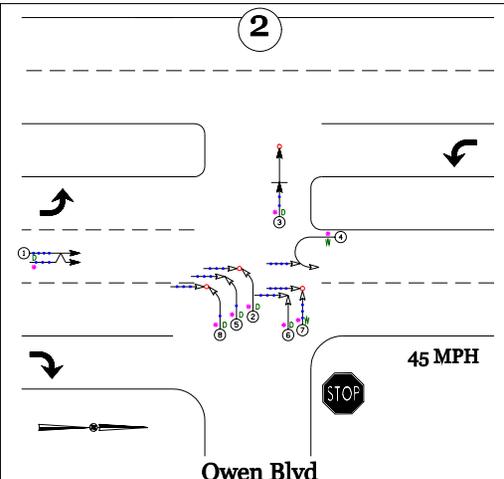
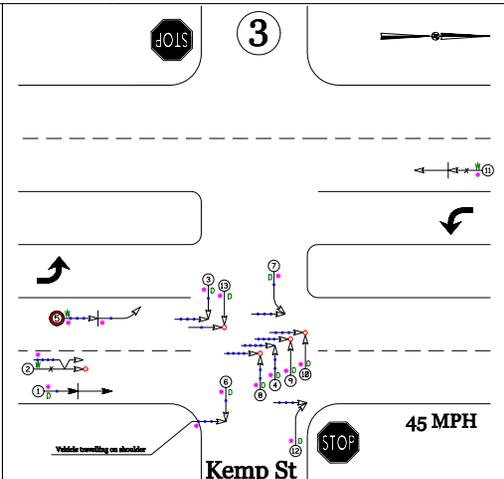
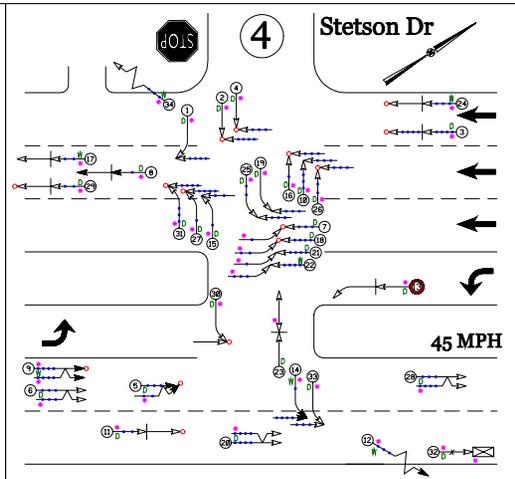
### AFTER PERIOD - TOTAL CRASHES

### January 1, 1998 - December 31, 2000 (3 Yrs)
