Hazard Elimination Project Evaluation

Project Log # 200608076

Hazard Elimination Project W-2940

**Evaluation of the Installation of Left Turn Lanes at Eight Median Crossovers on
US 1 / US 15 / US 501 from 0.48 miles north of US 15-501 to 0.17 miles north of NC 78
Lee Co.**

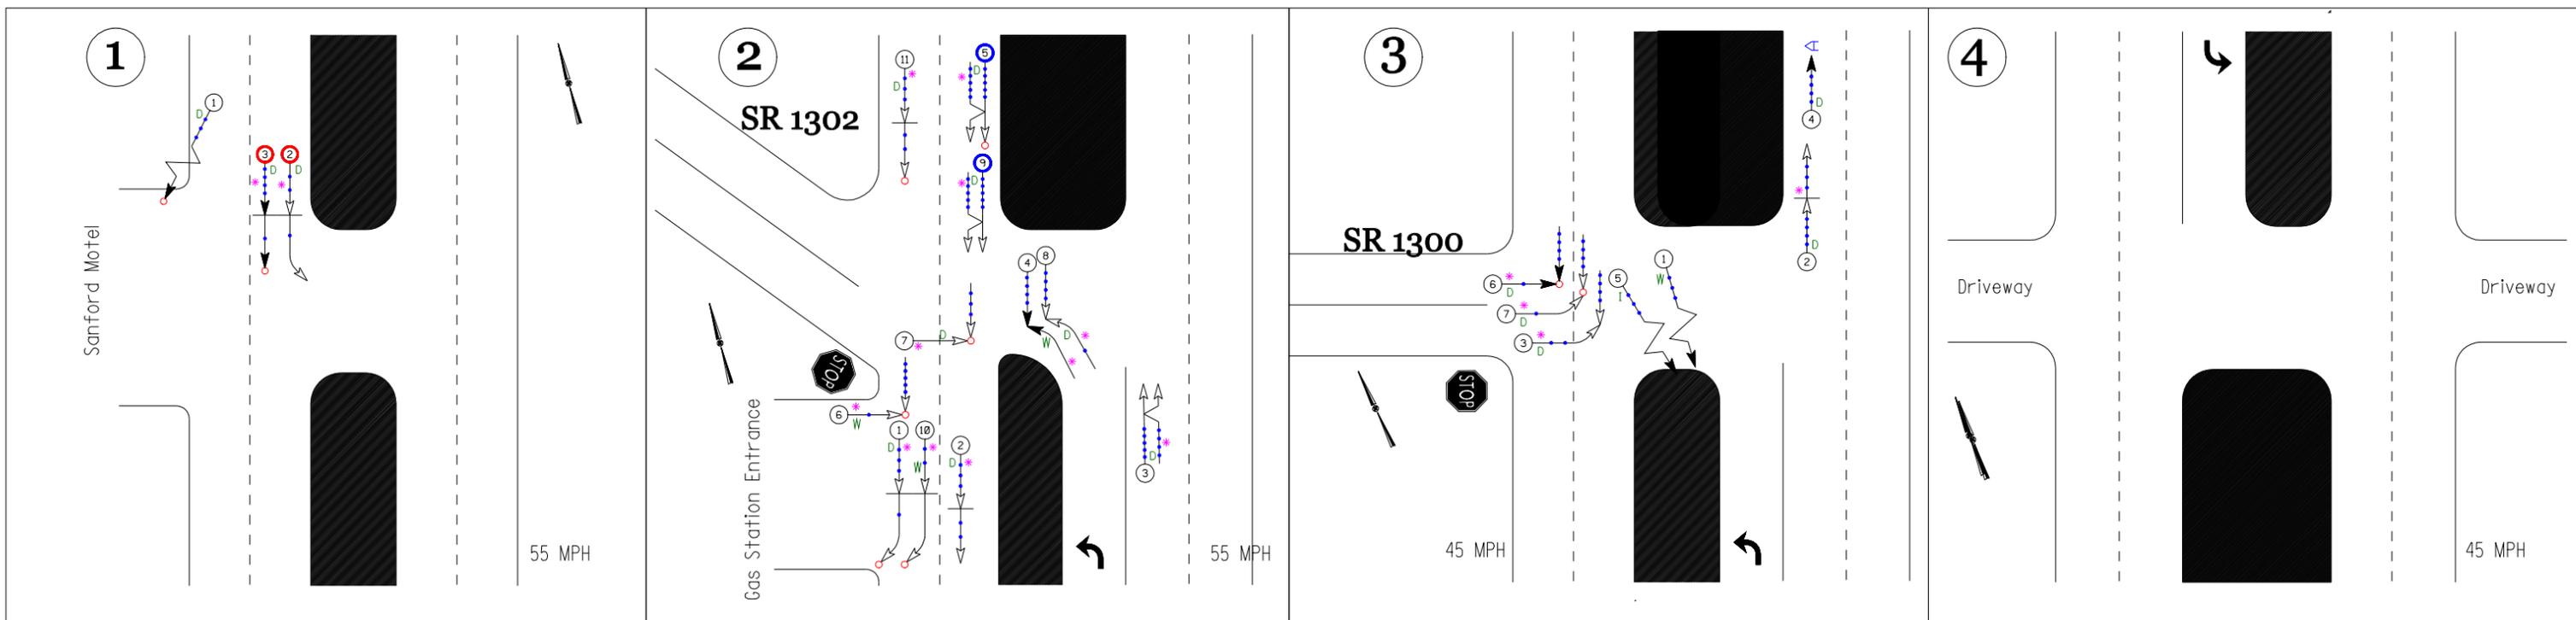
BEFORE PERIOD - TOTAL CRASHES

Treatment Crossover Locations 1-4

On US 1/15/501 South of Sanford, Lee Co.

January 1, 1990 - August 31, 1998 (8.67 Yrs)

Please see the attached Collision Diagrams. Note that the crash numbers for Target Rear End Crashes, Target Sideswipe Crashes, and Target Left Turn-Same Roadway Crashes are circled on the diagrams in Red, Blue, and Green, respectively.

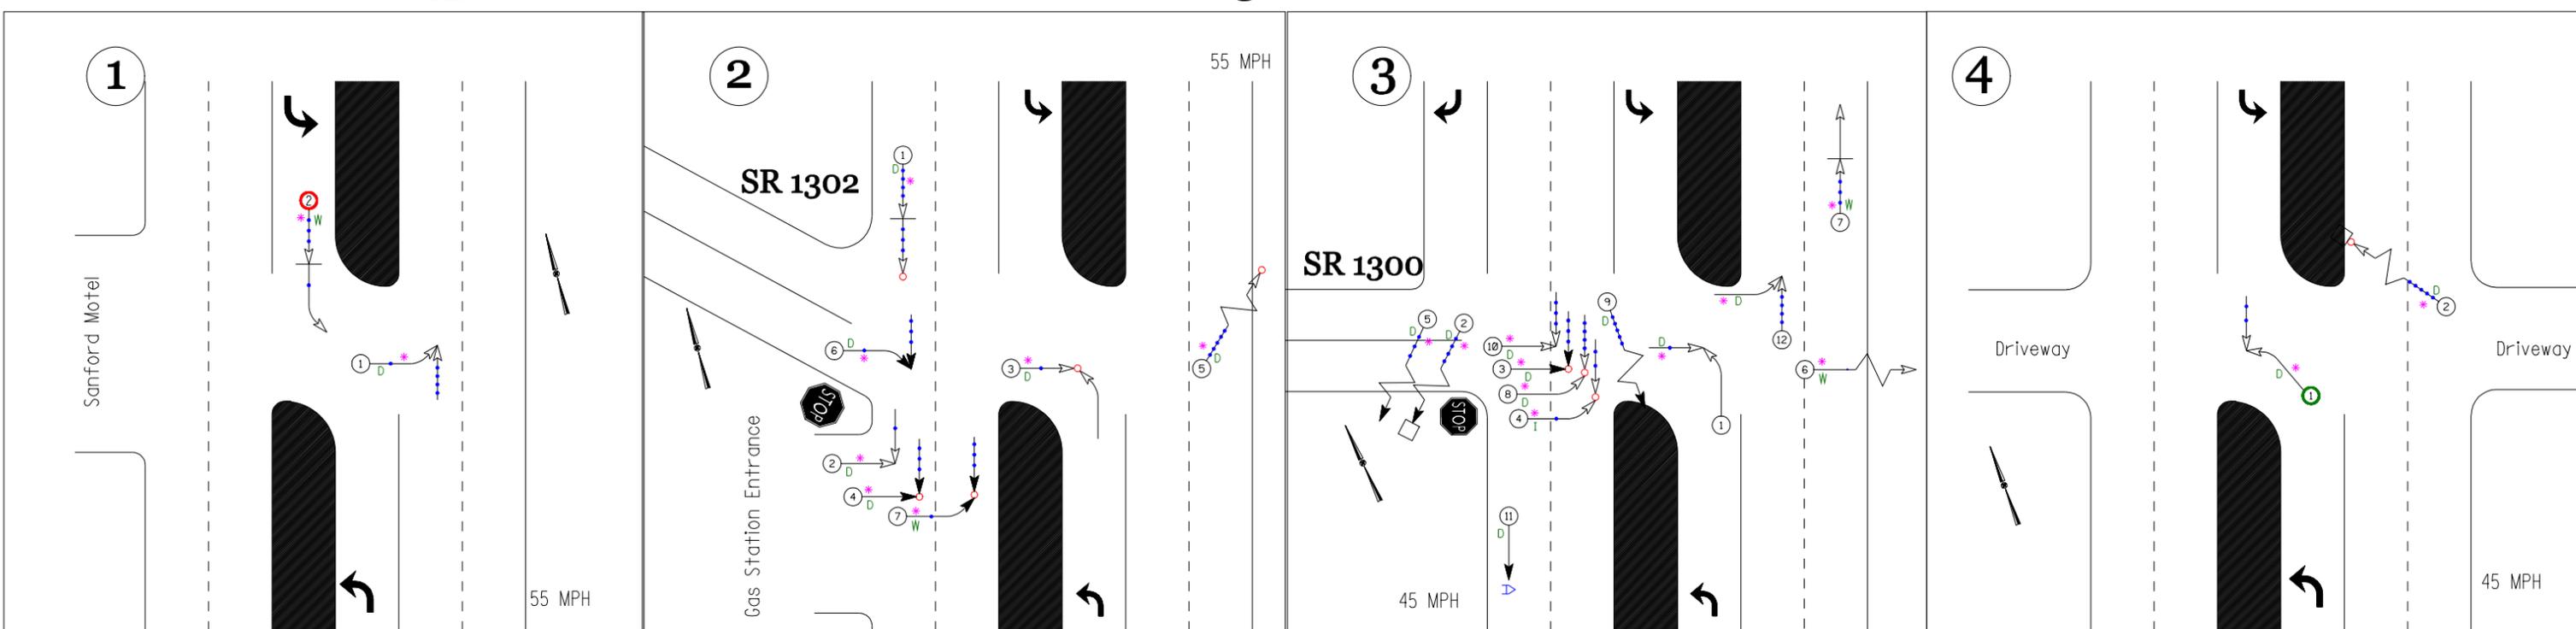
AFTER PERIOD - TOTAL CRASHES

August 1, 1999 - March 31, 2008 (8.67 Yrs)

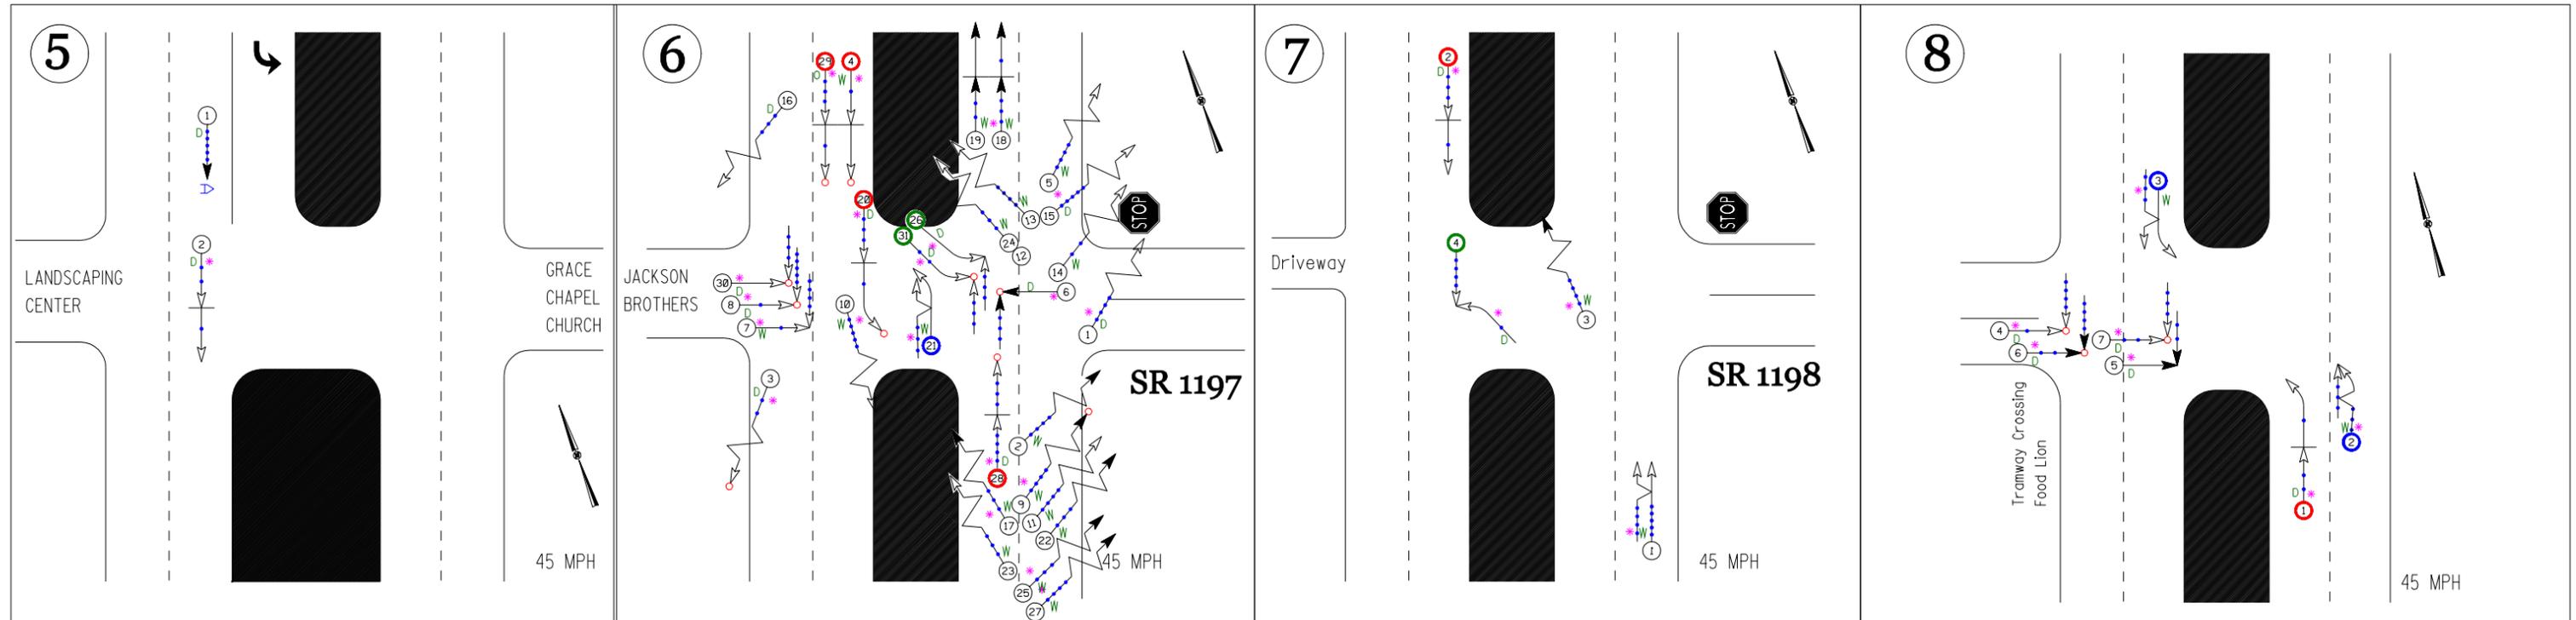
BEFORE PERIOD - TOTAL CRASHES

Treatment Crossover Locations 5-8

On US 1/15/501 South of Sanford, Lee Co.

January 1, 1990 - August 31, 1998 (8.67 Yrs)

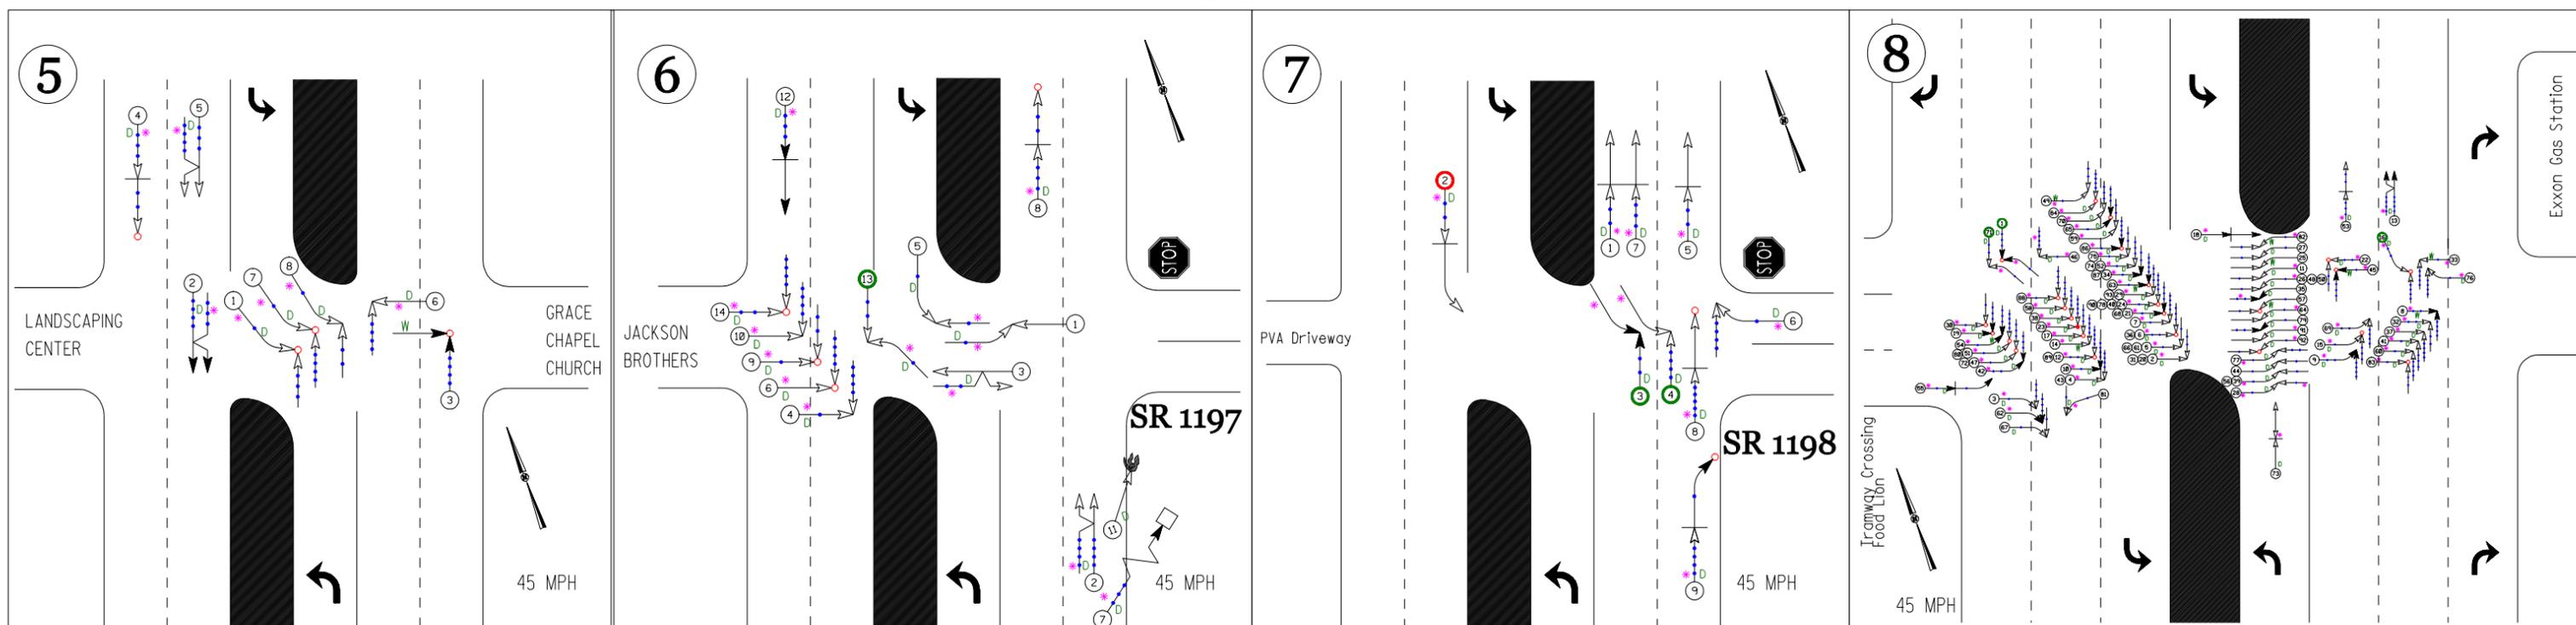
AFTER PERIOD - TOTAL CRASHES

August 1, 1999 - March 31, 2008 (8.67 Yrs)

The number of Total Crashes at Crossover 8 increased by over 1000 percent from the before to after period (from 7 to 93 crashes). The two largest after period crash patterns include:

- Angle & Left Turn-Different Roadway Crashes involving southbound US 1 / 15 / 501 vehicles and vehicles leaving Tramway Crossing driveway (48 crashes), and
- Left Turn-Same Roadway Crashes involving vehicles from Tramway Crossing and Exxon Gas Station driveways (18 crashes).

Vehicles are having difficulty making safe gap choices when crossing US 1 / 15 / 501 from Tramway Crossing and Exxon driveways. From the before to the after period, the width of US 1 / 15 / 501 at Crossover 8 has widened significantly. There are now five additional lanes at the crossover, including southbound left and right turn lanes with a southbound left turn lane for the downstream NC 78 intersection AND northbound left and right turn lanes.
