Hazard Elimination Project Evaluation

Hazard Elimination Project W-4422

Evaluation of the Six (6) Median Crossover Removals, Left Turn Lane Installations at Two (2) Existing Crossovers, and One (1) New Crossover US 1 (Capital Blvd) in Franklin County

Safety Evaluation Group
Traffic Safety Systems Management Section
Transportation Mobility and Safety Division
North Carolina Department of Transportation

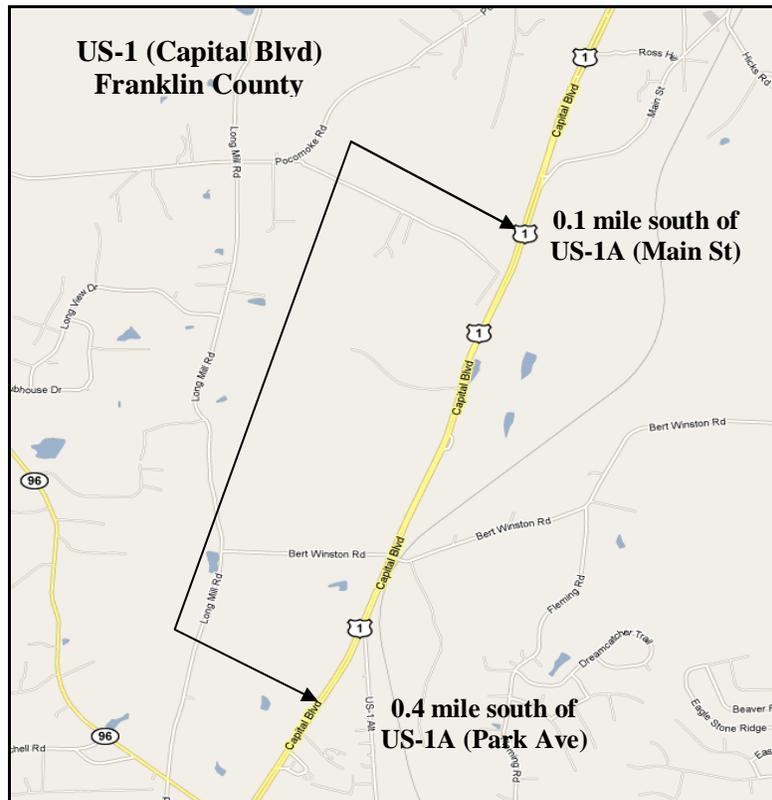
Google Maps – Evaluation Limits

The study segment was separated into the following parts:

- A: Begin Study – MP 2.988 – 0.4 mile south of US-1A (Park Ave)
- B: MP 3.24 – Dirt Crossover – Removed in After Period (Range 3.212-3.268)
- C: MP 3.388 – US-1 at US-1A (Park Avenue) Intersection – Crossovers consolidated, left turn lanes installed (Range 3.360-3.416)

- D: MP 3.736 – US-1 at SR 1133 (Bert Winston Road) – Crossover in the before period, offset left turn lanes installed; Signal 05-2398 installed in June 2010 (Range 3.708-3.764)

- E: MP 4.14 – Paved Crossover (Marita Business) – Removed in After Period (Range 4.112-4.168)
- F: MP 4.39 – Dirt Crossover – Removed in After Period (Range 4.362-4.418)

- G: MP 4.54 – New After Crossover with Left Turn Lanes – Materials Drive (Range 4.512-4.568)
- H: MP 4.64 – Dirt Crossover – Removed in After Period (Range 4.612-4.668)

- I: MP 4.99 – Dirt Crossover – Removed in After Period (Range 4.962-5.018)
- J: MP 5.09 – Dirt Crossover – Removed in After Period (Range 5.062-5.118)
- K: End of Study – MP 5.376 – 0.1 mile south of US-1A (Main Street)

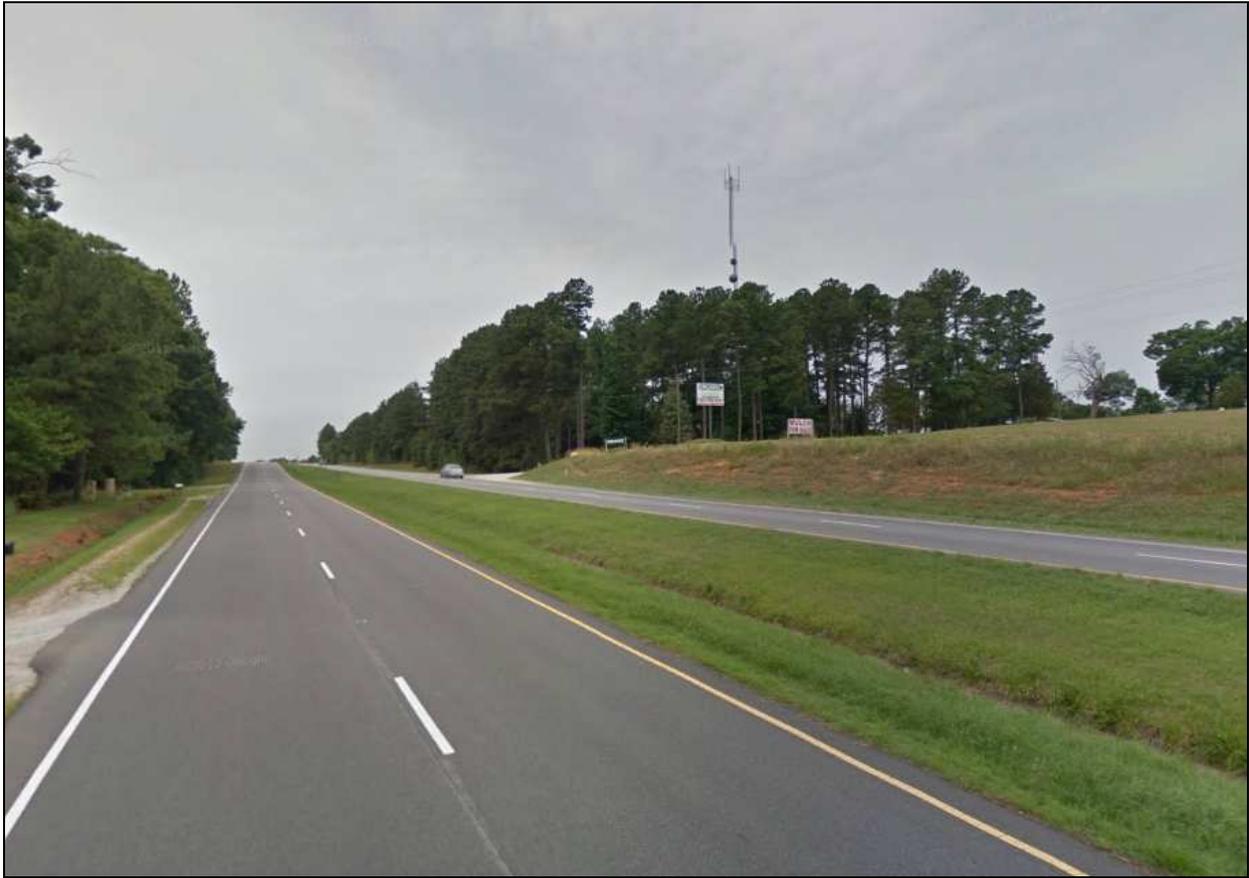
**Typical Section of Treatment Area - View near the SR 1133 Intersection looking south
Google Maps Street View – June 2011 Photo**

US-1 (Capital Boulevard) along this section of roadway is a rural four-lane divided facility with a posted speed limit of 55 mph and variable width grass median. This section had several dirt and paved median crossovers in the before period with limited roadway guidance.

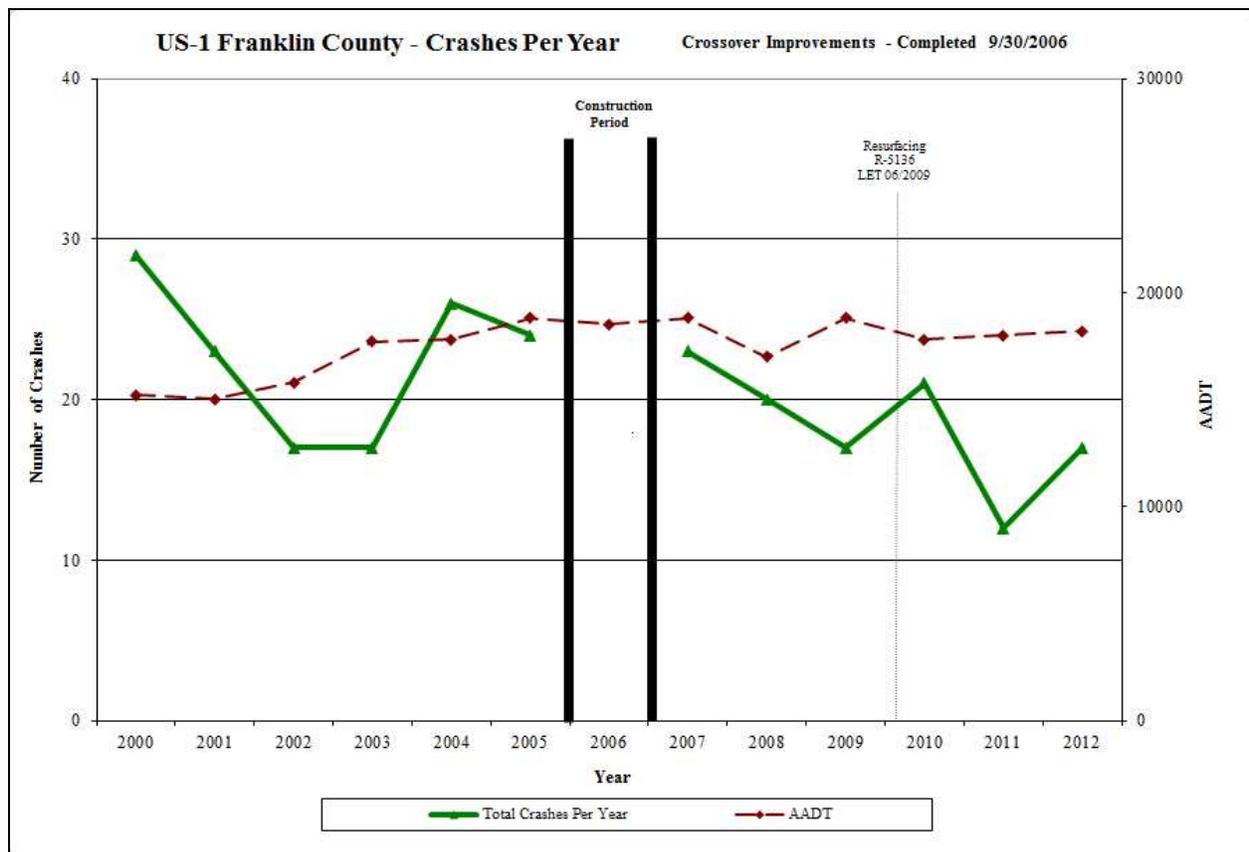
The following chart depict the number of Total Crashes per year plotted in the before and after period, along with the AADT to show the change over time. The chart also highlights an additional resurfacing project that took place on this segment in 2009.

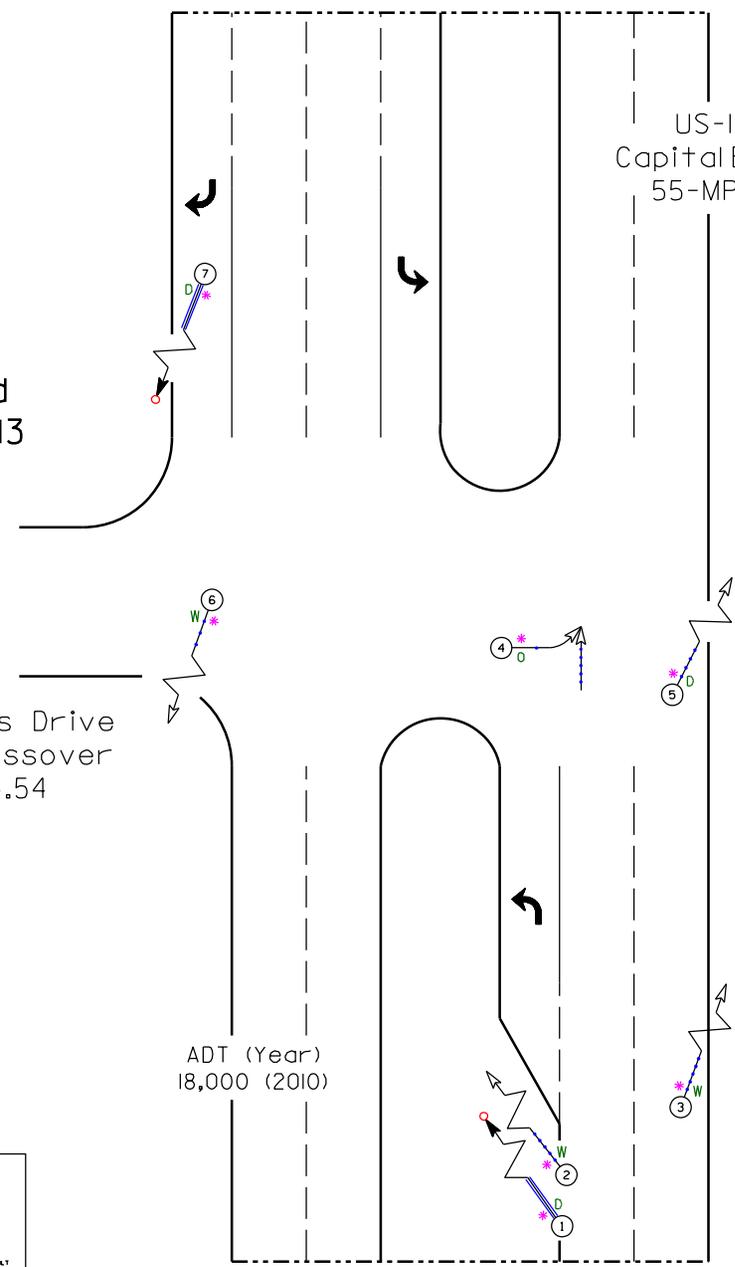
W-4422
 Order# 41000011039
 Wake County
 Section-G

The Safety Evaluation Group also has provided Before-After Collision Diagrams for Section-G and Section-I. Section-G (new crossover at Materials Drive) experienced a crash increase from two (2) in the before period to seven (7) in the after period. From the diagram, the main crash type is ran-off road in the vicinity of the median opening with only one (1) frontal impact crash. Section-I was the removal of a dirt crossover at MP-4.99 in the before period. The total crashes remained the same at nine (9) in the before and after periods.

BEFORE Period
 7/1/99 - 12/31/05
 6.5 Years

AFTER Period
 1/1/07 - 6/31/13
 6.5 Years

Materials Drive
 New Crossover
 MP-4.54
