# **An Evaluation of Nine-Panel Specific Service Logo Signs and Overflow Combination Service Logo Signs**

Safety Evaluation Group  
Traffic Safety Systems Management Section  
Traffic Engineering and Safety Systems Branch  
North Carolina Department of Transportation

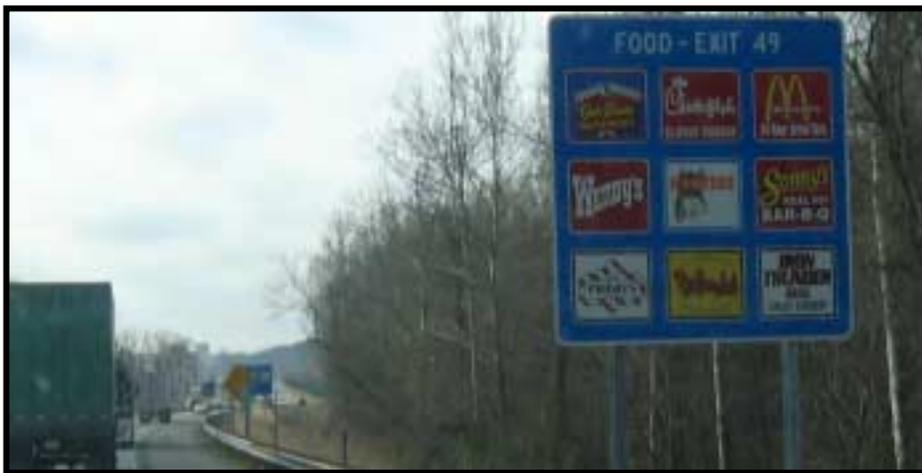
**Figure 1. Nine-Panel Logo Sign**

Nine-panel logo signs include nine-panels on one sign. Overflow combination logo signs include a service type on more than one sign in advance of an interchange. Although motorists may benefit from the additional service selection, there is need to address the potential safety concerns when the number of logo panels is increased for a given service at an interchange.

Figure 1 shows a nine-panel logo sign. Figure 2 shows an overflow combination logo sign.

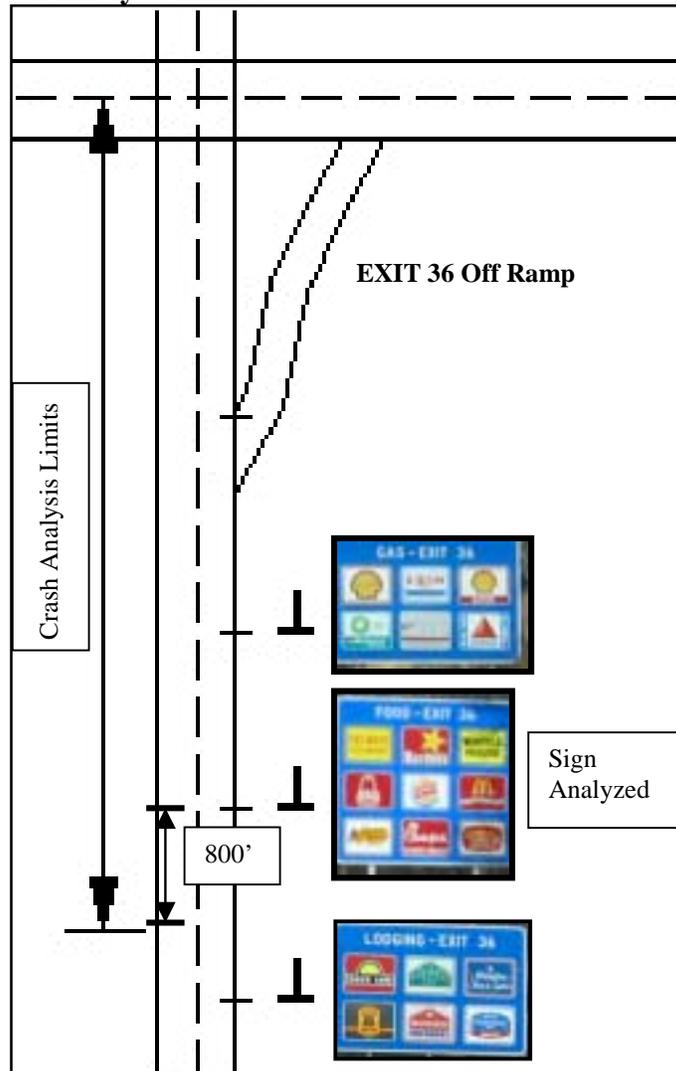
**Figure 3. Crash Analysis Limits**

The crash analysis included all reported crashes from 800 feet in advance of the sign being evaluated up to the overpass of the nearest upstream interchange. If the exit-ramp for the interchange was located beyond the overpass, then the crash analysis was extended to the exit-ramp gore area. See Figure 3 for a visual representation of the crash analysis limits. The crash analyses only included mainline crashes in the direction of the sign being analyzed. Note that because only one direction of travel was analyzed, a directional ADT was used assuming a 50/50 directional split. There were several nine-panel logo sign locations with multiple nine-panel logo signs. In these cases, the crash analyses began in advance of the nine-panel logo sign located furthest from the interchange.
