Snowplowable Delineation Alternatives

Preface: NCDOT has moved away from the use of cast-iron snowplowable pavement markers. There have been incidences of cast-iron markers coming out of the pavement and causing damage to vehicles. Because of this the Signing & Delineation Unit has tested alternatives. The following shows several alternatives that have been tested and do well depending on the situation in which they were installed.

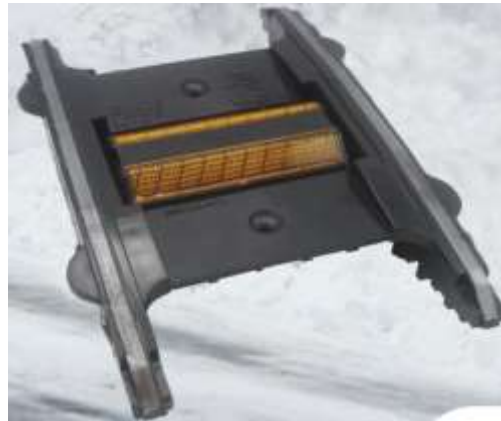
Option 1: Polycarbonate H-shaped Marker

This is the most common marker currently used by NCDOT. Although there have been issues in heavily snowplowed parts of the state, this has been a good alternative. Divisions 2, 4, and 10 have had no issues with the use of this product. In heavily snowplowed areas the issues have not been markers coming out of the road and striking vehicles. The damage has been to the markers, lenses, and parts of the marker which cause other minor damages to vehicles and reduce the life of the marker.

These markers were initially installed in Division 4 in 2017 and performed well. They have been reviewed in other portions of the state and have performed well. This might not be the best option in higher elevation locations in the state.

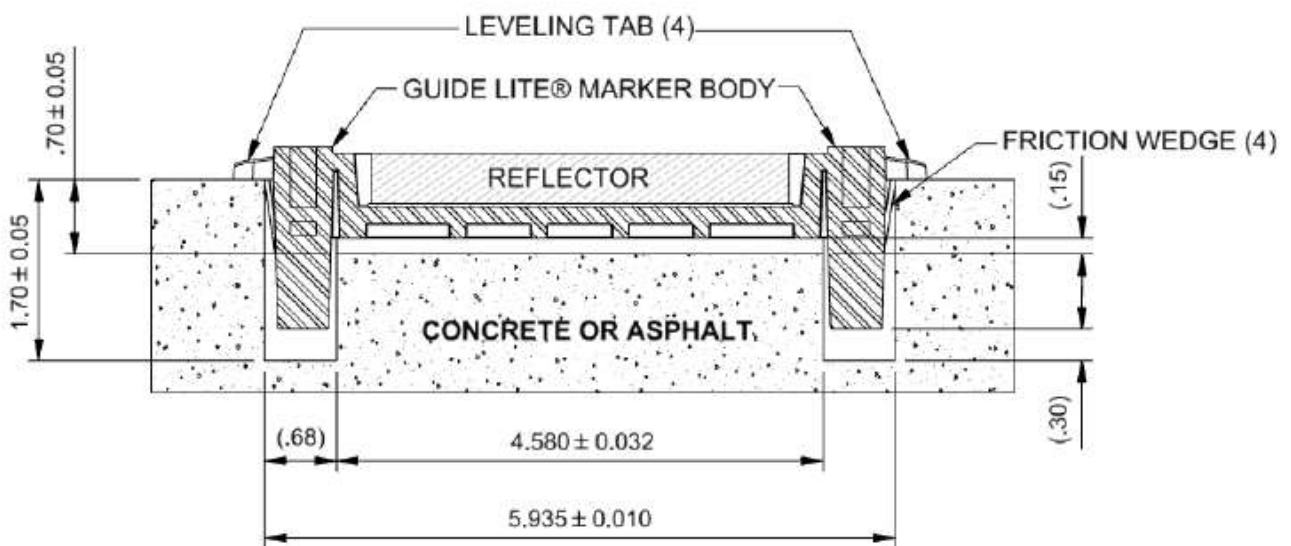
Figure 8 - Section View Showing Slot Dimensions and Marker Position in Slot

Slot Dimensions

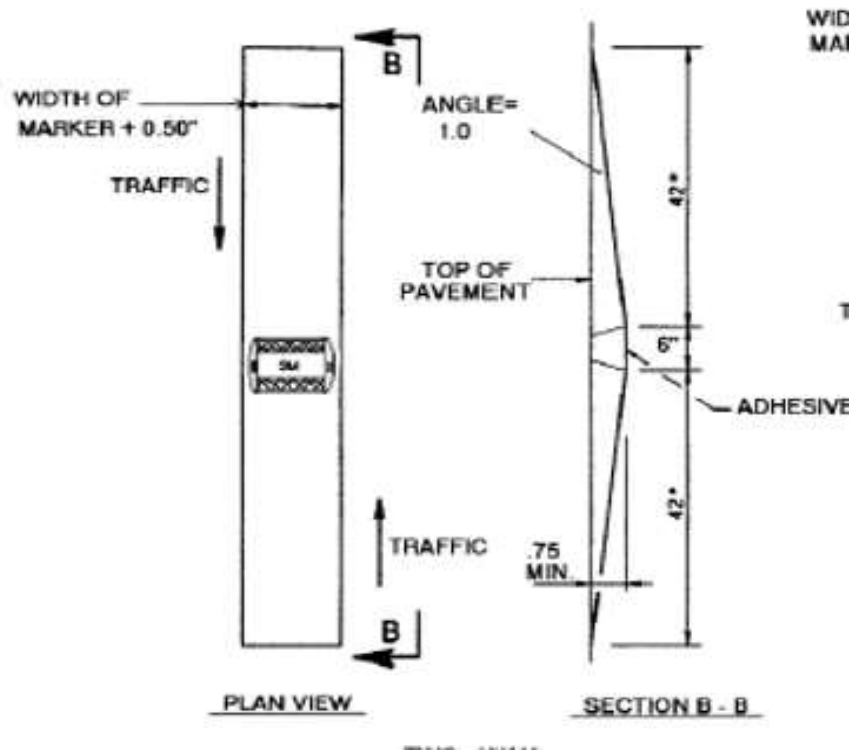
Option 2: Inlaid Raised Pavement Marker

This is a treatment that has been used effectively by other states in the past. It places the marker slightly below the surface of the pavement, reducing snowplow strikes. The concern is that cutting a groove to this depth will create a “trap” for debris and water. This is more of a concern in geographically flatter parts of the state. The groove dimensions can vary if the marker can be seen by the driver.

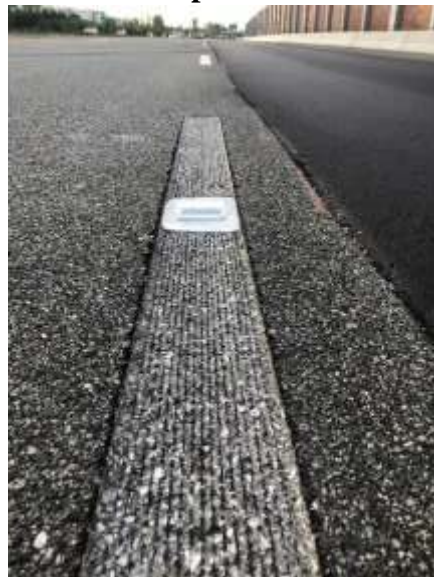
[NC 885 Toll](#)

Installed on NC 885 in fall of 2019 and inspected spring of 2020. All markers were in place at the time of inspection.

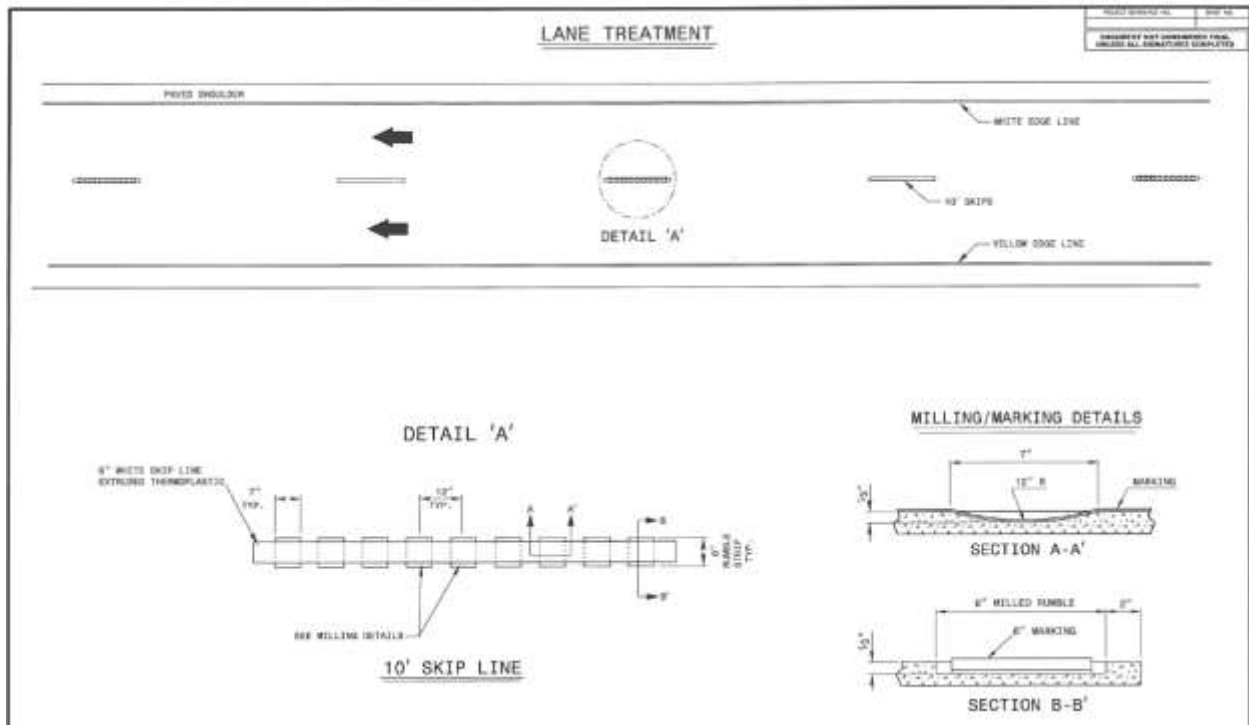
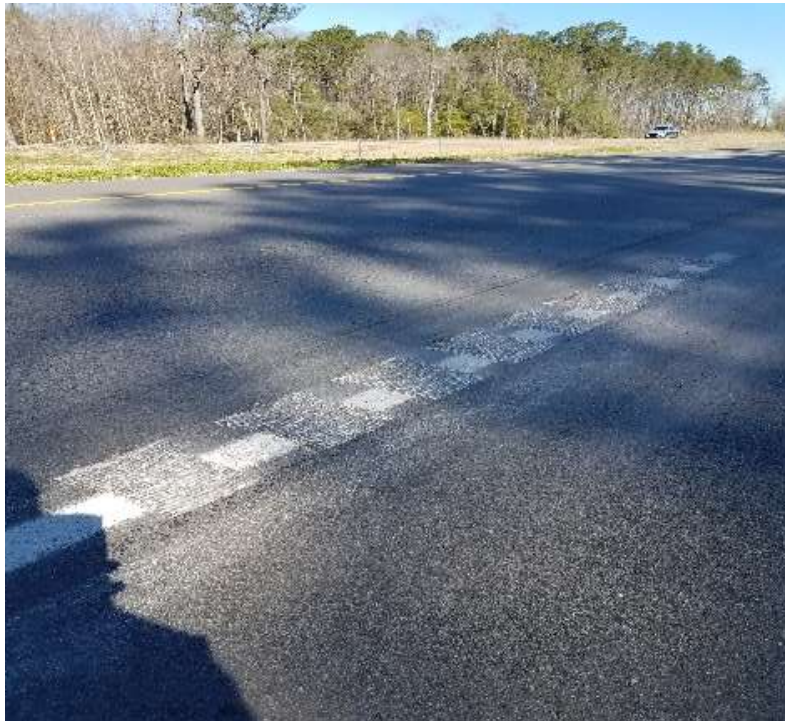
Option 3: Rumble Skips

Installed on NC 117 near Mt. Olive in 2019. Inspected in 2022 and performed well.

Install rumble skip lines in place of every other center skip line. This will consist of a rumble strip with a durable pavement marking skip line placed on top.

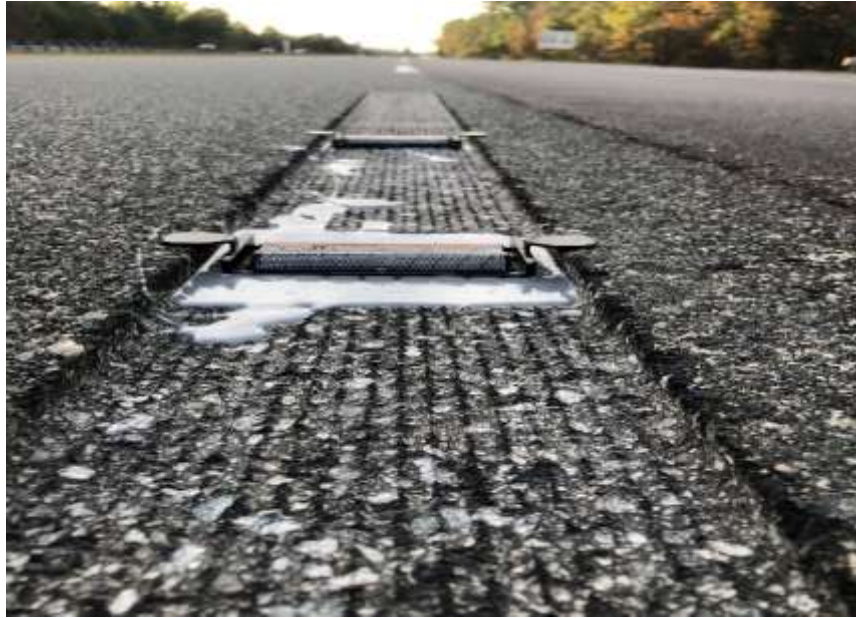
Option 4: Inlaid Cradle Marker

US 301- Installed 2020. Inspected in 2022 and no markers are missing at the time of inspection.

I-85 – Installed in 2019. Inspected in 2023 and no markers are missing at the time of inspection.

Rock Service Station Road – Installed in 2018. Inspected in 2023 and no markers are missing at the time of inspection.

This is the recommended marker in North Carolina, the price shown above is based off the drawing shown below. Inlaid Cradle Markers have been used extensively in Virginia with good results. Like with option 2, there are concerns that cutting a groove to this depth will create a “trap” for debris and water. This is more of a concern in geographically flatter parts of the state.

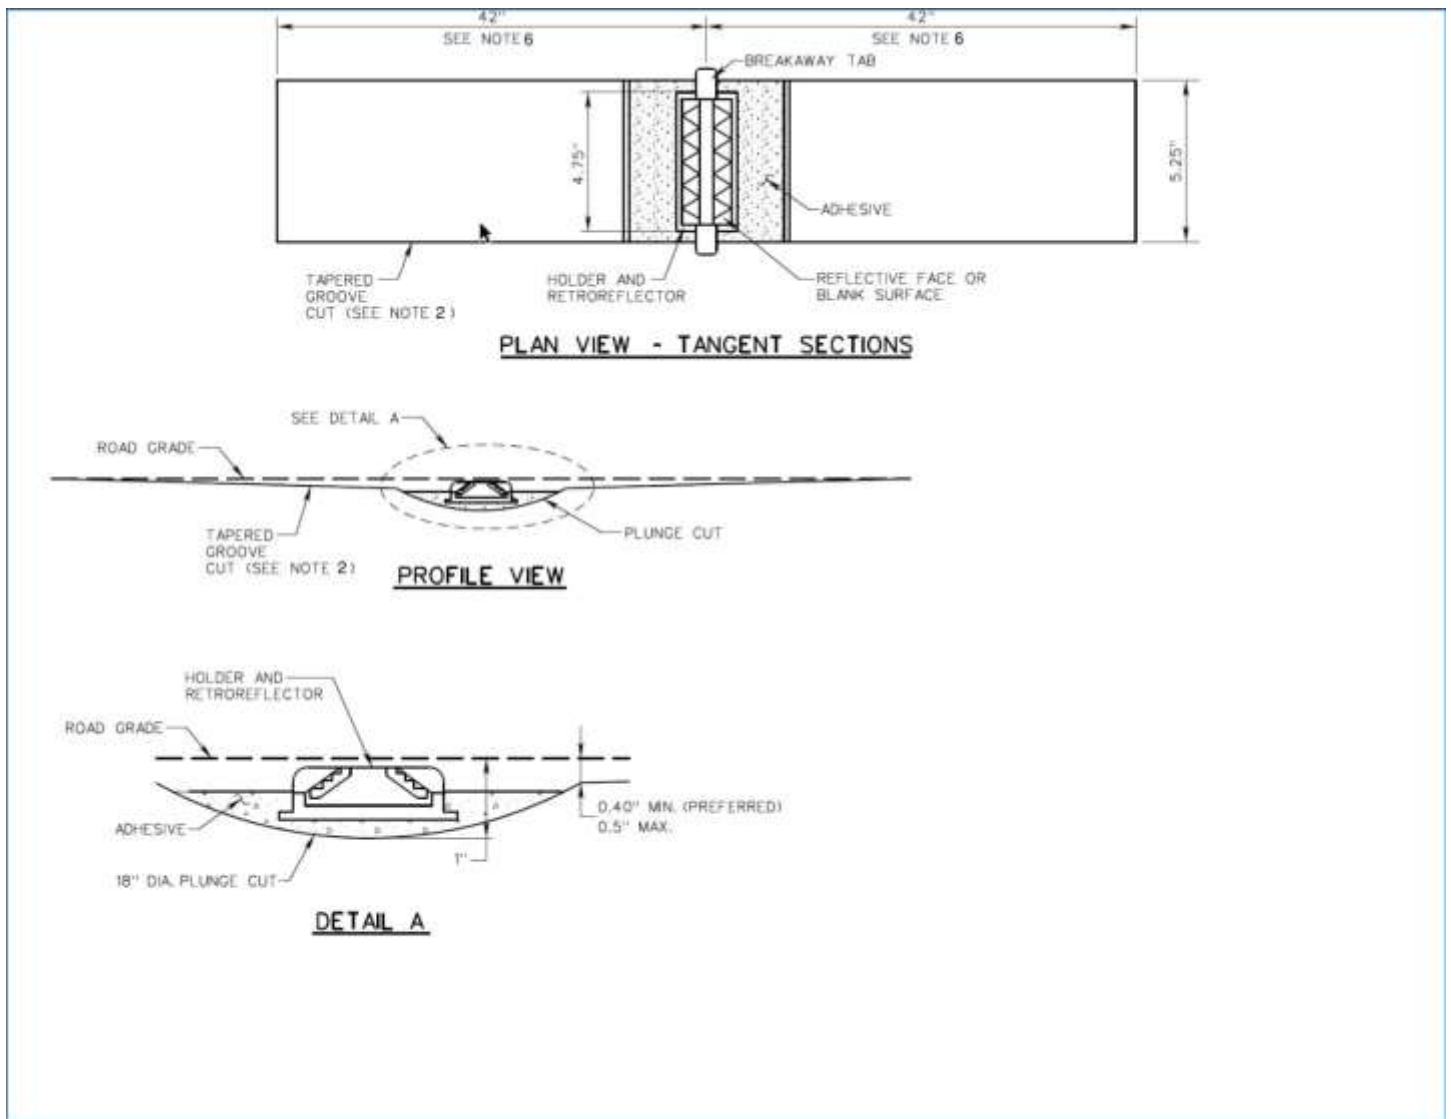
Shown on the next page is what VDOT uses as a Standard for these types of installations. This is what is recommended in NC. The groove dimensions can vary if the marker can be seen by the driver.

1. When installed in existing pavement, all groove edges shall be at least 2 inches from any seam or pavement joint.
2. Groove cuts may be tapered or beveled. Tapered cuts shall start at road level on each end and taper at a fixed rate as shown on the profile view. Beveled groove cuts shall be at a constant 0.3"-0.4" depth.

3. Groove and plunge cuts shall be clean and dry prior to placement of adhesive.
4. The epoxy adhesive shall be thoroughly mixed until it is uniform in color and applied in accordance with the manufacturer's installation instructions.

5. Marker shall be installed as per manufacturer's installation instructions with the breakaway tabs resting on the pavement surface. The epoxy shall be filled to the level of the top of the marker holder. Epoxy shall not touch the retroreflector.

6. Total groove length may be shortened to 54" on sharp curves if approved by the engineer.
7. Grooves shall not overlap with loop detector wires.

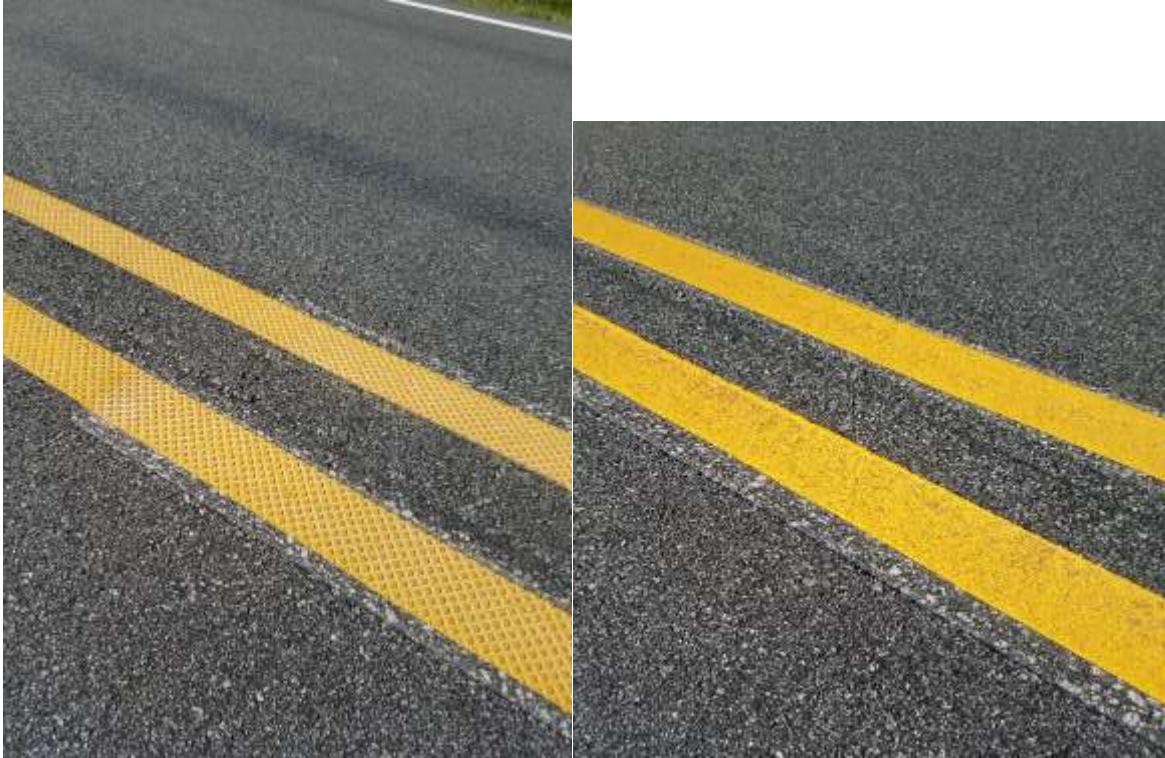
Option 5: Inlaid Pavement Markings

- Inlaid Cold Applied Thermoplastic and Inlaid Extruded Thermoplastic
Rock Service Station Rd and NC 147 (now NC 885)

These markings need to be placed at least 10 mils below the roadway surface.

Rock Service Station Road – Installed in 2018. Inspected in 2023 and no markings are missing at time of inspection. Very little damage noticed after being snowplowed.

NC 147 Toll – Installed in 2019. Inspected in 2020 and no markings were damaged at time of inspection. After this route was resurfaced the Turnpike Authority chose to use inlaid markings.

10 ft inlaid markings every 80 ft.
