NCDOT Bus Stop and Pedestrian Crossing Guidance

NCDOT Traffic Safety Unit

November 2024

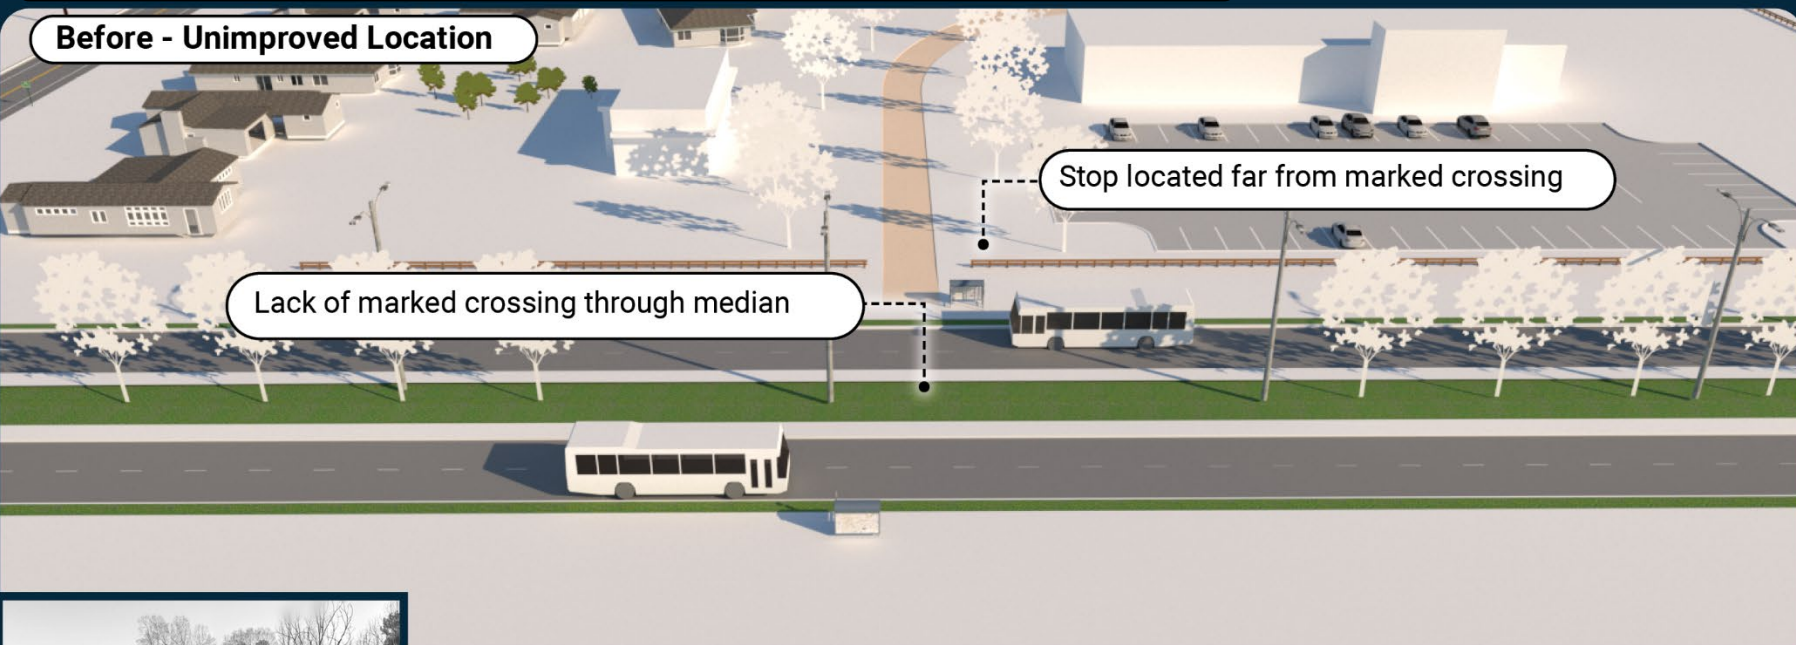
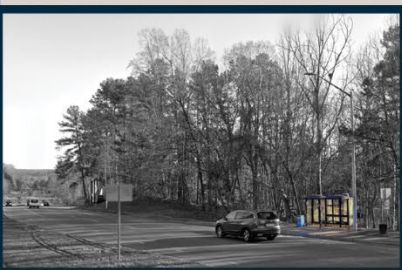
Figure 3 - Improve Crossing at Existing Bus Stop Location – Mid-block

Before - Unimproved Location

Lack of marked crossing through median

Stop located far from marked crossing

Multi-lane roadway Median, Bus stops on both sides of roadway

After - Improvement of Existing Bus Stop Location

Remove vegetation to improve sight distance

Implement Z - Crossing to increase Pedestrian Safety at mid block.

Enhance new crossing with High Visibility Crossing, RRFBs, and refuge island to increase pedestrian safety

Figure 3 first illustrates a bus stop pair along a multi-lane arterial with a raised median and no marked crossing. The existing stops are located mid-block approximately 500' from marked crossings at upstream and downstream intersections. Pedestrians may be anticipated to assess gaps in traffic and cross through the median at locations without visibility enhancements. The second image shows how establishing a marked crossing enhanced with a median refuge island, high visibility crosswalk marking, Rectangular-Rapid-Flashing Beacon (RRFB), relocation of the stops to the far-side of the new mid-block crossing, and treatment of vegetation can significantly increase the safety of transit riders crossing to board or alight the bus. The configuration also shows an offset pedestrian crossing, where the pedestrian enters the refuge area and turns to face oncoming traffic before reentering the roadway to cross travel lanes. Bus operations are not expected to be affected since the stop remains at the same general location.

For mid-block locations generally, the bus stops should be downstream of the enhanced uncontrolled crossing location and not on the crosswalk approach. This is especially important on multi-lane corridors, as the pedestrians are directed to cross behind the bus and are visible to oncoming vehicles travelling in the same direction as the bus. This allows for the pedestrian to assess gaps in traffic, actuate the RRFB or Pedestrian Hybrid Beacon (if applicable), and determine that vehicles are yielding or stopping before initiating the crossing.

Alternative modifications could include relocating the stops to the nearest controlled intersection or placing barriers or fencing in the median to discourage crossings.

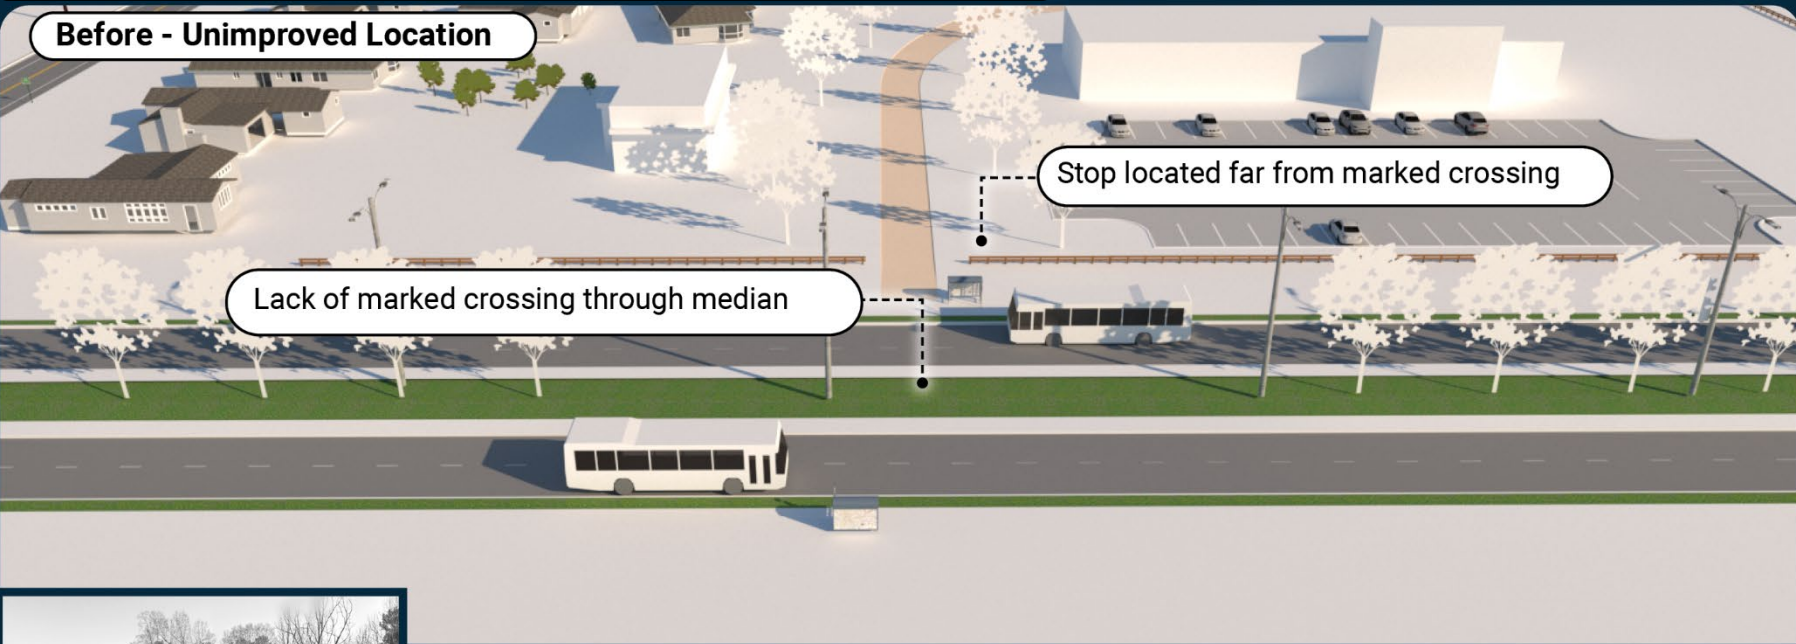
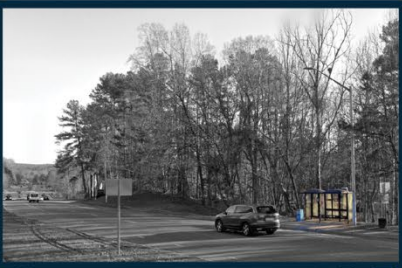
Figure 4 - Relocate Bus Stops to Improved Crossing Locations - Signalized

Before - Unimproved Location

Multi-lane roadway Median, Bus stops on both sides of roadway

Figure 4 first illustrates a bus stop pair along a multi-lane arterial with a raised median and no marked crossing. The existing stops are located mid-block approximately 500' from marked crossings at upstream and downstream intersections. Pedestrians may be anticipated to assess gaps in traffic and cross through the median at locations without visibility enhancements. The second image shows how establishing a marked crossing enhanced with a median refuge island, high visibility crosswalk marking, Pedestrian Hybrid Beacon (PHB), relocation of the stops to the far-side of the new mid-block crossing, and treatment of vegetation can significantly increase the safety of transit riders crossing to board or alight the bus. Bus operations are not expected to be affected since the stop remains at the same general location. In Figure 4, the bus is shown stopping at a bus stop located on the near side of the PHB crossing. All vehicles, including buses, are required to stop for pedestrians in the crosswalk when the PHB is actuated. Alternative modifications could include relocating the stops to the nearest controlled intersection or placing barriers or fencing in the median to discourage crossings.

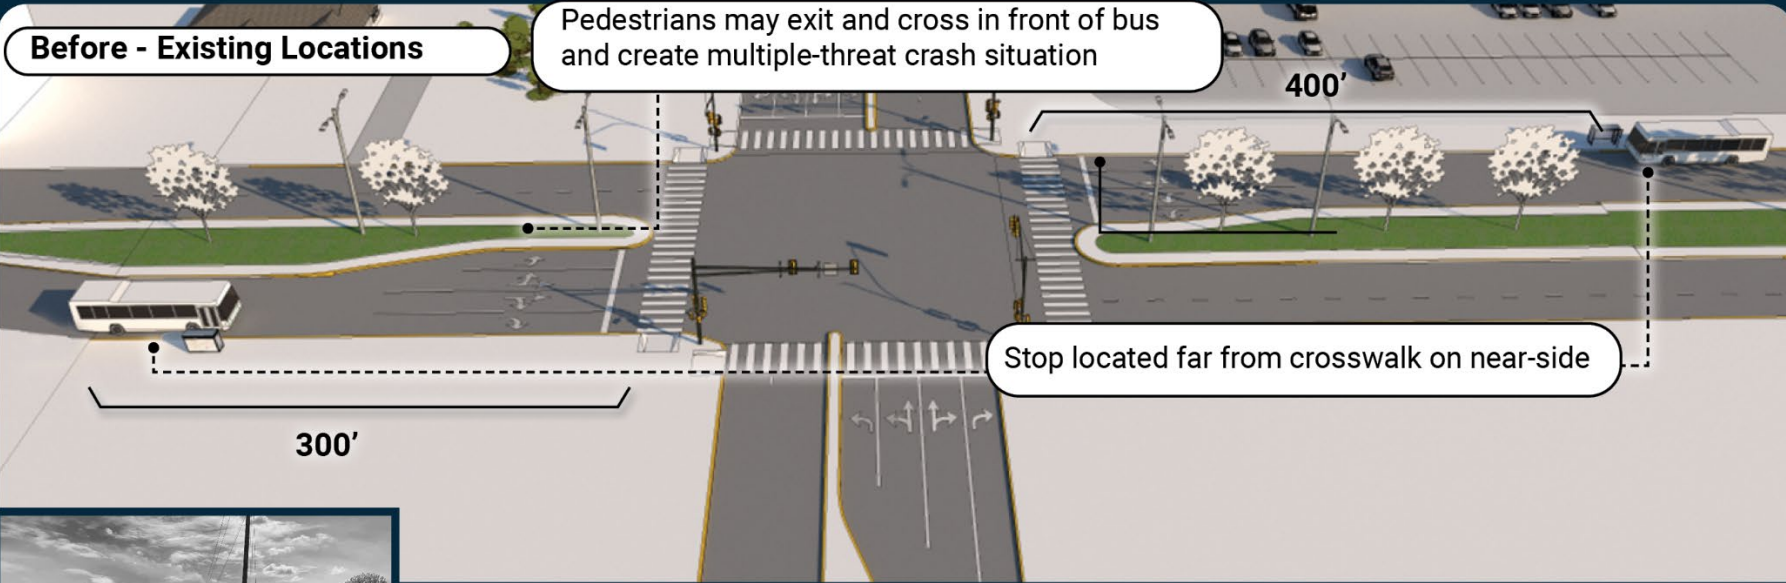
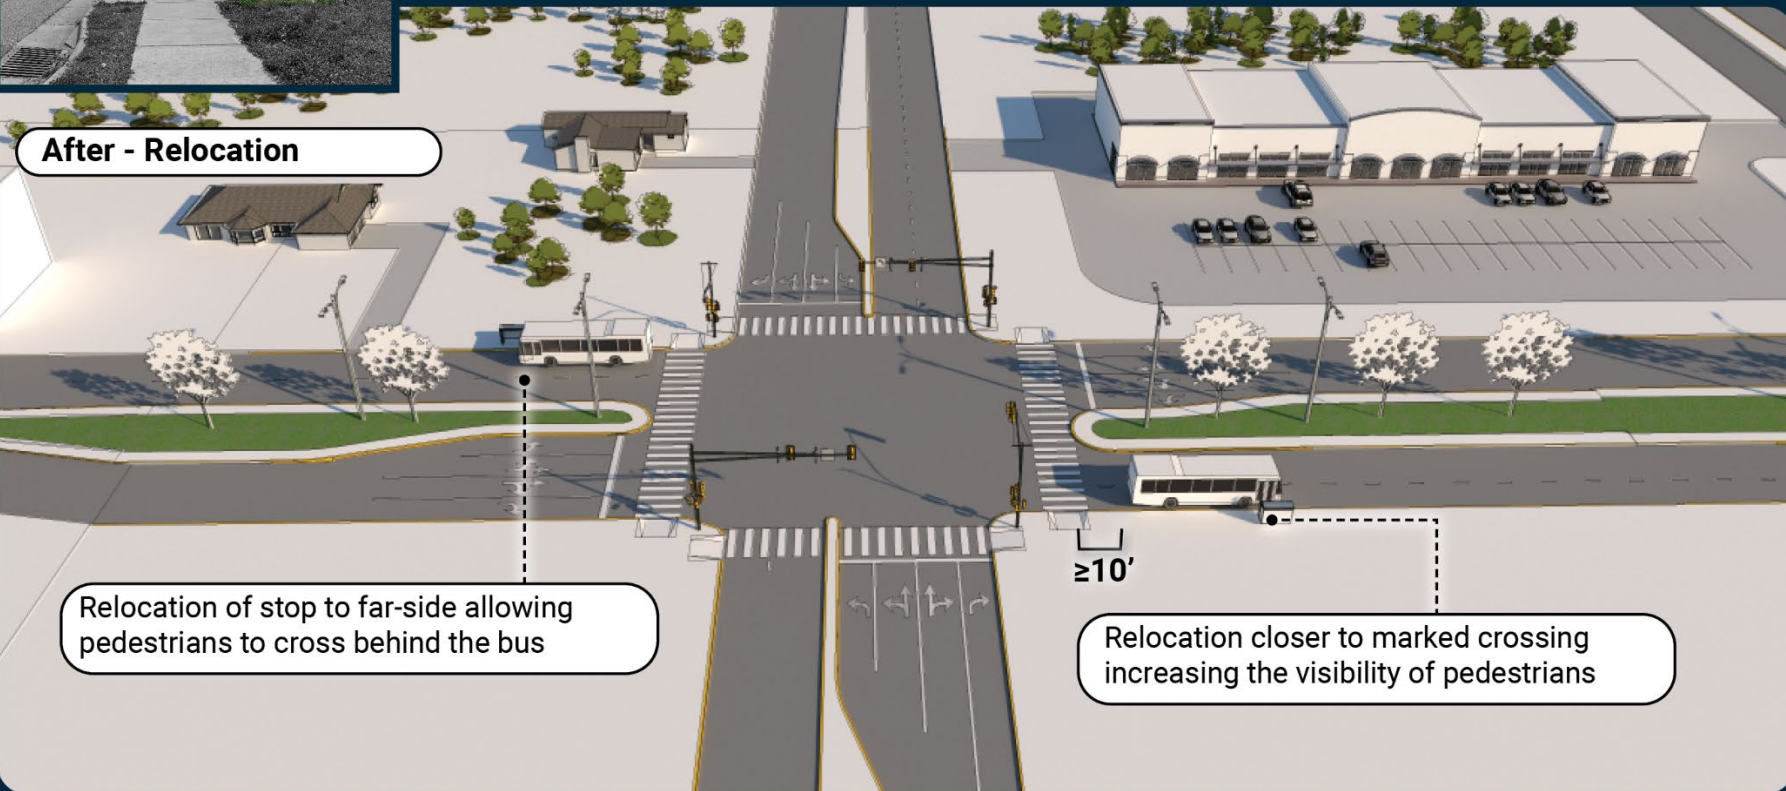
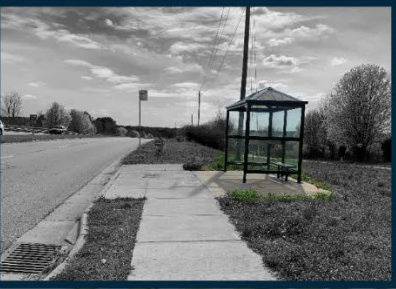
Figure 5 - Relocate Bus Stops to Improved Crossing Locations - Signalized

Before - Existing Locations

Pedestrians may exit and cross in front of bus and create multiple-threat crash situation

Multi-lane roadway, Stop located in advance of signalized intersection

After - Relocation

Relocation of stop to far-side allowing pedestrians to cross behind the bus

≥10'

Relocation closer to marked crossing increasing the visibility of pedestrians

Figure 5 first illustrates bus stops on the near-side of a signalized intersection of two-way streets. While the intersection has pedestrian crossing infrastructure, the bus stops are placed far in advance of the marked crossings, and pedestrians may be expected to cross the roadway away from the intersection and in front of the bus. The second image shows how relocating the bus stops to the far-side of the intersection reduces the distances pedestrian must walk to reach a marked crossing location and encourages the alighting pedestrians to cross behind the bus, thereby improving visibility to oncoming vehicles. In addition to pedestrian safety, special consideration should be paid to right-turning vehicle volumes, through lane volumes, and bus stop frequency and stopping duration when evaluating bus and motor vehicle operations tradeoffs for near-side and far-side placements. See Table 2 for advantages and disadvantages for bus stop placement relative to intersections.

Alternative modifications could include moving the stops closer to the near-side intersection, relocating or consolidating the stops to adjacent intersections that have shorter distances to a marked crossing, relocating the stops to a mid-block location if greater than 300' from a non-signalized intersection or 400' from a signalized intersection, improving the signalized intersection for pedestrians (e.g. high visibility crosswalk markings, pedestrian signal heads, and Leading Pedestrian Interval), and enhancing wayfinding signage to the existing crossing.

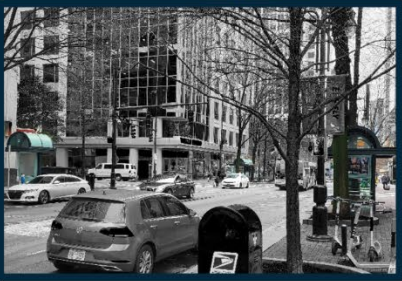
Figure 6 - Consolidate Bus Stops to Improved Crossing Location

Figure 6 first illustrates bus stops on the near-side of a signalized intersection along a multi-lane arterial. The bus stops are placed far in advance of the marked crossings; and, similar to Figure 5, pedestrians may be expected to cross the roadway away from the intersection and in front of the bus, creating a multiple-threat crash situation. The second image shows how relocating the bus stops closer to the intersection, on the near-side, reduces the distances pedestrian must walk to reach a marked crossing location. Alternative modifications could include moving the stops closer to the far-side intersection, improving the intersection for pedestrians (e.g. high visibility crosswalk markings, pedestrian signal heads, and Leading Pedestrian Interval), and adding refuge islands to allow for people cross the intersection in stages.

Urban area, Frequent stop locations

Figure 7 first illustrates numerous bus stops at locations along four-block corridor (~1,250'). The stops are located at near-side, far-side, and mid-block locations and are within 400'-500' of other stops serving the same routes. The pedestrian crossings near the bus stops also vary in their levels of enhancements. While the number of available bus stops provides pedestrians with reduced walking distance to reach a stop, the placement increases the number of crossing locations to be enhanced to meet the need. The second image shows how consolidating or balancing bus stops to locations that support enhanced marked crossings can improve pedestrian safety with minimal reductions in pedestrian access. Reducing bus stop frequency by removing low utilization stops and stops with poor pedestrian accessibility and safety can also increase overall bus performance and on-time reliability for riders, as well as reduce vehicle delay from buses stopping in-lane or re-entering the travel lane from a bus stop.

Alternative modifications may include enhancing the crossings for each stop pair (e.g. high visibility crosswalk markings, pedestrian signal heads, and Leading Pedestrian Interval), and relocating stops to locations that have or would support crossing enhancements.
