PROJECT NO. 15BPR.3

RANDOLPH COUNTY

BRIDGE NO. 191

PRESTRESSED GIRDER REPAIR LOCATIONS SPANS E & F

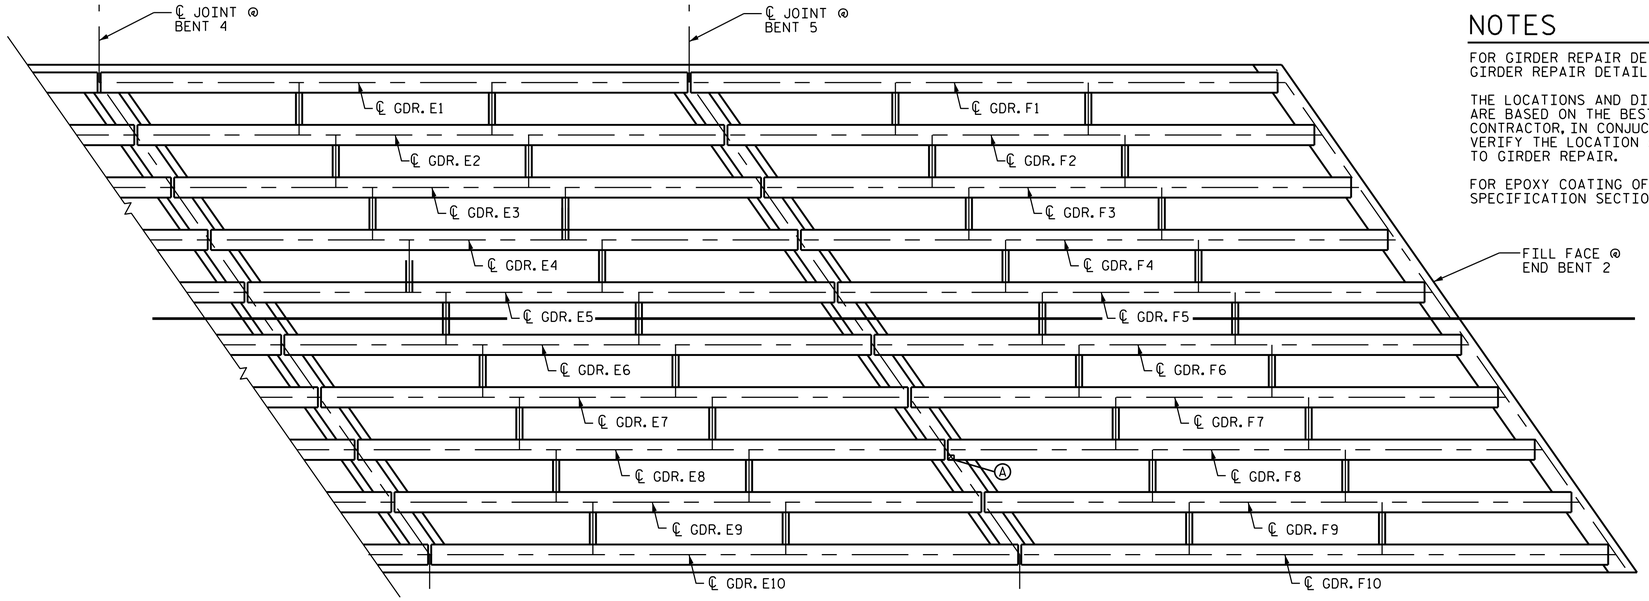
TOP OF GIRDER REPAIR LOCATIONS

GIRDER	LOCATION	REPAIR SIZE (L x W)	LABEL
E1			
E2			
E3			
E4			
E5			
E6			
E7			
E8			
E9			
E10			
F1			
F2			
F3			
F4			
F5			
F6			
F7			
F8	TOP FLG.	8" x 6"	A
F9			
F10

FOR GIRDER REPAIR DETAILS AND SEQUENCE, SEE "PRESTRESSED GIRDER REPAIR DETAILS AND SUMMARY" SHEET.

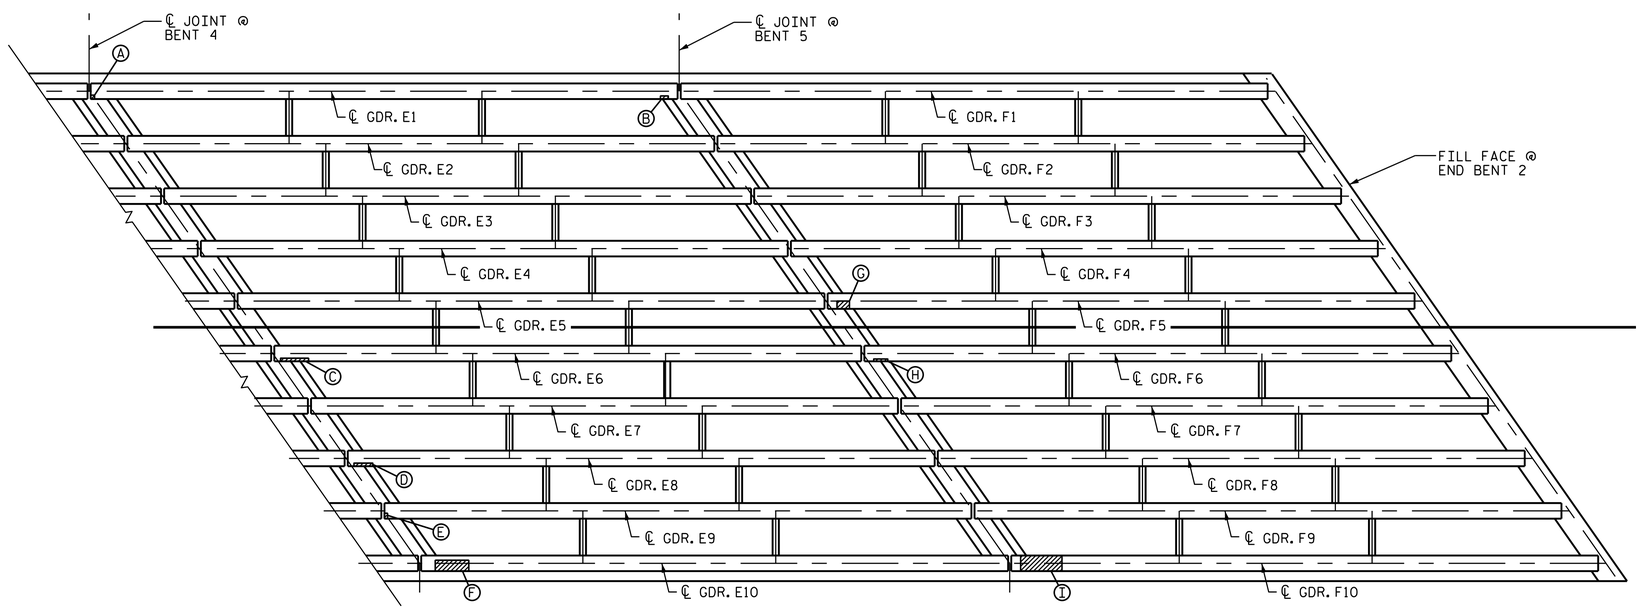
BOTTOM OF GIRDER REPAIR LOCATIONS

GIRDER	LOCATION	REPAIR SIZE (L x W)	LABEL
E1	GDR. END BTM. FLG.	5" x 5" 8" x 10"	A B
E2			
E3			
E4			
E5			
E6	BTM. FLG.	2'-6" x 4"	C
E7			
E8	BTM. FLG.	2'-0" x 4"	D
E9	BTM. FLG.	7" x 4"	E
E10	BTM. FLG.	3'-7" x 1'-2"	F
F1			
F2			
F3			
F4			
F5	BTM. FLG.	1'-0" x 8"	G
F6	BTM. FLG.	3'-0" x 3"	H
F7			
F8			
F9			
F10	BTM. FLG.	4'-5" x 1'-1"	I
