PROJECT NO. 15BPR.3

RANDOLPH COUNTY

BRIDGE NO. 191

PRESTRESSED GIRDER REPAIR LOCATIONS SPANS C & D

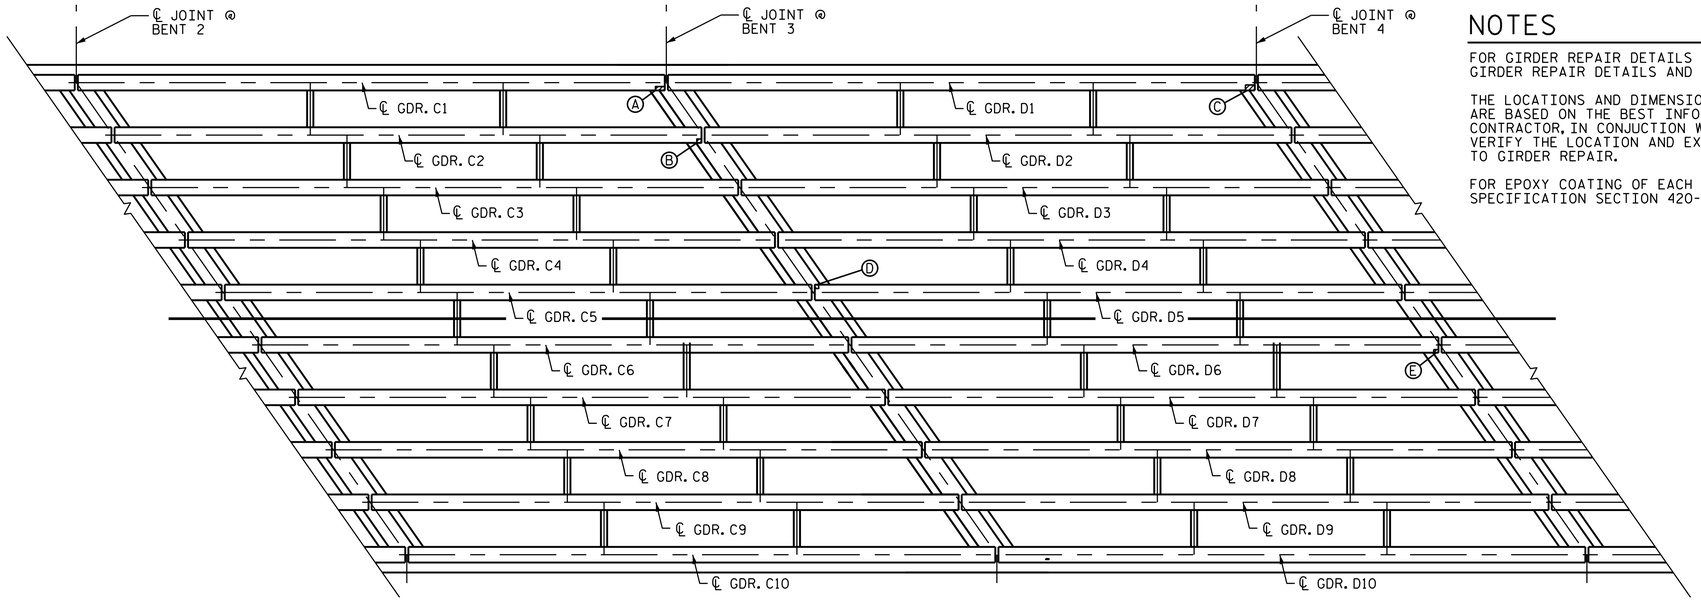
TOP OF GIRDER REPAIR LOCATIONS

SPAN C - TOP OF GIRDER

SPAN D - TOP OF GIRDER

GIRDER	LOCATION	REPAIR SIZE (L x W)	LABEL
C1	TOP FLG.	1'-0" x 7"	A
C2	TOP FLG.	6" x 9"	B
C3			
C4			
C5			
C6			
C7			
C8			
C9			
C10			
D1	TOP FLG.	1'-0" x 7"	C
D2			
D3			
D4			
D5	TOP FLG.	5" x 5"	D
D6	TOP FLG.	6" x 7"	E
D7			
D8			
D9			
D10

FOR GIRDER REPAIR DETAILS AND SEQUENCE, SEE "PRESTRESSED GIRDER REPAIR DETAILS AND SUMMARY" SHEET.

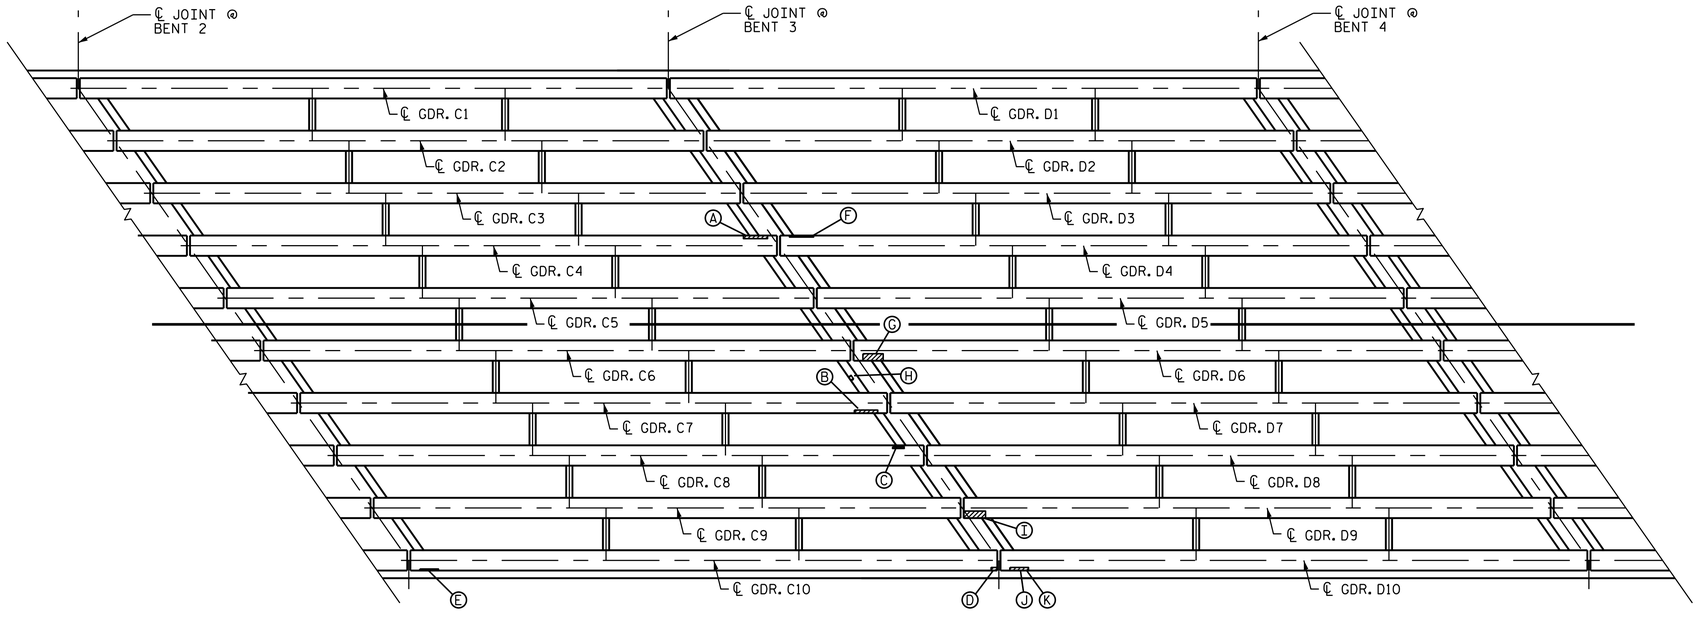
BOTTOM OF GIRDER REPAIR LOCATIONS

SPAN C - BOTTOM OF GIRDER

SPAN D - BOTTOM OF GIRDER

GIRDER	LOCATION	REPAIR SIZE (L x W)	LABEL
C1			
C2			
C3			
C4	BTM. FLG.	2'-7" x 4"	A
C5			
C6	DIAPHRAGM	10" x 4"	H
C7	BTM. FLG.	2'-6" x 6"	B
C8	BTM. FLG.	1'-3" x 2"	C
C9			
C10	BTM. FLG. BTM. FLG.	1'-0" x 2" 8" x 2'-0"	D E
D1			
D2			
D3			
D4	BTM. FLG.	2'-7" x 4"	F
D5			
D6	BTM. FLG.	2'-2" x 9"	G
D7			
D8			
D9	BTM. FLG.	2'-4" x 9"	I
D10	WEB BTM. FLG.	4" x 1" 1'-6" x 2"	J K
