PROJECT NO. BP-5500DD
SWAIN COUNTY
BRIDGE NO. 13

SHEET 2 OF 3

STATE OF NORTH CAROLINA
DEPARTMENT OF TRANSPORTATION
RALEIGH

BENT 1

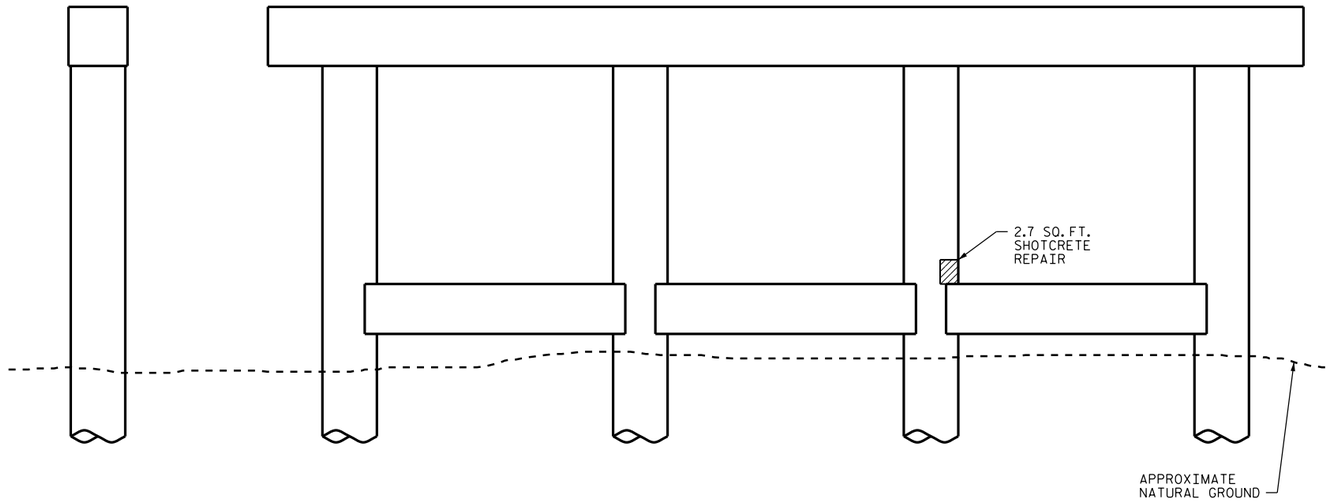
BENT 1 - EAST END

BENT 1 - SPAN "A" SIDE

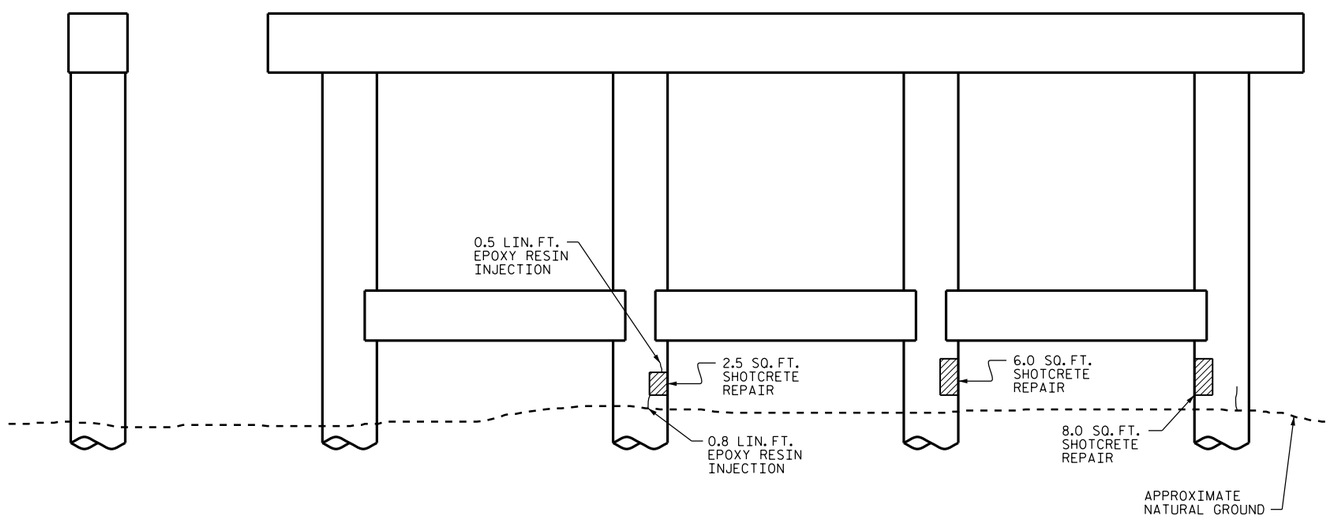
BENT 1 - WEST END

BENT 1 - SPAN "B" SIDE
