PROJECT NO. 15BPR.4

NASH COUNTY

BRIDGE No. 94

GIRDER & DIAPHRAGM REPAIR SPANS 11 THRU 13

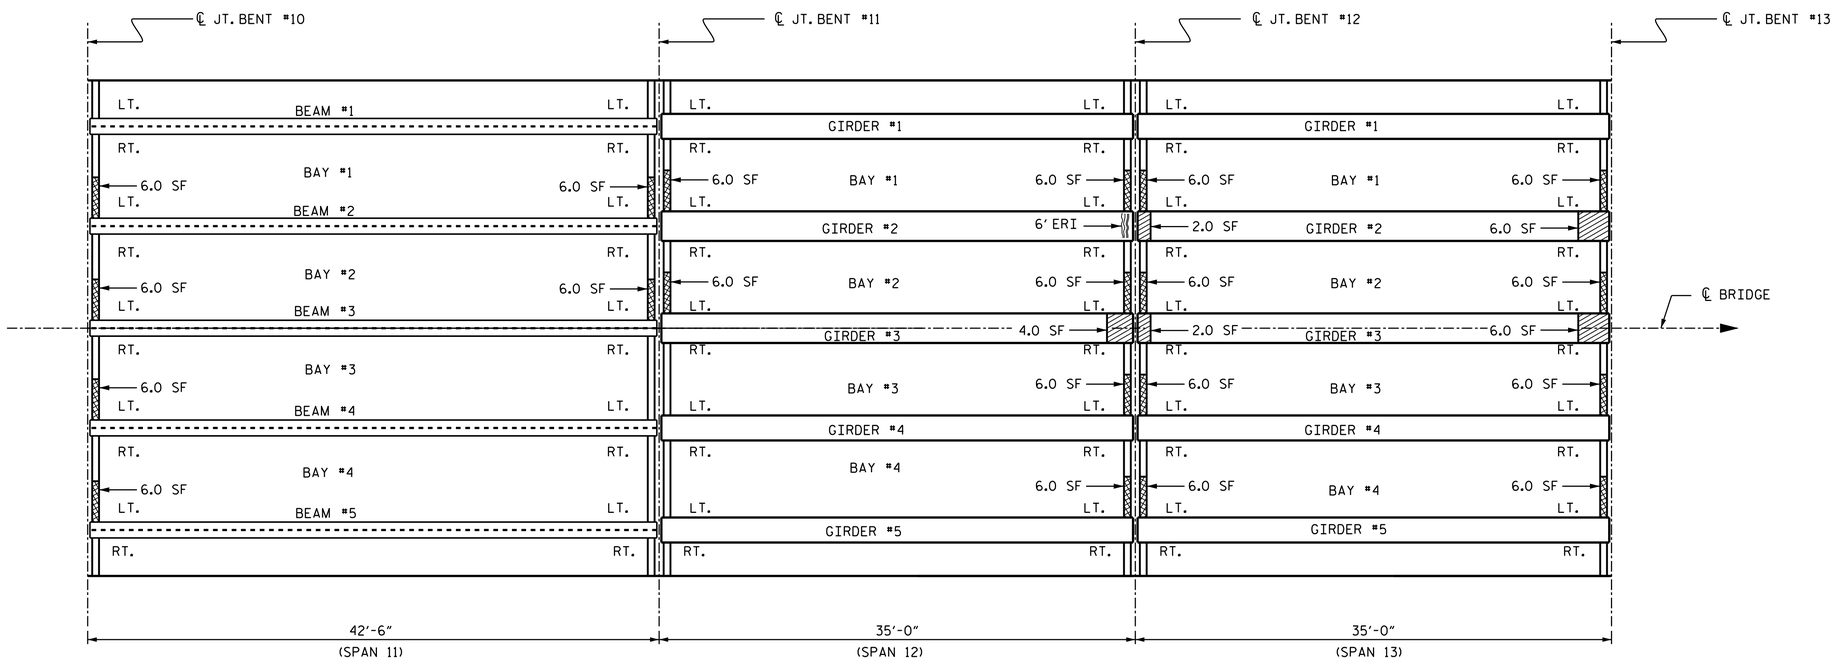
PLAN OF SPAN

UNDERSIDE OF DECK	QUANTITIES			
	ESTIMATE		ACTUAL	
SHOTCRETE REPAIRS	AREA SF	VOLUME CF	AREA SF	VOLUME CF
UNDERSIDE OF DECK & OVERHANG	0.0	0.0		
BENT DIAPHRAGMS	120.0	60.0		
GIRDER REPAIRS				
RC DECK GIRDERS	20.0	10.0		
EPOXY RESIN INJECTION		LN. FT		LN. FT
BENT DIAPHRAGMS		0.0		
GIRDERS		6.0

VALUES IN CHART REPRESENT ESTIMATED REPAIR TOTALS AFTER REMOVAL OF UNSOUND CONCRETE, MIN. OF 1" BEHIND EXPOSED REBAR AND MIN. 2" CL TO SAWCUT. SEE REPAIR DETAILS.
