PROJECT NO. 15BPR.4

BRIDGE No. 94

SUPERSTRUCTURE

GIRDER & DIAPHRAGM REPAIR SPANS 8 THRU 10

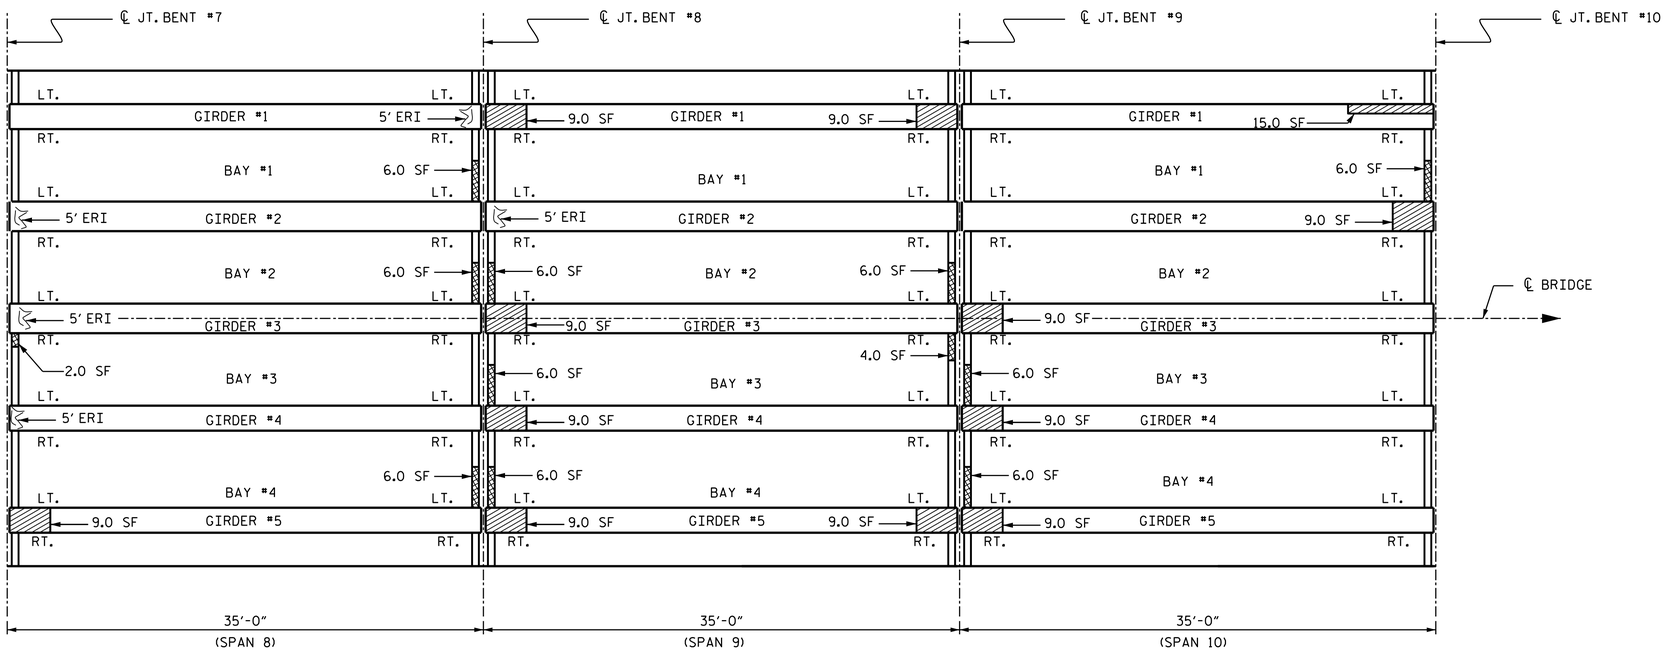
PLAN OF SPAN

UNDERSIDE OF DECK	QUANTITIES			
	ESTIMATE		ACTUAL	
SHOTCRETE REPAIRS	AREA SF	VOLUME CF	AREA SF	VOLUME CF
UNDERSIDE OF DECK & OVERHANG	0.0	0.0		
BENT DIAPHRAGMS	66.0	33.0		
GIRDER REPAIRS				
RC DECK GIRDERS	96.0	48.0		
EPOXY RESIN INJECTION		LN. FT		LN. FT
BENT DIAPHRAGMS		0.0		
GIRDERS		25.0

VALUES IN CHART REPRESENT ESTIMATED REPAIR TOTALS AFTER REMOVAL OF UNSOUND CONCRETE, MIN. OF 1" BEHIND EXPOSED REBAR AND MIN. 2" CL TO SAWCUT. SEE REPAIR DETAILS.
