PROJECT NO. 15BPR.4

NASH COUNTY

BRIDGE NO. 94

SUBSTRUCTURE REPAIR BENT 11

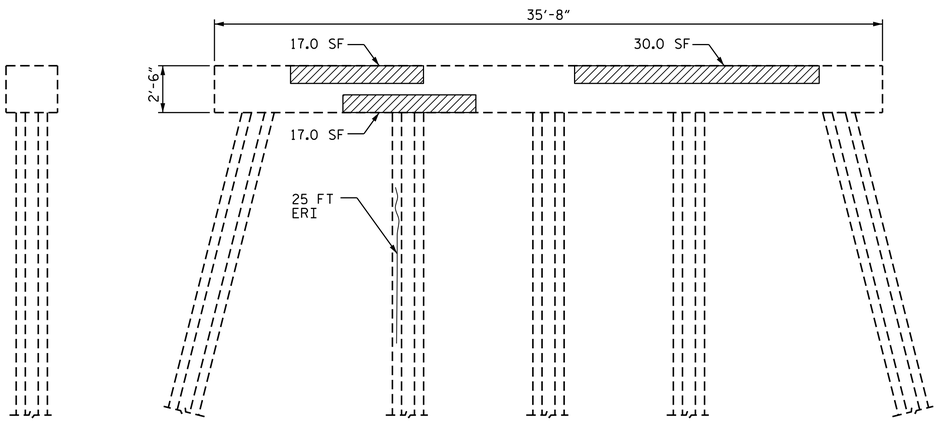
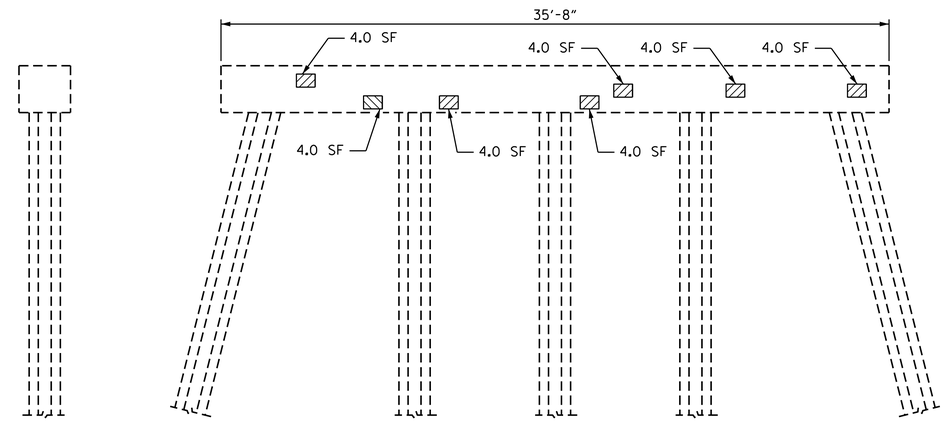
BENT 11	QUANTITIES			
	ESTIMATE		ACTUAL	
SHOTCRETE REPAIRS	AREA SF	VOLUME CF	AREA SF	VOLUME CF
CAP (VERTICAL FACE)	92.0	46.0		
CAP (HORIZONTAL FACE, CORNER)	20.0	10.0		
COLUMN	0.0	0.0		
CONCRETE REPAIRS	AREA SF	VOLUME CF	AREA SF	VOLUME CF
CAP (VERTICAL FACE)	0.0	0.0		
CAP (HORIZONTAL FACE, CORNER)	0.0	0.0		
COLUMN	0.0	0.0		
EPOXY RESIN INJECTION		LN. FT		LN. FT
CAP		0.0		
COLUMN		25.0		
EPOXY COATING	AREA SF			
TOP OF CAP	90.0

VALUES IN CHART REPRESENT ESTIMATED REPAIR TOTALS AFTER REMOVAL OF UNSOUND CONCRETE, MIN. OF 1" BEHIND REBAR AND MIN. 2" CL TO SAWCUT. SEE REPAIR DETAILS.

FOR CAP AND COLUMN REPAIR DETAILS, SEE "TYPICAL CAP AND COLUMN REPAIR DETAILS" SHEET.

FOR SHOTCRETE REPAIRS, SEE SPECIAL PROVISIONS.

FOR CONCRETE REPAIRS, SEE SPECIAL PROVISIONS.

FOR EPOXY RESIN INJECTION, SEE SPECIAL PROVISIONS.
