PROJECT NO. 15BPR.4

NASH COUNTY

SUPERSTRUCTURE

GIRDER & DIAPHRAGM REPAIR SPANS 14 THRU 16

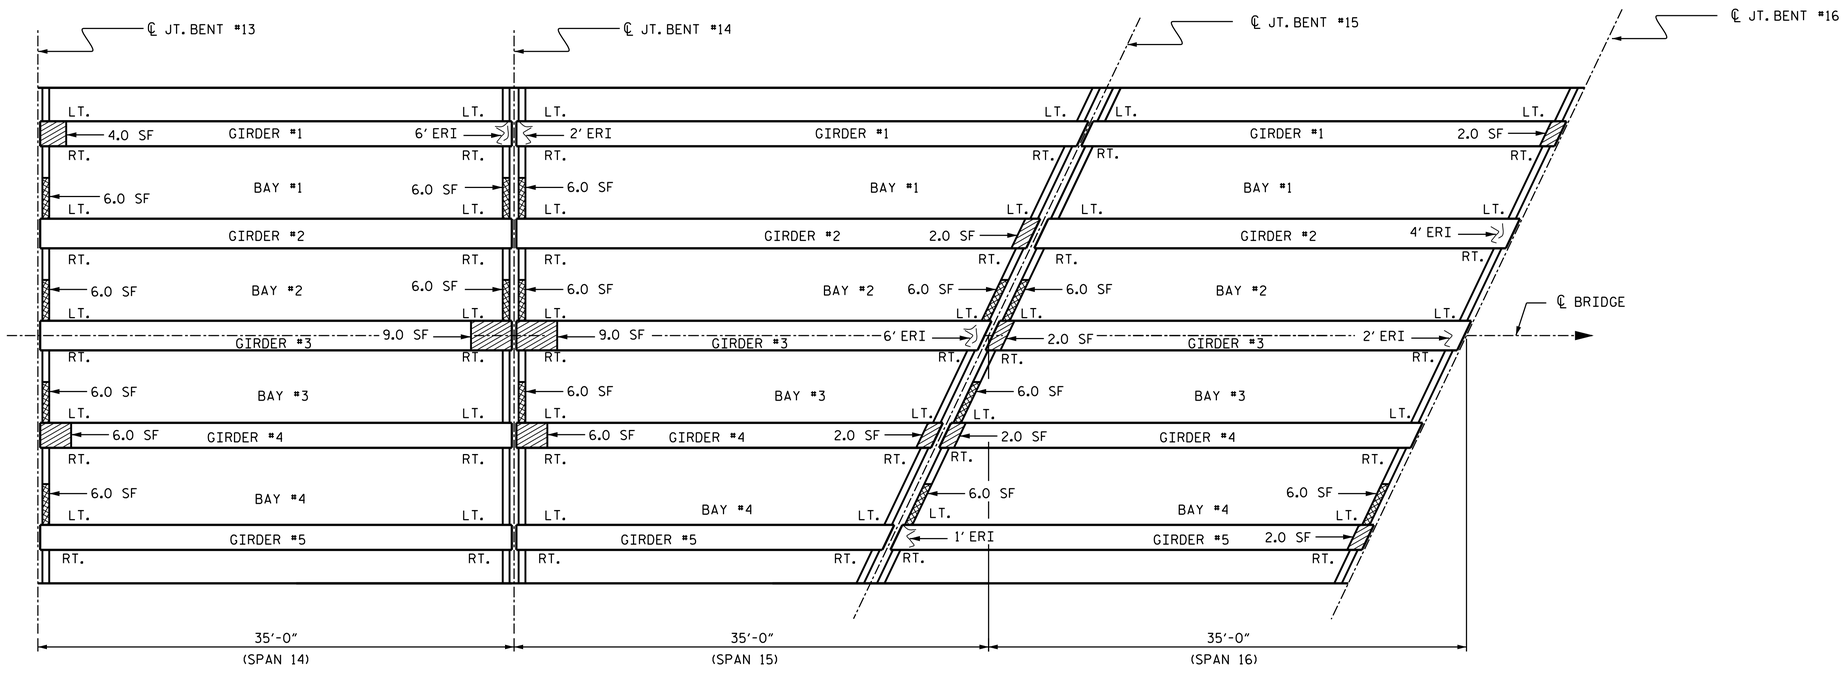
PLAN OF SPAN

UNDERSIDE OF DECK	QUANTITIES			
	ESTIMATE		ACTUAL	
SHOTCRETE REPAIRS	AREA SF	VOLUME CF	AREA SF	VOLUME CF
UNDERSIDE OF DECK & OVERHANG	0.0	0.0		
BENT DIAPHRAGMS	84.0	42.0		
GIRDER REPAIRS				
RC DECK GIRDERS	46.0	23.0		
EPOXY RESIN INJECTION		LN. FT		
BENT DIAPHRAGMS		0.0		
GIRDERS		24.0

VALUES IN CHART REPRESENT ESTIMATED REPAIR TOTALS AFTER REMOVAL OF UNSOUND CONCRETE, MIN. OF 1" BEHIND EXPOSED REBAR AND MIN. 2" CL TO SAWCUT. SEE REPAIR DETAILS.

FOR BENT DIAPHRAGM AND RC DECK GIRDER REPAIR DETAILS, SEE "TYPICAL GIRDER AND DIAPHRAGM REPAIR DETAILS" SHEET.

FOR SHOTCRETE REPAIRS, SEE SPECIAL PROVISIONS.

FOR EPOXY RESIN INJECTION, SEE SPECIAL PROVISIONS.
