PROJECT NO. 15BPR.4

BRIDGE No. 94

SUPERSTRUCTURE

GIRDER & DIAPHRAGM REPAIRS SPANS 1 THRU 3

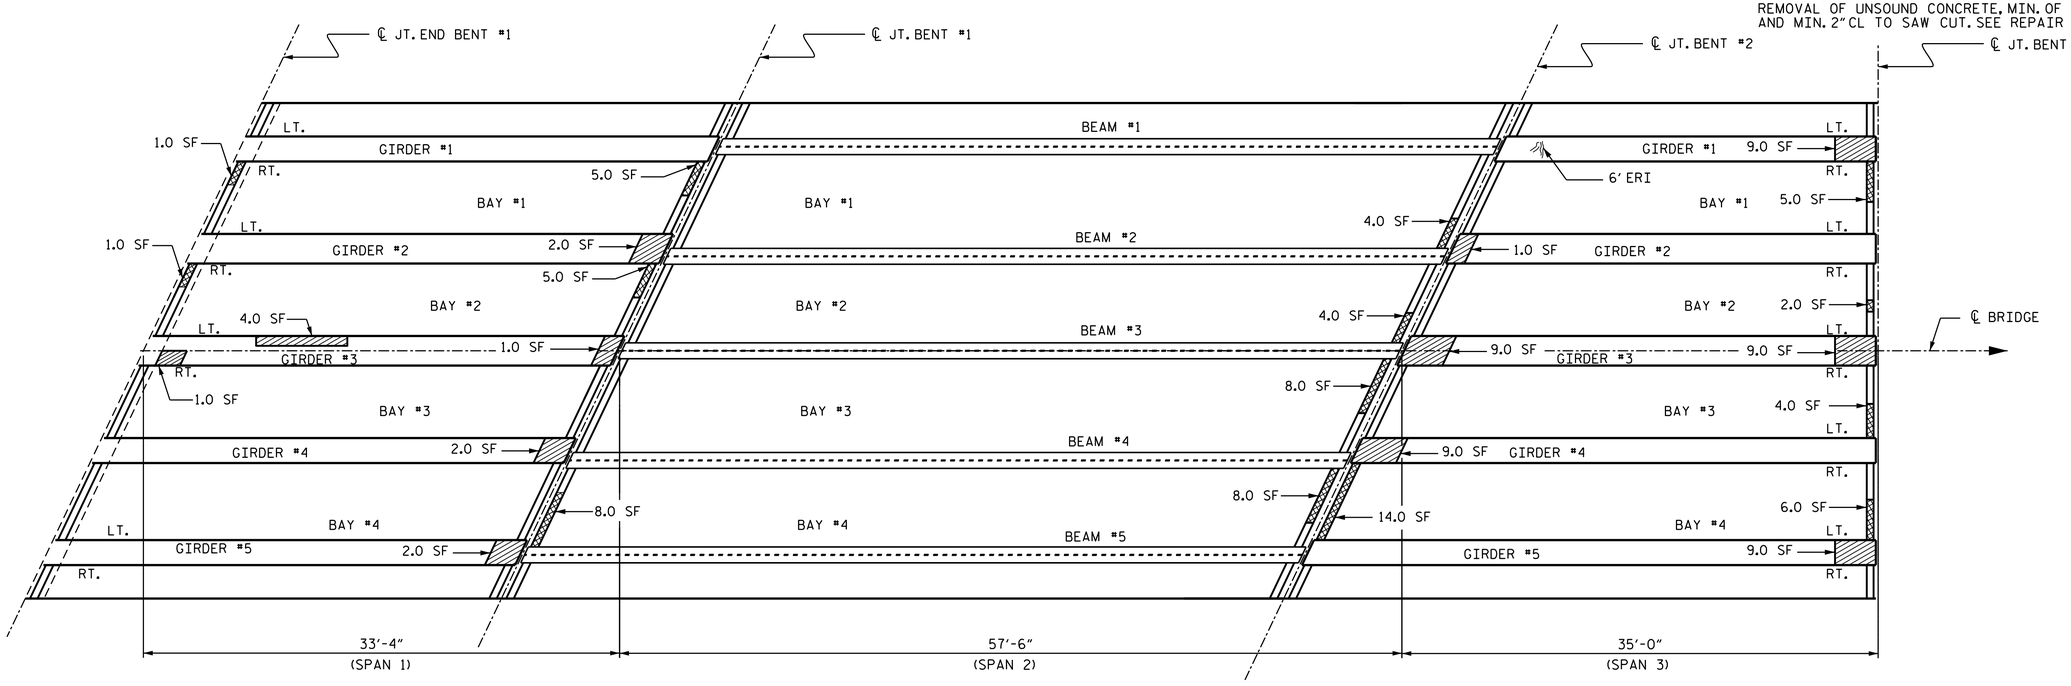
PLAN OF SPAN

- DIAPHRAGM REPAIR
- GIRDER REPAIR

ERI - EPOXY RESIN INJECTION

UNDERSIDE OF DECK	QUANTITIES			
	ESTIMATE		ACTUAL	
SHOTCRETE REPAIRS	AREA SF	VOLUME CF	AREA SF	VOLUME CF
UNDERSIDE OF DECK & OVERHANG	0.0	0.0		
BENT DIAPHRAGMS	75.0	37.5		
GIRDER REPAIRS				
RC DECK GIRDERS	58.0	29.0		
EPOXY RESIN INJECTION		LN. FT		LN. FT
BENT DIAPHRAGMS		0.0		
GIRDERS		6.0

VALUES IN CHART REPRESENT ESTIMATED REPAIR TOTALS AFTER REMOVAL OF UNSOUND CONCRETE, MIN. OF 1" BEHIND EXPOSED REBAR AND MIN. 2" CL TO SAW CUT. SEE REPAIR DETAILS.
