PROJECT NO. 15BPR.4

NASH COUNTY

BRIDGE No. 94

GIRDER & DIAPHRAGM REPAIR SPANS 23 THRU 25

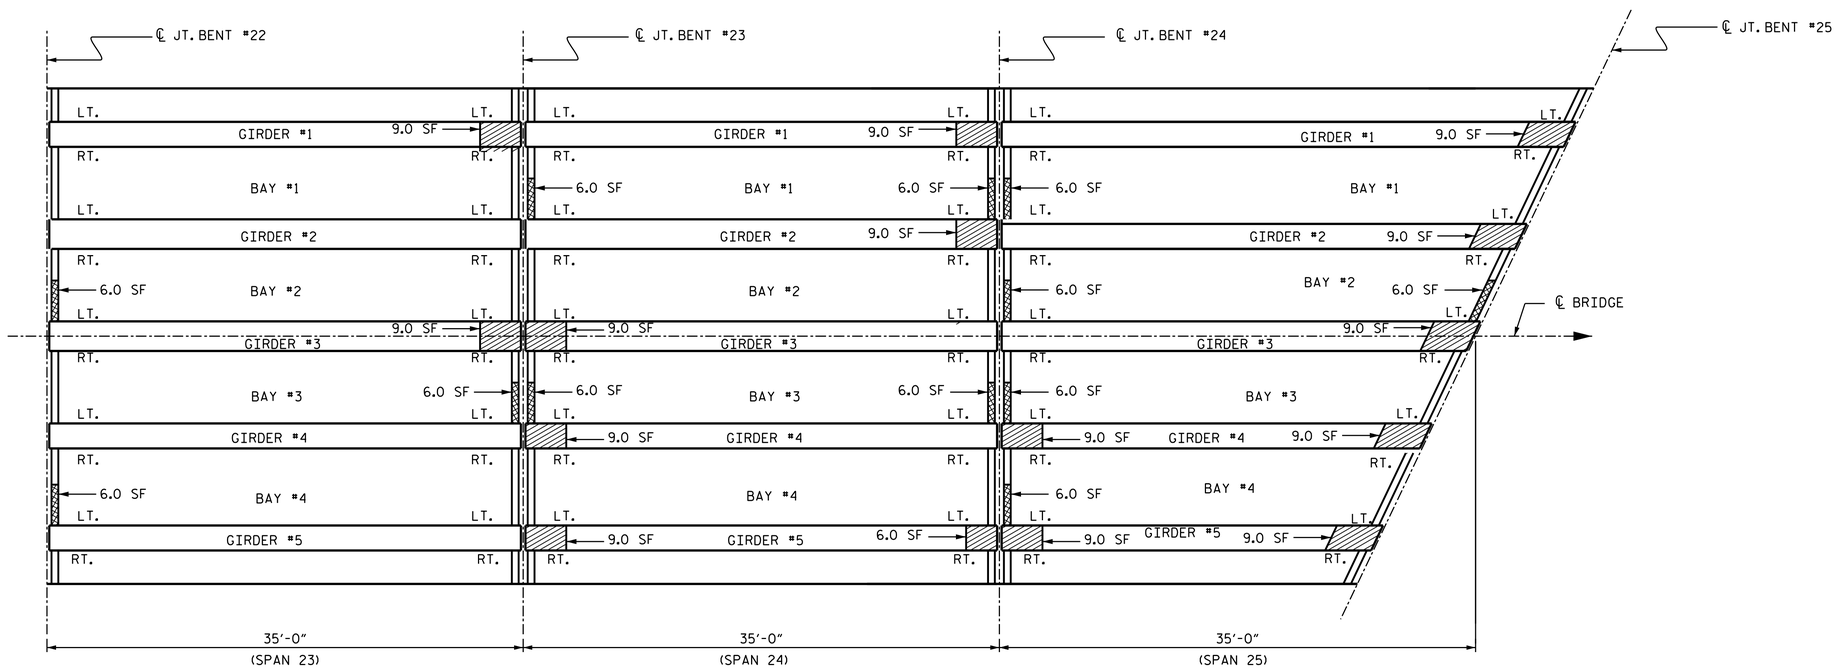
PLAN OF SPAN

UNDERSIDE OF DECK	QUANTITIES			
	ESTIMATE		ACTUAL	
SHOTCRETE REPAIRS	AREA SF	VOLUME CF	AREA SF	VOLUME CF
UNDERSIDE OF DECK & OVERHANG	0.0	0.0		
BENT DIAPHRAGMS	72.0	36.0		
GIRDER REPAIRS				
RC DECK GIRDERS	132.0	66.0		
EPOXY RESIN INJECTION		LN. FT		
BENT DIAPHRAGMS		0.0		
GIRDERS		0.0

VALUES IN CHART REPRESENT ESTIMATED REPAIR TOTALS AFTER REMOVAL OF UNSOUND CONCRETE, MIN. OF 1" BEHIND EXPOSED REBAR AND MIN. 2" CL TO SAWCUT. SEE REPAIR DETAILS.

FOR BENT DIAPHRAGM AND RC DECK GIRDER REPAIR DETAILS, SEE "TYPICAL GIRDER AND DIAPHRAGM REPAIR DETAILS" SHEET.

FOR SHOTCRETE REPAIRS, SEE SPECIAL PROVISIONS.

FOR EPOXY RESIN INJECTION, SEE SPECIAL PROVISIONS.
