NC DEPARTMENT OF TRANSPORTATION
DIVISION OF HIGHWAYS
STRUCTURE MANAGEMENT UNIT

Structure Safety Report

Routine Element Inspection - Contract

DIVISION: 14 **COUNTY:** HAYWOOD **STRUCTURE NUMBER:** 430236 **FREQUENCY:** 24 MONTHS

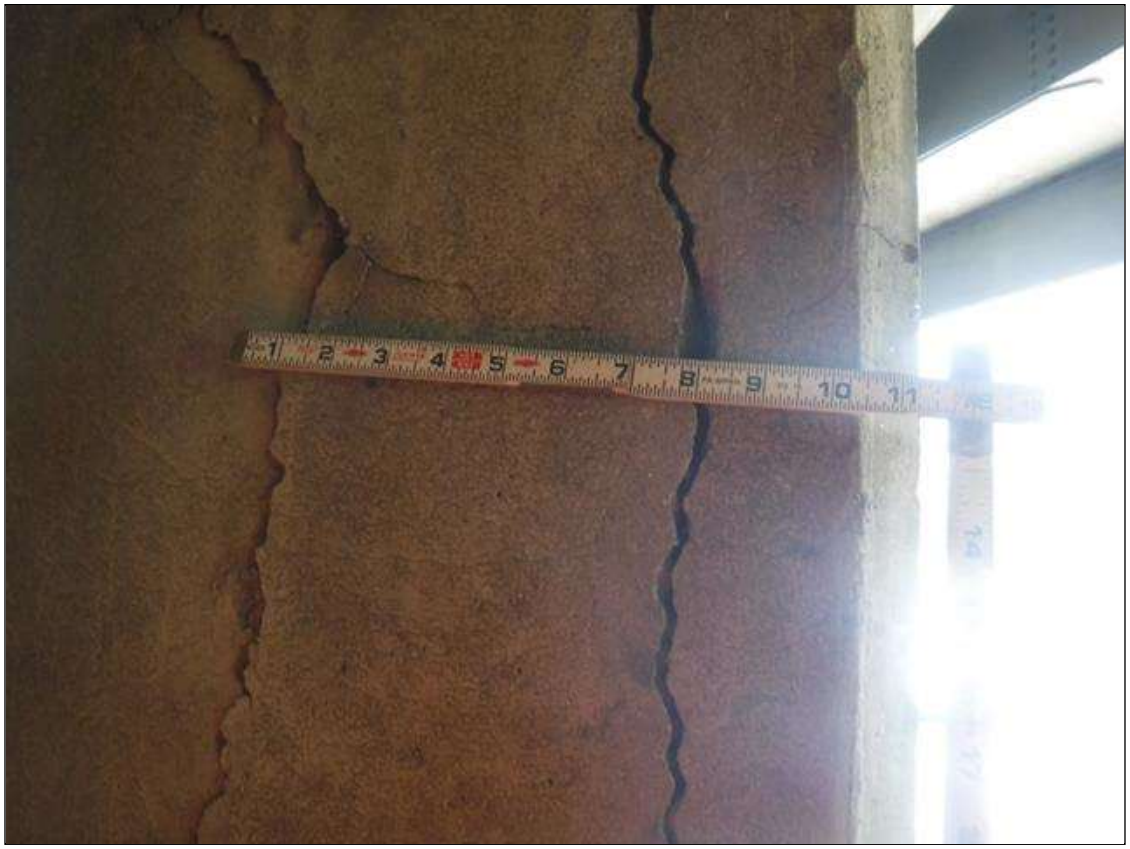
Bent 1 Pile 4: (PAR) 96" X 8" X 7" SPALL WITH EXPOSED REBAR IN SOUTHEAST CORNER OF COLUMN EXTENDING FROM BOTTOM OF CAP

Bent 1 Pile 4: 52" X 8" AREA OF DELAMINATION WITH UP TO 1/2" VERTICAL CRACKS IN SPAN 1 FACE OF COLUMN EXTENDING FROM BOTTOM OF CAP

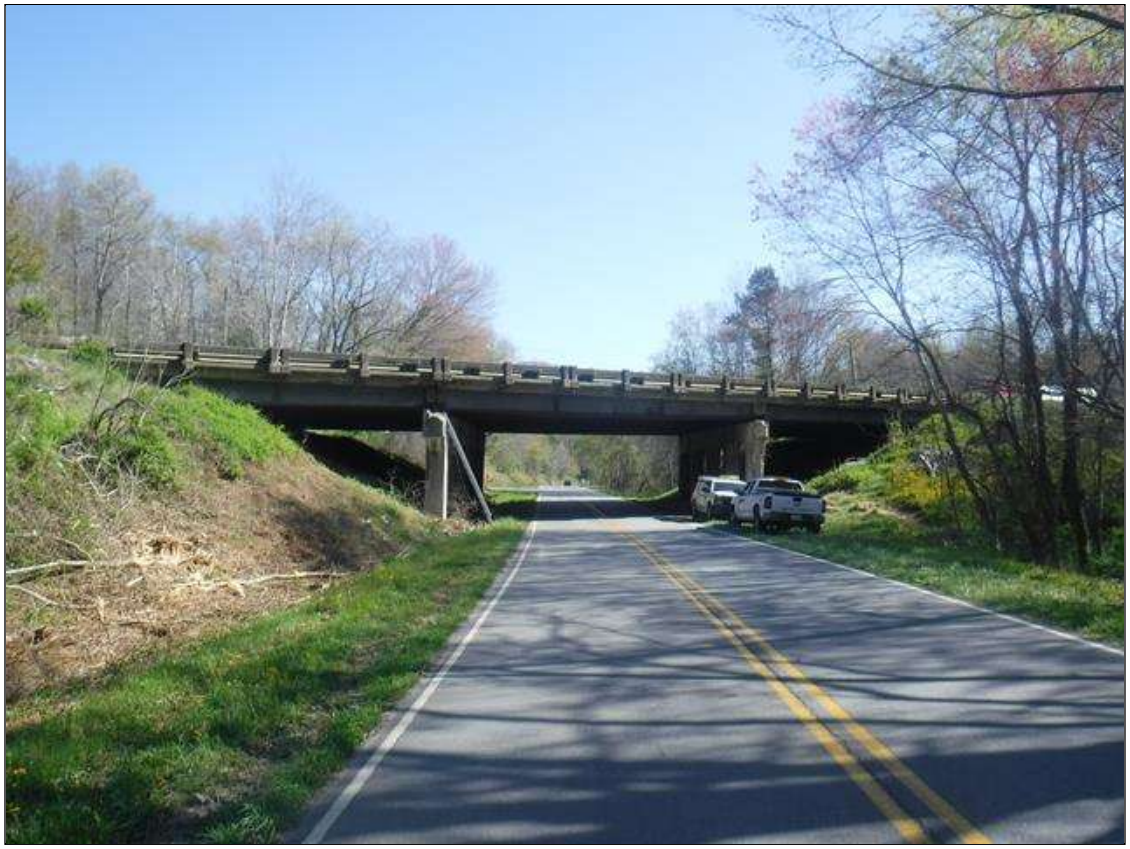
TYPICAL SUPERSTRUCTURE UNDERSIDE, SPAN 2 SHOWN
