RACEY MITIGATION SITE ON LAXON CREEK, WATAUGA COUNTY

Monitoring Report

NORTH CAROLINA DEPARTMENT OF TRANSPORTATION
STREAM MITIGATION PROGRAM

Period Covered: July 30, 2002 - February 25, 2004

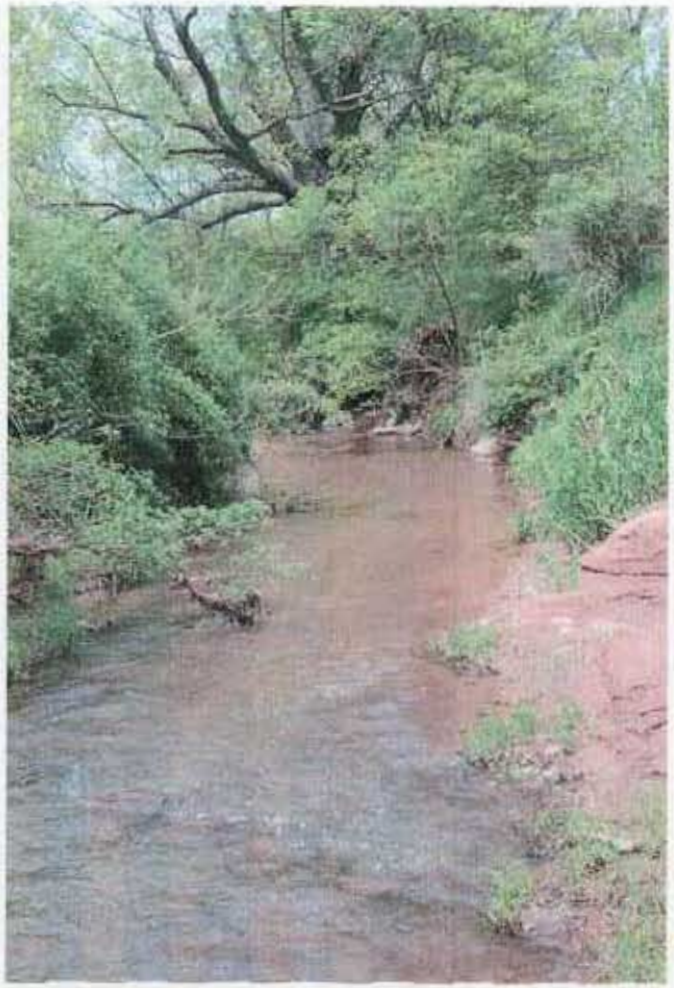
The longitudinal thalweg profile has shifted little since 2001 (Figure 2). There has been aggradation of materials at some locations and deepening at other locations; however, none of this activity indicates a migration towards an unstable stream channel. These changes appear to be normal adjustments to stream flow and weather conditions. From 2002 to 2003 pool habitat increased from 50% to 65%. This pool habitat increase is the direct result of three new beaver dams. These dams have backed water over traditional riffle habitats. There has been no shift in

A.2.23. On of th bea 'er dam located within the mitigation site during th July 2003 monitoring ey station 8+48.
