Monitoring Data Record

Project Title: R-2231CB (US 220 Bypass) COE Action ID: 199400590
Stream Name: UT to Big Mountain Creek (Site 6) DWQ Number: 000874
City, County and other Location Information: Montgomery County, US 220 Bypass (Station 268+00 LT.
Date Construction Completed: Water was turned on 9/19/05
Monitoring Year: (5) of 5
Ecoregion: 8 digit HUC unit 03040203
USGS Quad Name and Coordinates:
Rosgen Classification:
Length of Project: 253' Urban or Rural: Rural Watershed Size:
Monitoring DATA collected by: M. Green, J. Young, & O. Pilkington Date: 6/8/11
Applicant Information:
Name: NCDOT Roadside Environmental Unit
Address: 1425 Rock Quarry Road Raleigh, NC 27610
Telephone Number: (919) 861-3772 Email address: mlgreen@ncdot.gov
Consultant Information:
Name:
Address:
Telephone Number: Email address:
Project Status: Complete

UT Big Mountain Creek (Site 6)

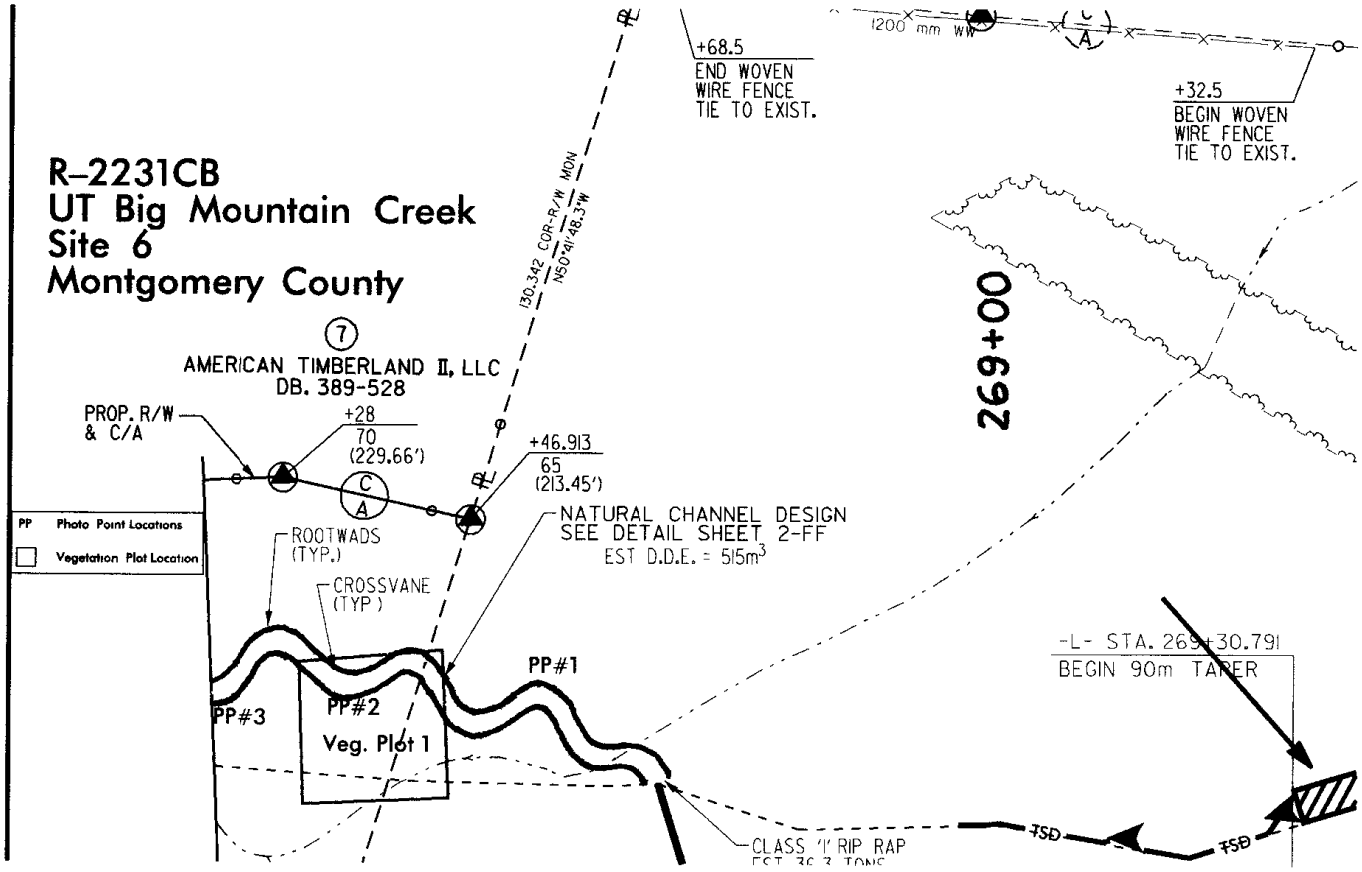
Overview of Site

The stream relocation is stabilized for the 2011 evaluation. NCDOT proposes to discontinue channel stability monitoring at this stream relocation.
