Re-Evaluation Bridge Inspection Report

- 2014 -

Piedmont & Northern Railway

Mt. Holly Subdivision

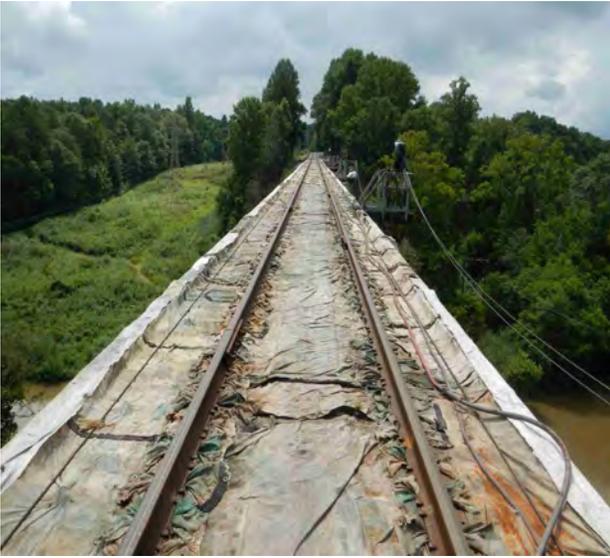
Bridge 19.30 Section 2 Deck View

Findings:	Finding Notes:
Span 1 Floor System	Minor corrosion to all Steel throughout Minor pitting to Top and Bottom Flange Angles of Stringers
Span 2 Floor System	Minor corrosion to all Steel throughout Minor pitting to Top and Bottom Flange Angles of Stringers
Ties	OK
Guard Timber	OK
Walkout Platforms	OK
Other	Limited access to bridge due to repairs at the time of inspection

Item#	Priority	Who Fixes	Repair Description
1	3	Railroad	Perform an Underwater Inspection of Substructure

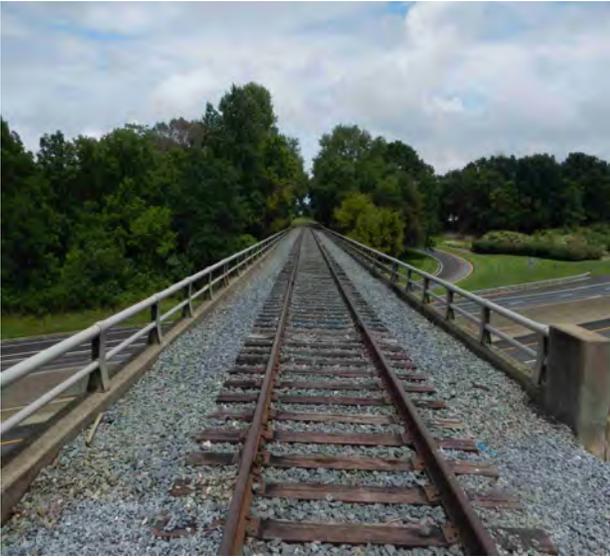
Bridge 21.50 Deck View

Findings:	Finding Notes:
Abutment 1	
Bearings	Minor corrosion to bearings
Span 1	
Beams	Minor corrosion to Top Flange Angles at Concrete Slab Interface Minor paint peeling to Beams near Bottom Flange Angles
Span 2	
Beams	Minor corrosion to Top Flange Angles at Concrete Slab Interface Minor paint peeling to Beams near Bottom Flange Angles
Span 3	
Beams	Minor corrosion to Top Flange Angles at Concrete Slab Interface Minor paint peeling to Beams near Bottom Flange Angles
Span 4	
Beams	Minor corrosion to Top Flange Angles at Concrete Slab Interface Minor paint peeling to Beams near Bottom Flange Angles
Span 5	
Beams	Minor corrosion to Top Flange Angles at Concrete Slab Interface Minor paint peeling to Beams near Bottom Flange Angles
Approaches	OK
Line and Surface	OK
Handrail	OK
Other	No significant defects located at the time of this inspection

Item#	Priority	Who Fixes	Repair Description
1	5	Railroad	Continue to inspect bridge on a regular railroad inspection schedule

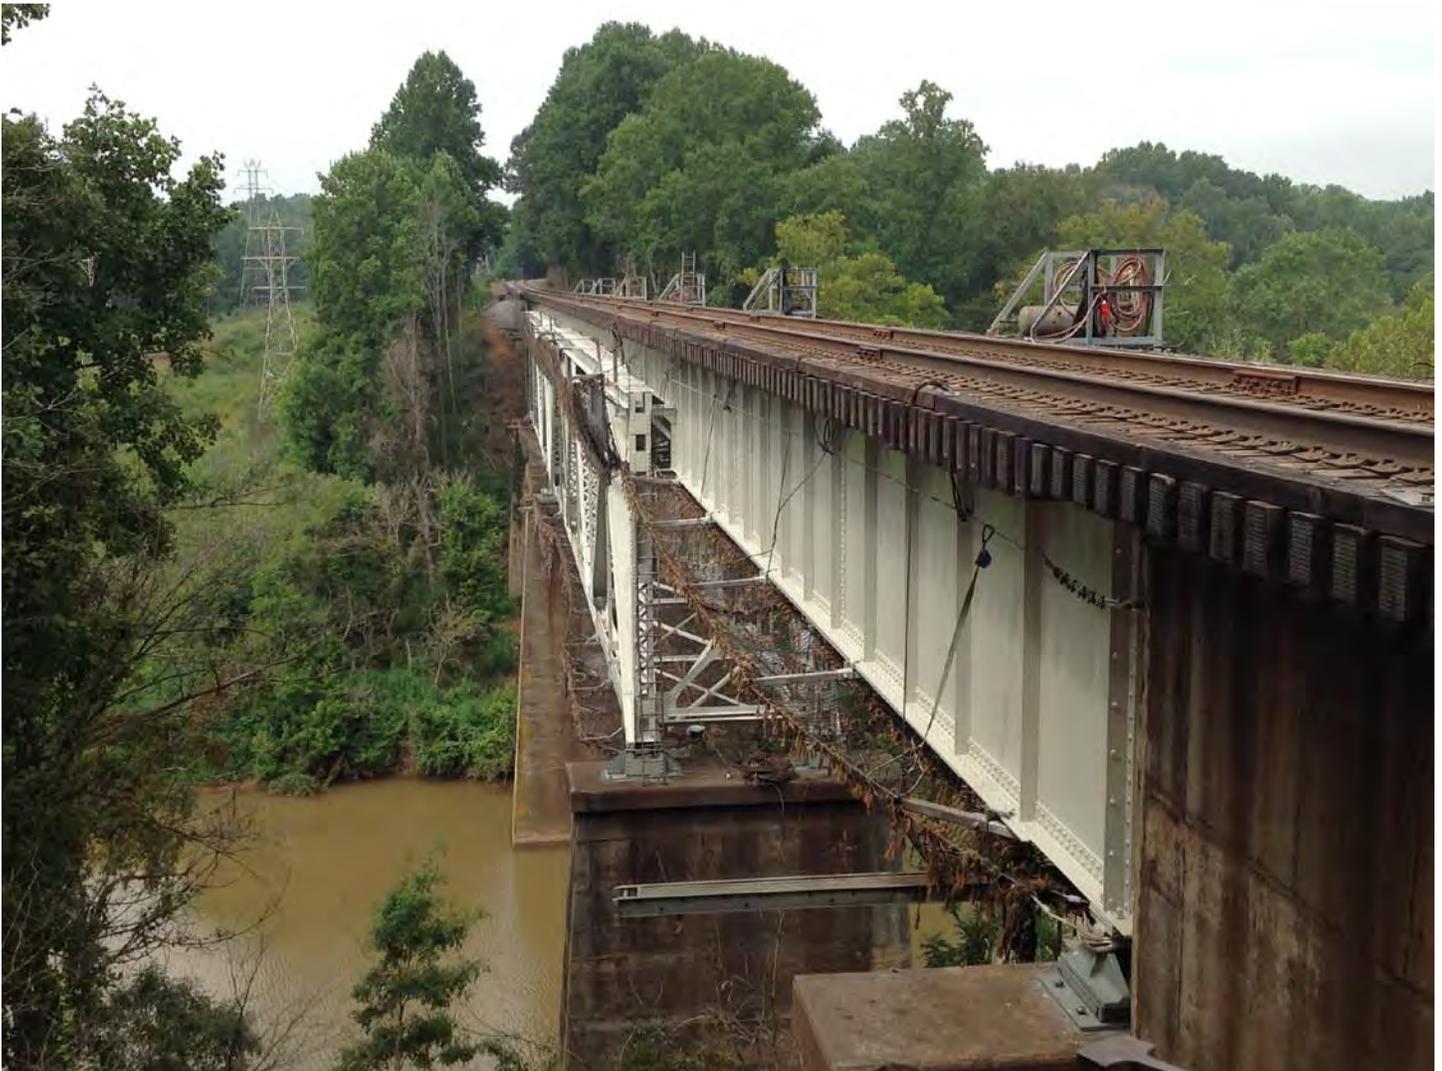
Picture #1

The bridge on Piedmont & Northern Corridor Rail line at MP SFT 16.3 carries a single track over the South Fork of the Catawba River. The track is supported by an open timber deck consisting of ties resting on the superstructure. The bridge, constructed in 1911, is a combination of steel deck plate girders and trusses having a total length of 460 feet. The approach spans, 80 feet each, are steel deck plate girders while the two spans are steel deck trusses with length of 150 feet each. Both the plate girders and trusses are riveted built-up sections. Floor beams and stringers are also riveted built-up members. Top and bottom lateral bracing and sway bracing are steel angle sections or built up from angle sections. The estimated area to be cleaned and painted is 10, 500 square feet see picture #1. This

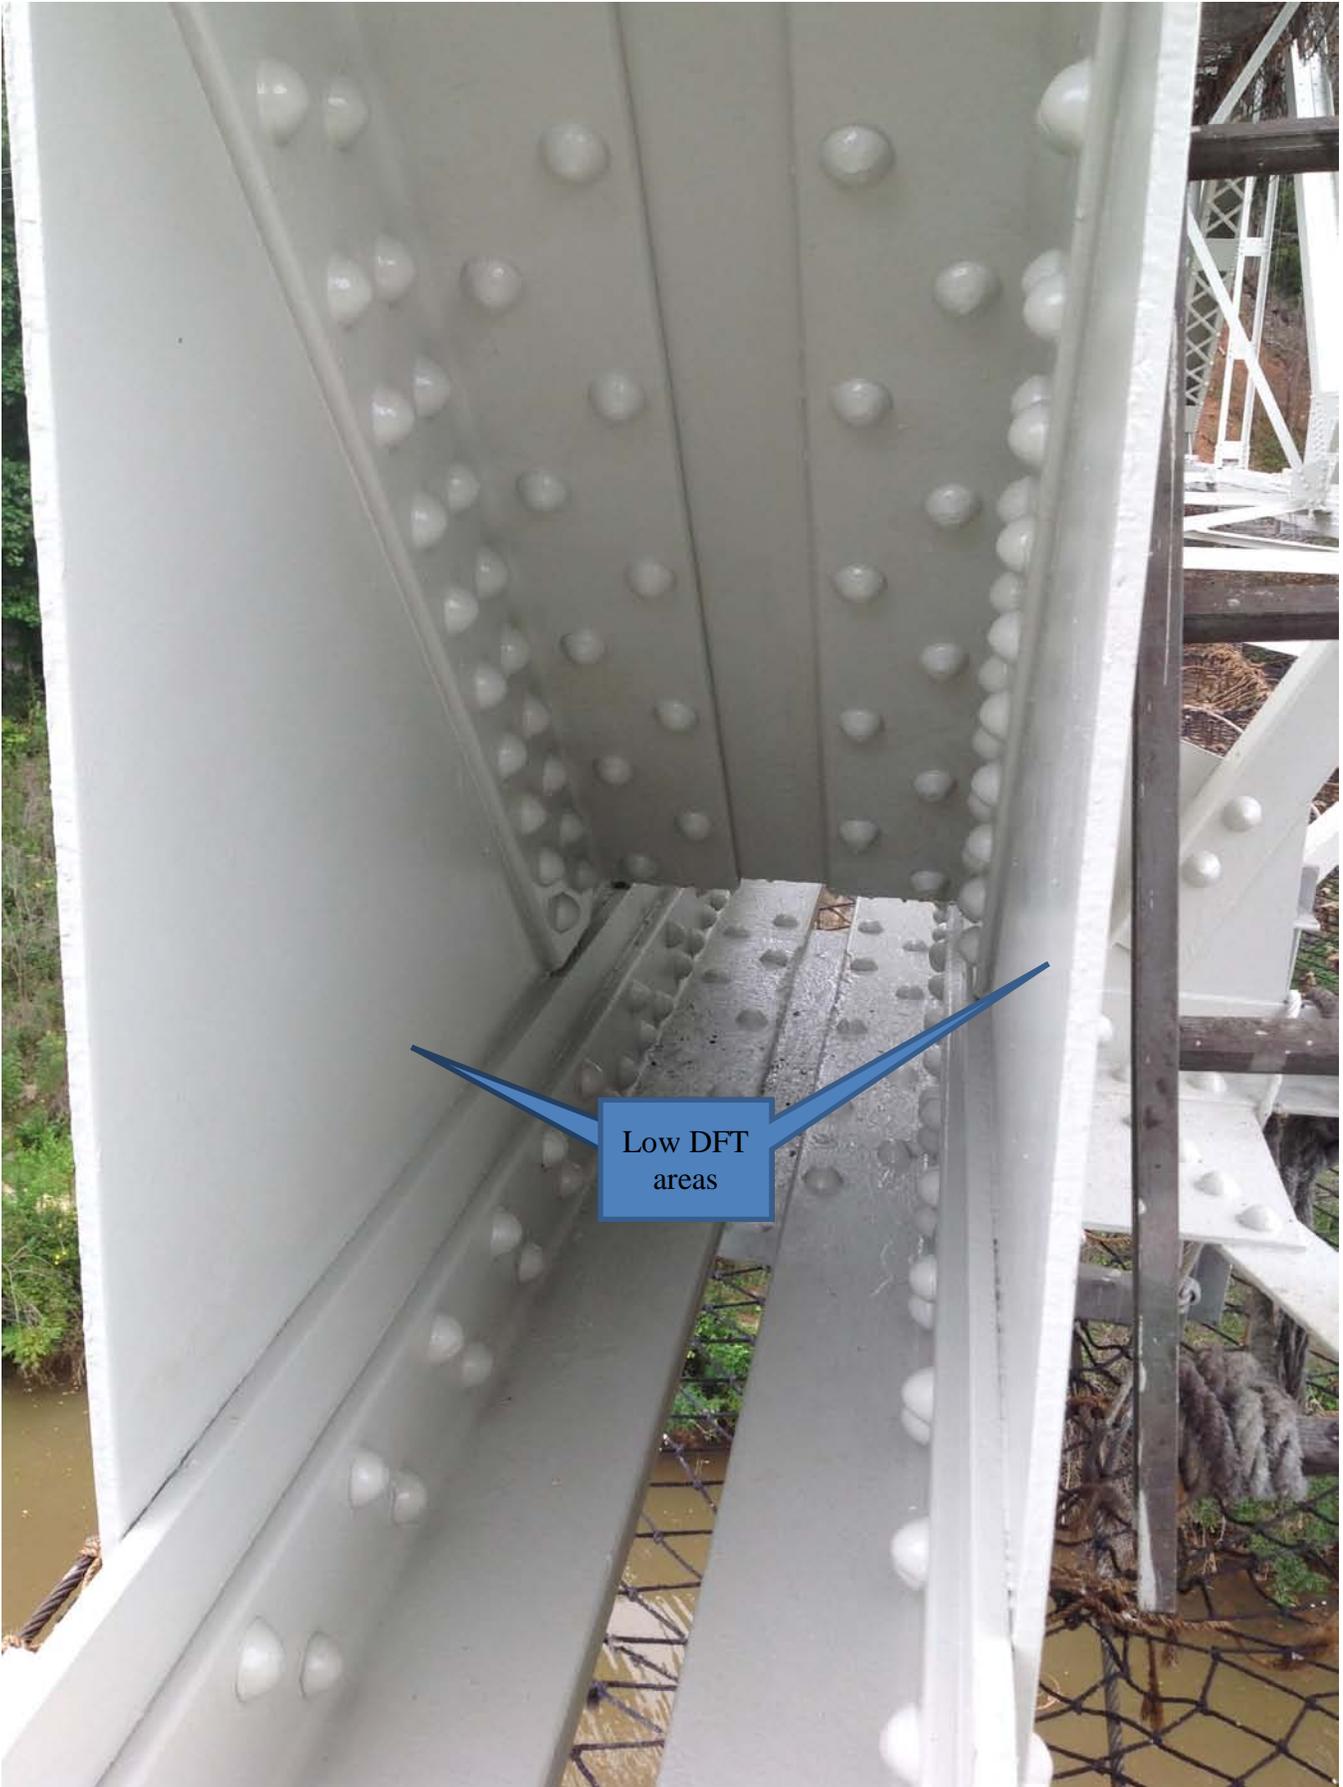
Picture #9

- a. Span 1 & Span 3
 - i. DFT areas that were below the 80% minimum on girder web panels, angle cross members and bottom of top flange members see picture #4, #5 & #6 respectively.
- b. Span 2
 - i. DFT areas that were below the 80% minimum on the inside of vertical chord members shown in picture #7, bottom of horizontal angle bracing shown in picture #8, inside sway bracing plates shown in picture #9 and vertical bracing angles as shown in picture #10.
- c. All Spans
 - i. Perform touch up on all areas where rigging was attached and or damage painted during containment assembly removal. All bare steel areas are to be cleaned touched up with a zinc rich paint and apply remaining top coats as needed see picture set #11.

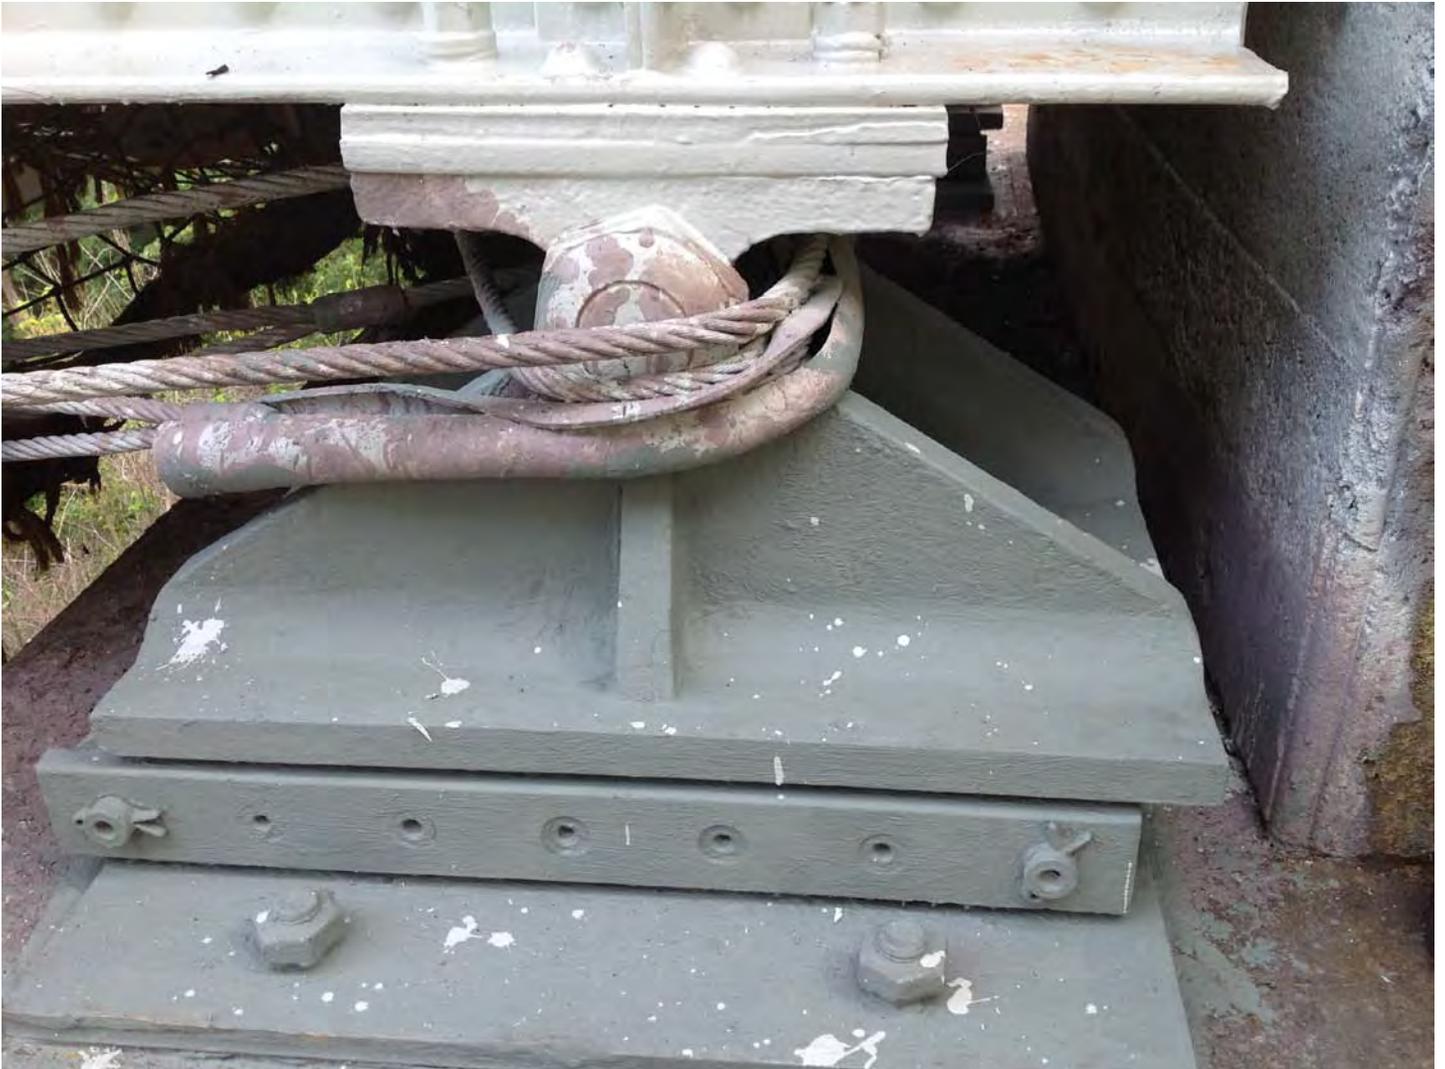
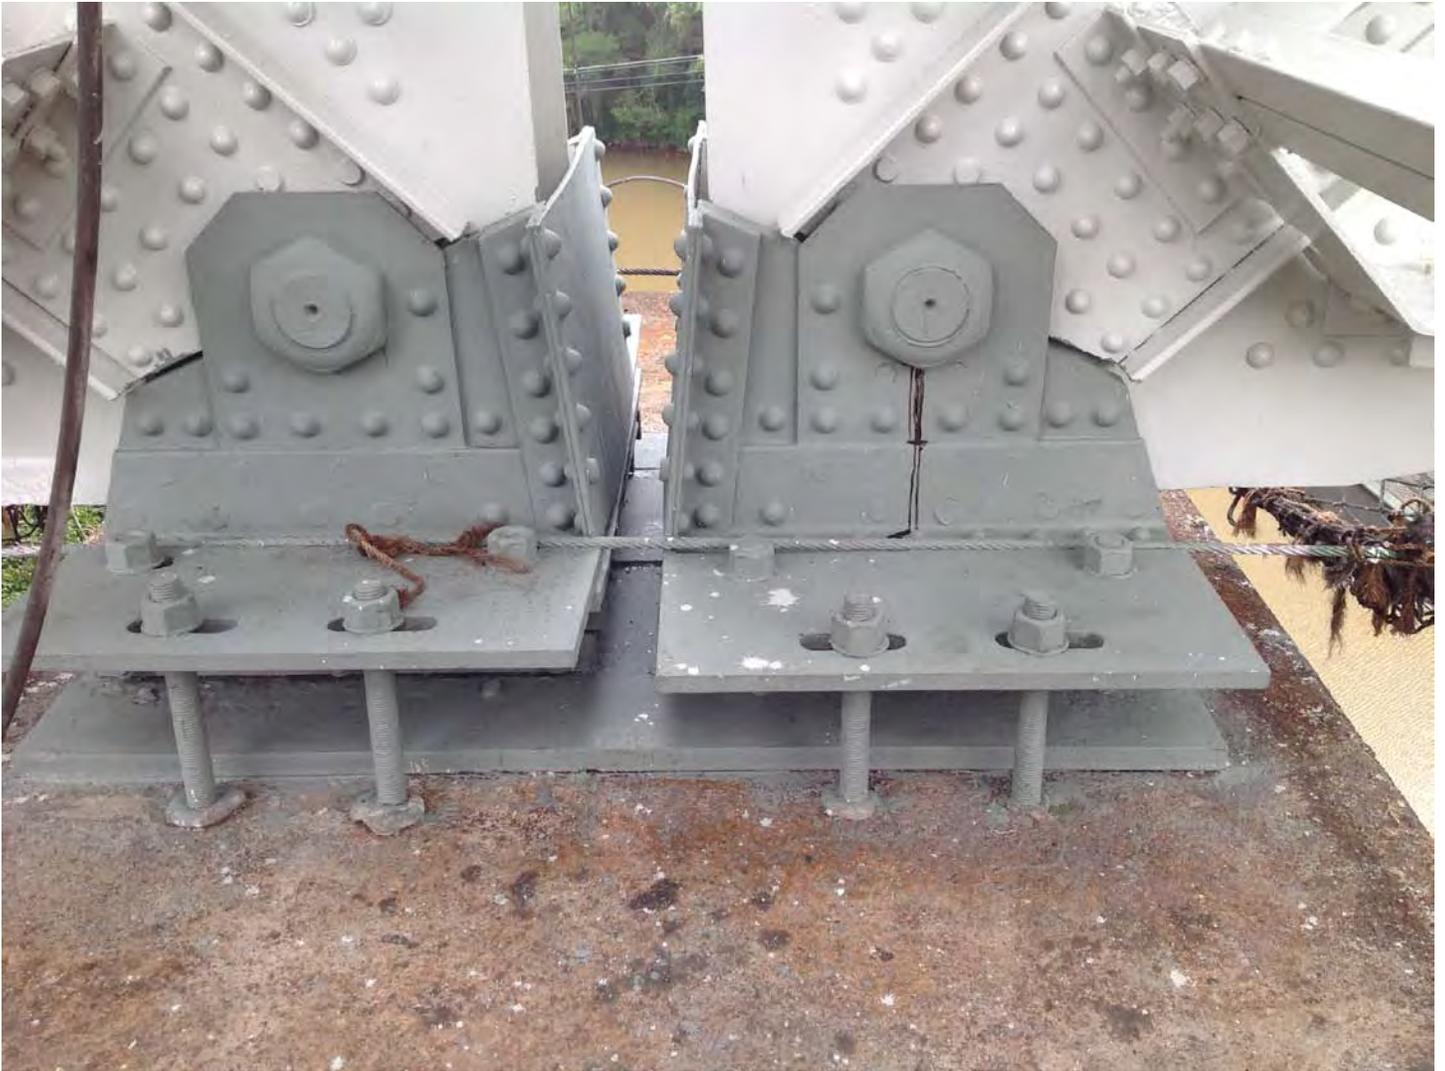
Picture Set #12

Typical touch up areas where containment attaches to the structure
