# *Ecusta Rail Trail Planning Study & Economic Impact Analysis*

March 2012

## *Rail Line Structural Assessment*

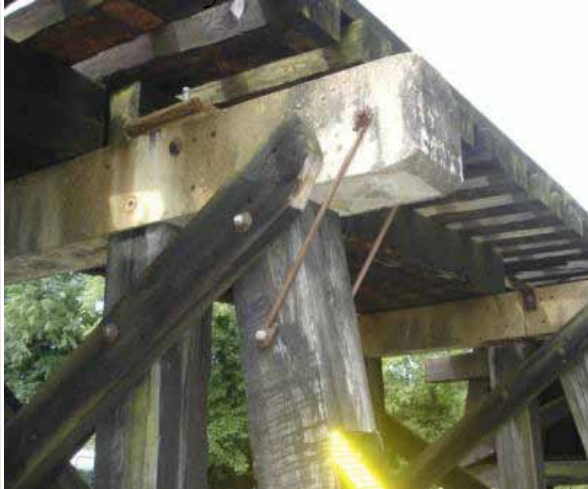
## Concrete Caps

**Substructure:** – Both back walls are in poor condition with signs of decay, deterioration, and severe weathering. There is minor undermining and detaching of wing walls. Timber caps are in satisfactory condition with top 1/2" deteriorated. Timber piles show no signs of deterioration and only minor weathering, but do show signs

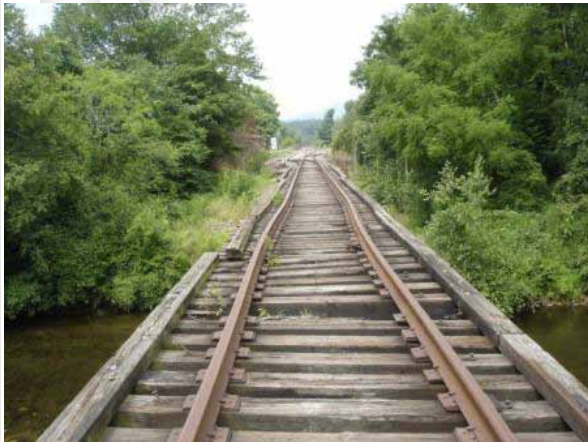
## East View

**Deck and Superstructure** – Ties are deteriorating and causing debris to accumulate along the girders and metal sheathing. Ties are also deflecting, causing shift in the overall alignment of the superstructure. Girders are in satisfactory condition with few areas of deterioration and minor weathering. Guard and running rails are deflecting, causing shift and detachment of the decking.

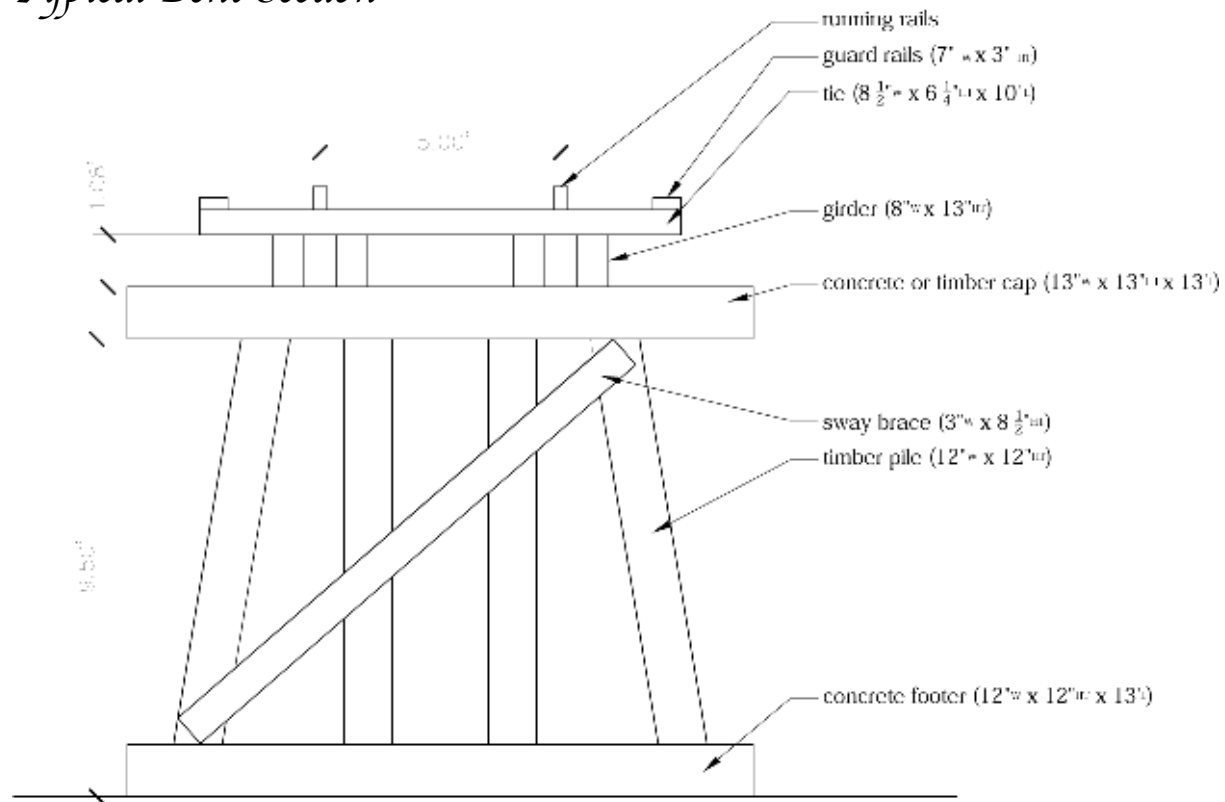
## Typical Bent Section

of deflecting. Metal sheathing shows signs of oxidation, resulting in severe corrosion. Wood shims show signs of severe deterioration. Substructure shows no signs of debris collection or vegetation growth. Sway braces show signs of minimal weathering and deterioration. Stone pile supports of river span show no signs of deflection or erosion. Metal bridge span shows surface rust, but no severe corrosion present.

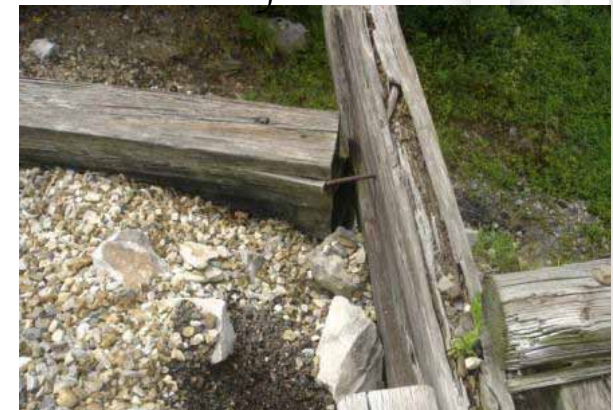
## Back Wall Deflection

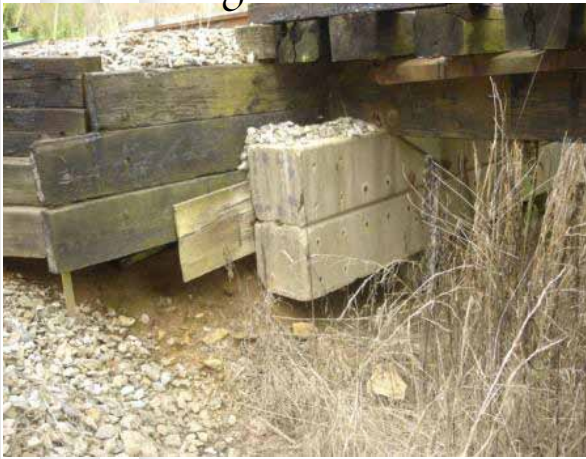
## Undermining at Back Wall

**Substructure –** Both back walls are in poor condition with signs of decay, deterioration and severe weathering. There is severe undermining and detaching of wing walls. Concrete caps are in satisfactory condition showing no visual signs of cracking. Timber piles show no signs of deterioration, only minor surface weathering. Wood shims show signs of severe deterioration. Substructure is collecting large amounts of debris

from upstream, resulting in severe sediment collection at all bents. Signs of frequent flooding are resulting in back wall and bent undermining.

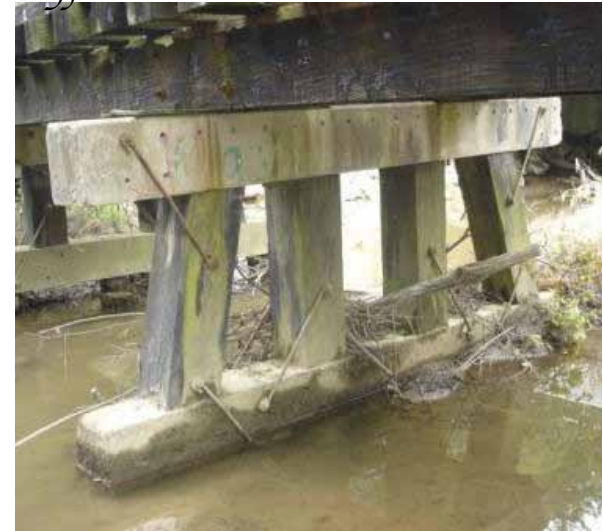
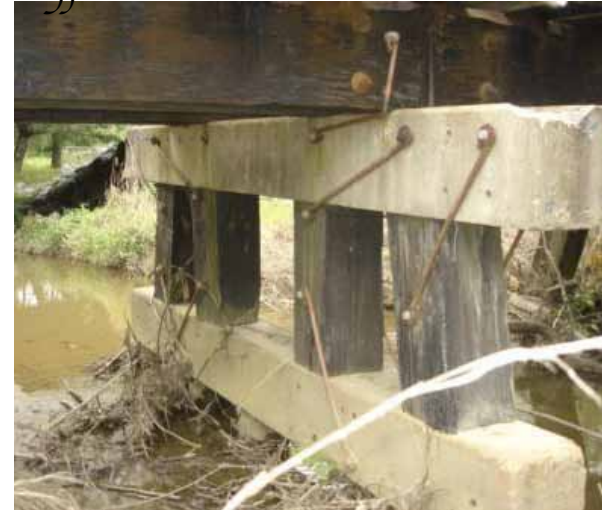
## Typical Bent

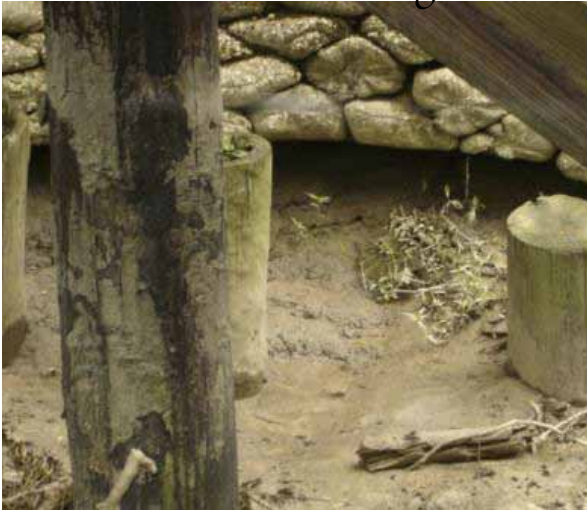
Substructure – Both back walls are in satisfactory condition, with minimal signs of deterioration and weathering. There is minor undermining and detachment of walls. North back wall constructed of concrete bags and timber ties.

## Back Wall Undermining

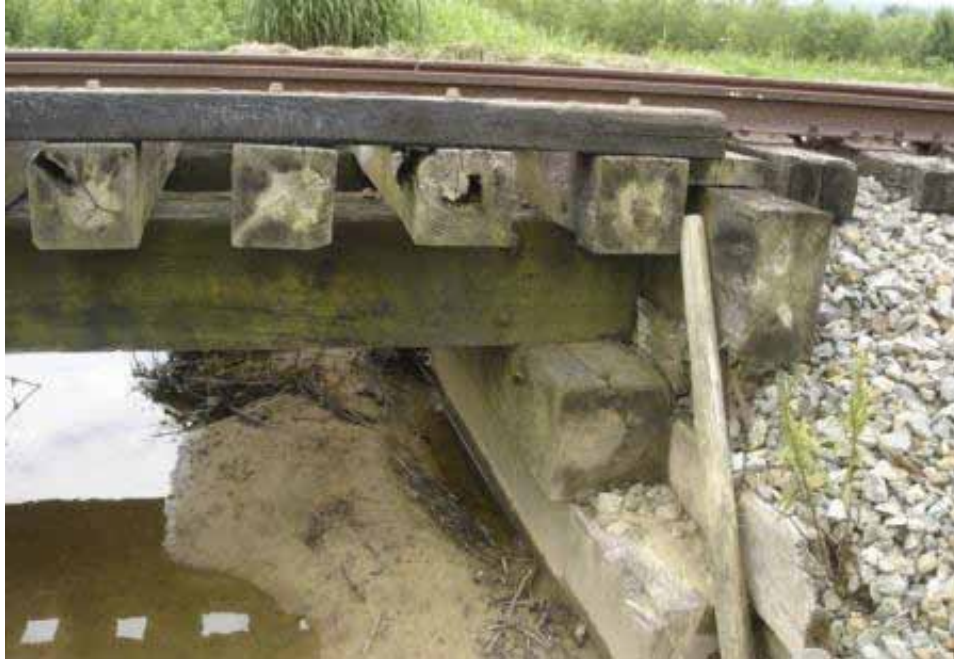
*South Back Wall*

Substructure – Both back walls are in satisfactory condition with minimal signs of deterioration and weathering. South wing deflecting into stream and is constructed of stacked concrete ties. Minor undermining and detachment of walls. Back walls constructed of timber ties. Timber piles show signs of deterioration and minor weathering. Wood shims show signs of minor deterioration. Substructure shows signs of debris collection.

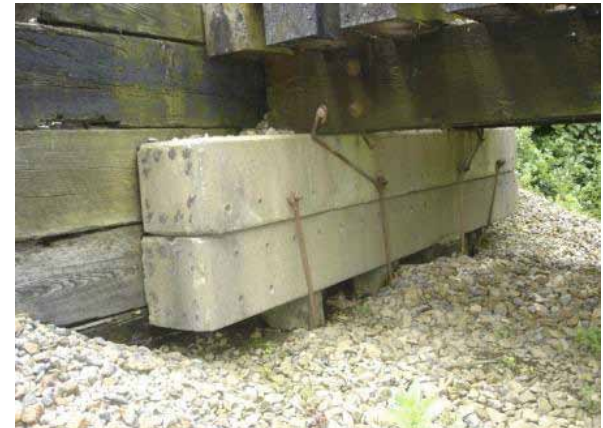
## South Back Wall

**Substructure** – Both back walls are in poor condition with signs of deterioration and weathering. Both back walls are further supported by stacked concrete ties. Minor undermining and detachment of walls are occurring as a result of frequent flooding. Back walls constructed of timber ties. Timber piles show signs of deterioration and weathering due to frequent flooding. Wood shims show signs of minor deterioration. Substructure shows signs of debris collection and significant vegetative growth.

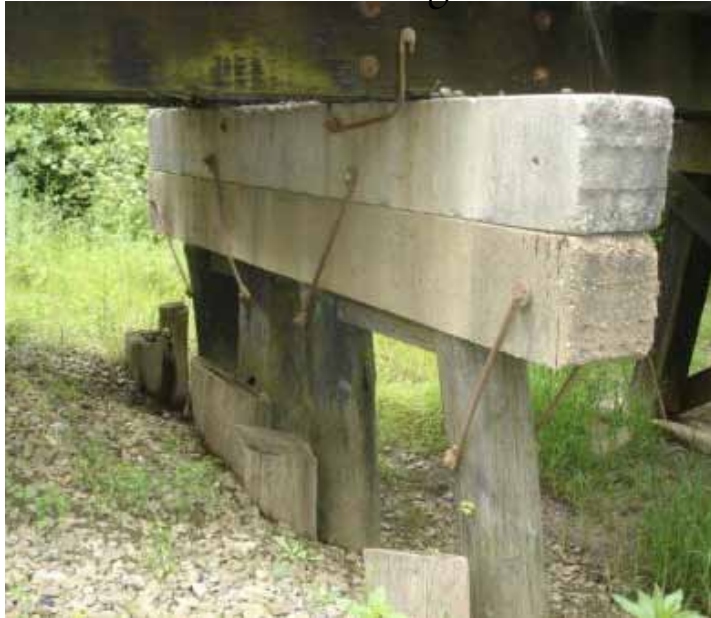
## Timber Pile Shims Along Bent

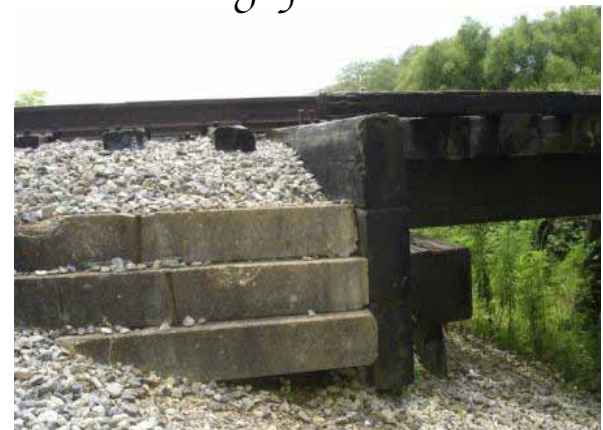
**Substructure** – Both back walls are in poor, with signs of deterioration and weathering. Both back walls are further supported by drilled timber piles. There is severe undermining and detachment of timber tie back walls.

*Undermining of South Back Wall*

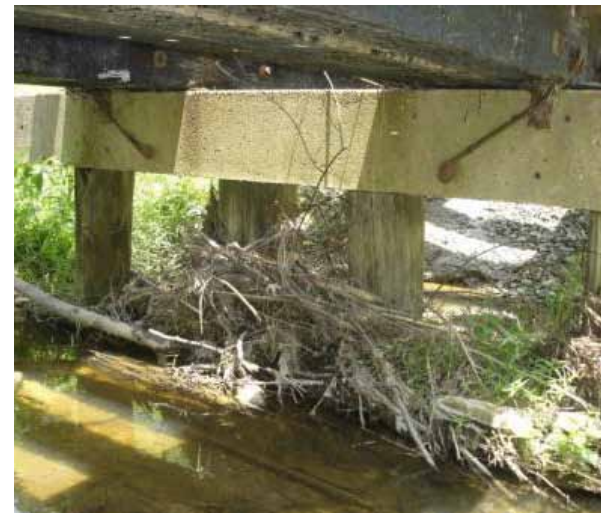
show signs of severe deterioration. Substructure shows significant signs of debris collection and vegetative growth due to frequent flooding.

## Debris Collection

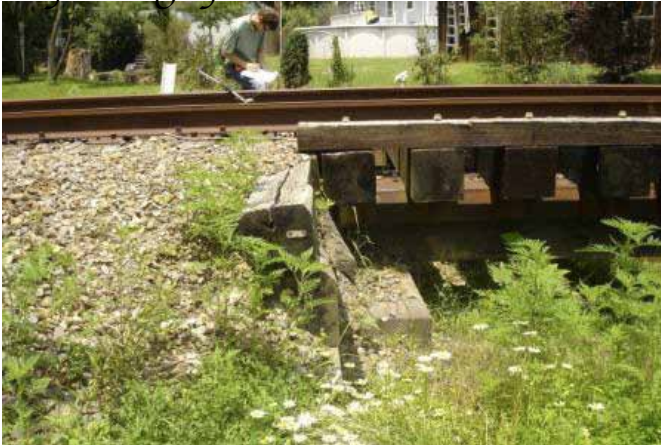
## Deflecting of Back Wall

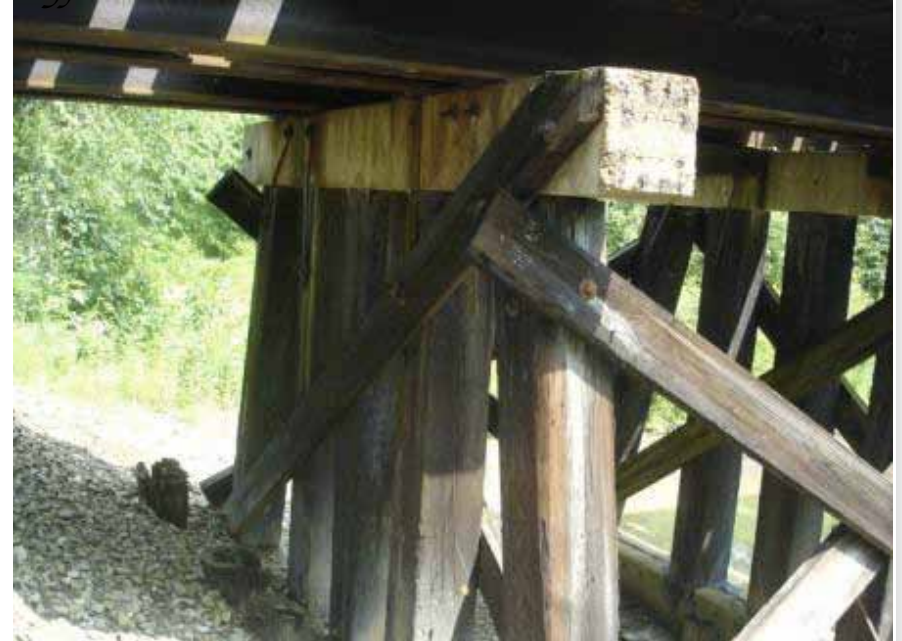
**Substructure** – Both back walls are in poor condition, with signs of decay, deterioration and severe weathering. There is minor undermining and detaching of wing walls. Timber caps are in satisfactory condition, with top 1/2" deteriorated. Timber piles show no signs of deterioration and only minor weathering, but do show signs

*Typical Bent Cross Brace*

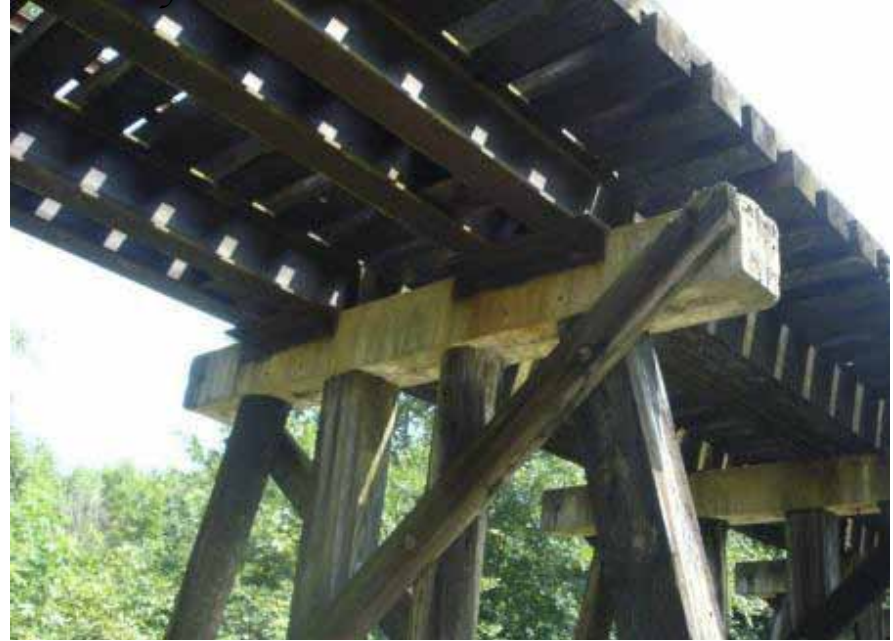
of deflecting. Metal sheathing showing signs of oxidation, resulting in severe corrosion. Wood shims show signs of severe deterioration. Substructure shows no signs of debris collection or vegetation growth. Sway braces show signs of minimal weathering and deterioration. Stone pile supports of river span show no signs of deflection and minimal erosion. Metal bridge span shows surface rust, but no severe corrosion present.

*Steel Bridge Foundation*

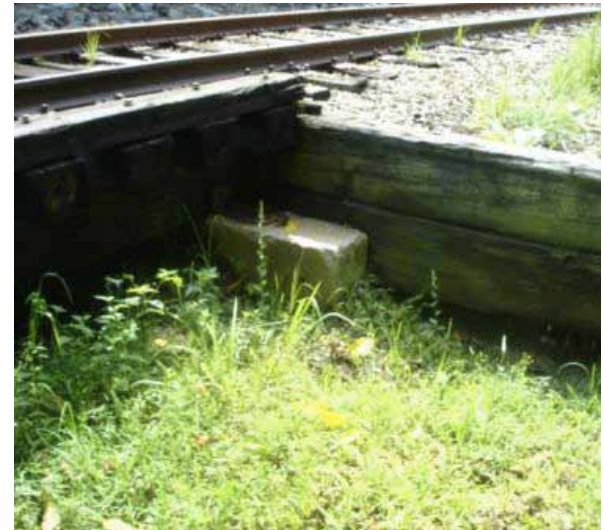
*Typical Bent*

**Substructure** – Both back walls are in satisfactory condition, with minor signs of decay, deterioration and weathering. There is minor undermining of wing walls. Concrete caps are in satisfactory condition, with no signs of cracking. Wood shims show minor signs of deterioration. Substructure shows no signs of debris collection, but does show wetland vegetative growth. Sediment and undermining is caused by frequent flooding.

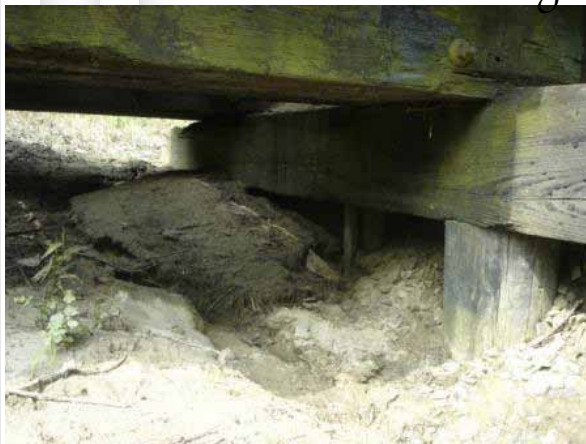
Sediment and undermining of timber piles and back walls is caused by frequent flooding.

## Sediment Build-up

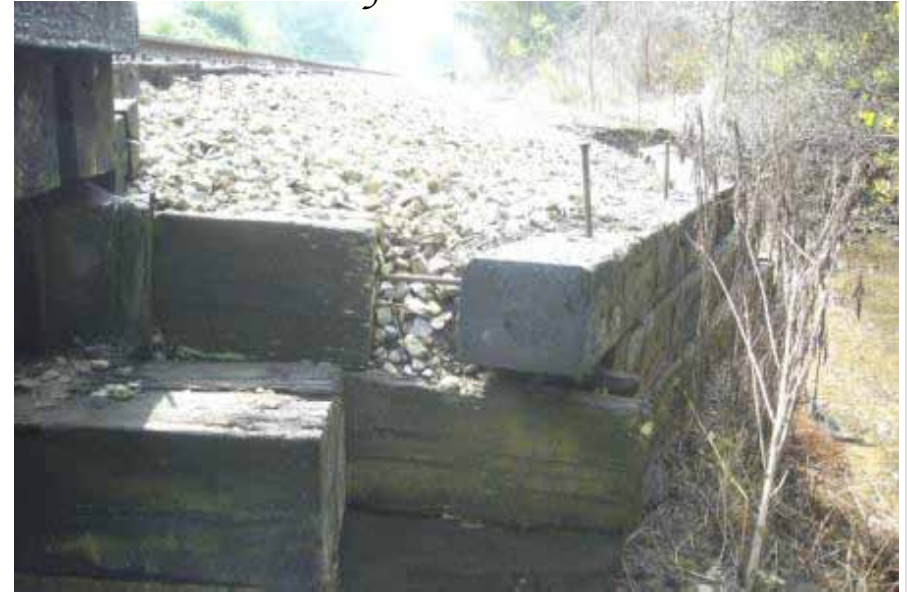
**Substructure** – Both back walls are in poor condition, with significant signs of decay, deterioration and weathering. There is severe undermining of both north and south back walls and wing walls. Timber piles show significant signs of deterioration and hollowing. Concrete caps are in satisfactory condition, with no signs of cracking. Wood shims show minor signs of deterioration. Substructure shows no signs of debris collection but does show wetland vegetative growth.

*Typical Bent Section*

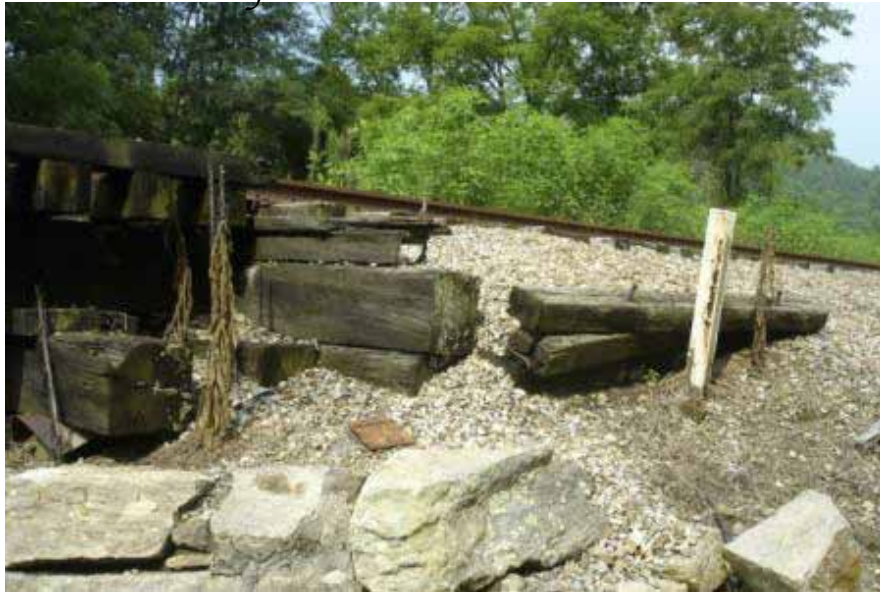
**Substructure** – Both back walls are in poor condition, with significant signs of decay, deterioration and weathering. There is severe undermining and deflection of both north and south back walls and wing walls. Sediment and undermining of stone foundation and back walls is caused by frequent flooding.

*South Back Wall Deflection*

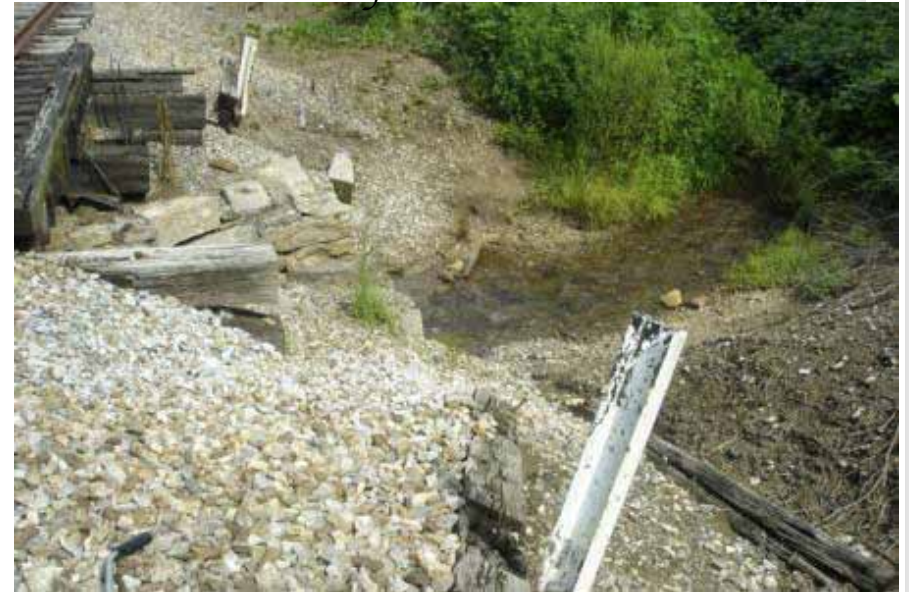
*North Back Wall Undermining*

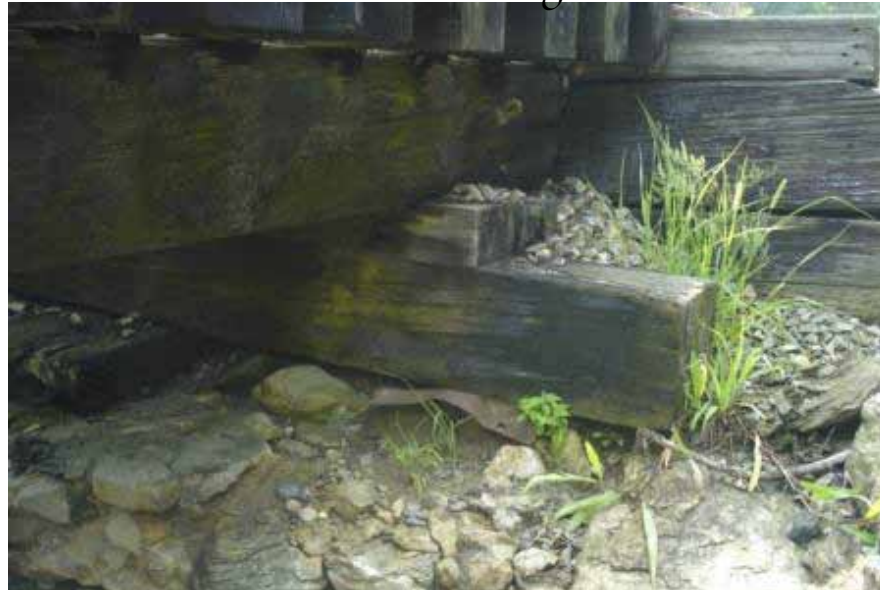
*Severe Erosion*

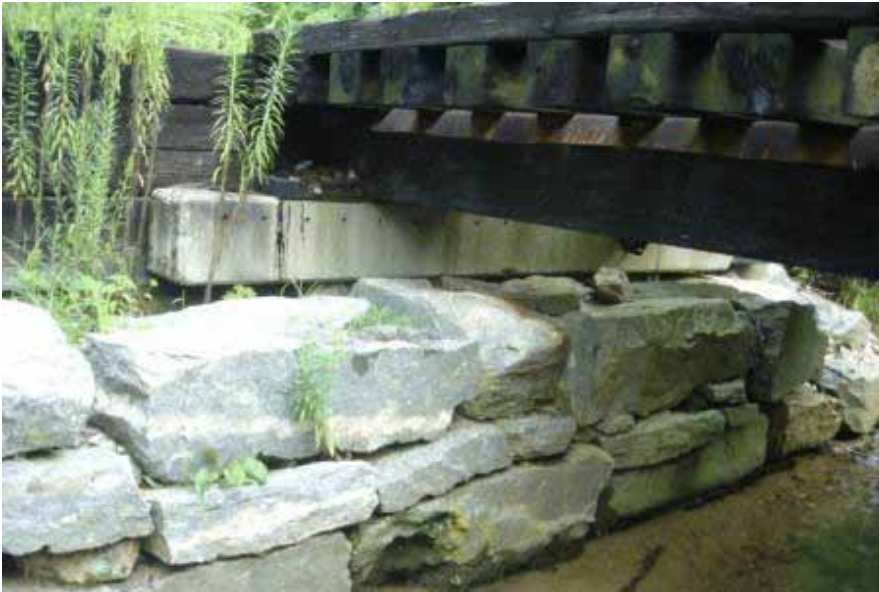
*South Back Wall*

**Substructure** – Both back walls are in poor condition, with significant signs of decay, deterioration and weathering. There is severe undermining and deflection of both north and south back walls and wing walls. Sediment and undermining of stone foundation and back walls is caused by frequent flooding.

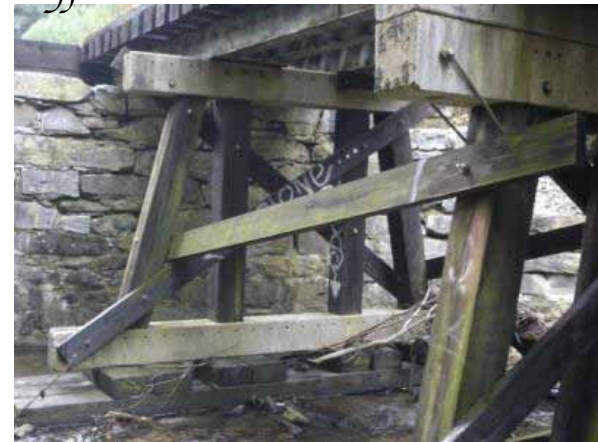
**Substructure** – Both back walls are in fair condition, with minor signs of deterioration and weathering. There is minor undermining and detaching of walls. Timber piles show signs of deterioration and minor weathering. Substructure shows significant signs of debris collection and vegetative growth due to frequent flooding. Stacked stone wall at edge of water shows signs of mortar cracking, undermining, and deflecting.

*South Back Wall Undermining*

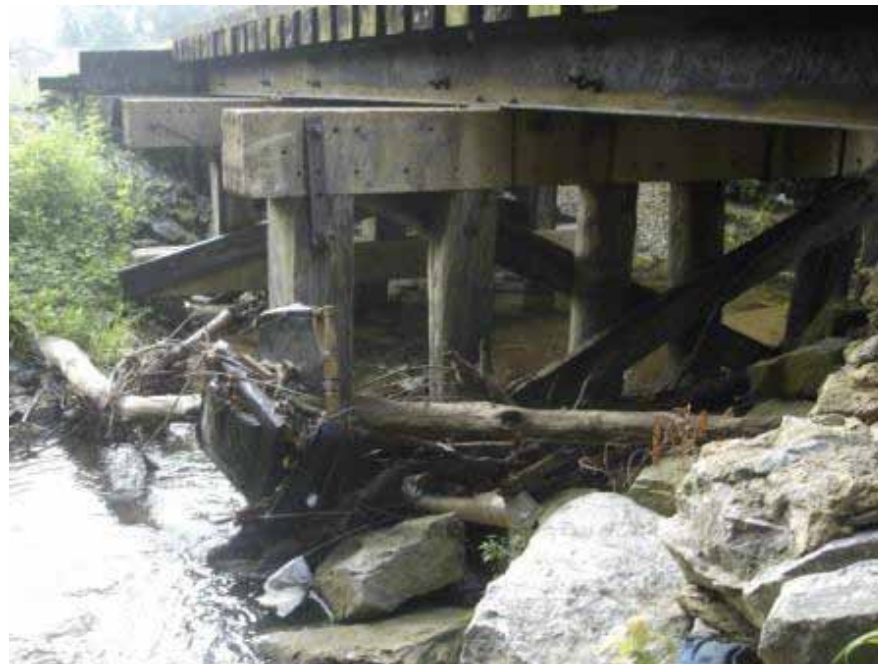
Wood shims show signs of severe deterioration. Substructure shows significant signs of debris collection and vegetative growth due to frequent flooding.

*Debris Collection*
