NC DEPARTMENT OF TRANSPORTATION  
DIVISION OF HIGHWAYS  
STRUCTURE MANAGEMENT UNIT  
COUNTY: RUTHERFORD DIV: 13

## Structure Safety Inspection Report

BRIDGE NUMBER: 800239 BRIDGE NAME: \_\_\_\_\_ PREVIOUS BRIDGE NUMBER: \_\_\_\_\_

LATITUDE: 35.48940000 LONGITUDE: -81.99338000 ROUTE: SR1325 M.P.: 0.0

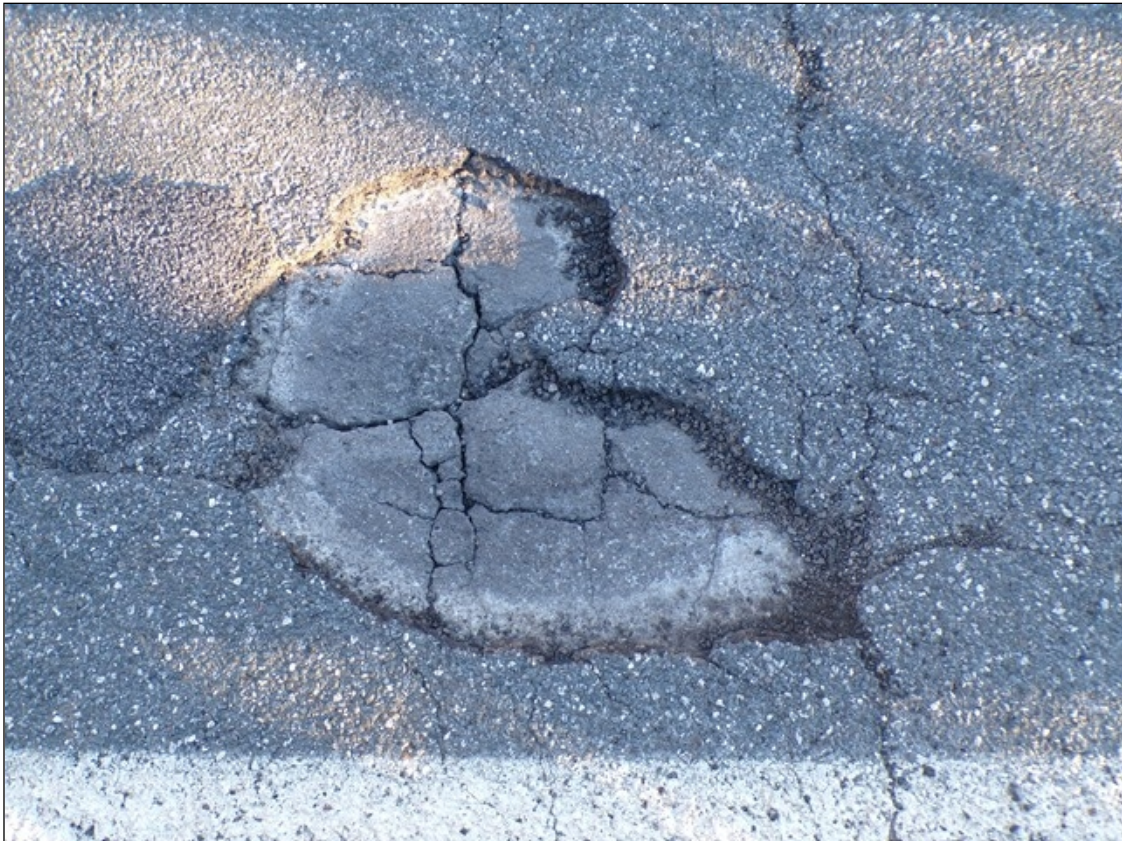
SPAN 1 Wearing Surface: 32 INCH X 27 INCH X 1 INCH DEEP AREA OF MISSING ASPHALT WEARING SURFACE  
IN RIGHT LANE, 2 FEET FROM BENT 1 (PAR)

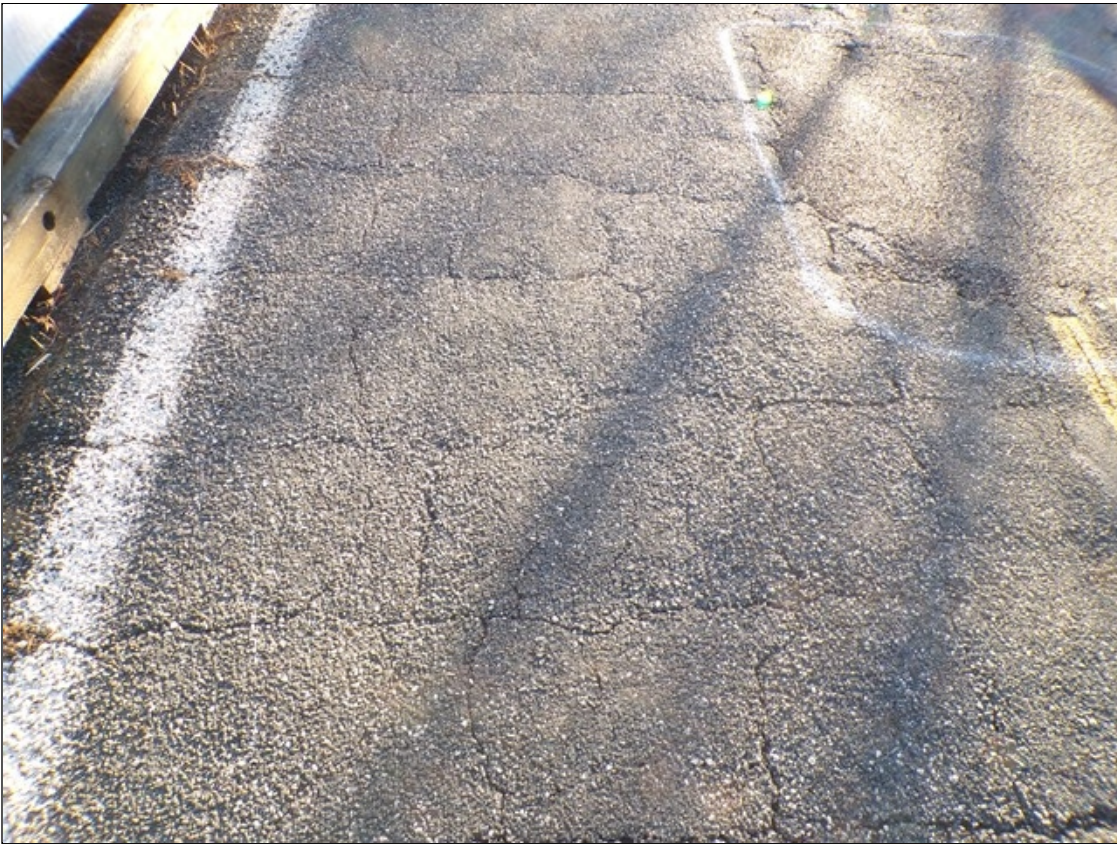
Span 1 Wearing Surface: TRANSVERSE AND LONGITUDINAL CRACKING (UP TO 1/16 INCH WIDE X FULL WIDTH) SCATTERED THROUGHOUT

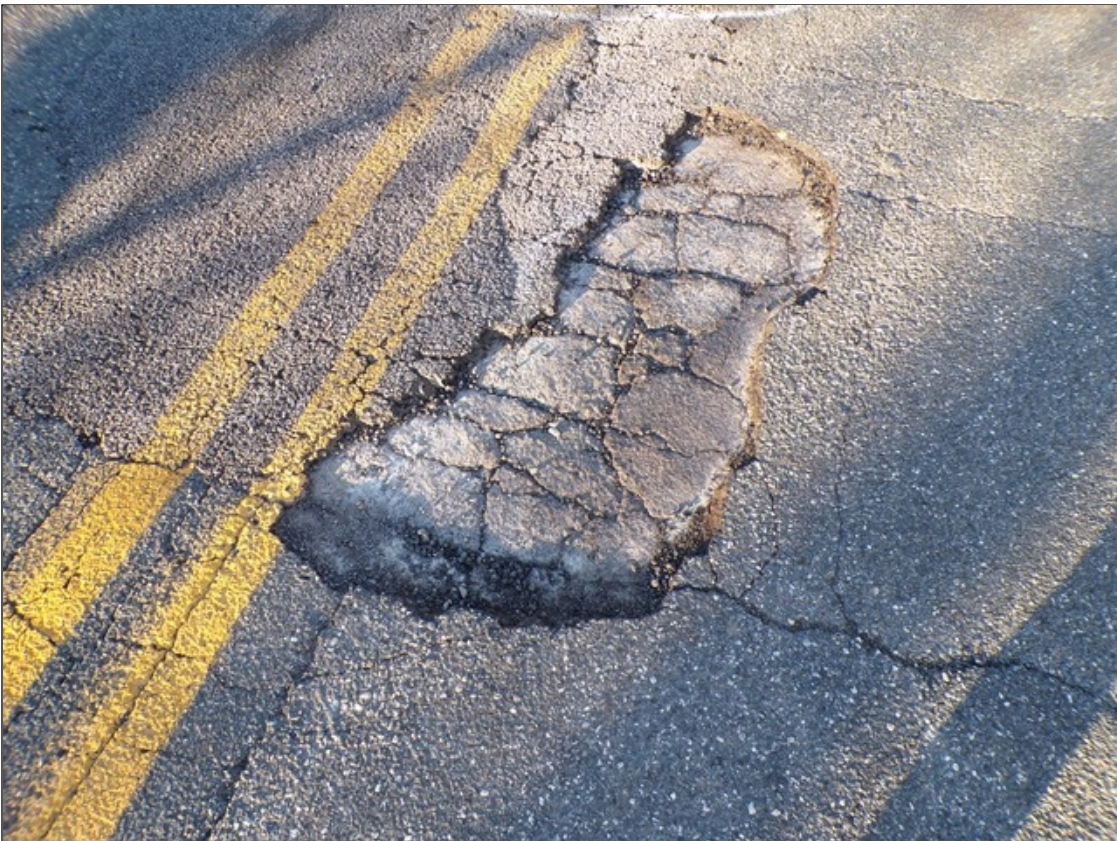
Span 1 Wearing Surface: 63 INCH X 28 INCH X 1 1/2 INCH DEEP AREA OF MISSING ASPHALT WEARING SURFACE IN WESTBOUND LANE, 5 FEET FROM BENT 1 (PAR)

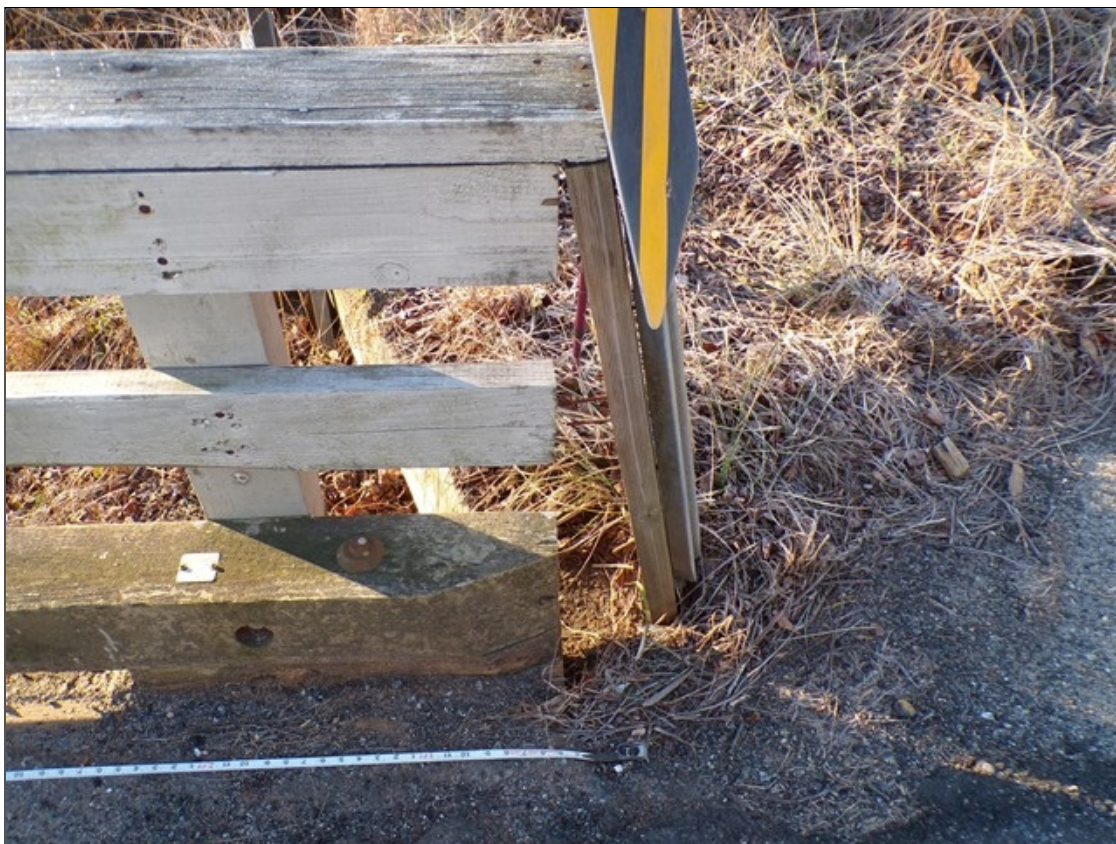
SPAN 1 Right Bridge Rail: DETACHED END POST (PAR)

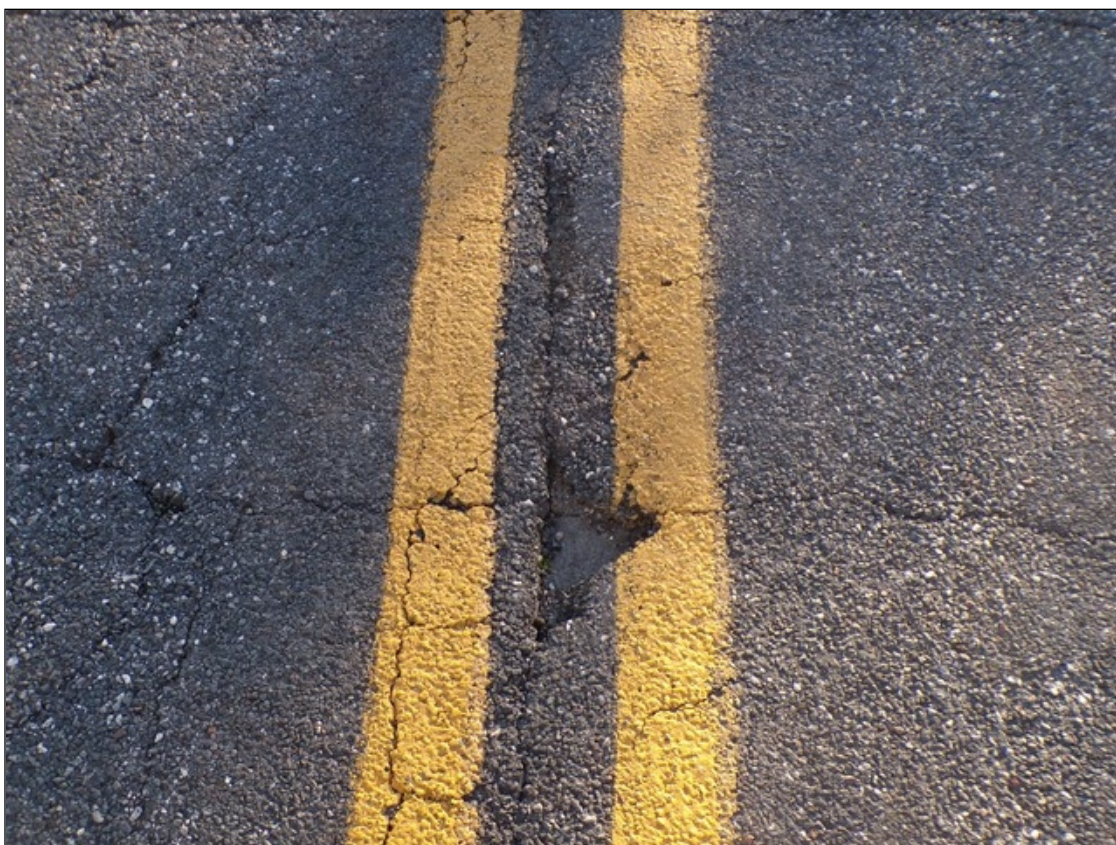
Span 3 Wearing Surface: CENTER OF ROADWAY AT MIDSPAN, SPALL (6 INCH LONG X 3 INCH WIDE X 1 INCH DEEP)

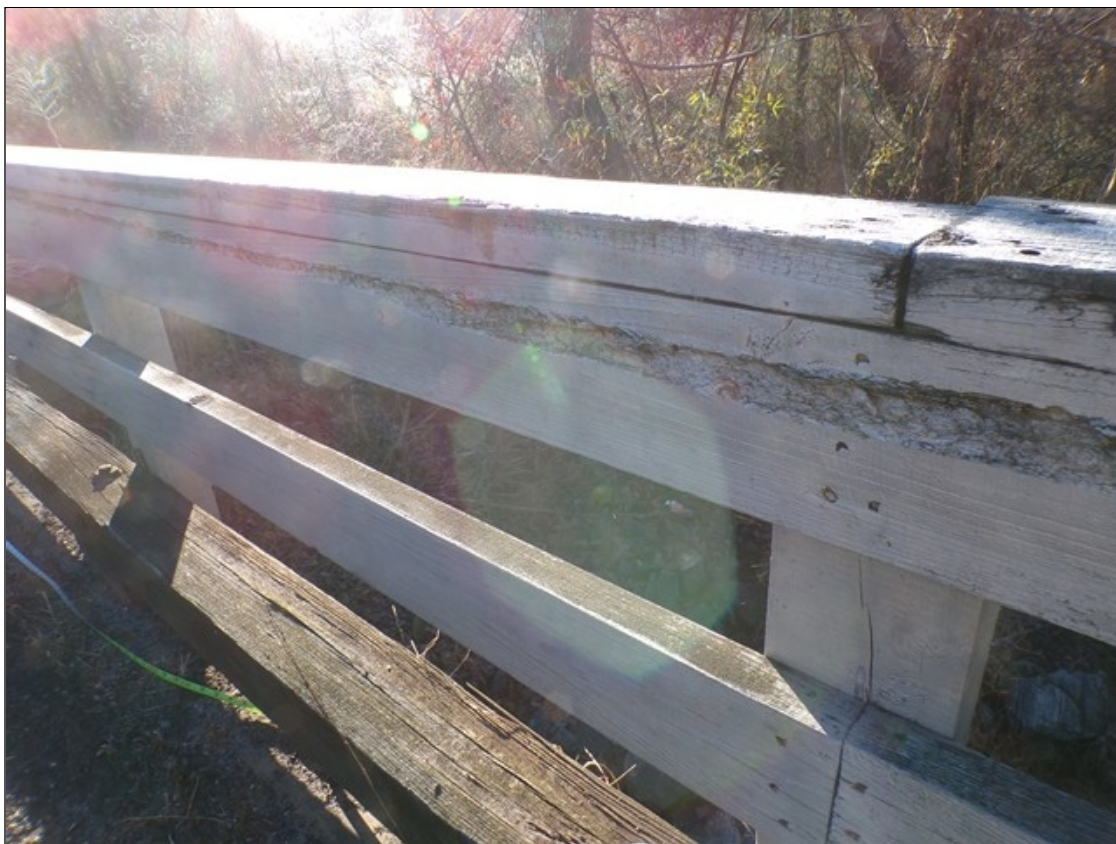
Span 3 Right Bridge Rail: GOUGE (25 FEET LONG X 2 INCH WIDE X 1/4 INCH DEEP) TO INSIDE TOP BOARD STARTING AT NEAR END

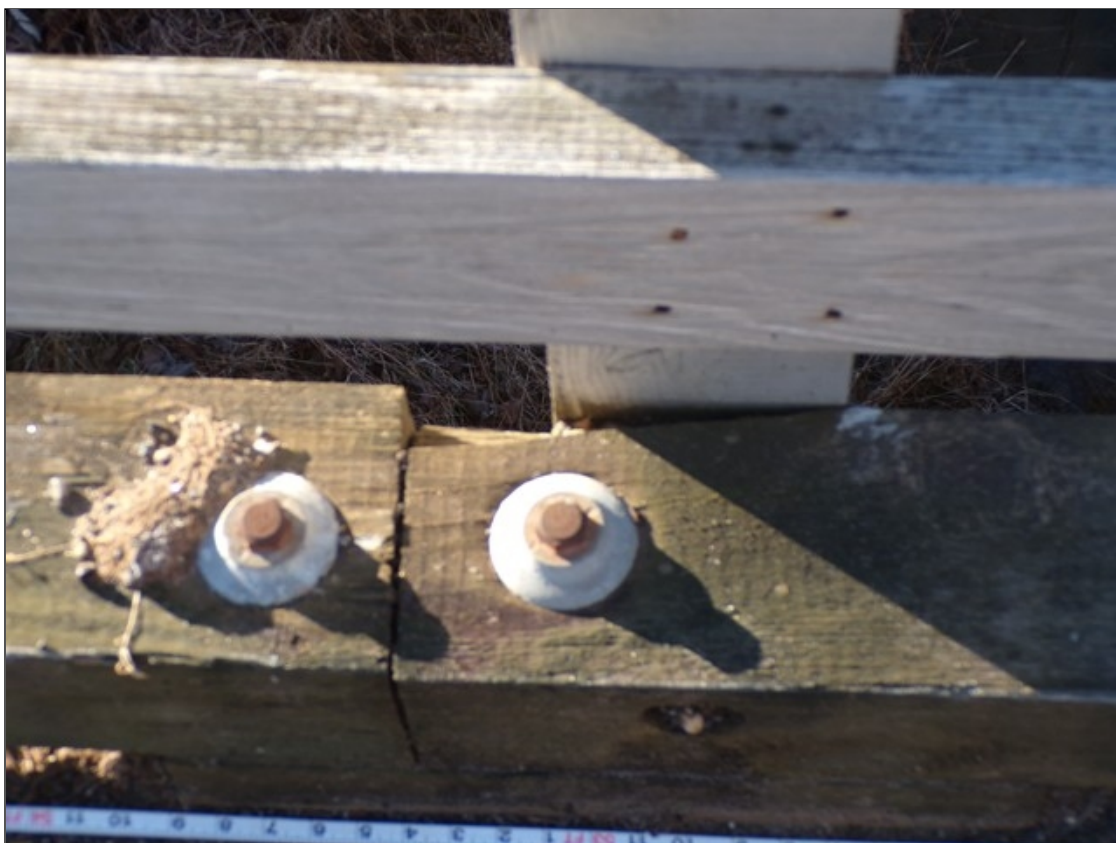
Span 3 Right Bridge Rail: TOP OF CURB RAIL, LOCATED AT BENT 2, UP TO 9 INCH LONG X 1 INCH WIDE X 1 INCH DEEP AREA OF SECTION LOSS

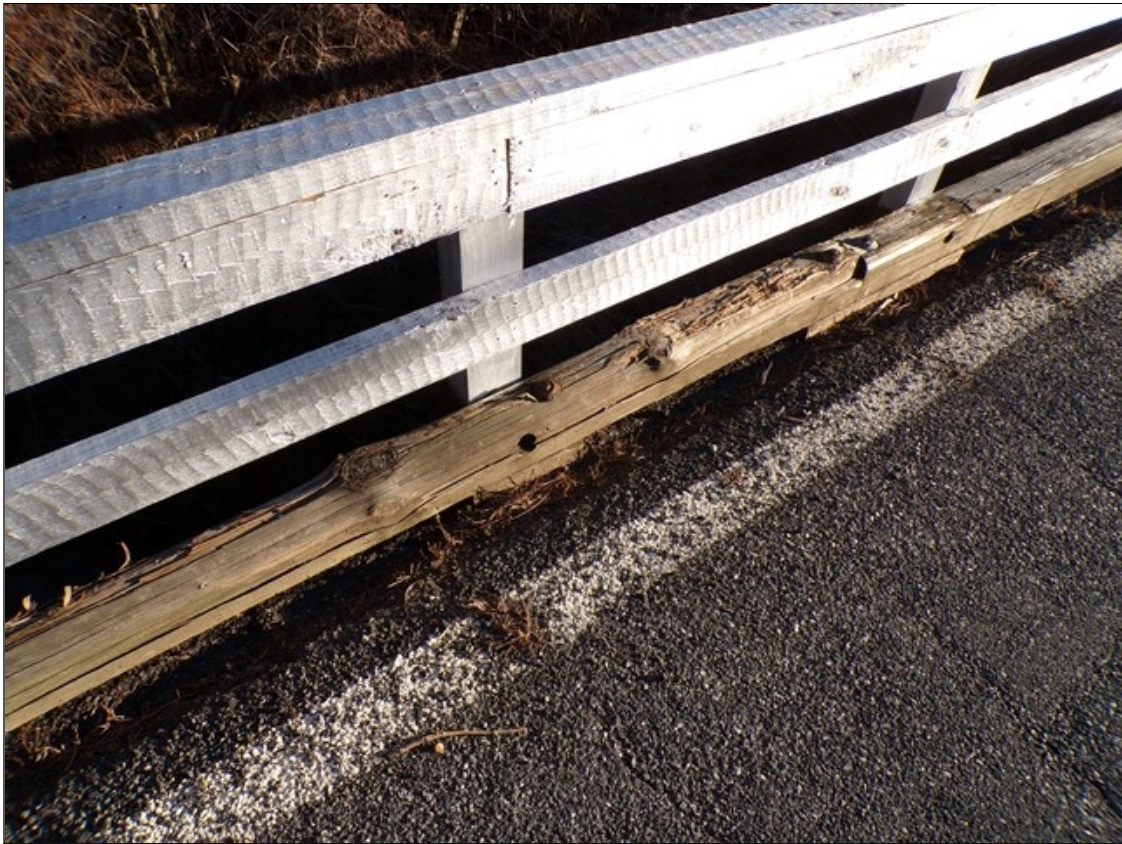
Span 2 Left Bridge Rail: WANE (21 FEET LONG X 3 INCH WIDE X 1 INCH DEEP) TO CURB

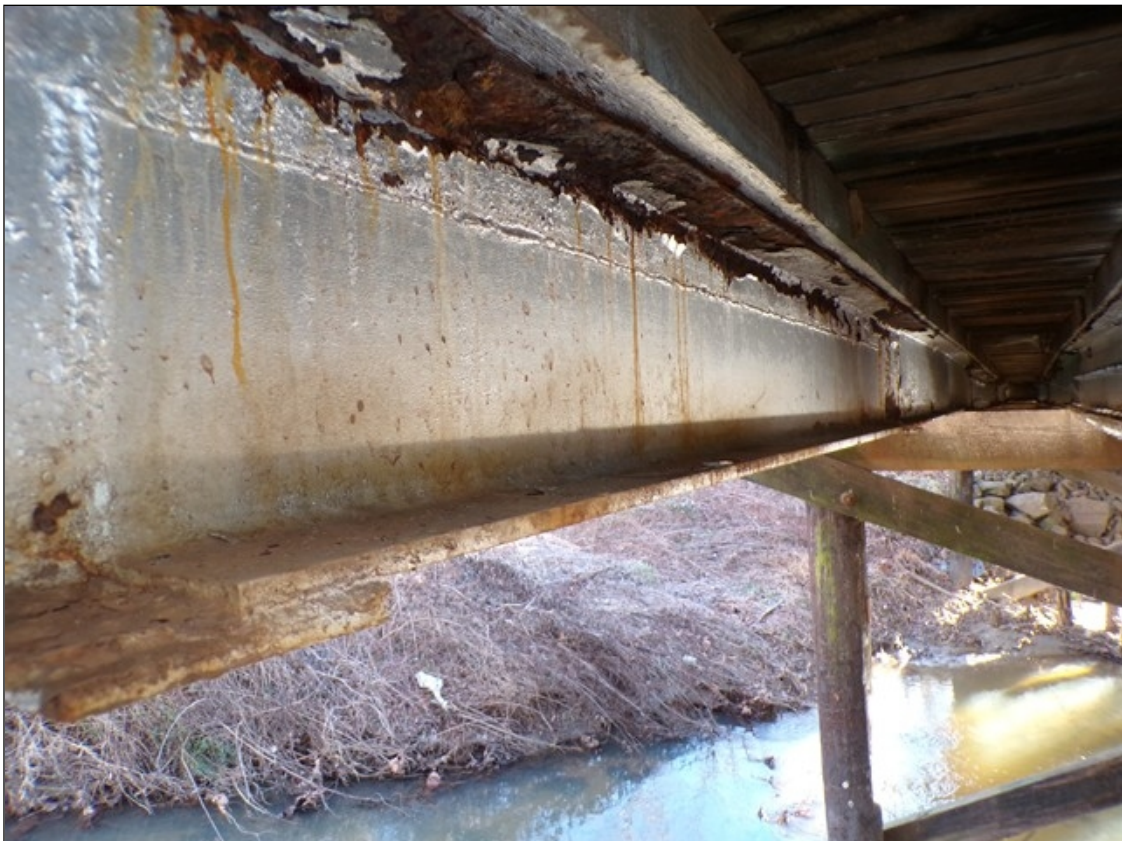
SPAN 1 BEAM 2: REPAIR PLATES: 10 FEET FROM NEAR END, BOTTOM FLANGE (6 FEET X 7 INCH X 7 INCH X 1/2 INCH THICK) WEB (6 FEET X 7 INCH X 1/4 INCH THICK)

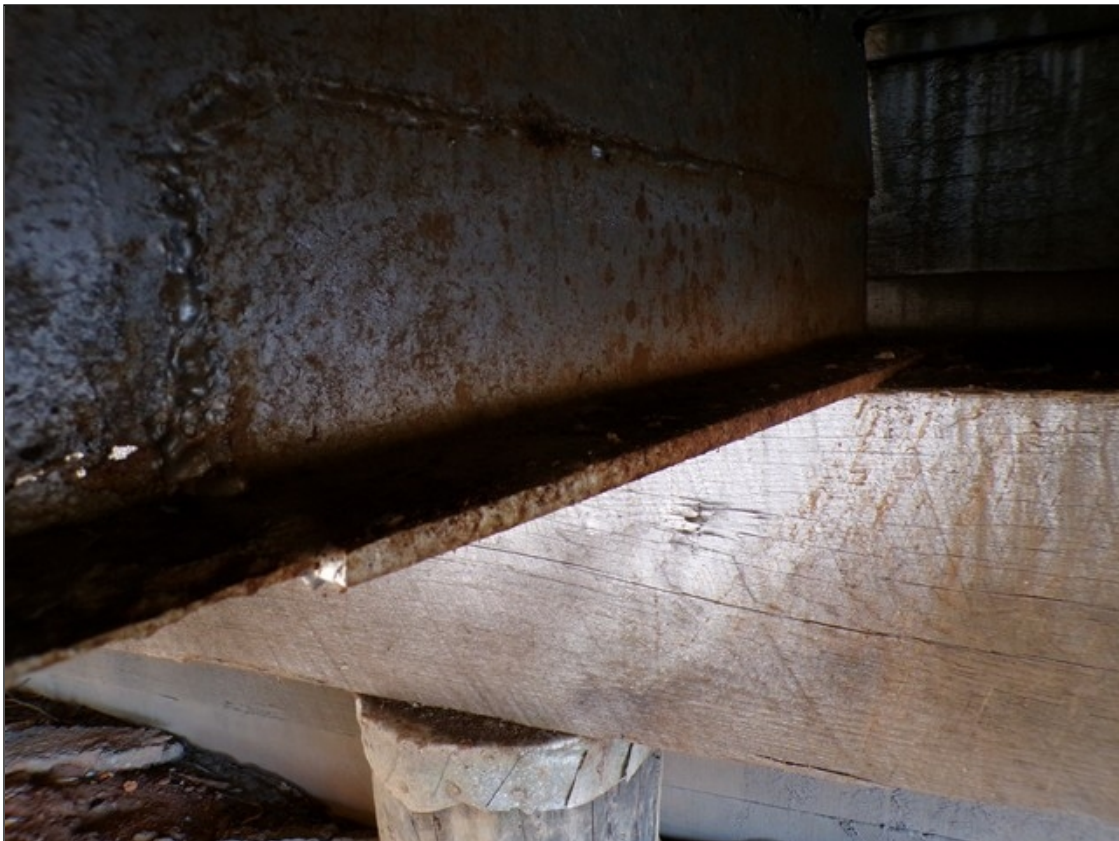
SPAN 1 BEAM 5: 25 INCH REPLACED BOTTOM FLANGE AND WEB BEAM SECTION AT END BENT 1

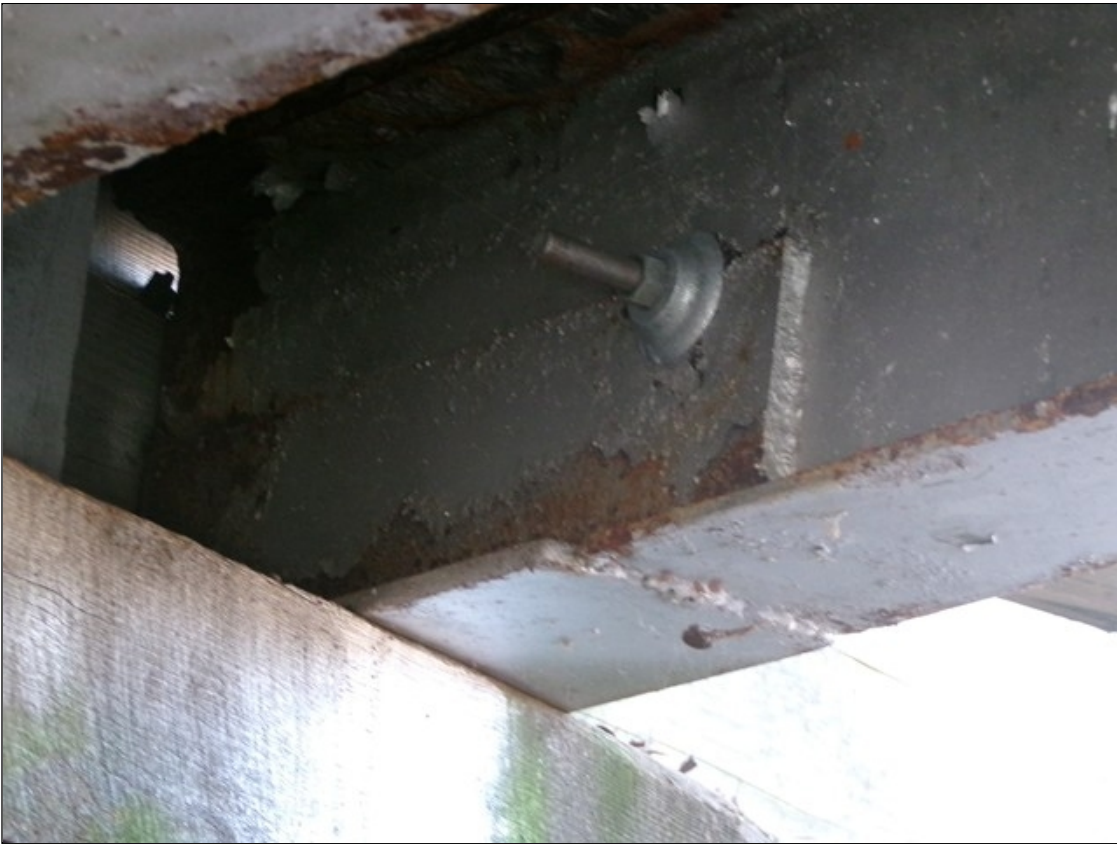
SPAN 1 BEAM 1: (REPAIRED PRIOR TO 2021 INSPECTION) REPAIR PLATES TO BOTTOM FLANGE, (7 INCH X 1/2 INCH THICK), AND WEB, (6 INCH X 22 INCH X 1/2 INCH, (BOTH SIDES)

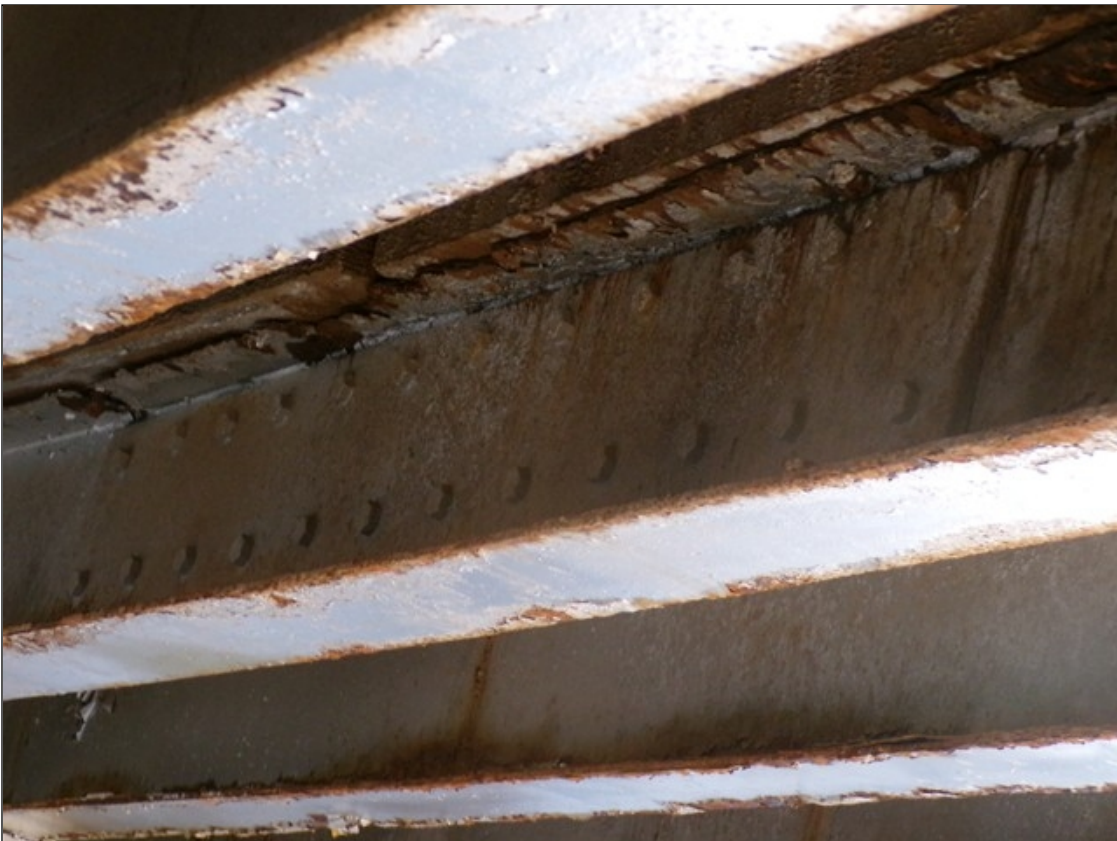
SPAN 1 BEAM 7: WEB, 12 FEET FROM END BENT 1, REPAIR PLATE ON BOTH SIDES, 6 FEET X 10 INCH X 1/2 INCH. REPAIR PLATES ADDED TO WEB BUCKLING LOCATION

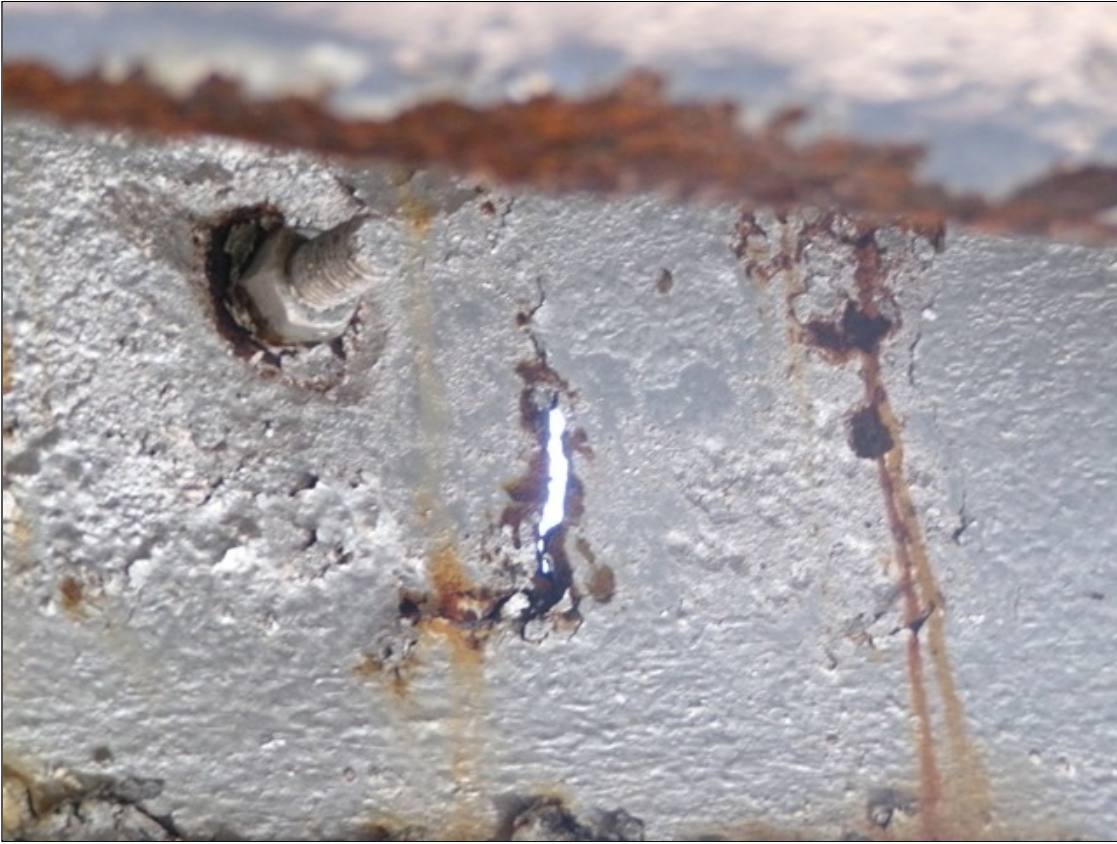
| 2 | Corrosion | 26 | SPAN 1 Beam 1: (PAR) TAPERED CORROSION WITH SECTION LOSS TO TOP FLANGE (WITH AREAS OF UP TO 100% SECTION LOSS) DOWN TO 1/8 INCH AVERAGE THICKNESS REMAINING AT EDGE FOR FULL WIDTH X FULL LENGTH AND WEB SECTION LOSS (DOWN TO 1/16 INCH THICKNESS REMAINING) TO BOTH SIDES, FOR (2) UP TO 3 INCH HIGH X UP TO 5 INCH LONG WITH 1 1/4 INCH X 3/4 INCH AREA OF 100% SECTION LOSS |

Span 1 Beam 1: (PAR) TAPERED CORROSION WITH SECTION LOSS TO TOP FLANGE (WITH AREAS OF UP TO 100% SECTION LOSS) DOWN TO 1/8 INCH AVERAGE THICKNESS REMAINING AT EDGE FOR FULL WIDTH X FULL LENGTH AND WEB SECTION LOSS (DOWN TO 1/16 INCH THICKNESS REMAINING) TO BOTH SIDES, FOR (2) UP TO 3 INCH HIGH X UP TO 5 INCH LONG WITH 1 1/4 INCH X 3/4 INCH AREA OF 100% SECTION LOSS

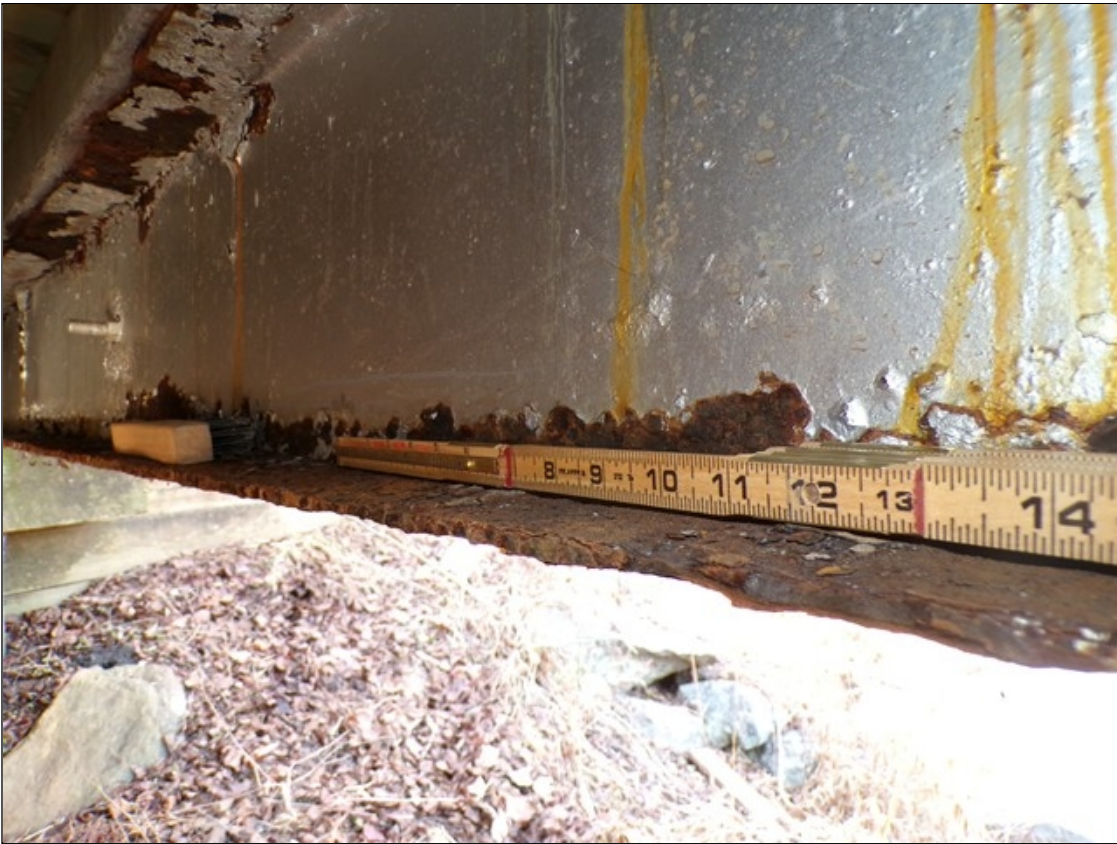
| 2 | Corrosion | 26 | SPAN 1 Beam 1: BOTTOM FLANGE SECTION LOSS (DOWN TO 3/16 INCH SECTION REMAINING) TO BOTH SIDES, 3 INCH WIDE X FULL LENGTH AND LOWER WEB SCALING WITH 1/32 INCH SECTION LOSS (PAR) |

Span 1 Beam 1: BOTTOM FLANGE SECTION LOSS (DOWN TO 3/16 INCH SECTION REMAINING) TO BOTH SIDES, 3 INCH WIDE X FULL LENGTH AND LOWER WEB SCALING WITH 1/32 INCH SECTION LOSS (PAR)

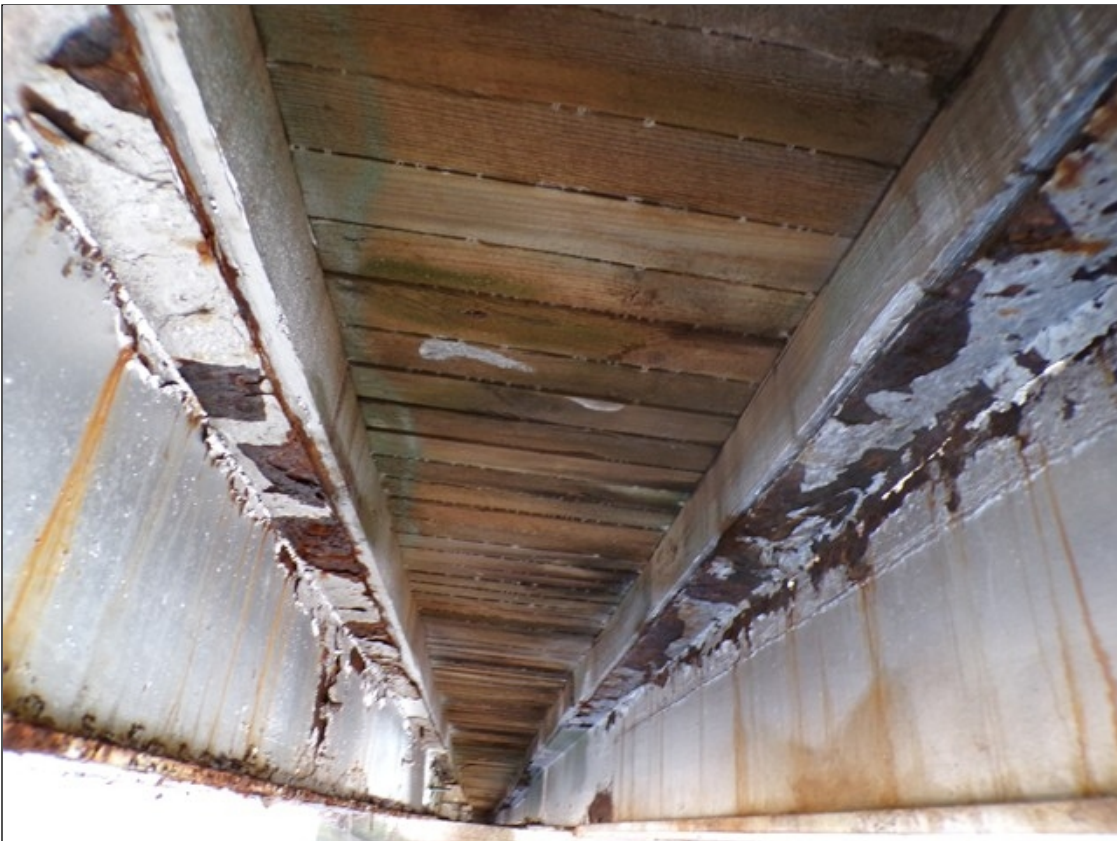
Span 1 Deck: THROUGHOUT BOTTOM OF DECK, SATURATION AND DECAY WITH WATER STAINING

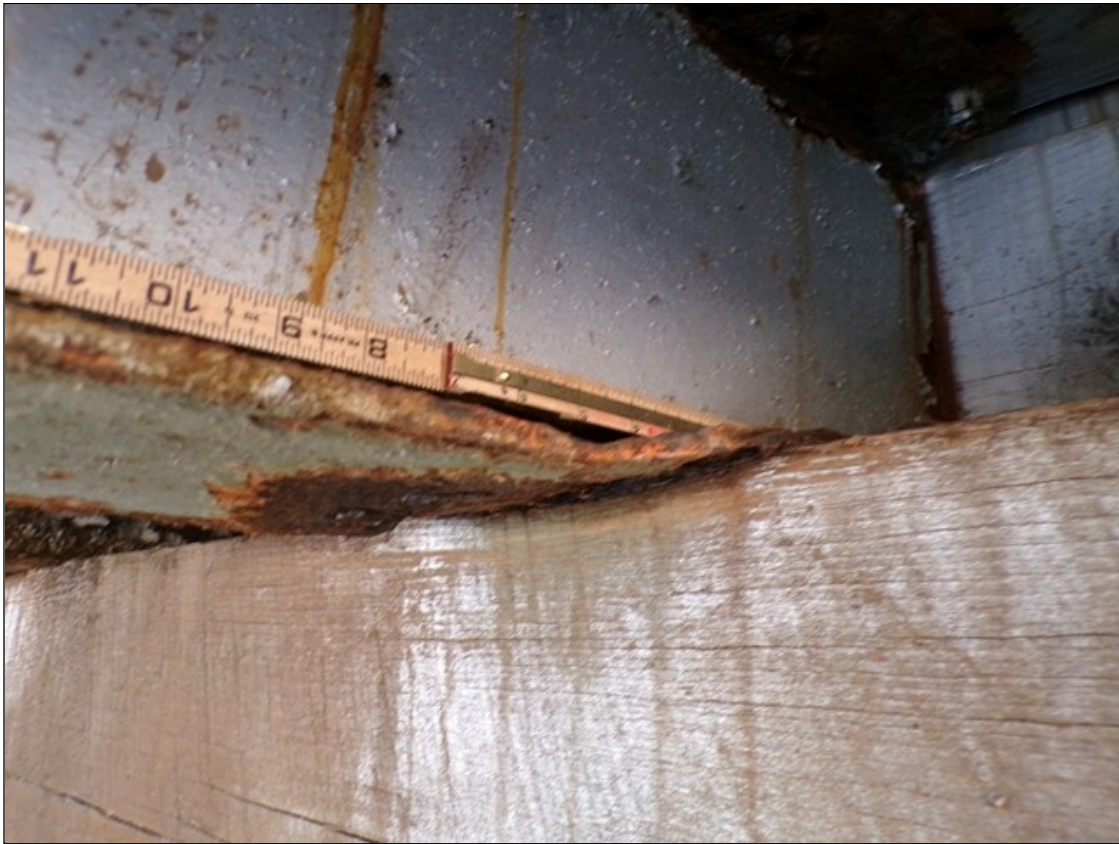
| 3 | Corrosion | 1 | SPAN 1 Beam 3: 5 INCH X 1 1/2 INCH DOWNWARD DEFLECTION WITH 9 INCH X FULL WIDTH AREA OF SECTION LOSS WITH KNIFE EDGE REMAINING AND 1 1/2 INCH X 1 INCH AREA OF 100% SECTION LOSS ON BOTH FLANGES AT END BENT 1 (PAR) |

SPAN 1 Beam 3: 5 INCH X 1 1/2 INCH DOWNWARD DEFLECTION WITH 9 INCH X FULL WIDTH AREA OF SECTION LOSS WITH KNIFE EDGE REMAINING AND 1 1/2 INCH X 1 INCH AREA OF 100% SECTION LOSS ON BOTH FLANGES AT END BENT 1 (PAR)

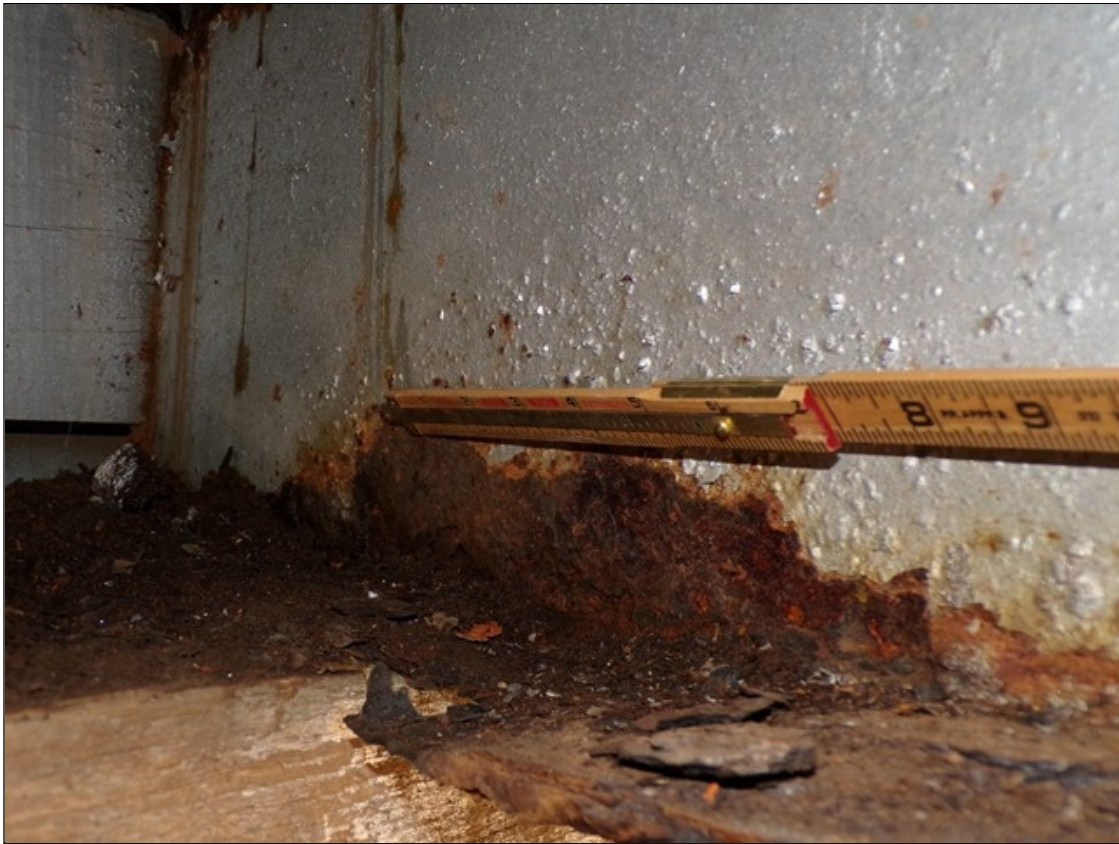
| 3 | Corrosion | 1 | SPAN 1 Beam 3: 12 INCH X 2 1/2 INCH AREA OF SECTION LOSS WITH KNIFE EDGE REMAINING AND 1/4 INCH DIAMETER HOLES ON UPPER AND LOWER WEBS AT END BENT 1 (PAR) |

SPAN 1 Beam 3: 12 INCH X 2 1/2 INCH AREA OF SECTION LOSS WITH KNIFE EDGE REMAINING AND 1/4 INCH DIAMETER HOLES ON UPPER AND LOWER WEBS AT END BENT 1 (PAR)

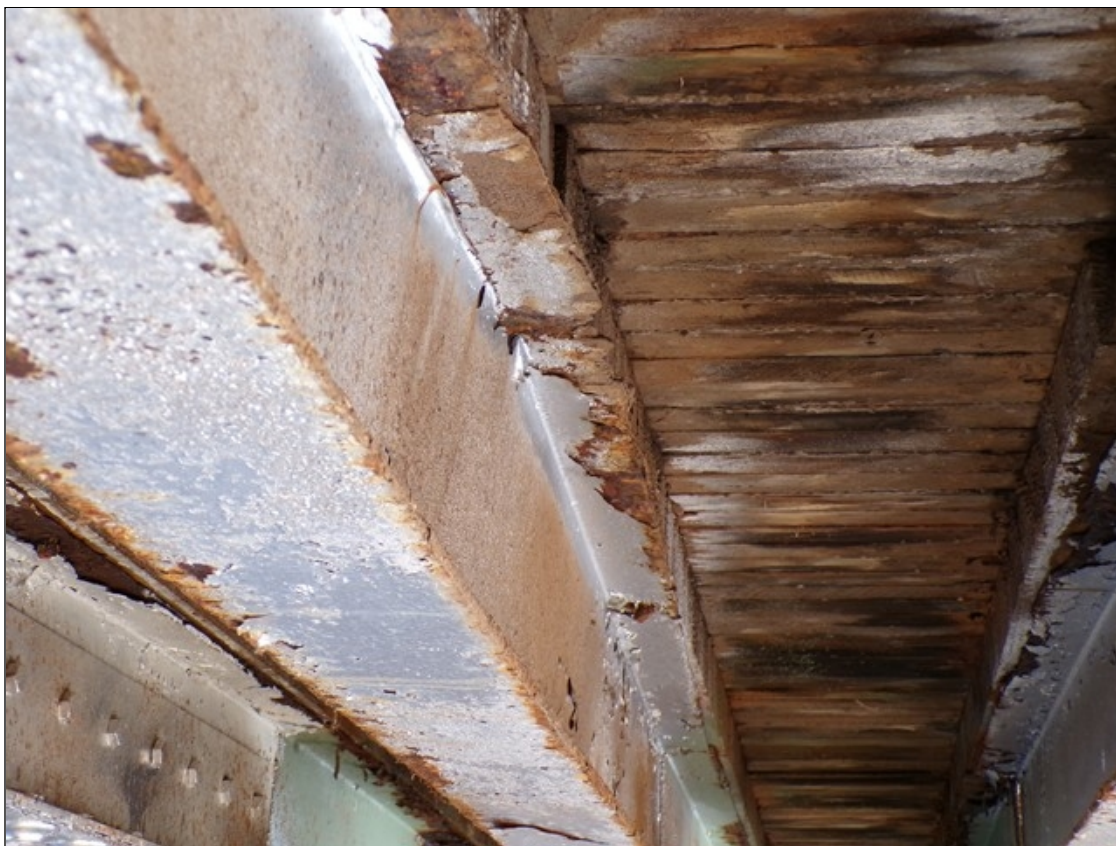
Span 1 Beam 4: 9 FEET X 1 1/4 INCH SOUTHERN ROTATION TO BEAM, 3 FEET FROM BENT 1 (PAR)

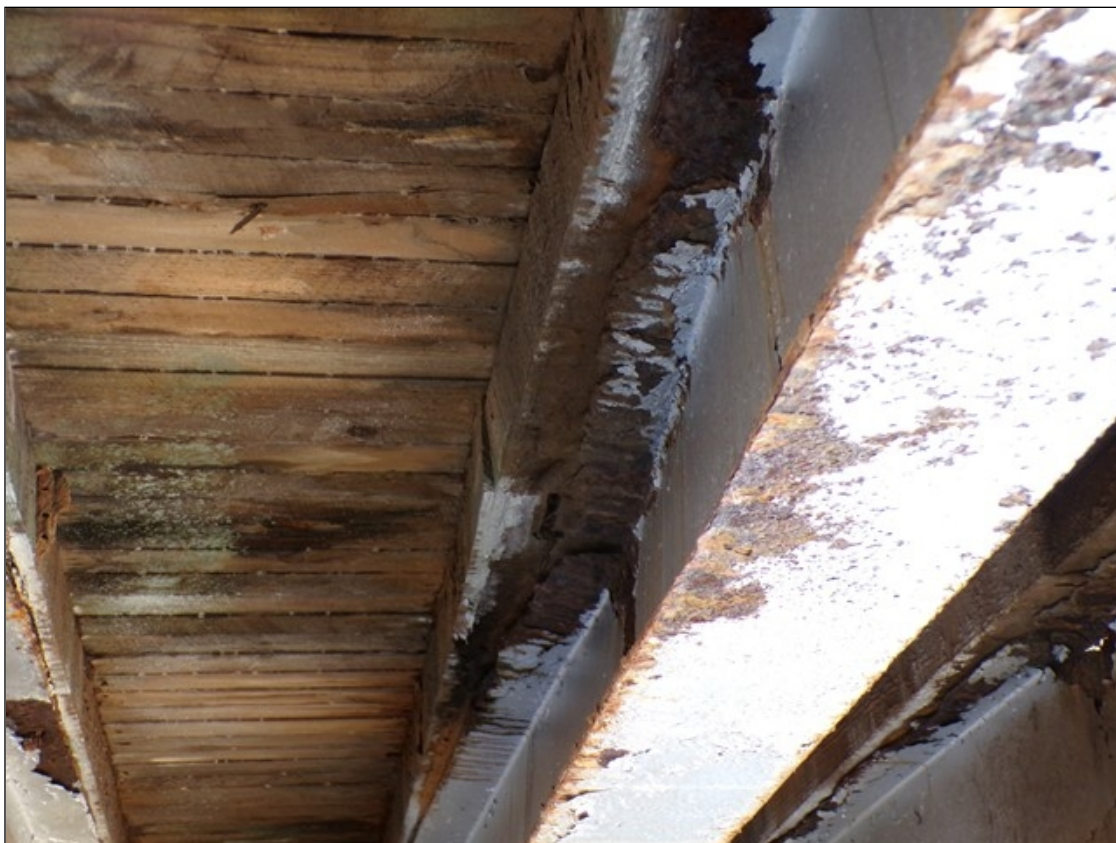
Span 1 Beam 4: 9 FEET X 1 1/4 INCH SOUTHERN ROTATION TO BEAM, 3 FEET FROM BENT 1 (PAR)

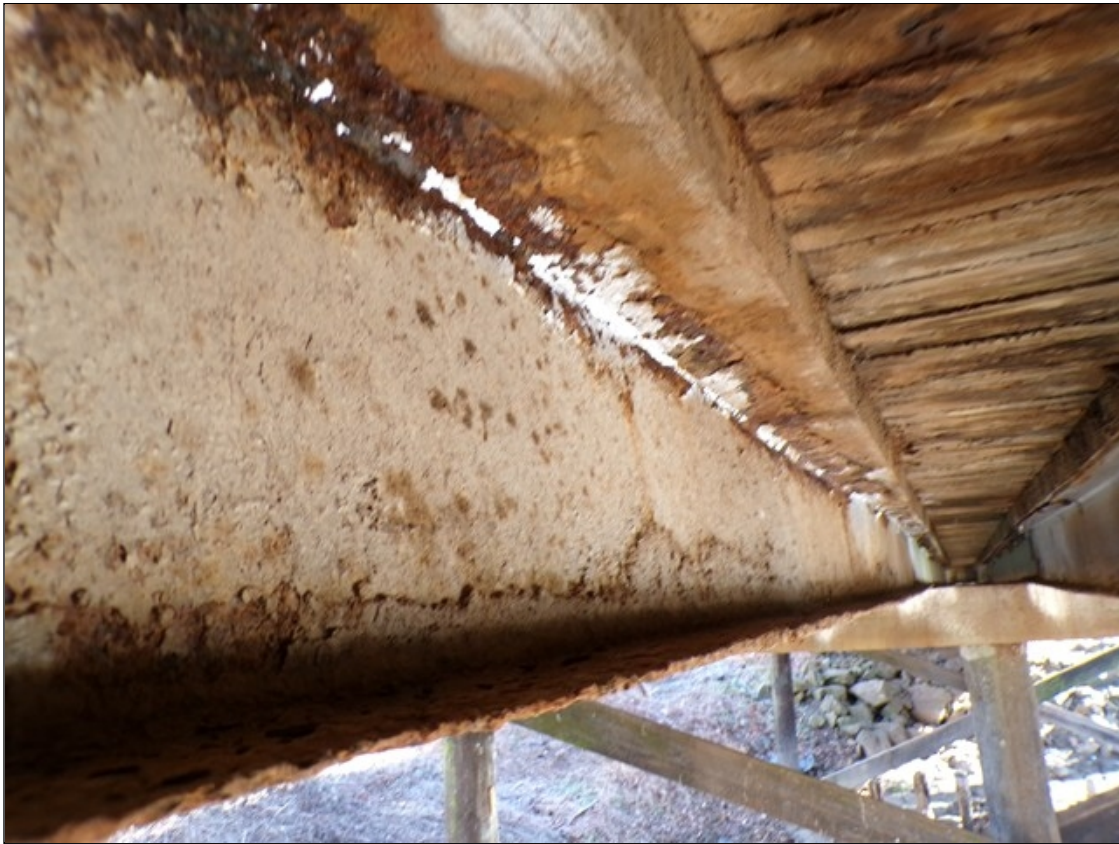
Span 1 Beam 5: 22 FEET X 1 INCH NORTHERN ROTATION TO BEAM, 3 FEET FROM BENT 1 (PAR)

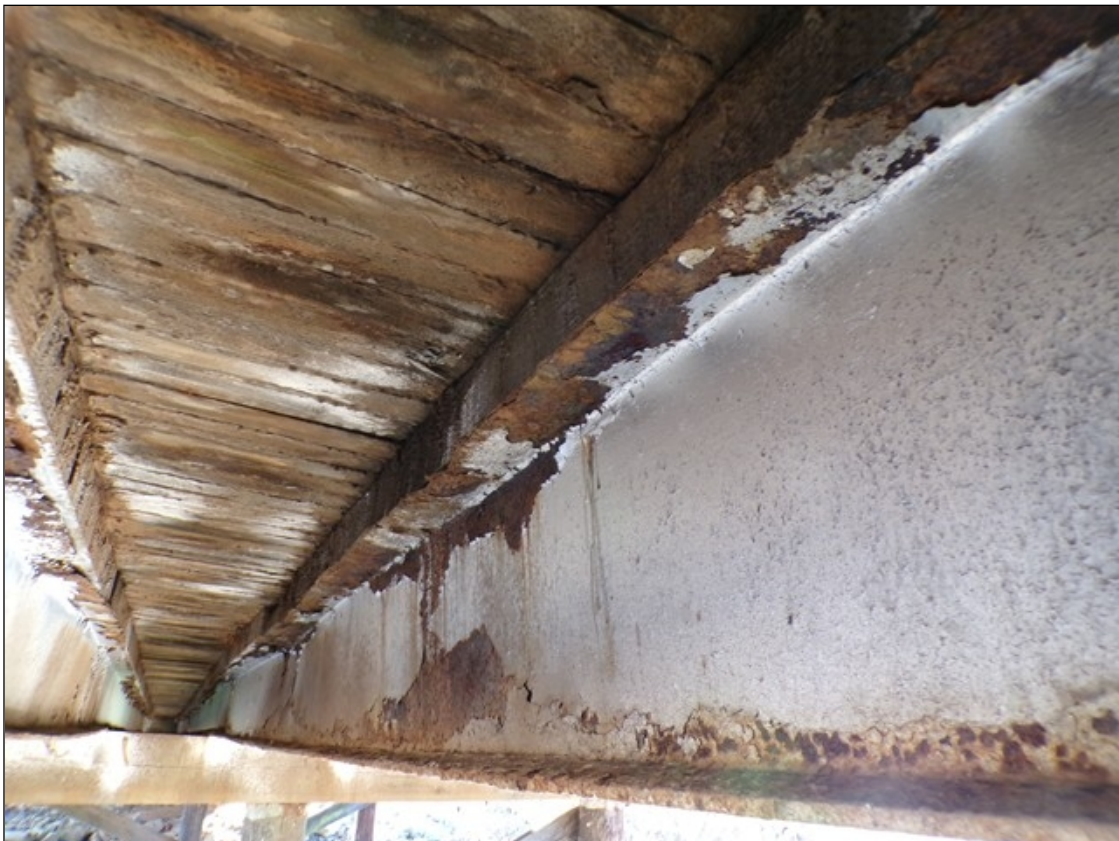
Span 1 Beam 5: 22 FEET X 1 INCH NORTHERN ROTATION TO BEAM, 3 FEET FROM BENT 1 (PAR)

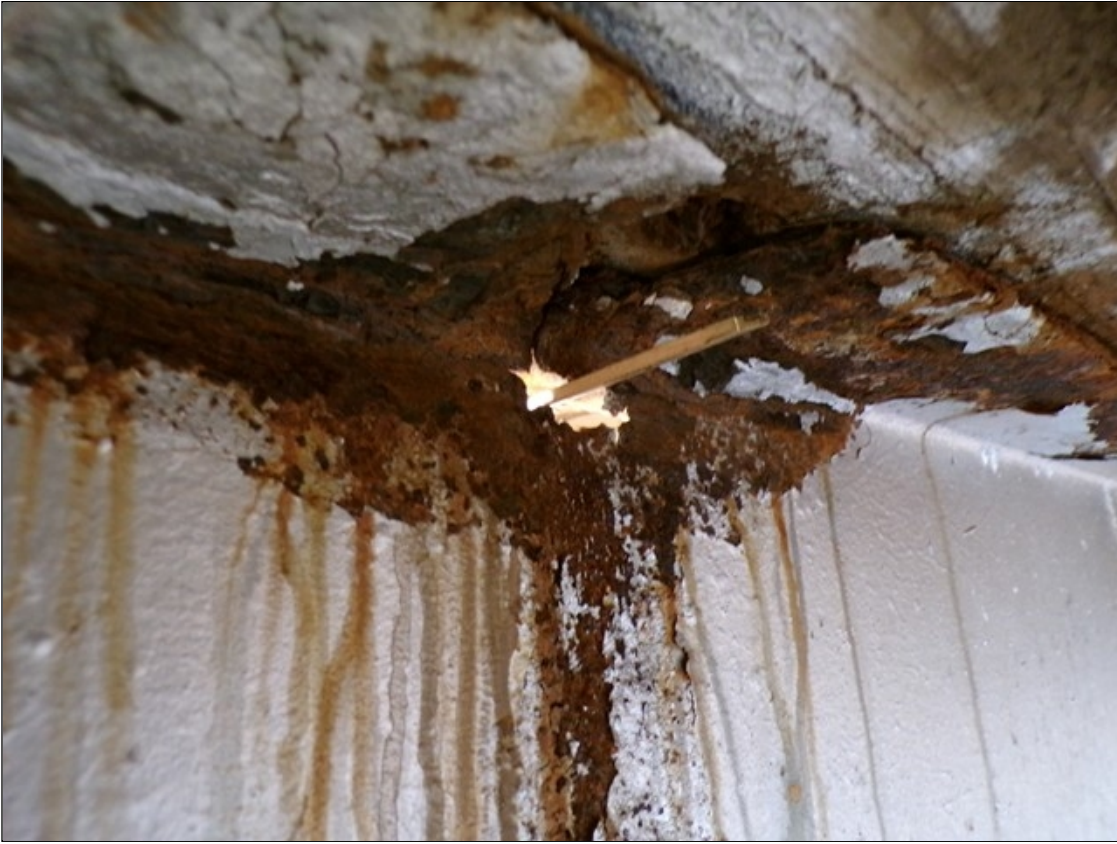
| Priority Level | Defect Type | Quantity | Defect Description |
|---|---|---|---|
| 4 | Corrosion | 20 | SPAN 1 Beam 5: (PAR) TOP FLANGE TAPERED CORROSION WITH SECTION LOSS BEGINNING AT NEAR END, 1/8 INCH AVERAGE THICKNESS REMAINING DOWN TO KNIFE'S EDGE X 4 INCH WIDE X 20 FEET AND 7 FEET X 2 INCH (WITH (3) AREAS OF 100% SECTION LOSS (2) UP TO 3 FEET X 1 INCH WIDE AND (1) 7 FEET X 2 INCH WIDE). UPPER AND LOWER WEB SECTION LOSS DOWN TO 1/16 INCH REMAINING, WITH CORROSION HOLE, 2 INCH X 1/2 INCH AND FULL DEPTH CRACK IN TOP WEB, 7 FEET FROM NEAR END |

SPAN 1 Beam 5: (PAR) TOP FLANGE TAPERED CORROSION WITH SECTION LOSS BEGINNING AT NEAR END, 1/8 INCH AVERAGE THICKNESS REMAINING DOWN TO KNIFE'S EDGE X 4 INCH WIDE X 20 FEET AND 7 FEET X 2 INCH (WITH (3) AREAS OF 100% SECTION LOSS (2) UP TO 3 FEET X 1 INCH WIDE AND (1) 7 FEET X 2 INCH WIDE). UPPER AND LOWER WEB SECTION LOSS DOWN TO 1/16 INCH REMAINING, WITH CORROSION HOLE, 2 INCH X 1/2 INCH AND FULL DEPTH CRACK IN TOP WEB, 7 FEET FROM NEAR END

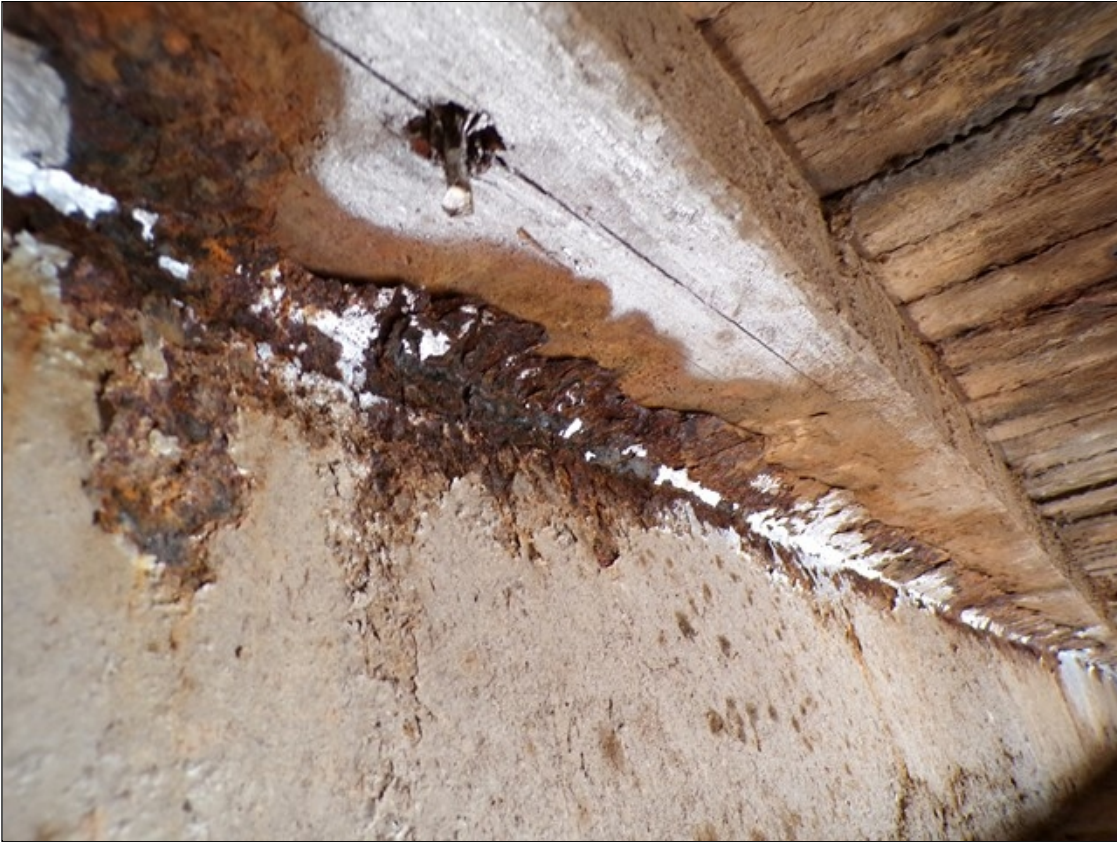
SPAN 1 Beam 5: (PAR) TOP FLANGE TAPERED CORROSION WITH SECTION LOSS BEGINNING AT NEAR END, 1/8 INCH AVERAGE THICKNESS REMAINING DOWN TO KNIFE'S EDGE X 4 INCH WIDE X 20 FEET AND 7 FEET X 2 INCH (WITH (3) AREAS OF 100% SECTION LOSS (2) UP TO 3 FEET X 1 INCH WIDE AND (1) 7 FEET X 2 INCH WIDE). UPPER AND LOWER WEB SECTION LOSS DOWN TO 1/16 INCH REMAINING, WITH CORROSION HOLE, 2 INCH X 1/2 INCH AND FULL DEPTH CRACK IN TOP WEB, 7 FEET FROM NEAR END
