NC DEPARTMENT OF TRANSPORTATION  
DIVISION OF HIGHWAYS  
STRUCTURE MANAGEMENT UNIT  
COUNTY: RUTHERFORD DIV: 13

## Structure Safety Inspection Report

BRIDGE NUMBER: 800239 BRIDGE NAME: \_\_\_\_\_ PREVIOUS BRIDGE NUMBER: \_\_\_\_\_

LATITUDE: 35.48940000 LONGITUDE: -81.99338000 ROUTE: SR1325 M.P.: 0.0

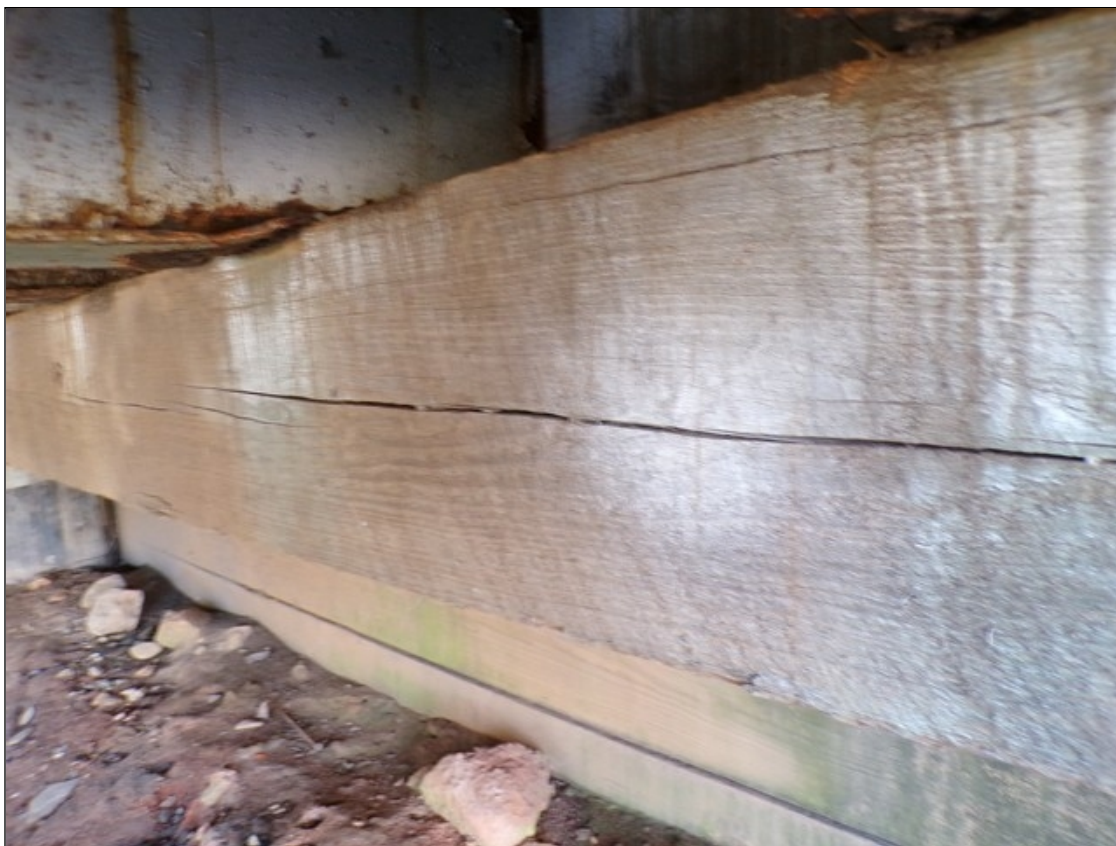
End Bent 1 Cap 1: CHECKING (UP TO 1/4 INCH WIDE X FULL LENGTH X 1 INCH DEEP) SCATTERED THROUGHOUT FACE

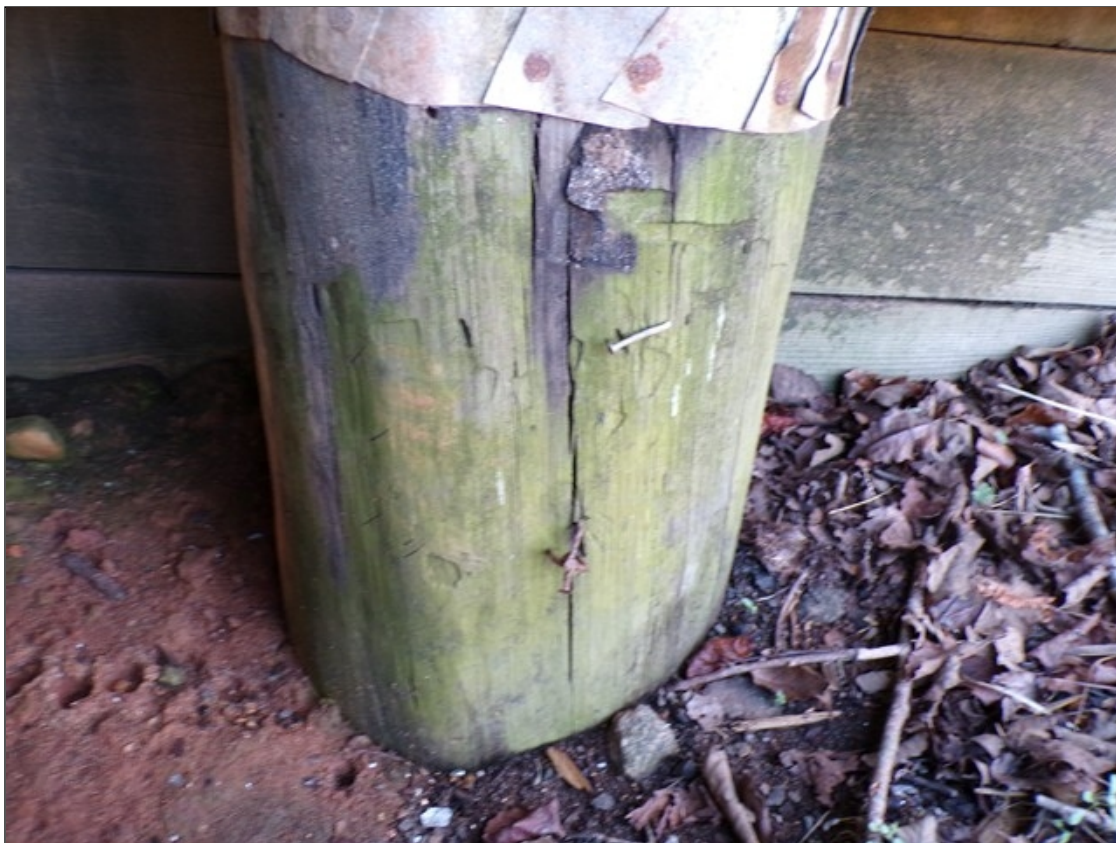
End Bent 1 Pile 1: CHECKING (UP TO 7/8 INCH DEEP) THROUGHOUT PILE

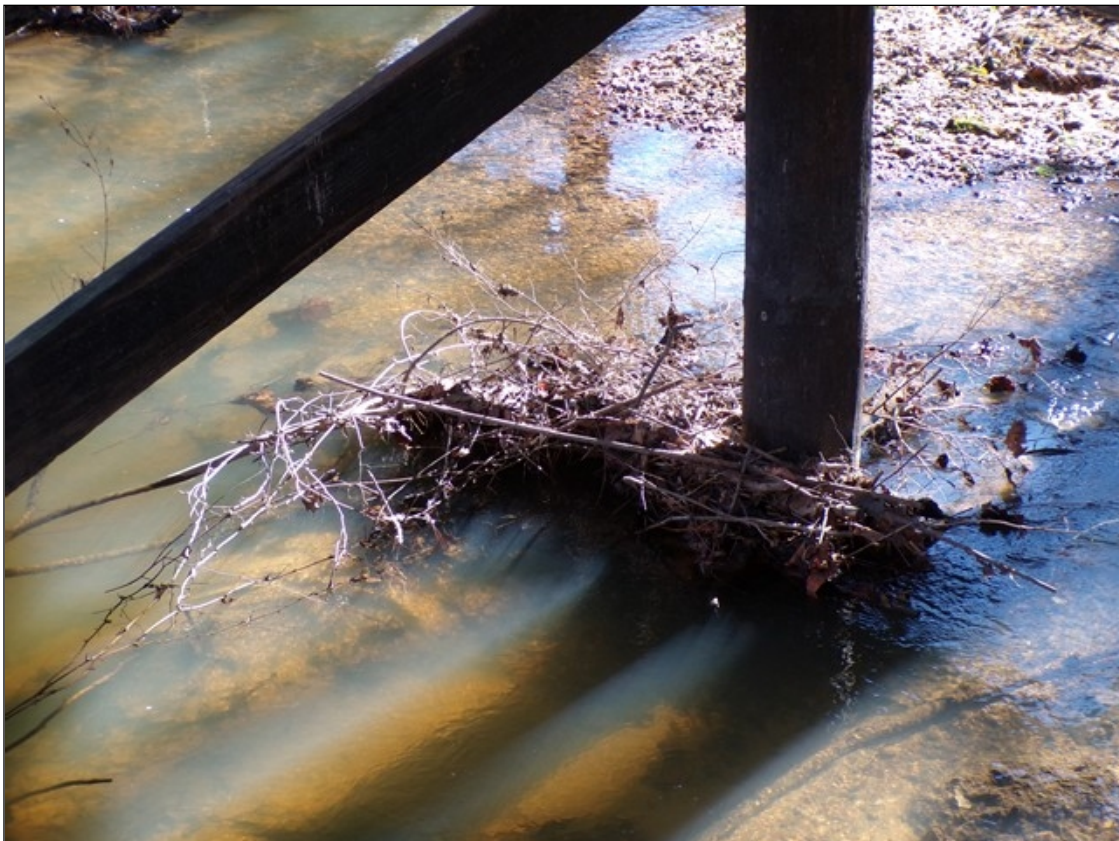
8 FEET X 7 FEET X 1 FOOT HIGH DRIFT AND DEBRIS AT PILE 1 OF BENT 1

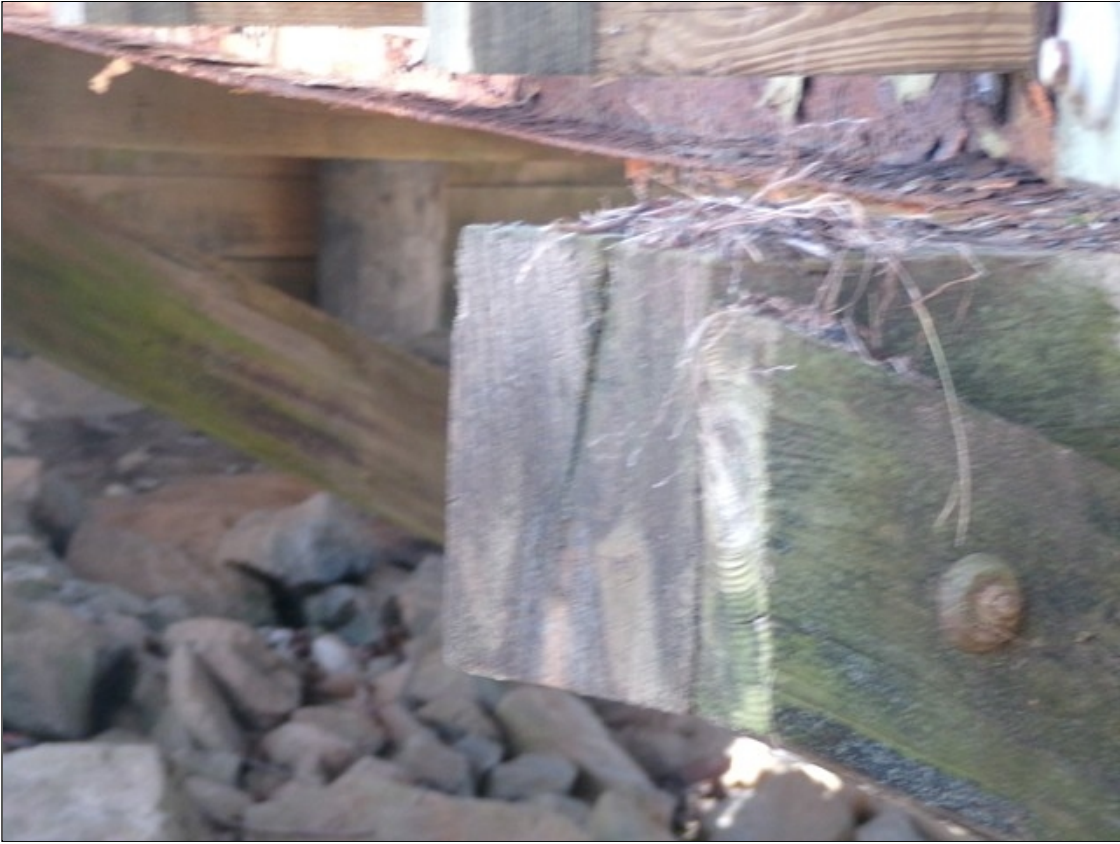
Bent 1 Cap 1: AT NORTH END, SPLIT, 8 INCH LONG X UP TO 1/2 INCH WIDE X UP TO 1/2 INCH DEEP, SIMILAR SOUTH FACE

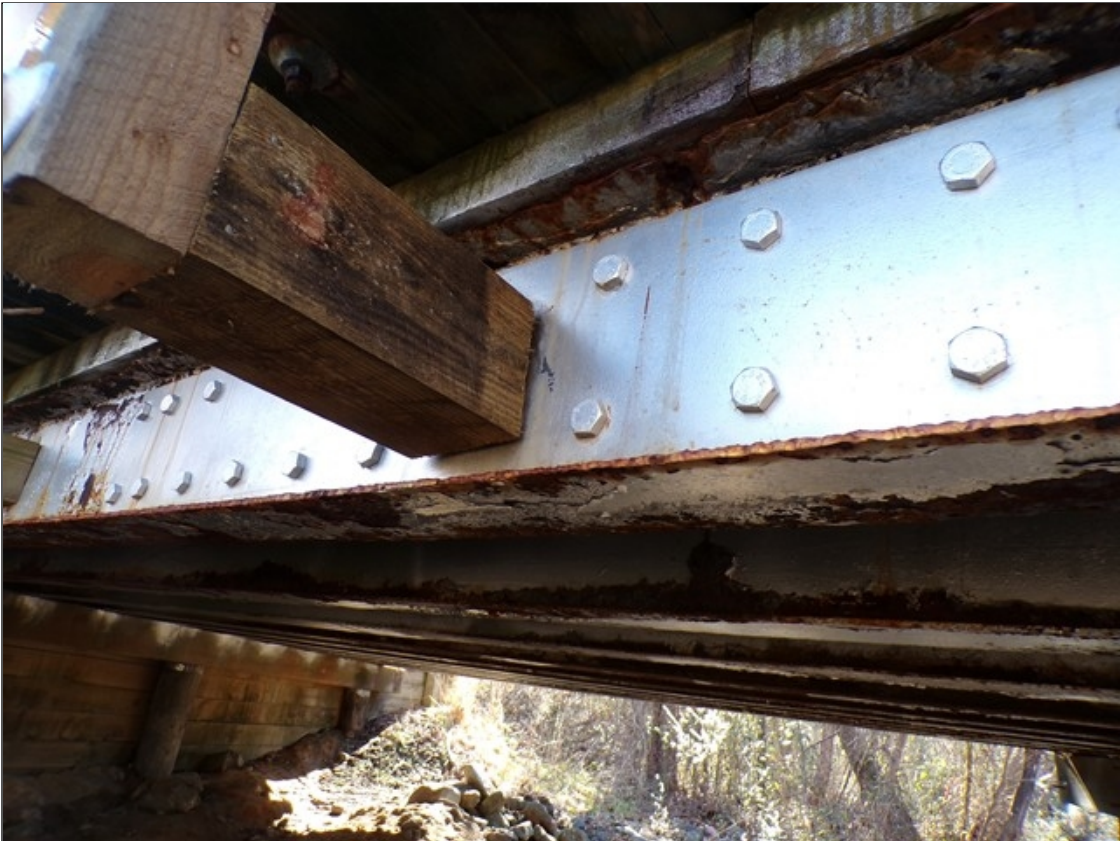
Span 3 Beam 1: 7 FEET FROM NEAR END, AREA OF 100% SECTION LOSS IN TOP OF WEB HAS BEEN REPAIRED WITH BOLTED PLATES (5 FEET X 10 INCH X 1/2 INCH THICK) ON EACH SIDE

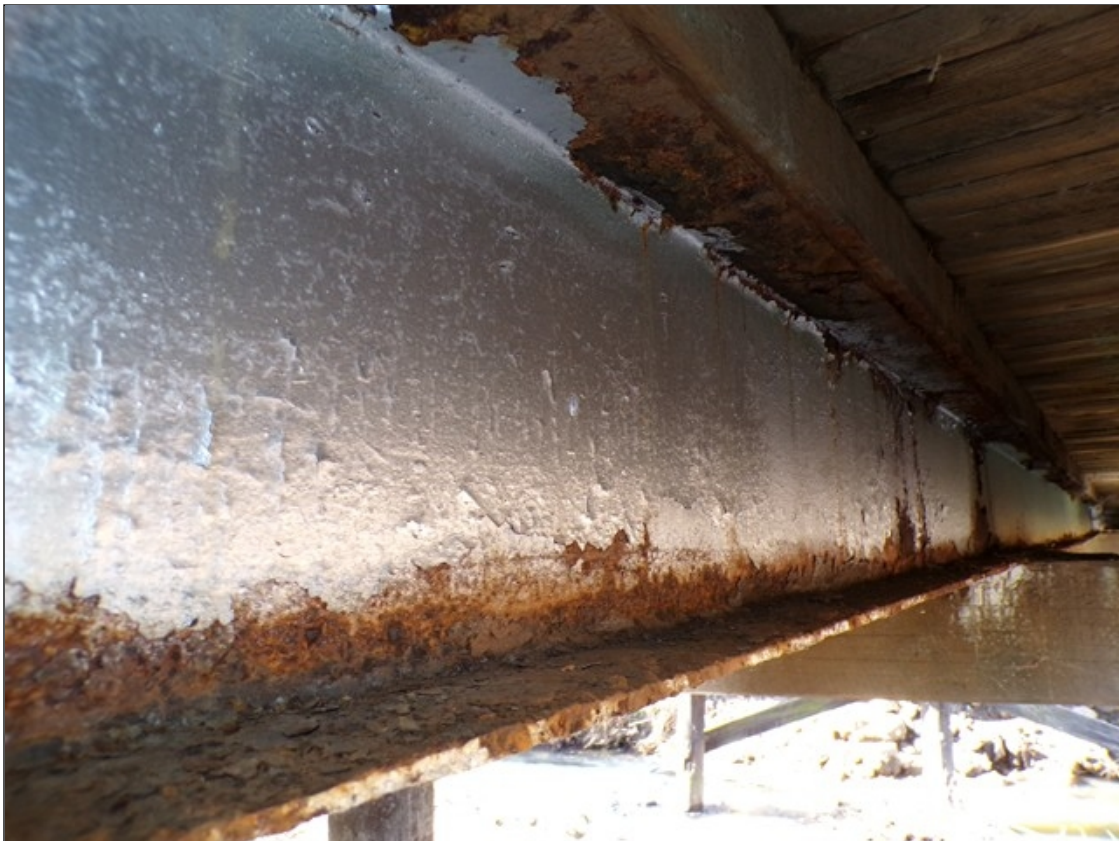
Span 3 Beam 3: AT NEAR END, SURFACE CORROSION IN BASE OF WEB, 4 INCH HIGH X 9 FEET LONG NO MEASURABLE SECTION LOSS

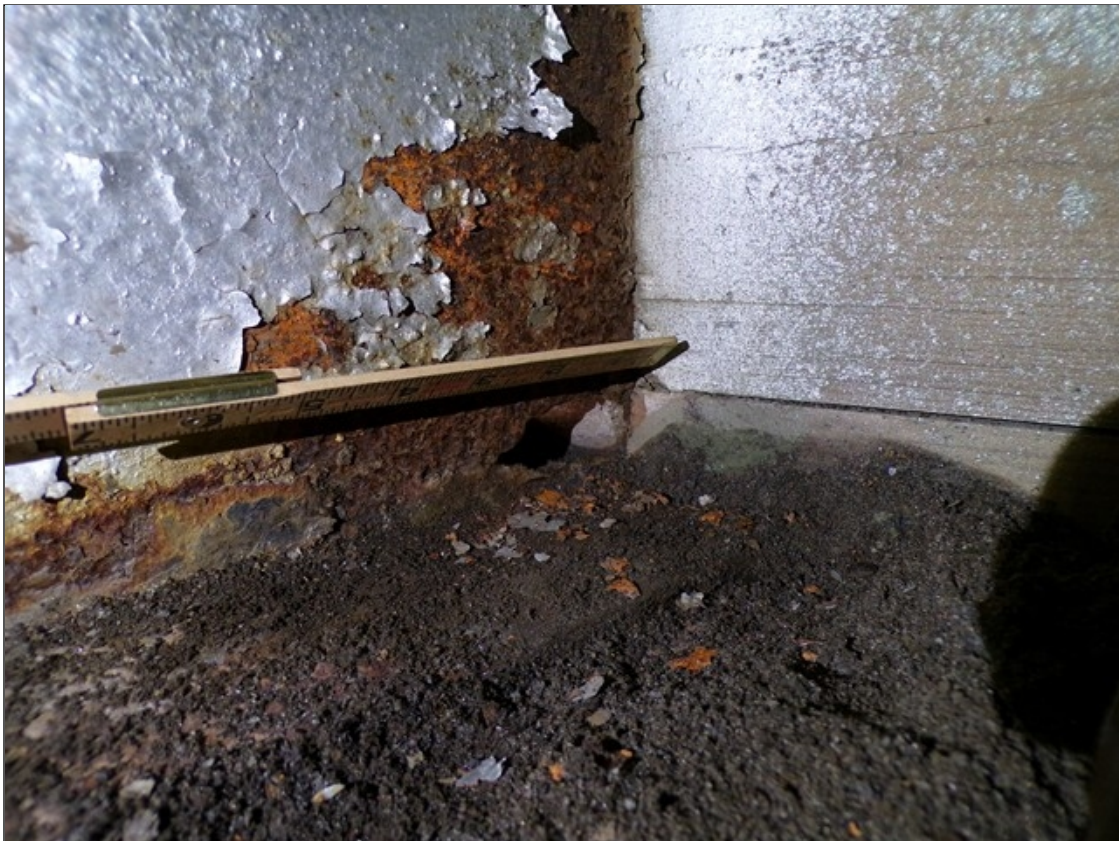
Span 3 Beam 2: 2 1/2 INCH X 1 INCH AREA OF 100% SECTION LOSS ON LOWER WEB AT END BENT 2 (PAR)

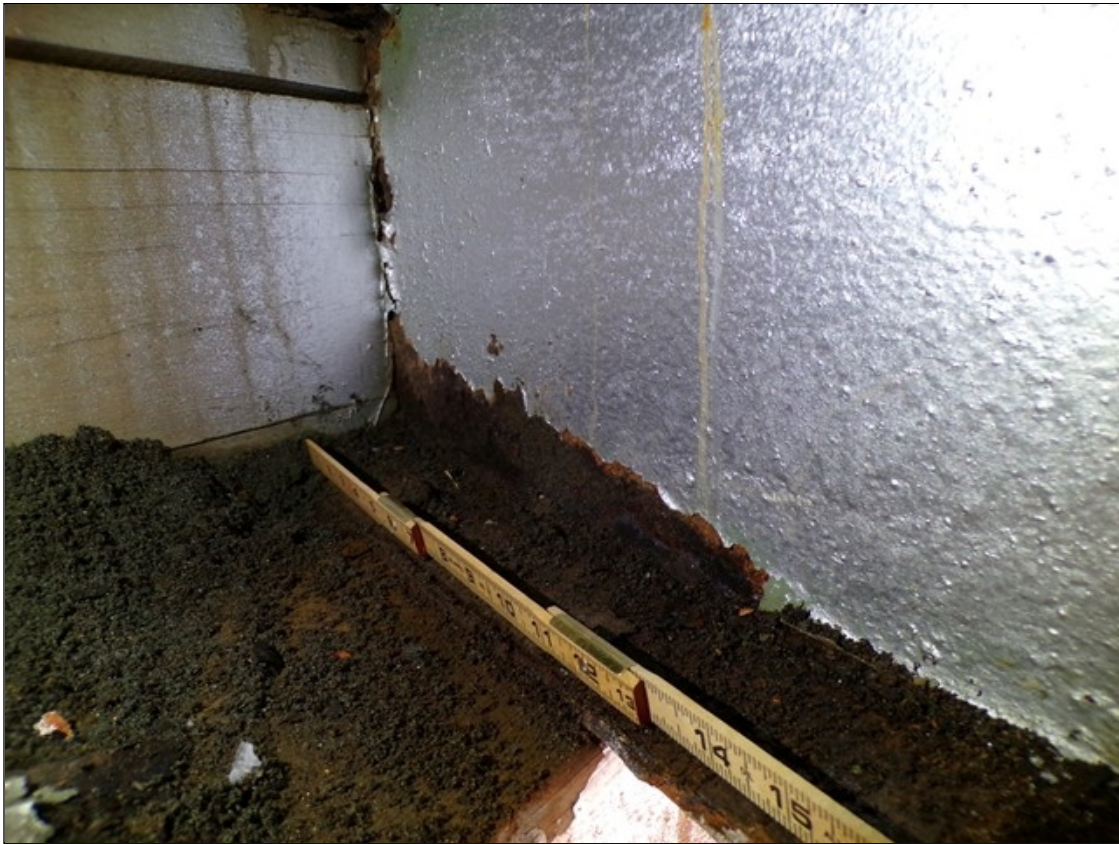
SPAN 3 Beam 4: 13 INCH X 4 INCH AREA OF 1/16 INCH SECTION LOSS (3/16 INCH REMAINING) ON LEFT SIDE OF WEB AT END BENT 2 (PAR)

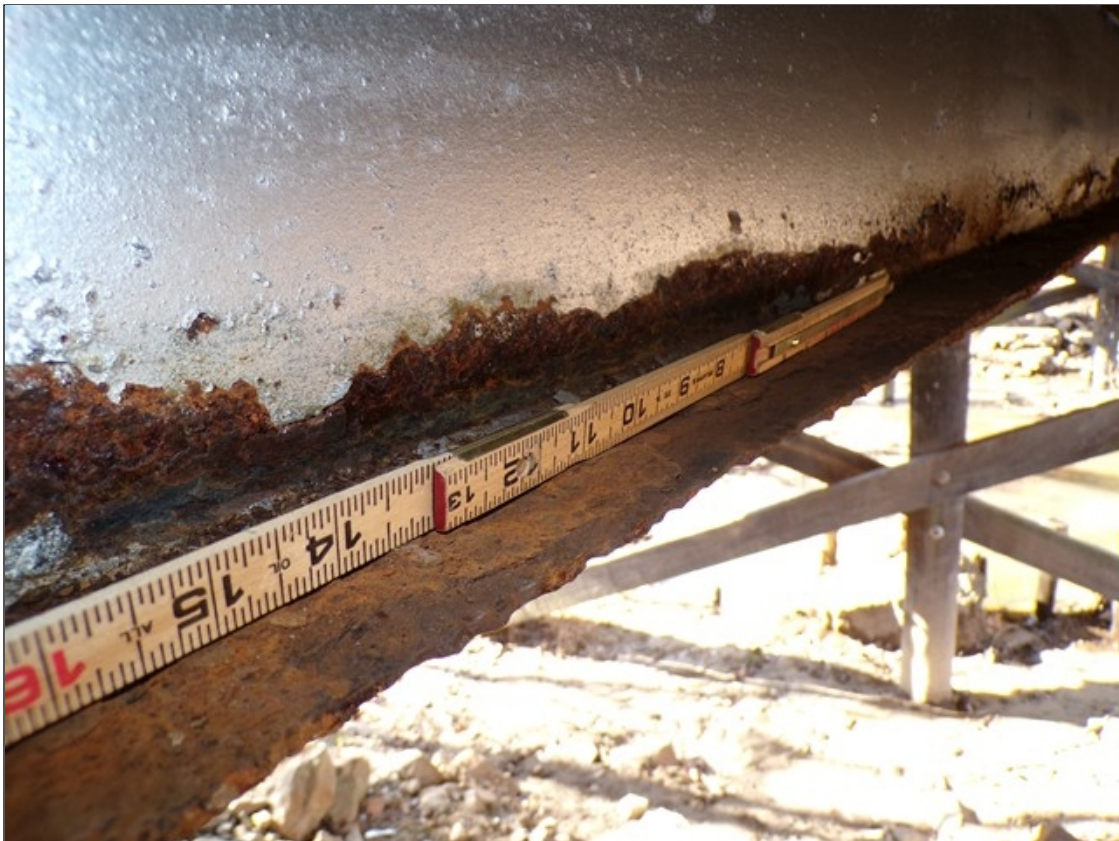
Span 3 Beam 4: (PAR) BEGINNING AT NEAR END, CORROSION WITH SECTION LOSS TO BOTTOM FLANGE (DOWN TO 1/8 INCH THICKNESS REMAINING) TO BOTH SIDES, FOR 3 INCH WIDE X 19 FEET LONG

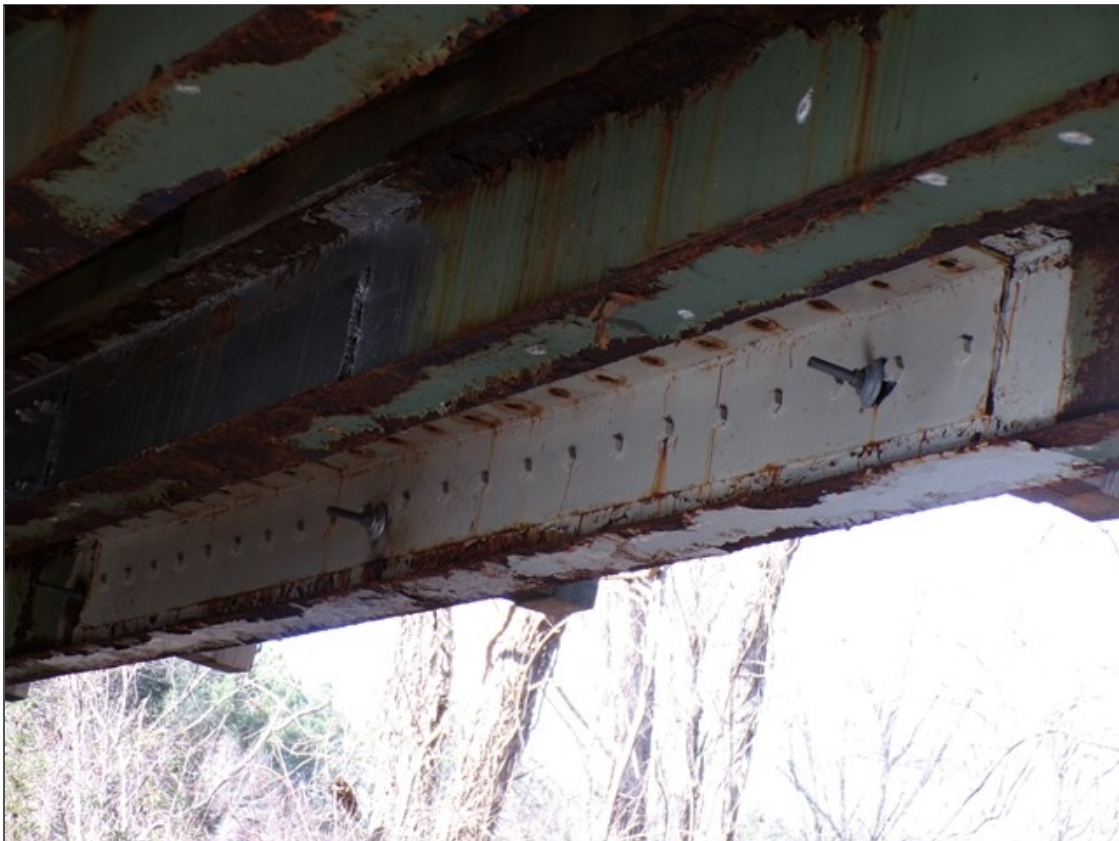
Span 2 Beam 1: (2023 REPAIR) BOLTED BUILT-UP ANGLE (8 INCH HIGH X 4 INCH WIDE X 1/4 INCH THICK X 10 FEET LONG) REPAIRING SECTION LOSS IN WEB AT MIDSPAN

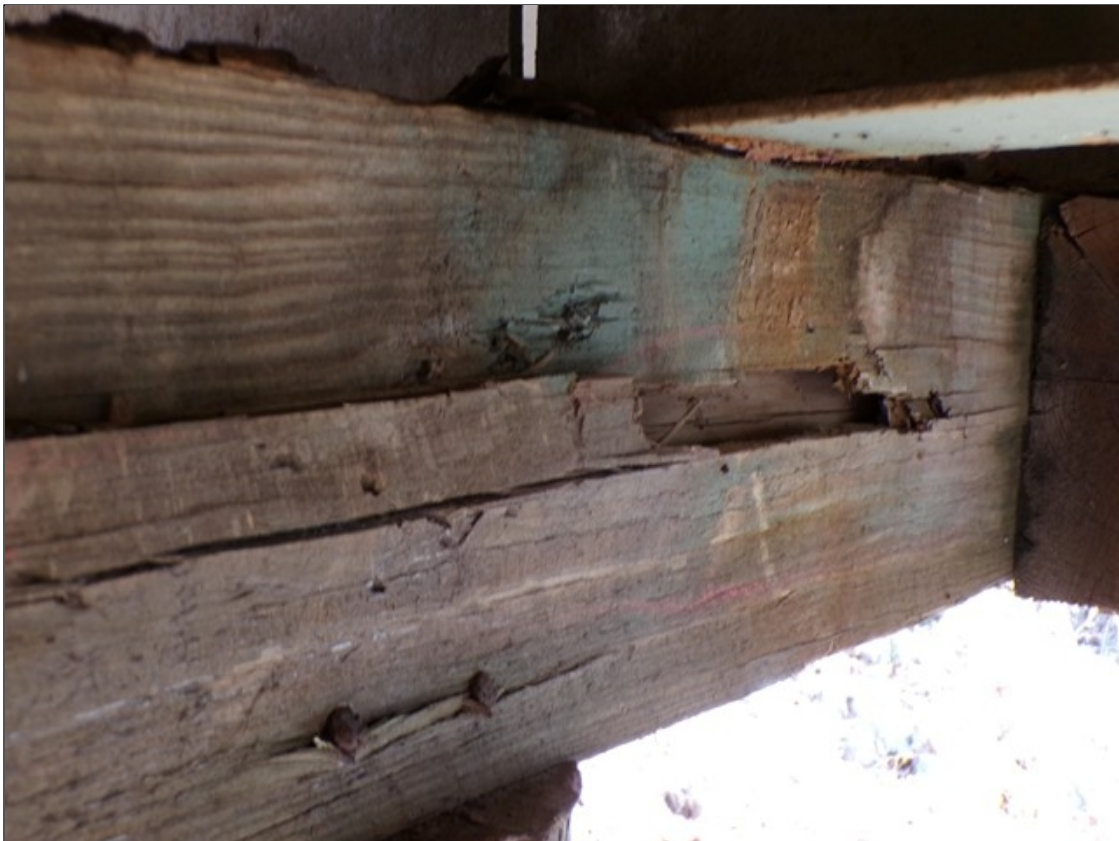
Bent 2 Cap 1: (PAR) NEAR FACE ABOVE PILE 2, CRUSHING (UP TO 6 INCH HIGH X 10 INCH WIDE) WITH MISSING SECTION (17 INCH X 2 INCH X 1 1/2 INCH DEEP)

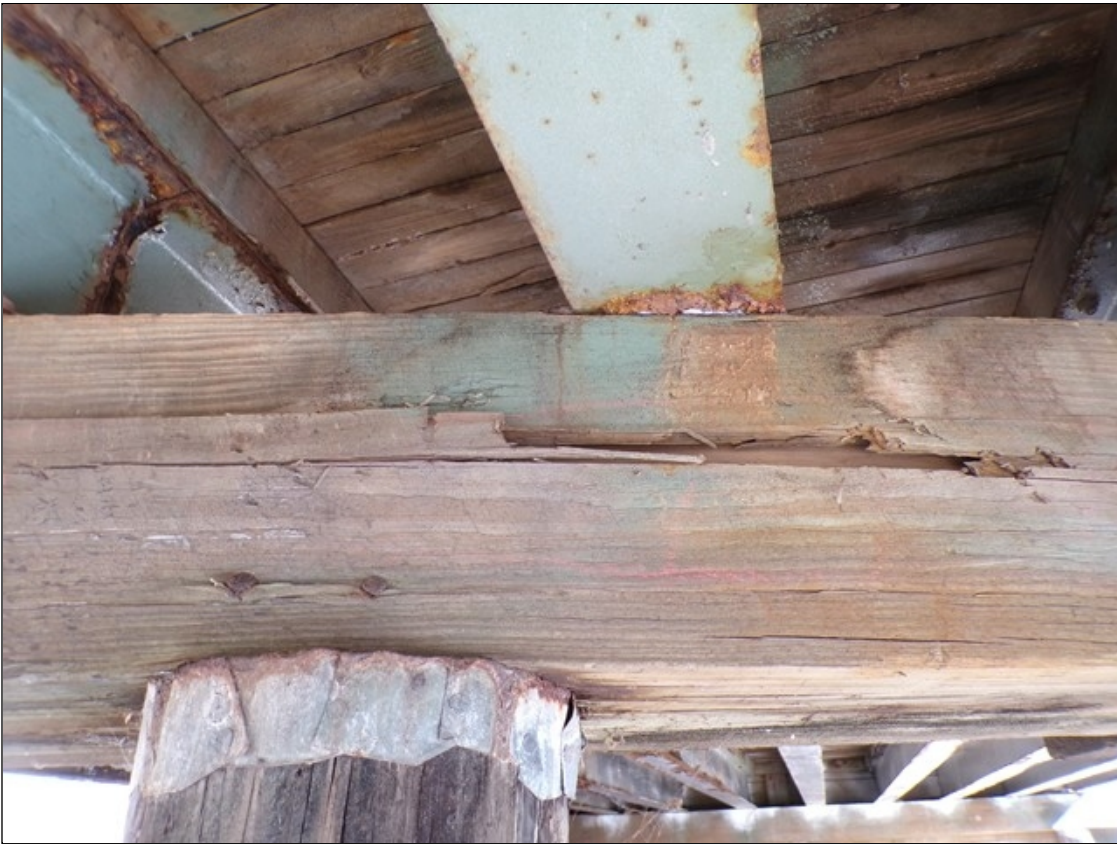
Bent 2 Cap 1: (PAR) NEAR FACE ABOVE PILE 2, CRUSHING (UP TO 6 INCH HIGH X 10 INCH WIDE) WITH MISSING SECTION (17 INCH X 2 INCH X 1 1/2 INCH DEEP)

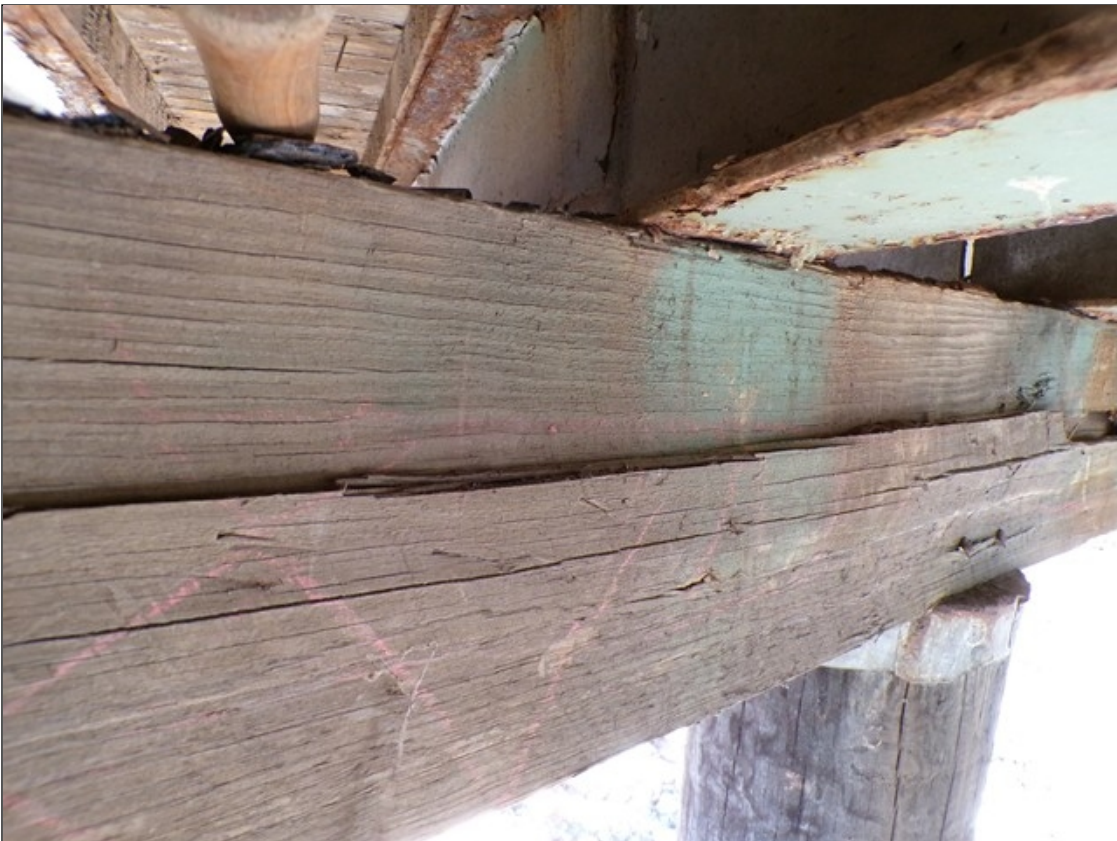
Bent 2 Cap 1: (PAR) NEAR SIDE BELOW BAYS 2-6, AREA OF DELAMINATION/DECAY (10 FEET LONG X 8 INCH HIGH X UP TO 1 INCH DEEP) HOLLOW WHEN SOUNDED

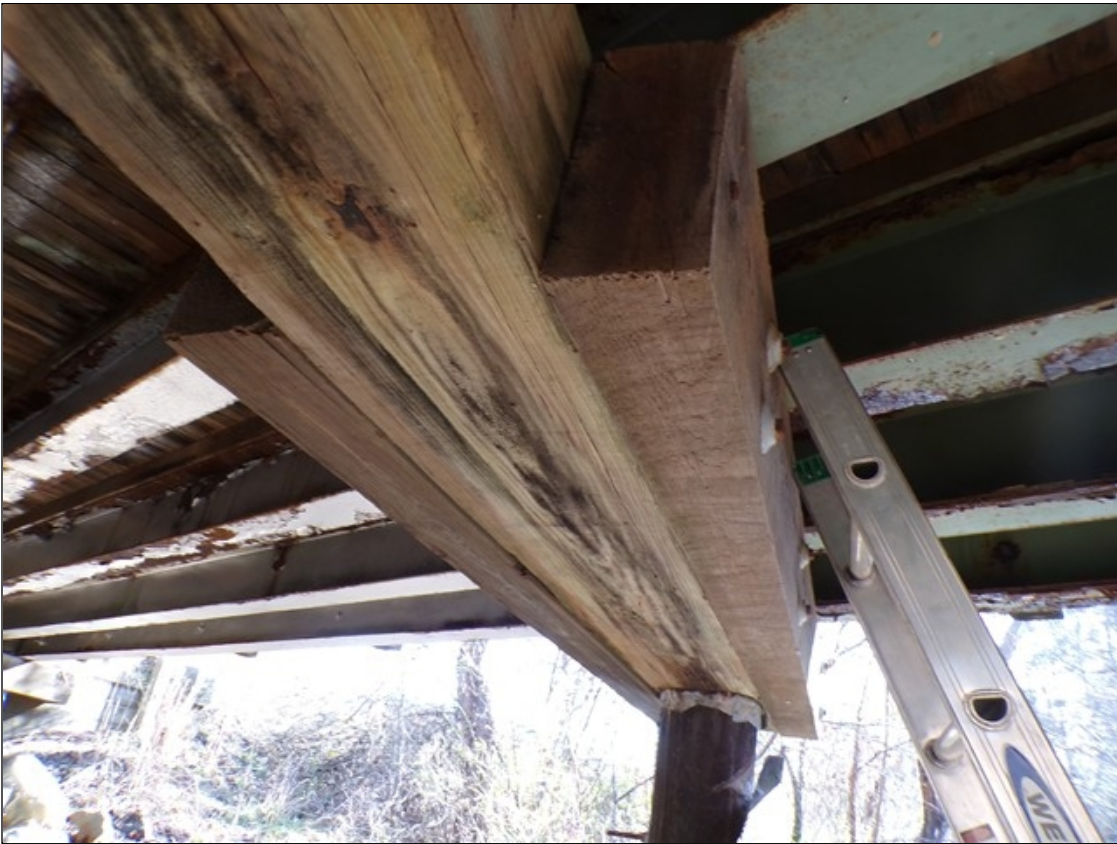
Bent 2 Cap 1: PREVIOUS REPAIR (PRIOR TO 2021 INSPECTION) - (2) TIMBERS (8.5 FEET LONG X 11.5 INCH HIGH X 5.5 INCH WIDE) ON NEAR AND FAR SIDE OF CAP AT RIGHT END REPAIRING DELAMINATION/ SPLITTING (4 FEET X 4 INCH X 4 INCH) TO TOP NEAR CORNER OF CAP UNDER BEAMS 9 AND 10

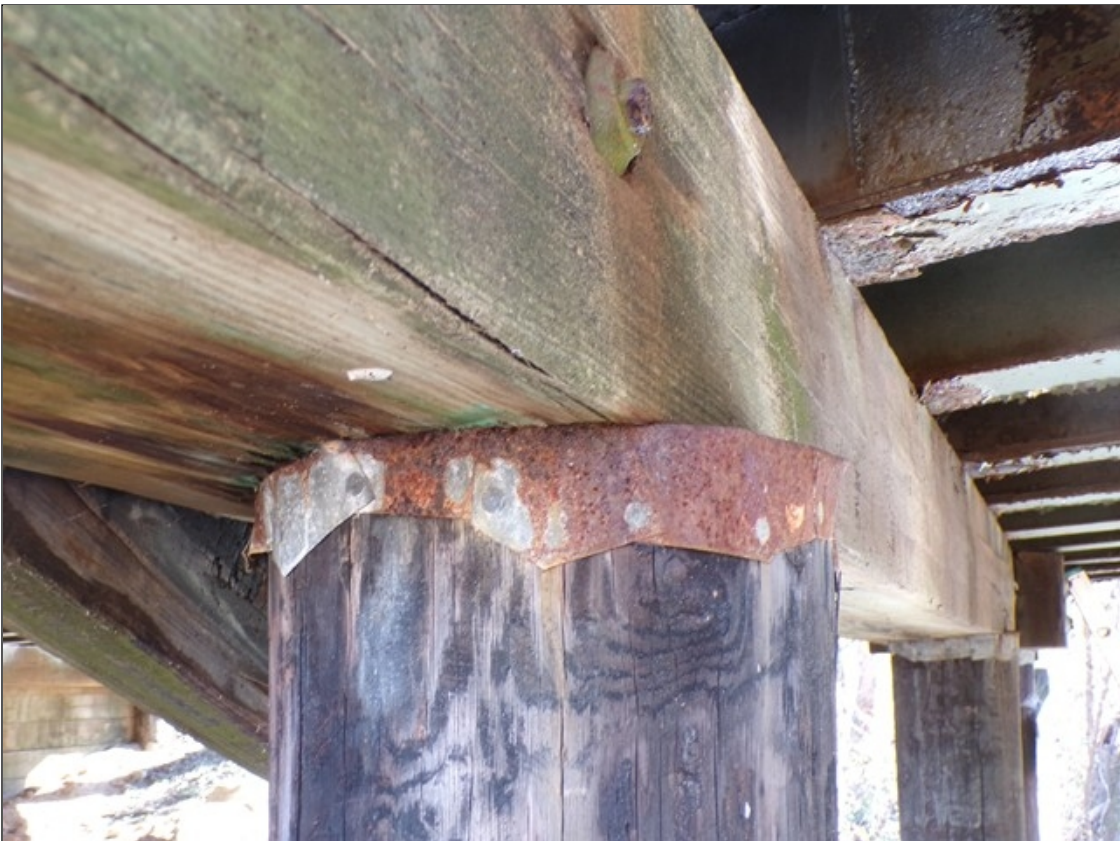
Bent 2 Pile 1: (PAR) MISALIGNMENT (UP TO 2 INCH) AT TOP OF PILE REDUCING BEARING AREA, CAP OVERHANGING PILE WITH APPROXIMATELY 11 PERCENT LOSS OF CAP BEARING

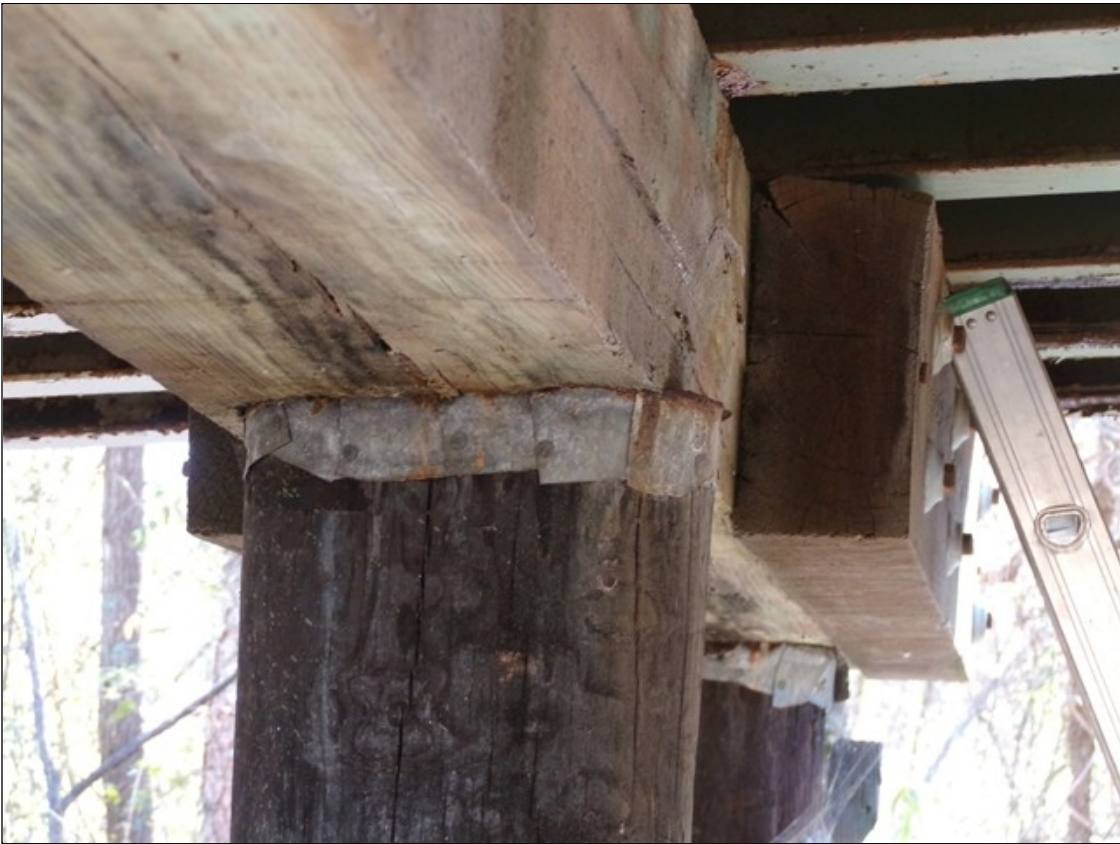
Bent 2 Pile 2: (PAR) MISALIGNMENT (UP TO 1/2 INCH) AT TOP OF PILE REDUCING BEARING AREA, CAP OVERHANGING PILE, WITH APPROXIMATELY 5% LOSS OF CAP BEARING

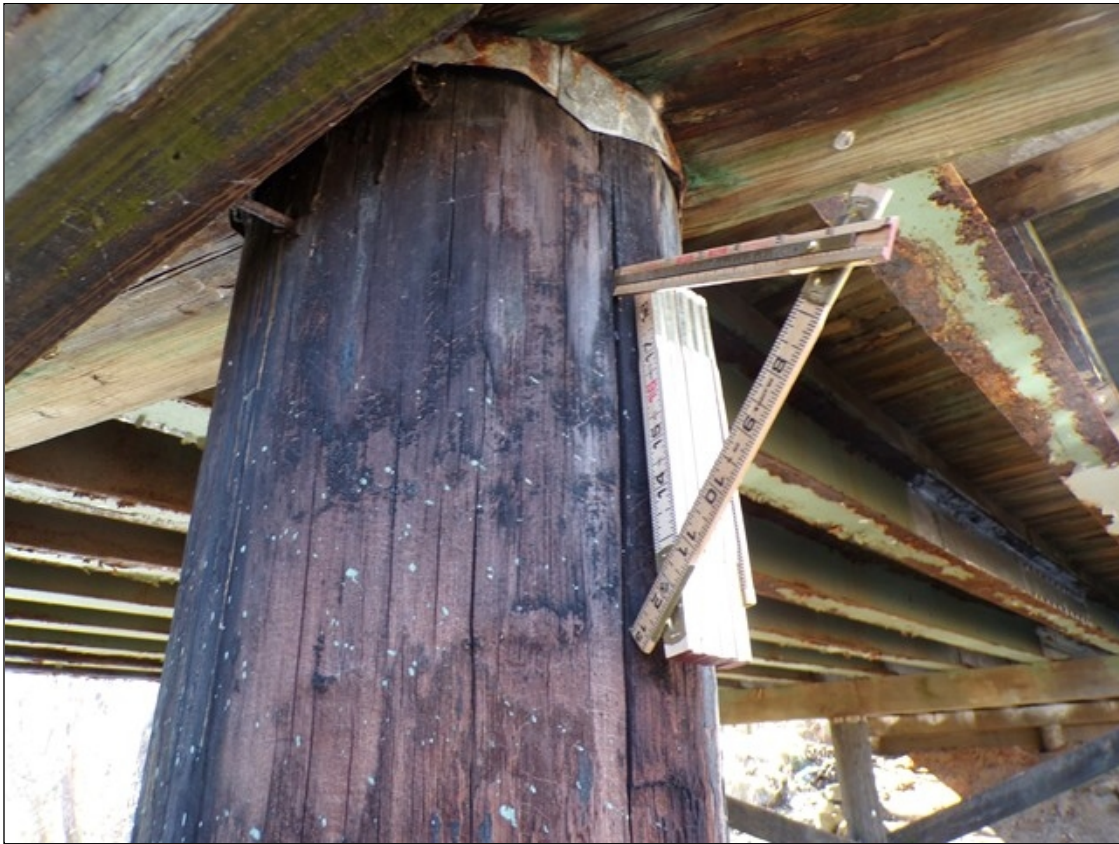
Bent 2 Pile 1: (PAR) CROSS BRACING - SECTION LOSS (5 FEET LONG X 2.5 INCH WIDE X 2 INCH DEEP) TO TOP AT FAR SIDE

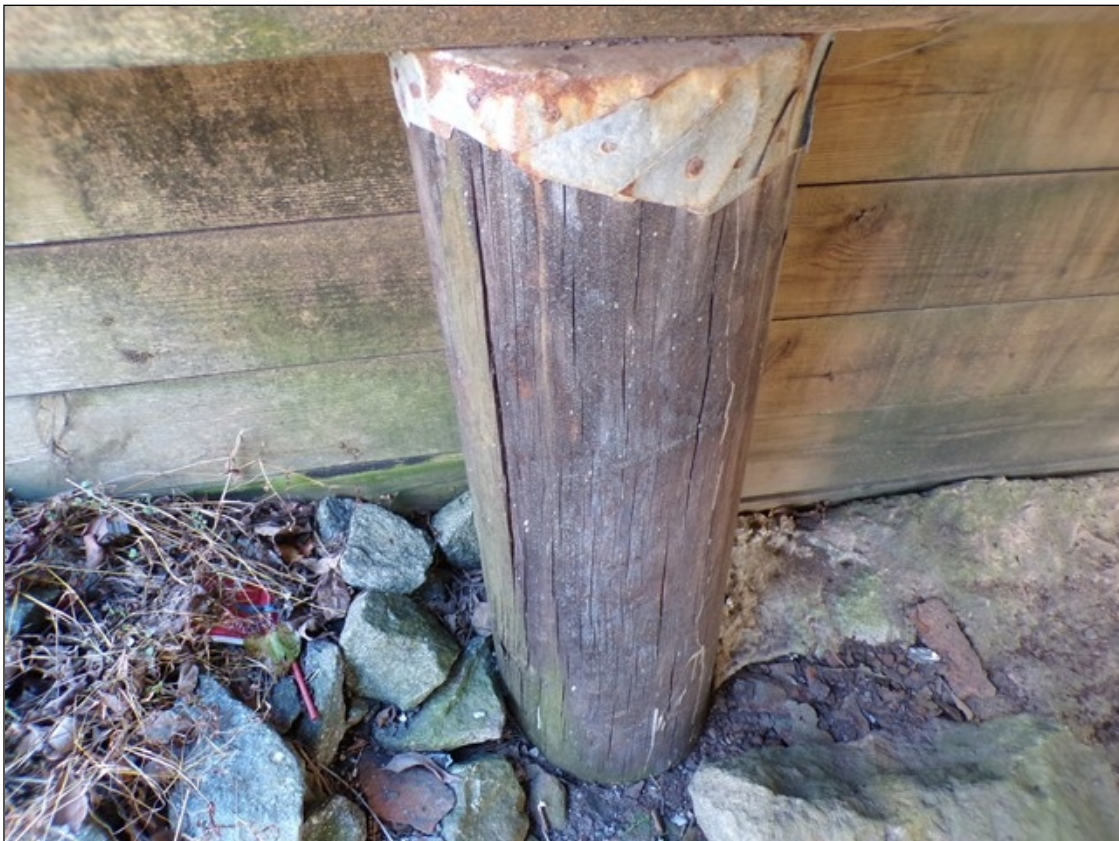
Bent 2 Pile 1: UP TO 1/4 INCH WIDE UP TO 1 INCH DEEP MINOR CHECKS TO PILE

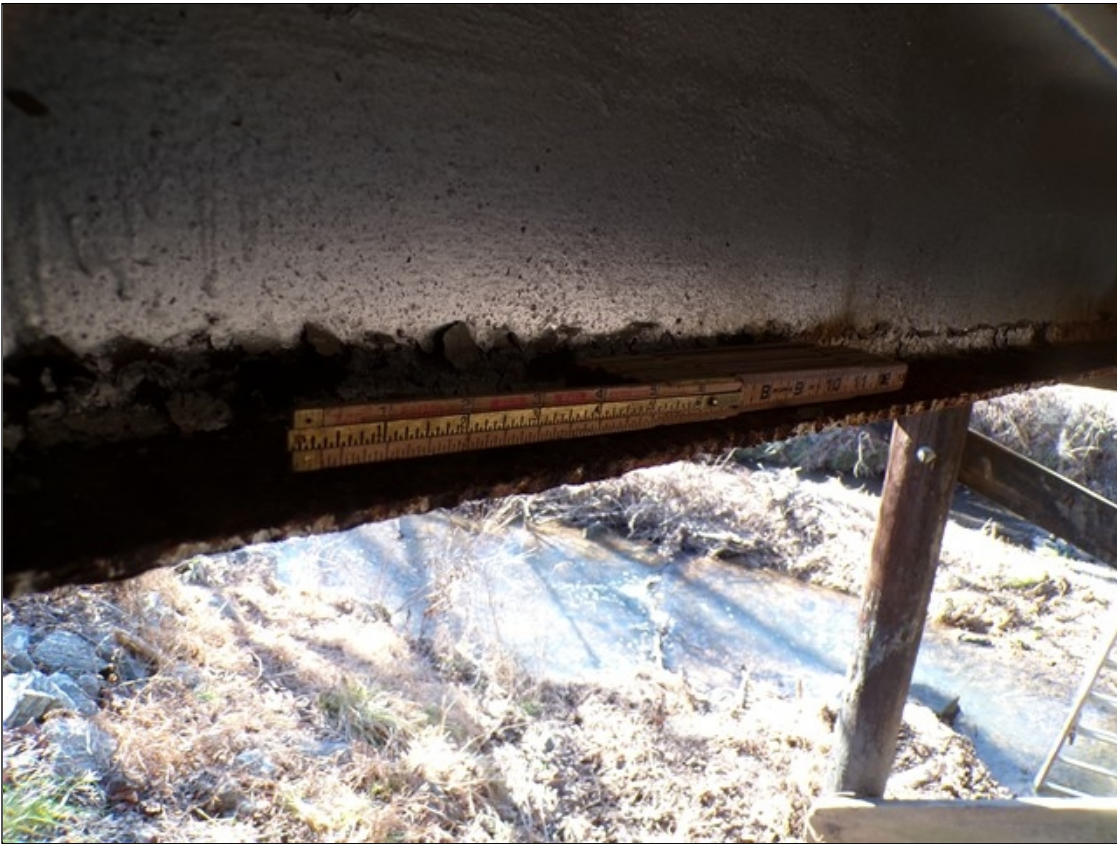
Span 3 Beam 7: (PAR) STARTING 6 FEET FROM NEAR END, TAPERED CORROSION WITH SECTION LOSS TO TOP FLANGE (DOWN TO 0.24 INCH THICKNESS REMAINING) TO BOTH SIDES, FOR 2.5 INCH WIDE X 20 FEET LONG

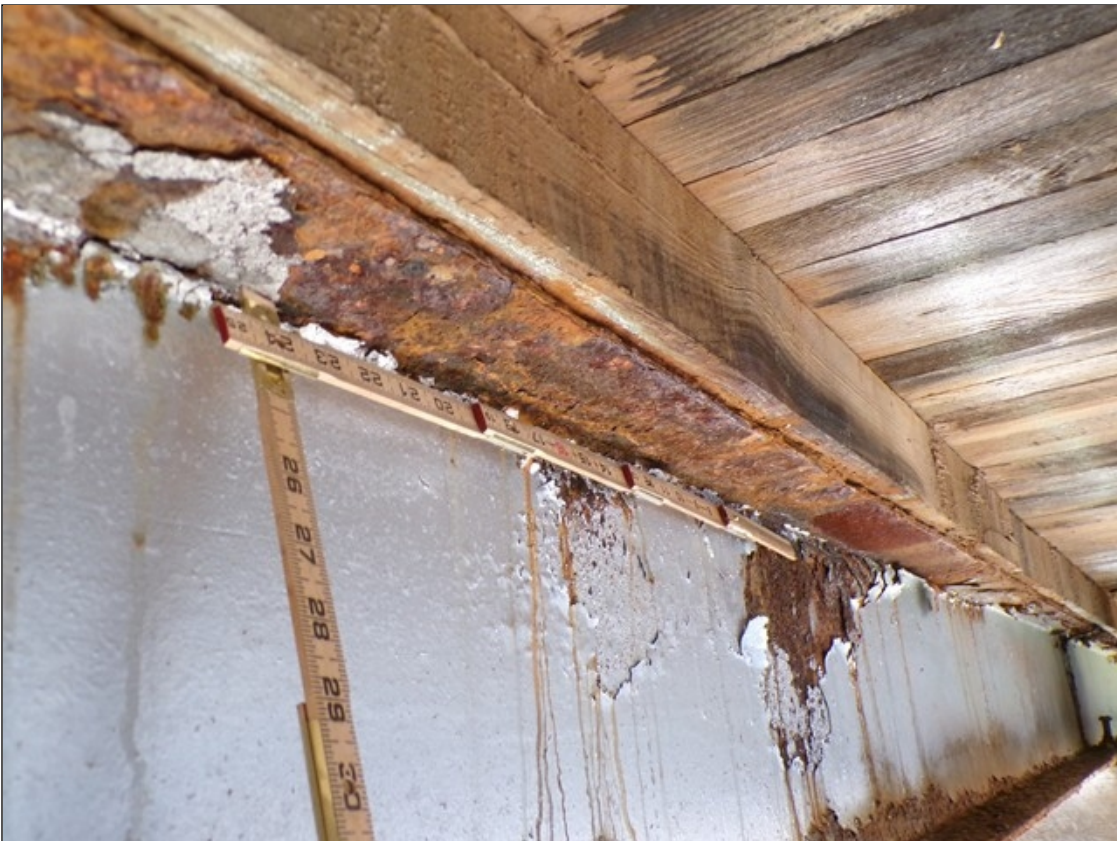
Span 3 Beam 8: (PAR) AT NEAR END, CORROSION WITH SECTION LOSS TO BOTTOM FLANGE (DOWN TO 3/16 INCH THICKNESS REMAINING) TO BOTH SIDES, FOR FULL WIDTH X 20 FEET LONG

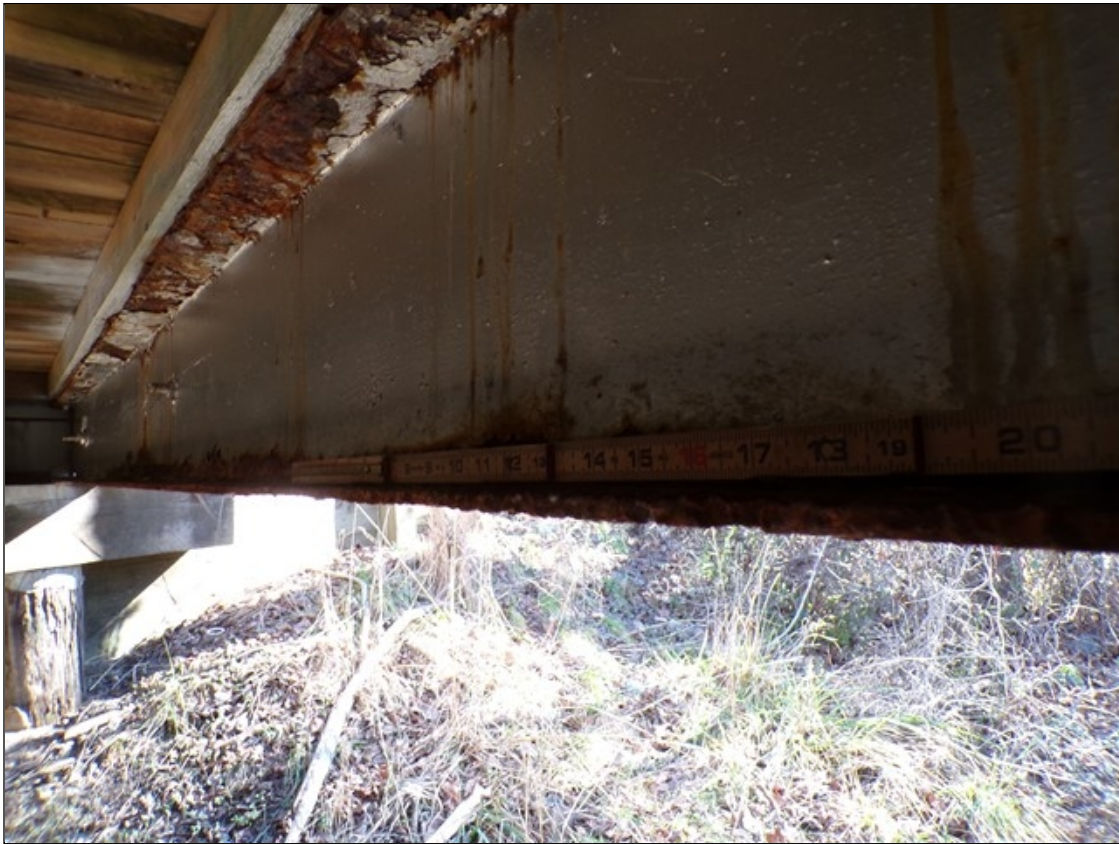
Span 3 Beam 9: STARTING 6 FEET FROM NEAR END (FOR 2 FEET LONG) AND AT NEAR END (FOR 2 FEET LONG), CORROSION WITH SECTION LOSS TO LEFT SIDE OF BOTTOM FLANGE (DOWN TO 1/4 INCH SECTION REMAINING) TO LEFT SIDE, FOR 2 INCH WIDE (PAR)

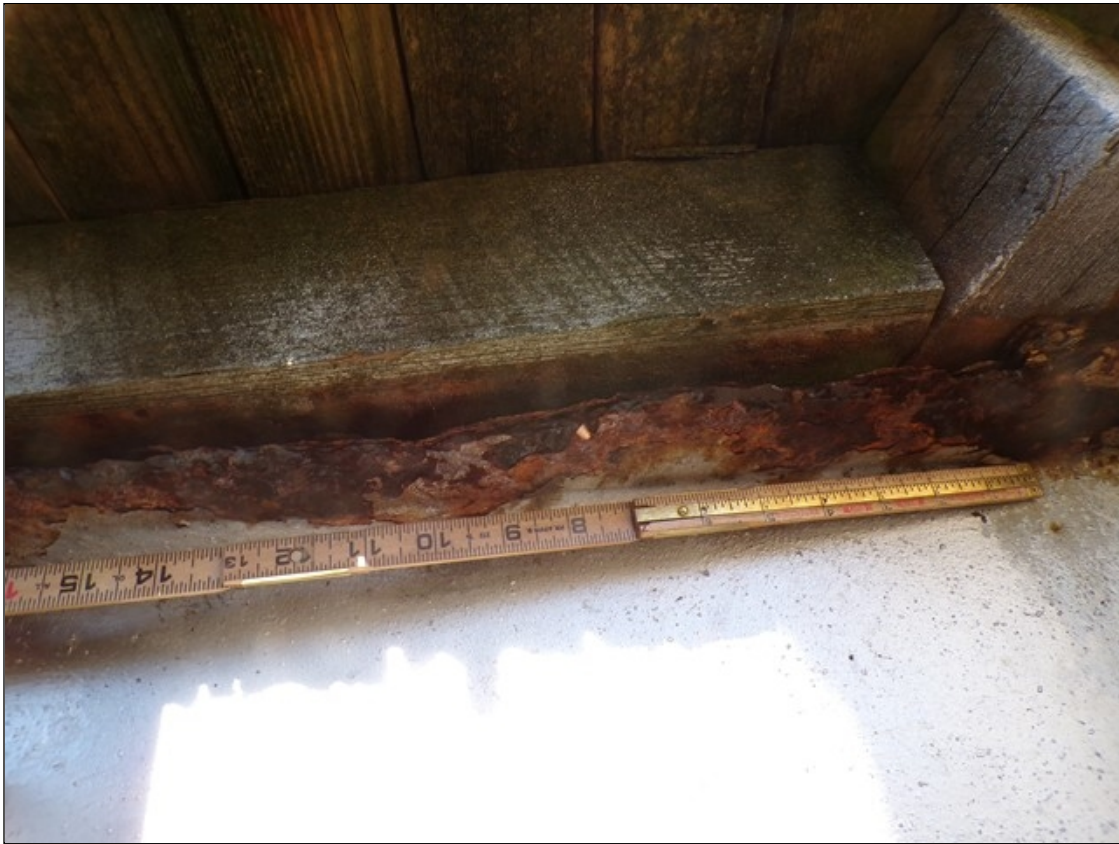
Span 3 Beam 10: (PAR) AT FAR END, CORROSION WITH COMPLETE SECTION LOSS IN LOWER WEB (1 INCH X 7 INCH LONG)

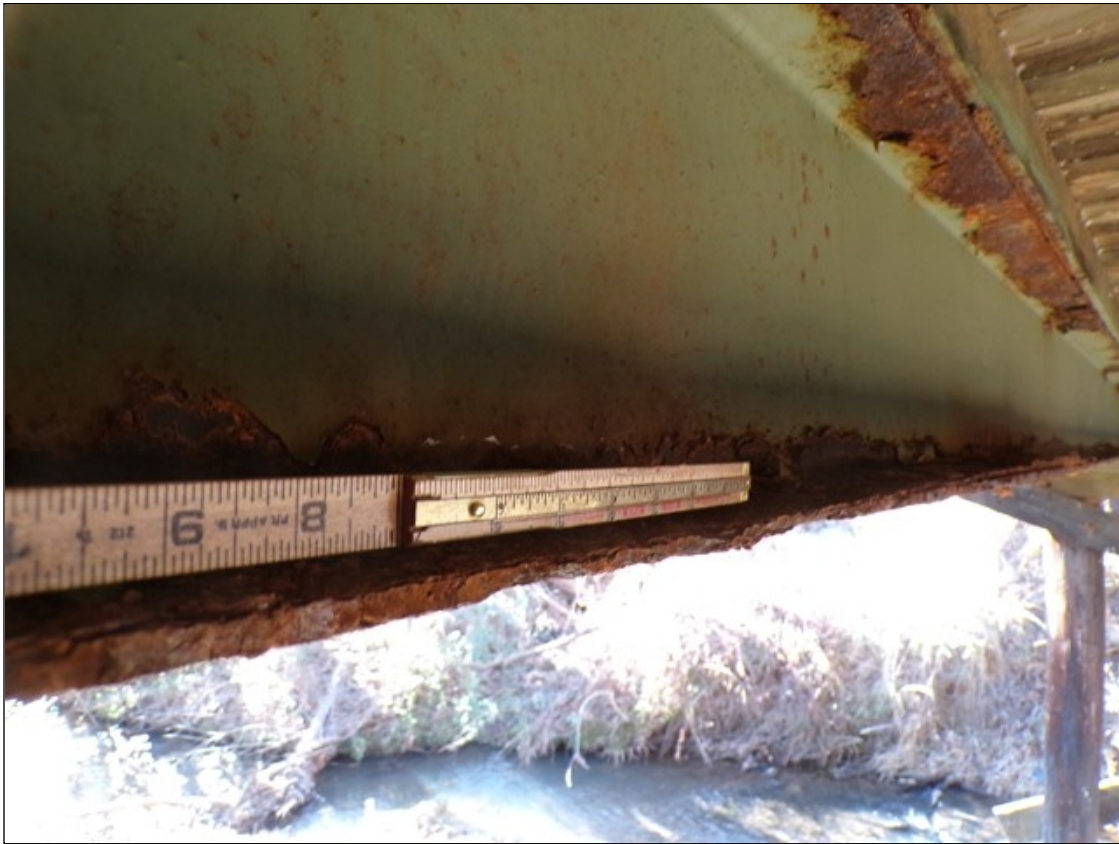
Span 3 Beam 10: (PAR) AT FAR END (FOR 15 FEET LONG) AND AT NEAR END (FOR 5 FEET LONG), TAPERED CORROSION WITH SECTION LOSS AT TOP FLANGE FOR FULL WIDTH, DOWN TO KNIFE'S EDGE THICKNESS REMAINING X REDUCED TO 5.5 INCH WIDTH OF FLANGE REMAINING
