NC DEPARTMENT OF TRANSPORTATION  
DIVISION OF HIGHWAYS  
STRUCTURE MANAGEMENT UNIT  
COUNTY: RUTHERFORD DIV: 13

## Structure Safety Inspection Report

BRIDGE NUMBER: 800239 BRIDGE NAME: \_\_\_\_\_ PREVIOUS BRIDGE NUMBER: \_\_\_\_\_

LATITUDE: 35.48940000 LONGITUDE: -81.99338000 ROUTE: SR1325 M.P.: 0.0

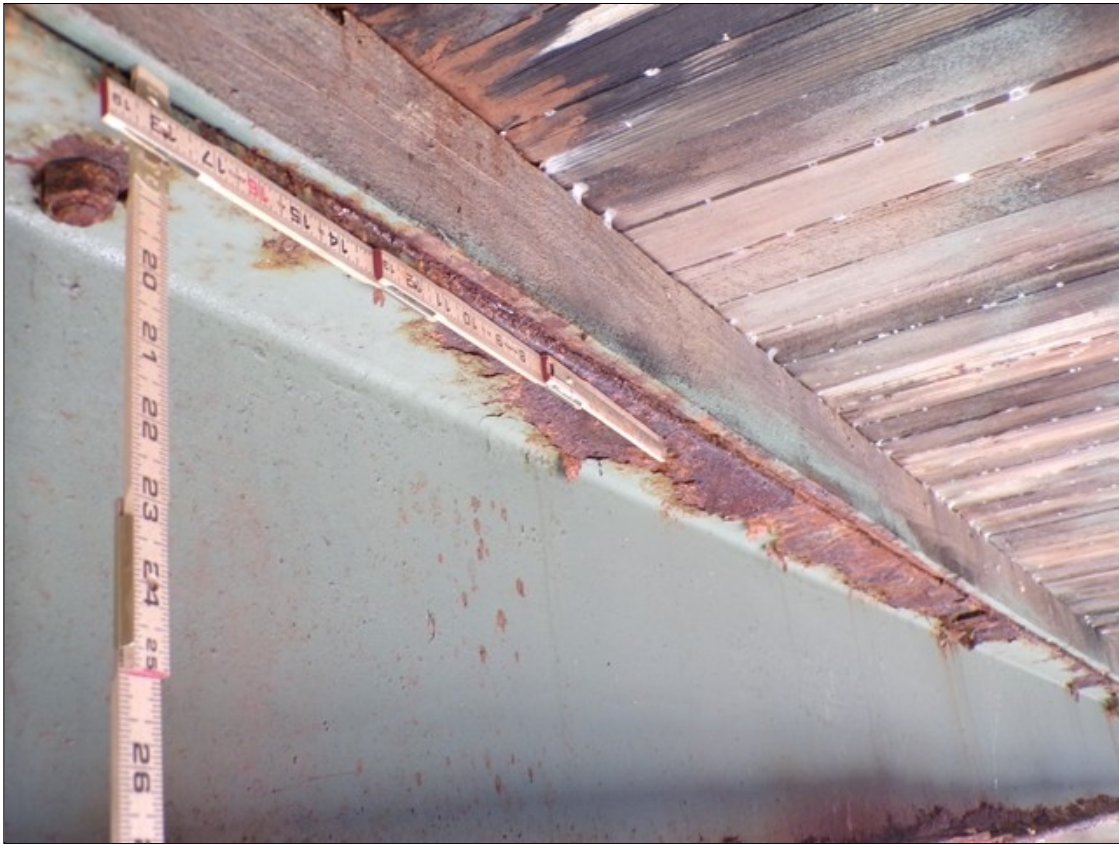
Span 2 Beam 9: (PAR) CORROSION WITH SECTION LOSS TO BOTTOM FLANGE (DOWN TO 3/16 INCH THICKNESS REMAINING) FOR 3 INCH WIDE X FULL LENGTH AND LOWER WEB SECTION LOSS (DOWN TO 0.16 INCH THICKNESS REMAINING) FOR 2 INCH HIGH ON BOTH SIDES

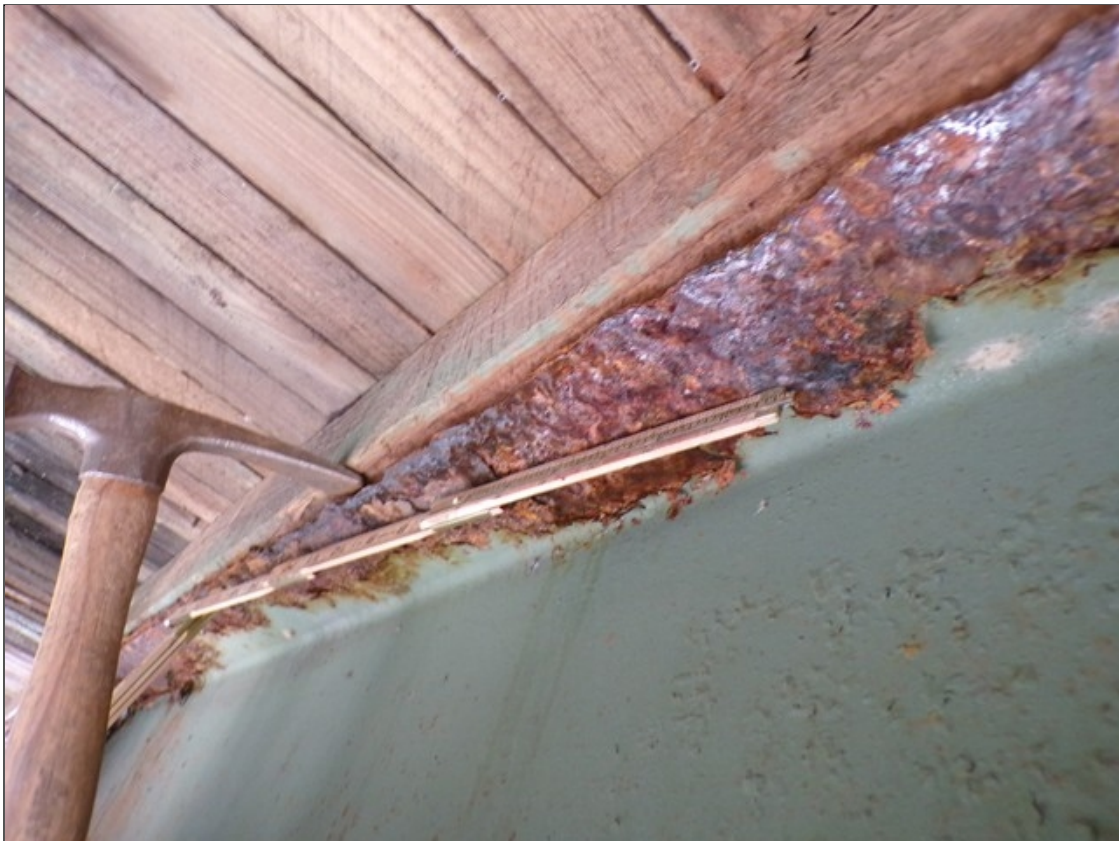
Span 2 Beam 9: (PAR) TOP FLANGE TAPERED CORROSION WITH SECTION LOSS, 0.20 INCH AVERAGE THICKNESS REMAINING X FULL WIDTH X FULL LENGTH

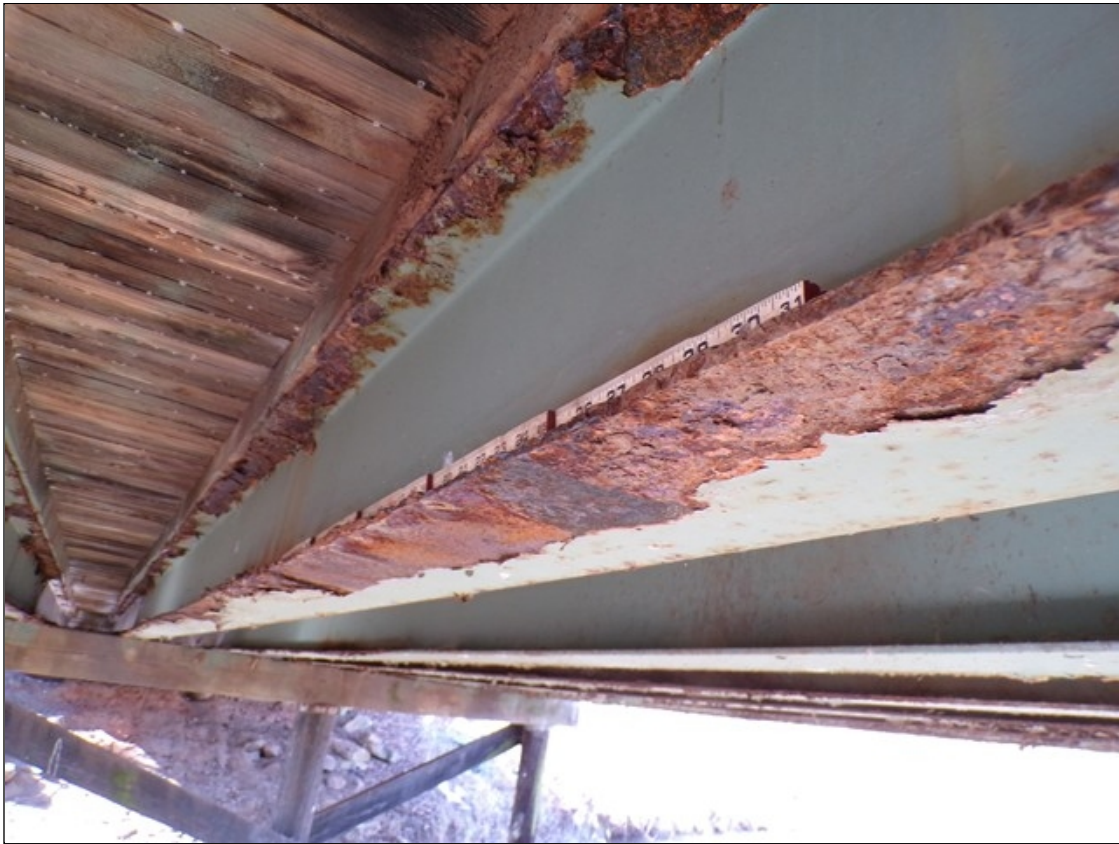
SPAN 2 Beam 9: 2 FEET X 1/8 INCH AREA OF 100% SECTION LOSS ON LEFT SIDE OF TOP FLANGE NEAR BENT 2 (PAR)

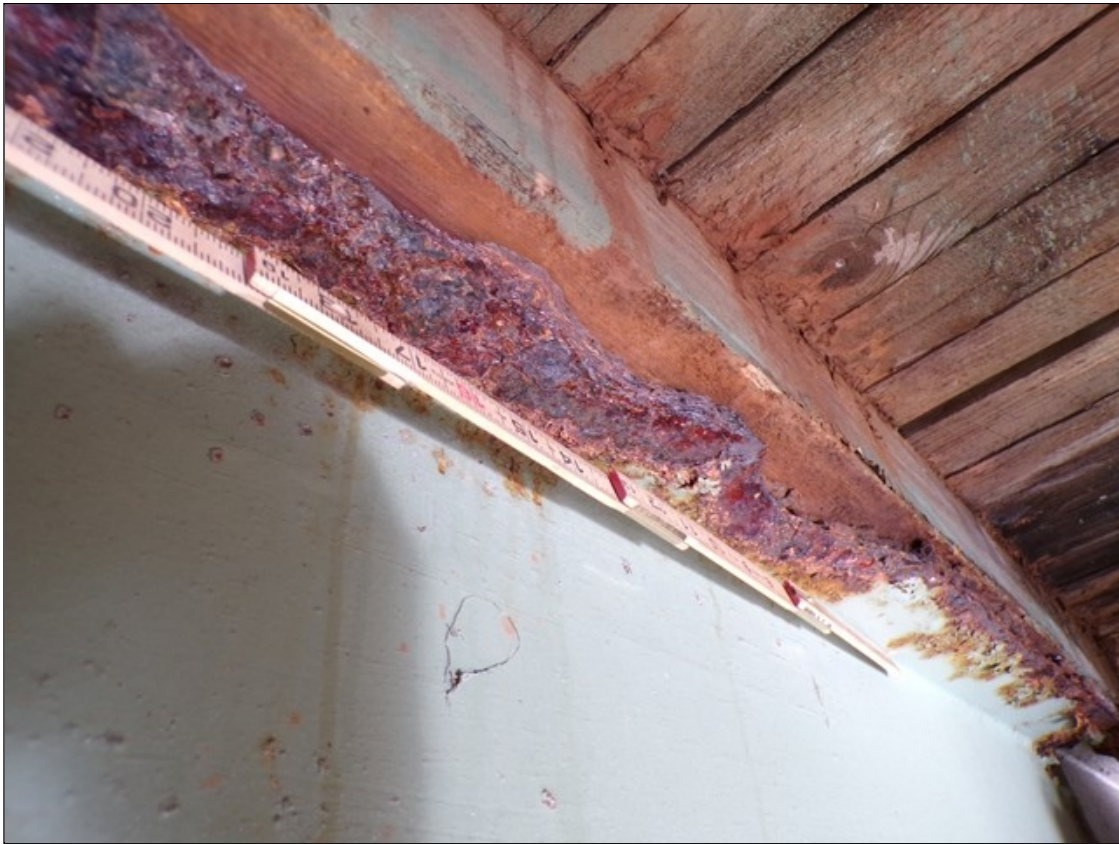
Span 2 Beam 8: (PAR) INTERMITTENT THROUGHOUT, BOTTOM FLANGE CORROSION WITH SECTION LOSS, 0.15 INCH AVERAGE REMAINING X 3 INCH WIDE, WITH WEB CORROSION 3/16 INCH THICK X UP TO 3 INCH HIGH

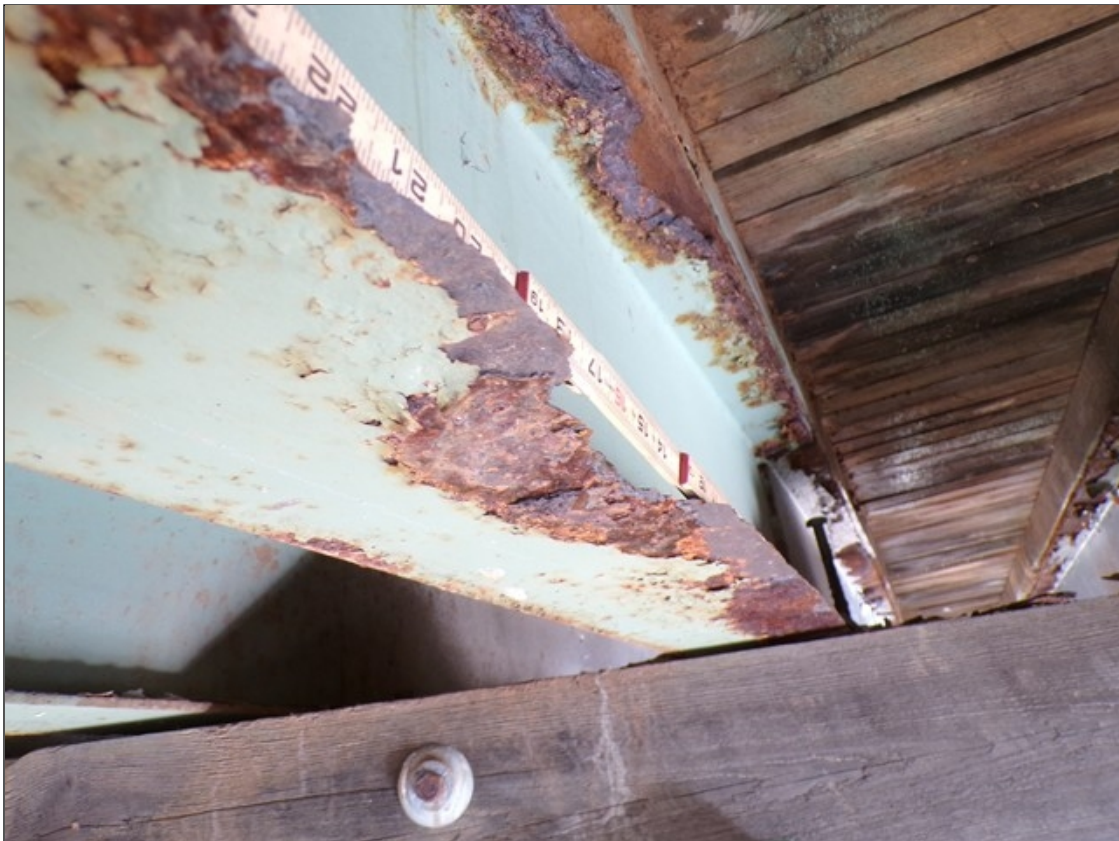
Span 2 Beam 8: (PAR) TOP FLANGE TAPERED CORROSION WITH SECTION LOSS, 1/8 INCH AVERAGE THICKNESS REMAINING DOWN TO KNIFE'S EDGE X FULL WIDTH REDUCED TO 5 INCH WIDE X 22 FEET

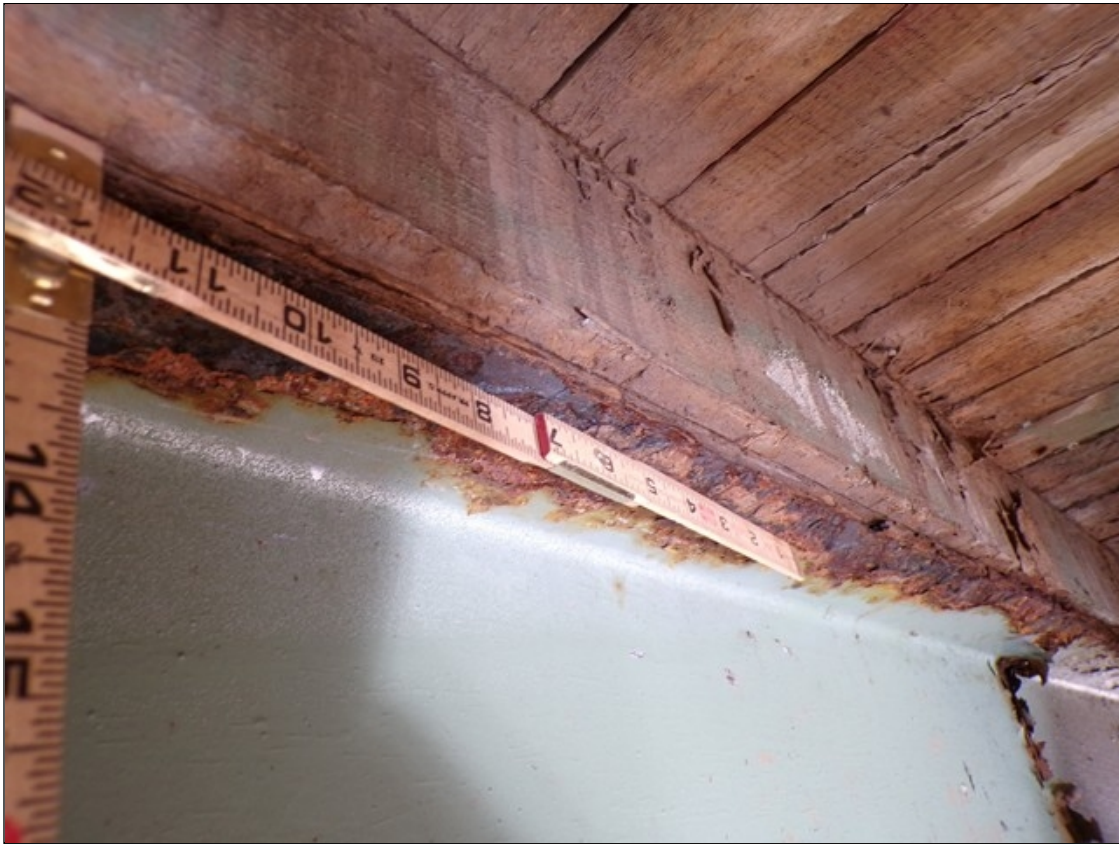
Span 2 Beam 8: 20 INCH X UP TO 1 INCH AREA OF 100% SECTION LOSS ON RIGHT SIDE OF BOTTOM FLANGE, 2 FEET FROM BENT 2 (PAR)

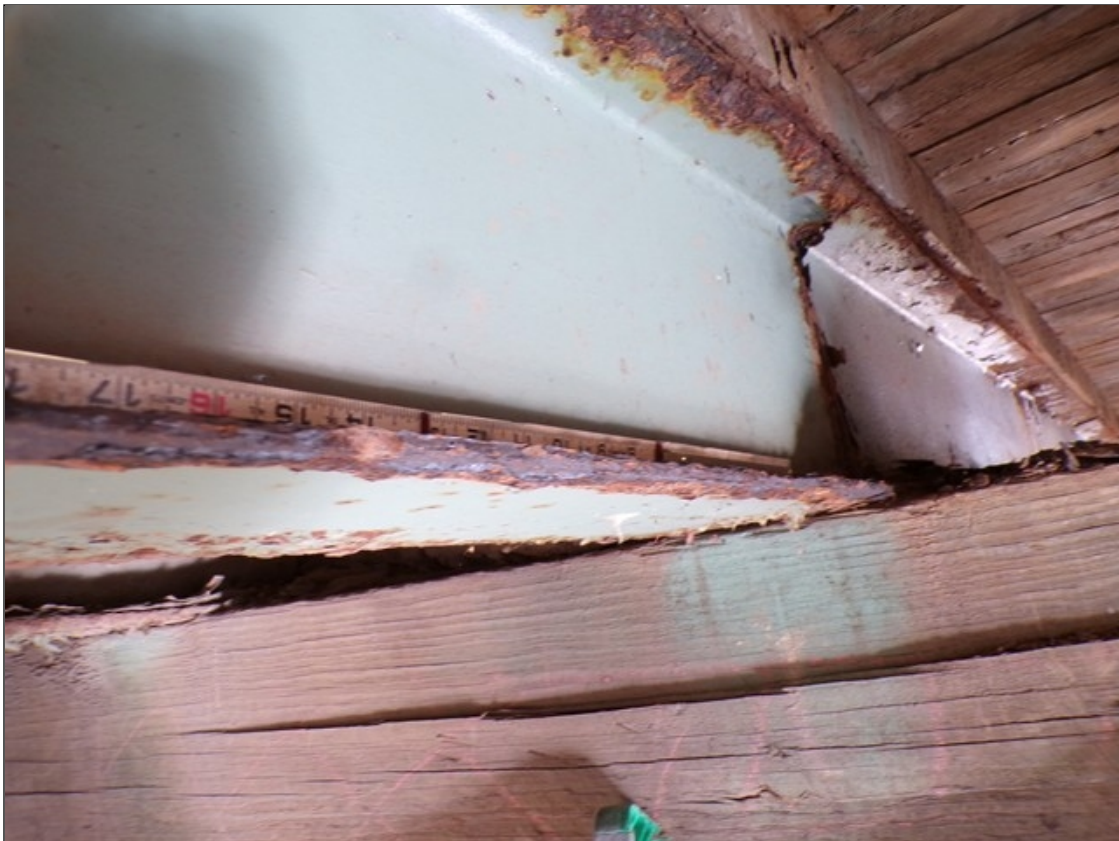
Span 2 Beam 5: (PAR) FULL LENGTH TOP FLANGE TAPERED CORROSION WITH SECTION LOSS DOWN TO KNIFE'S EDGE REMAINING WITH 13 FEET LONG AREA REDUCED TO 5 INCH WIDE BEGINNING AT NEAR END

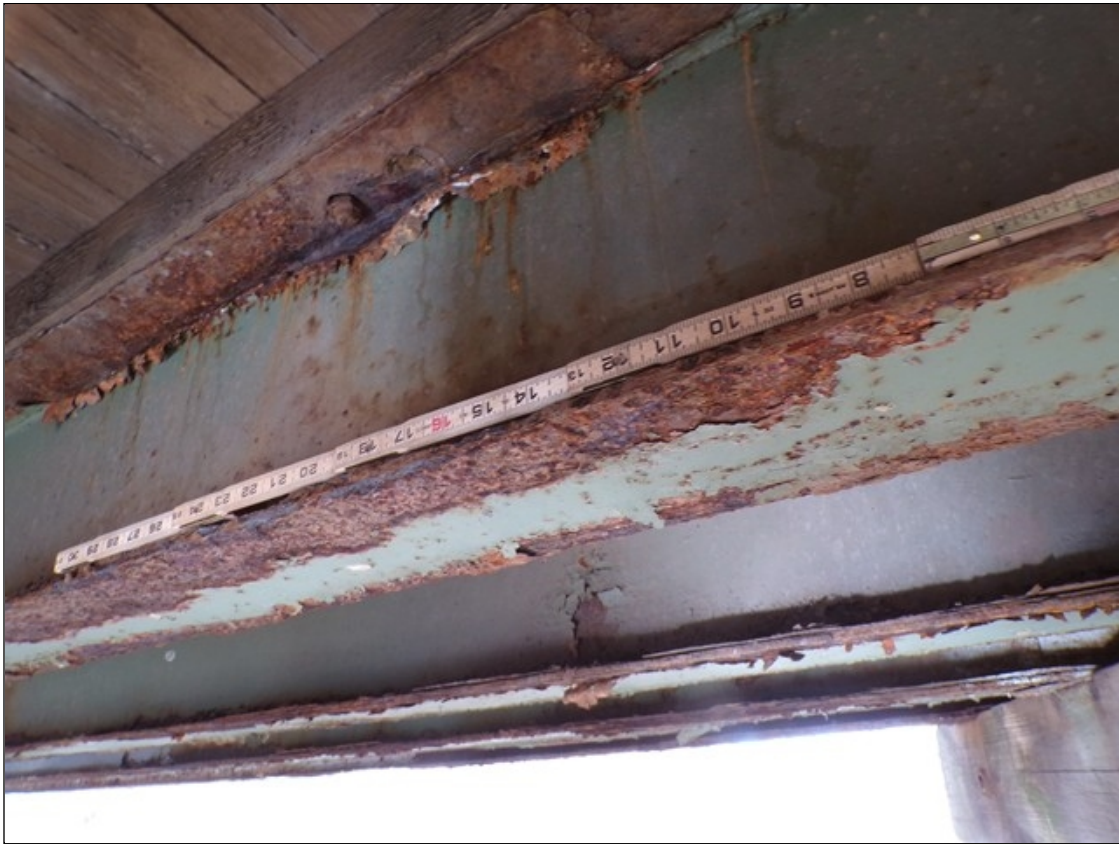
Span 2 Beam 5: (PAR) INTERMITTENT THROUGHOUT, BOTTOM FLANGE CORROSION WITH SECTION LOSS (0.26 INCH THICKNESS REMAINING X 18 FEET), AND LOWER WEB (1/8 INCH THICK X 2 INCH)

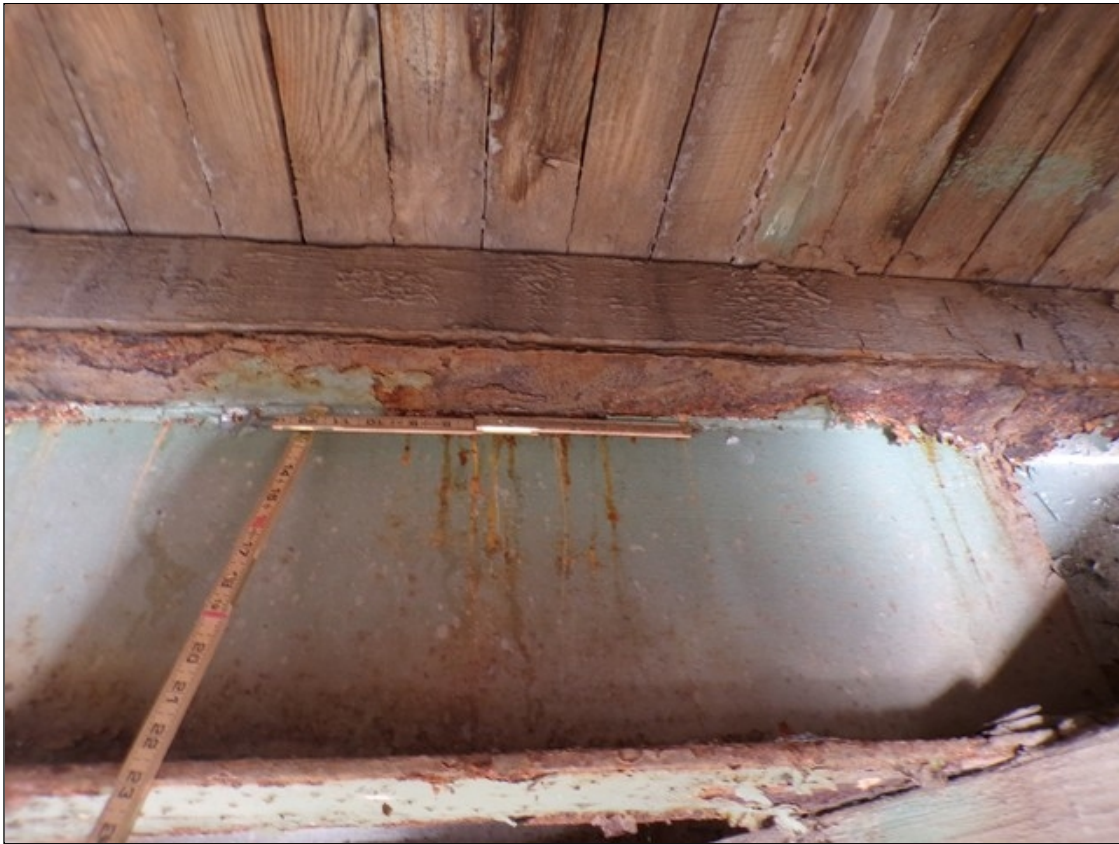
Span 2 Beam 4: (PAR) BOTTOM FLANGE SECTION LOSS (DOWN TO 0.15 INCH THICKNESS REMAINING ON BOTH SIDES) FOR 2 INCH WIDE X FULL LENGTH ON LEFT SIDE AND FOR 2 INCH WIDE X 20 FEET INTERMITTENT LENGTH ON RIGHT SIDE AND LOWER WEB SECTION LOSS (DOWN TO 3/16 INCH THICKNESS REMAINING) FOR 1 INCH HIGH

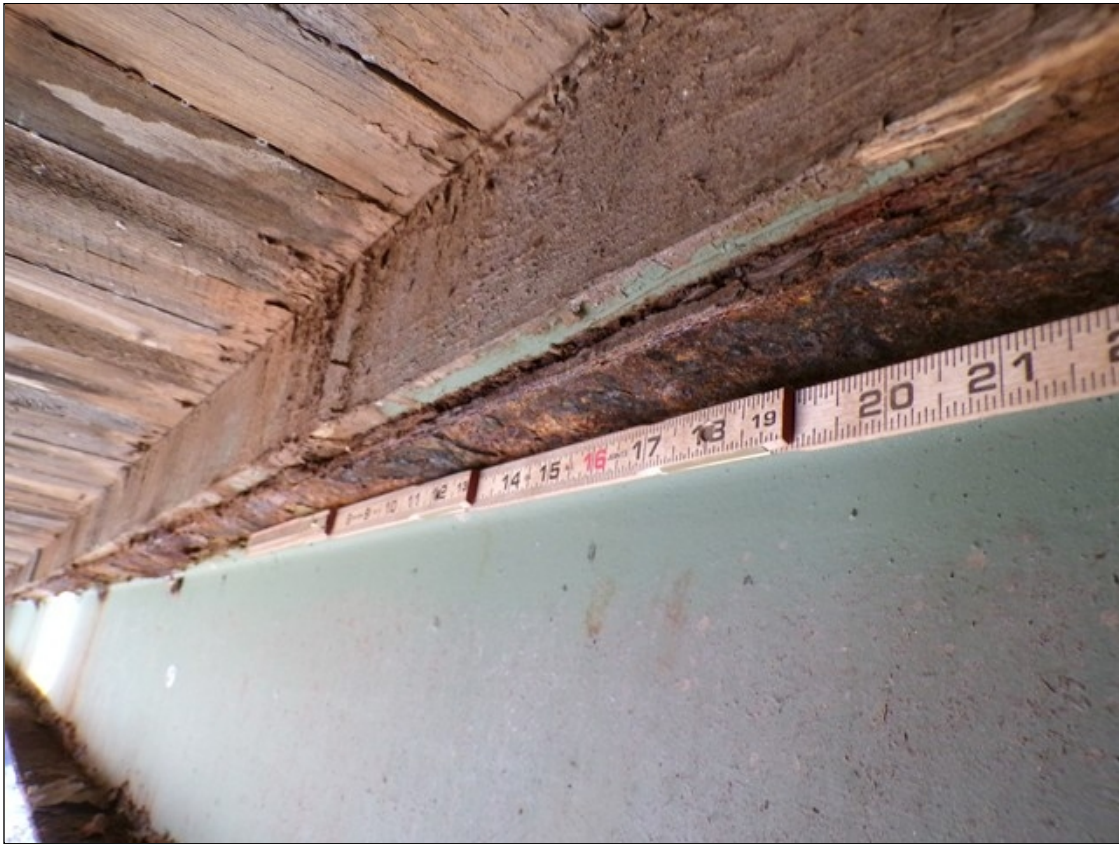
Span 2 Beam 4: (PAR) TOP FLANGE TAPERED CORROSION WITH SECTION LOSS, 1/8 INCH AVERAGE THICKNESS REMAINING DOWN TO KNIFE'S EDGEX FULL LENGTH (WITH AREAS REDUCED TO 5 INCH WIDE)

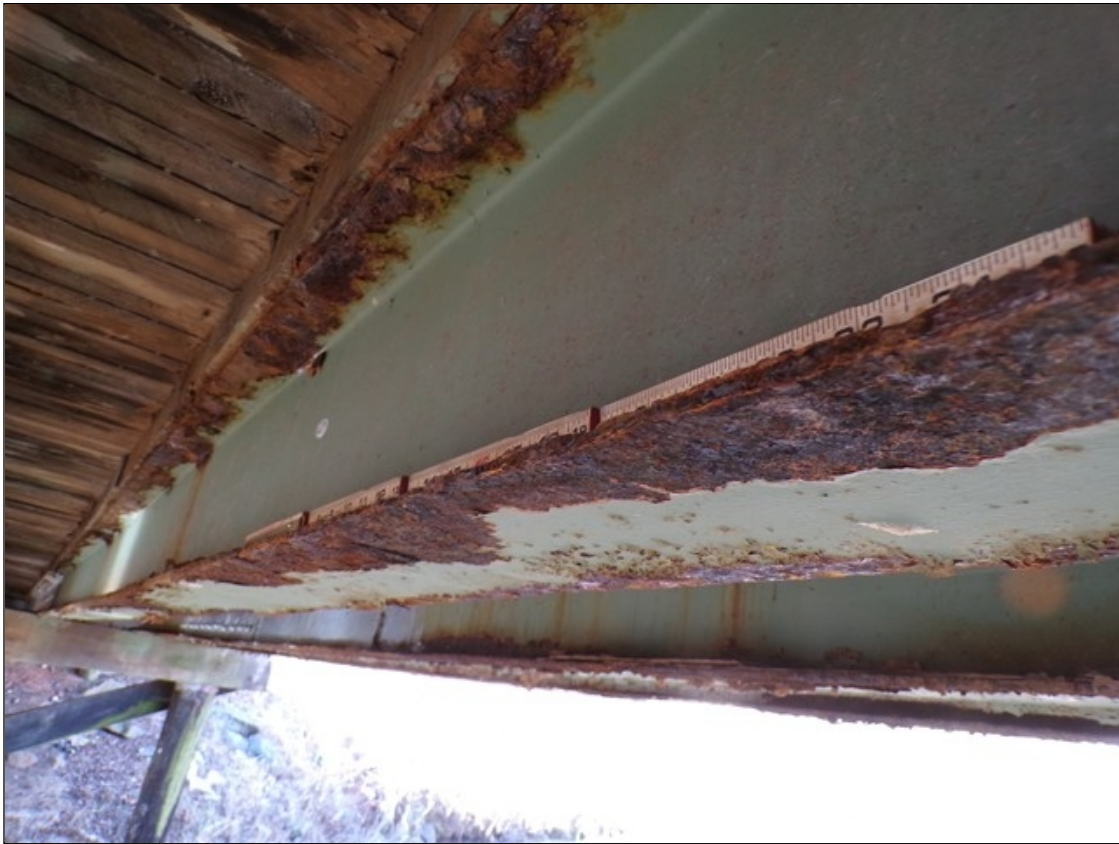
Span 2 Beam 3: (PAR) STARTING 5 FEET FROM NEAR END, TOP FLANGE TAPERED CORROSION WITH SECTION LOSS, 1/8 INCH AVERAGE THICKNESS REMAINING DOWN TO KNIFE'S EDGE X FULL WIDTH X 19 FEET (WITH AREAS OF 100% SECTION LOSS UP TO 10 INCH LONG X 3/4 INCH WIDE)

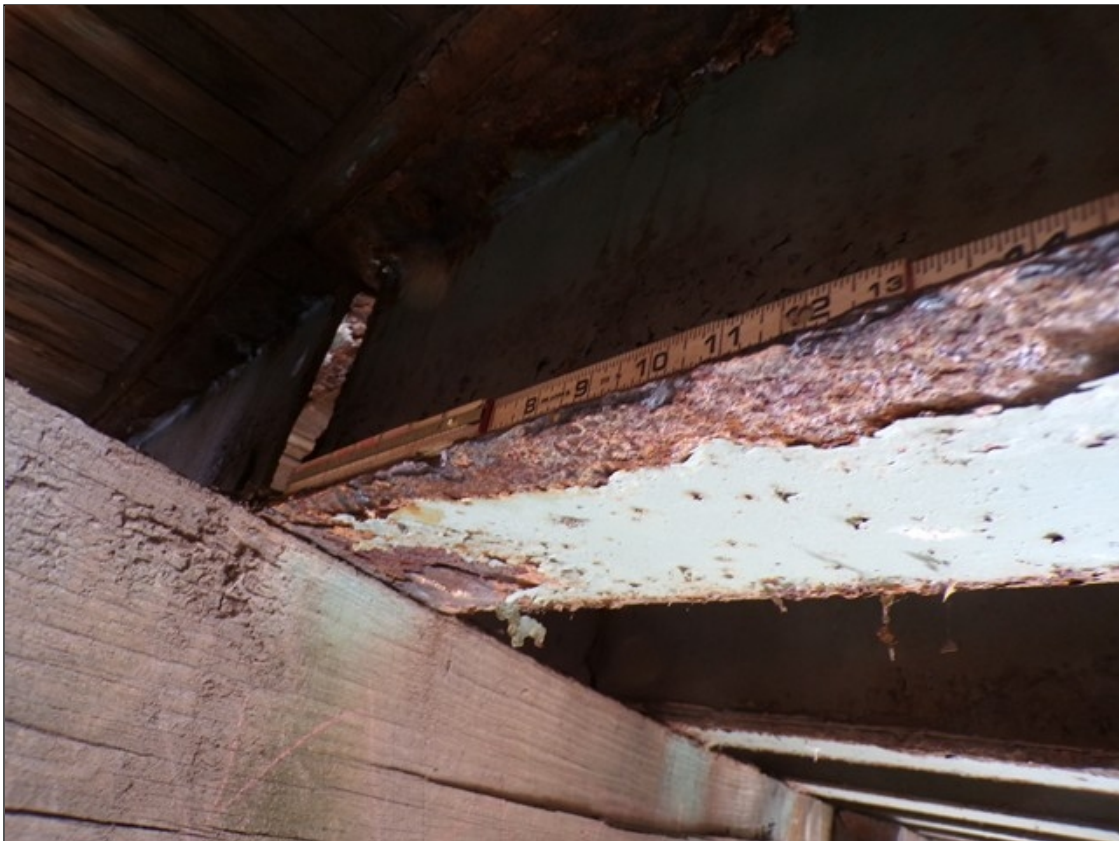
Span 2 Beam 3: (PAR) INTERMITTENT THROUGHOUT, CORROSION WITH SECTION LOSS TO BOTTOM FLANGE (DOWN TO 3/16 INCH SECTION REMAINING) TO BOTH SIDES, 2 INCH WIDE X 14 FEET LONG

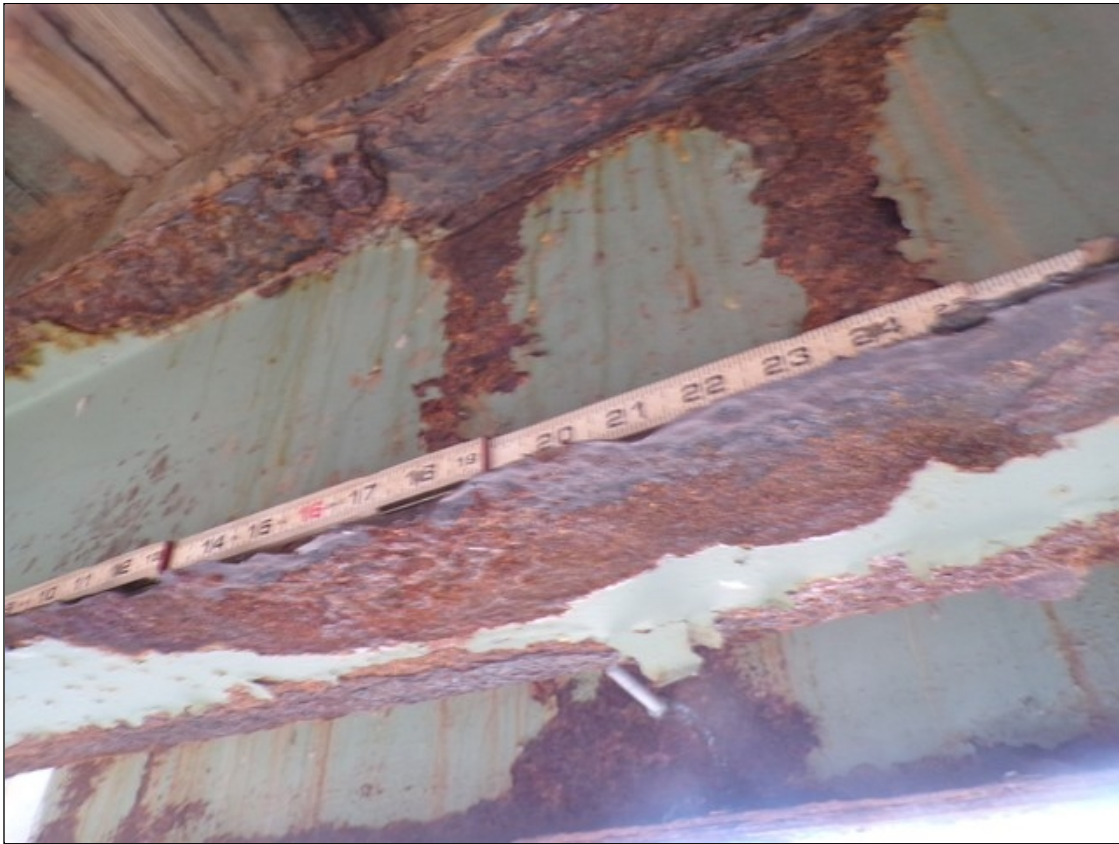
SPAN 2 Beam 4: 20 INCH X 1 1/2 INCH AREA OF SECTION LOSS WITH KNIFE EDGE REMAINING WITH 1 INCH X 1/2 INCH AREA OF 100% SECTION LOSS ON LEFT SIDE OF BOTTOM FLANGE AT BENT 2 (PAR)

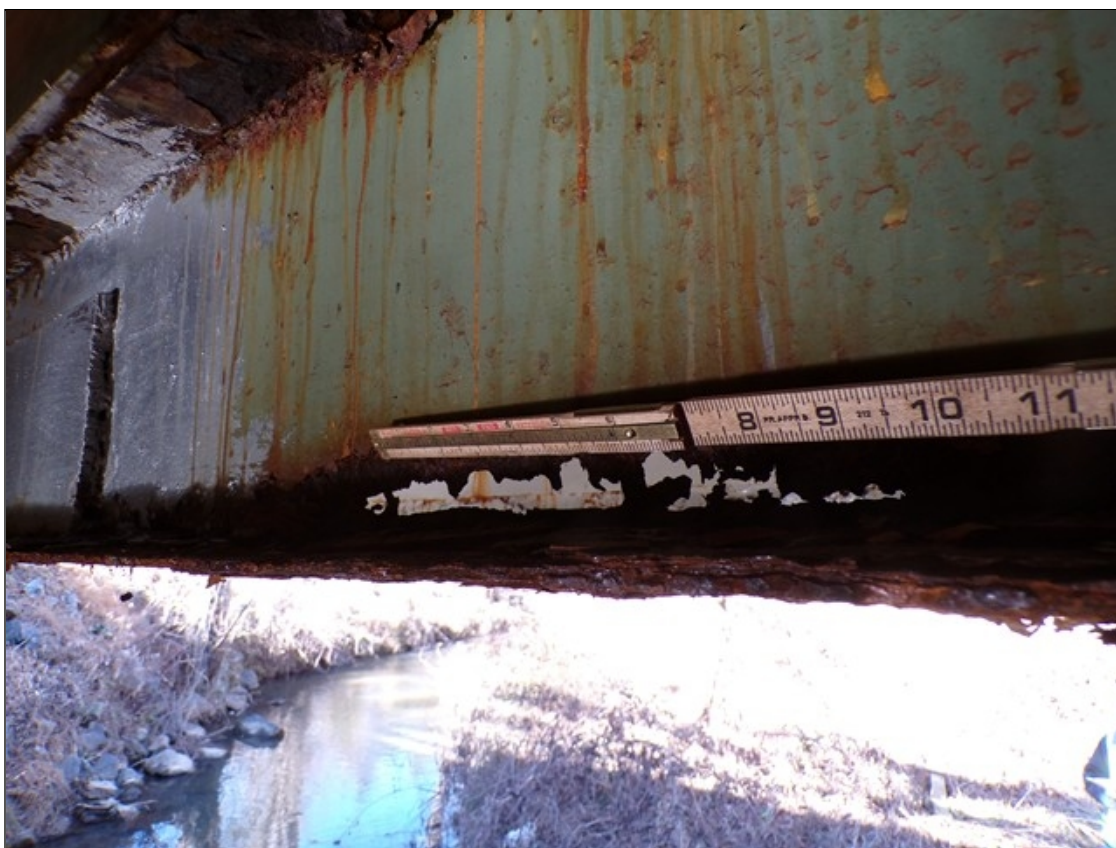
SPAN 2 Beam 2: (PAR) BOTTOM FLANGE CORROSION WITH SECTION LOSS, 1/8 INCH AVERAGE THICKNESS REMAINING X FULL LENGTH (AREAS OF 100% SECTION LOSS, LEFT SIDE 6 FEET FROM BENT 1, 3 FEET LONG X 1 INCH WIDE AND 2 FEET X 1/4 INCH AREA OF 100% SECTION LOSS ON RIGHT SIDE AT BENT 2)

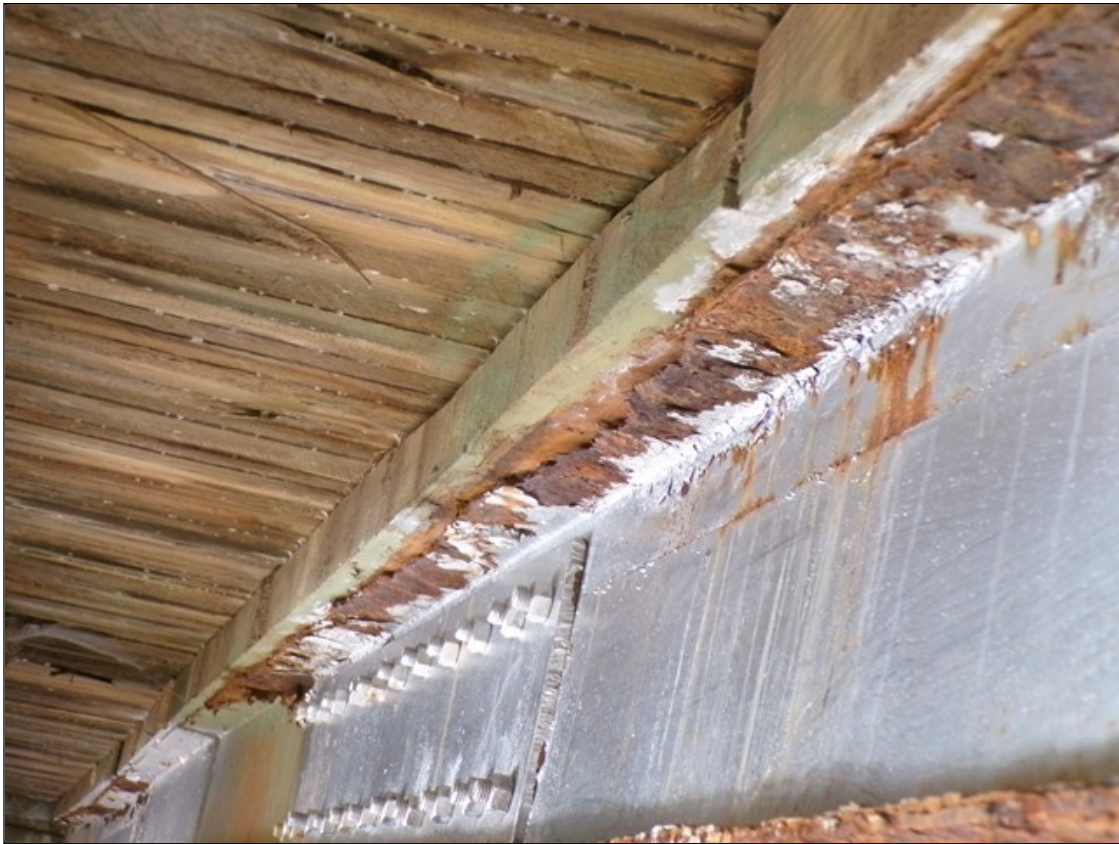
Span 2 Beam 2: 11 INCH X 1 INCH AREA OF 100% SECTION LOSS ON LOWER WEB, 8 FEET FROM BENT 2 (PAR)

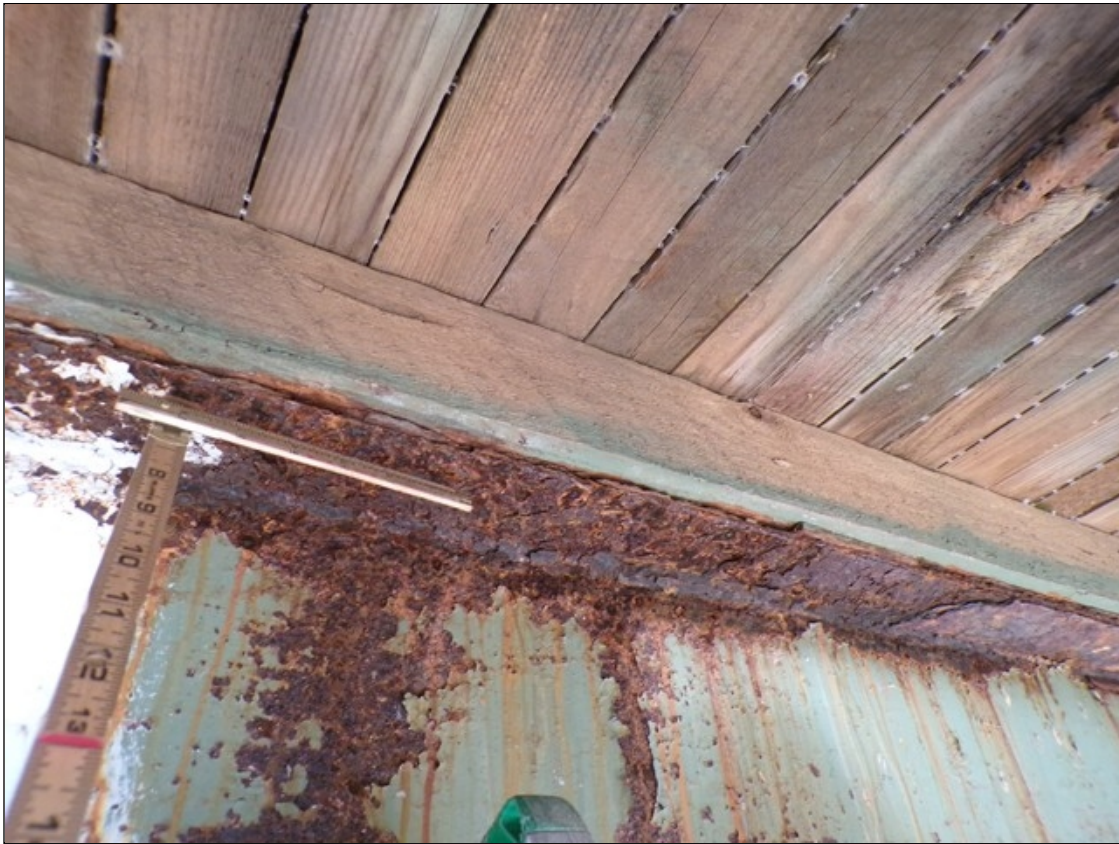
Span 2 Beam 2: (PAR) TOP FLANGE TAPERED CORROSION WITH SECTION LOSS, 1/8 INCH AVERAGE THICKNESS REMAINING X FULL LENGTH (WITH 2 FEET LONG AREA REDUCED TO 5 INCH WIDE NEAR MIDSPAN)

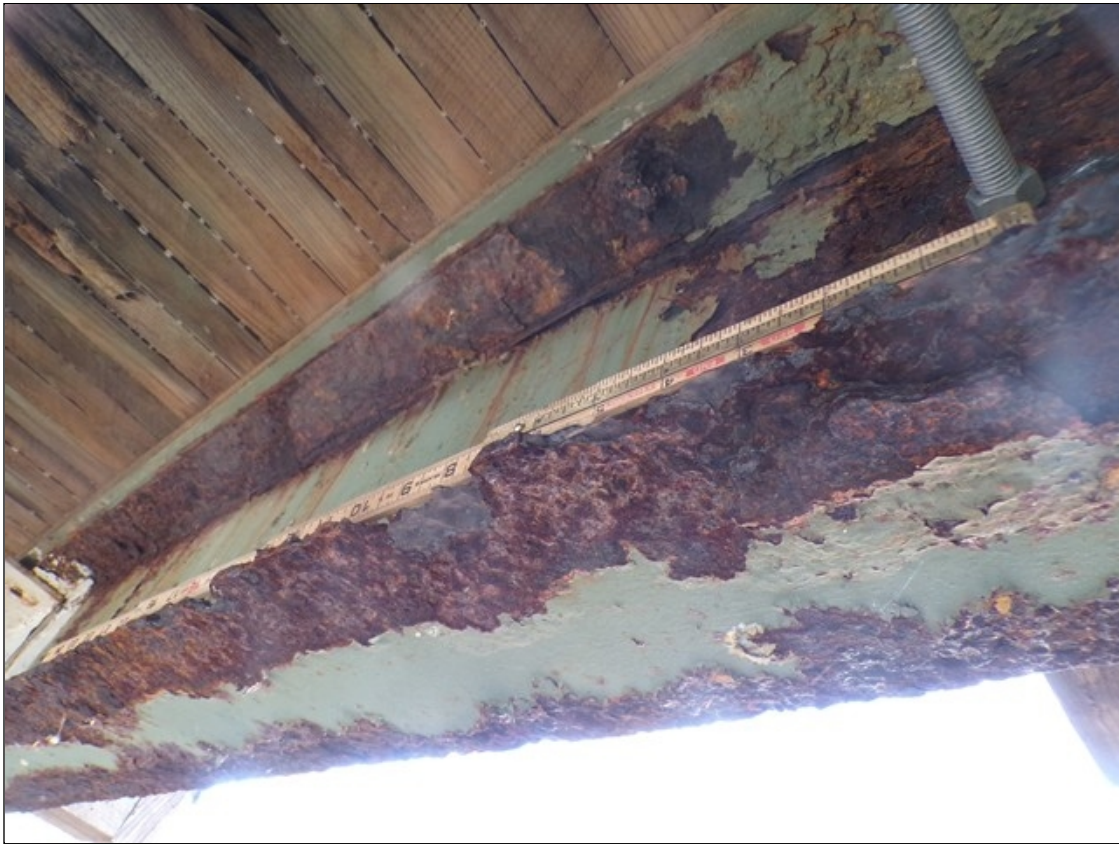
Span 2 Beam 1: (PAR) TOP FLANGE TAPERED CORROSION WITH SECTION LOSS, DOWN TO KNIFE'S EDGE  
REMAINING X FULL LENGTH (WITH AREAS OF 100% SECTION LOSS)

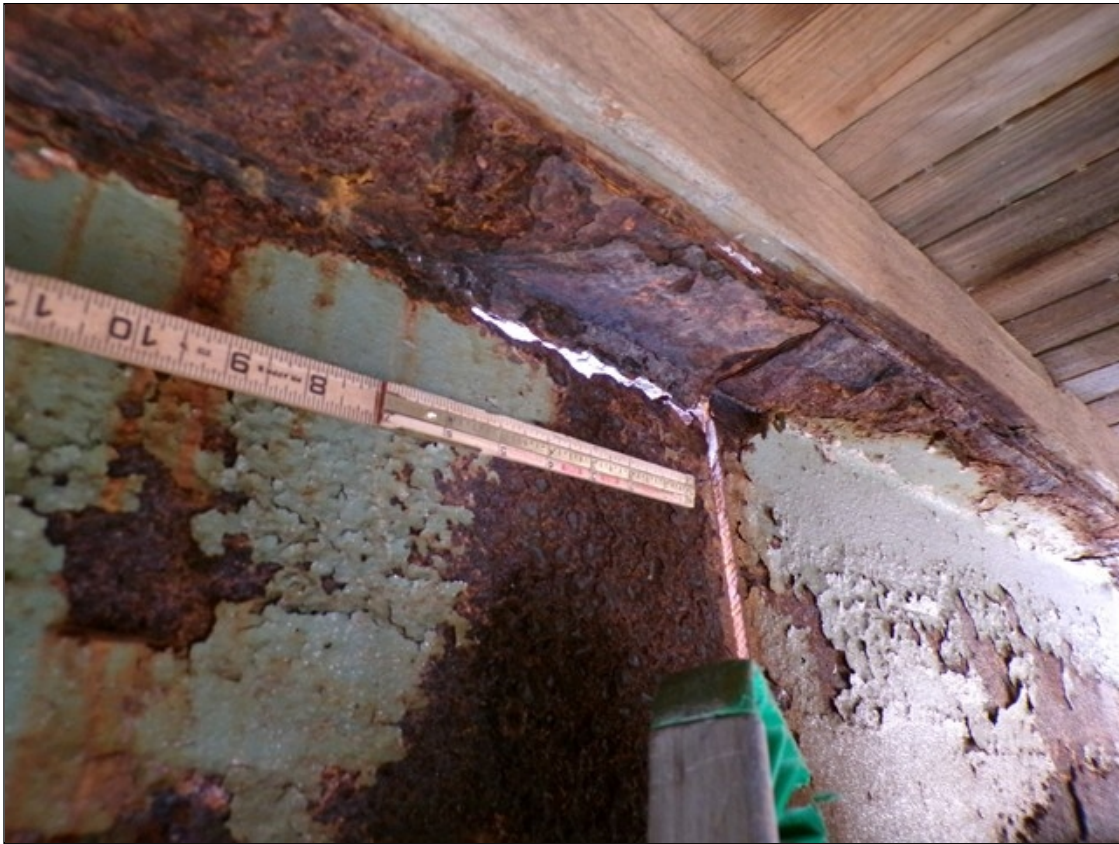
Span 2 Beam 1: (PAR) BOTTOM FLANGE CORROSION WITH SECTION LOSS (DOWN TO KNIFE EDGE REMAINING AND (2) UP TO 20 INCH X 1/2 INCH AREA OF 100% SECTION LOSS) TO BOTH SIDES, 3 INCH WIDE X FULL LENGTH, AND WEB SECTION LOSS DOWN TO 1/8 INCH THICKNESS REMAINING IN BOTTOM 3 INCH

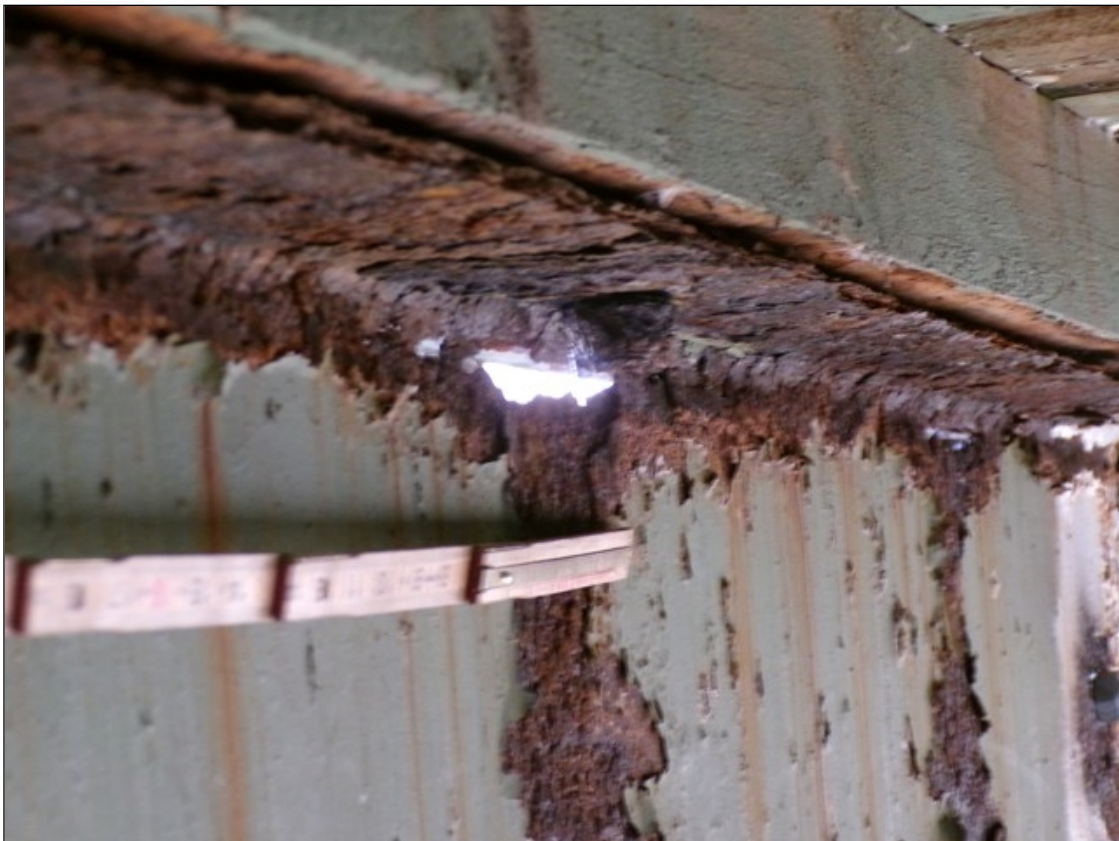
SPAN 2 Beam 1: 7 INCH X 3/4 INCH AREA OF 100% SECTION LOSS ON UPPER WEB AT BENT 2 (PAR)

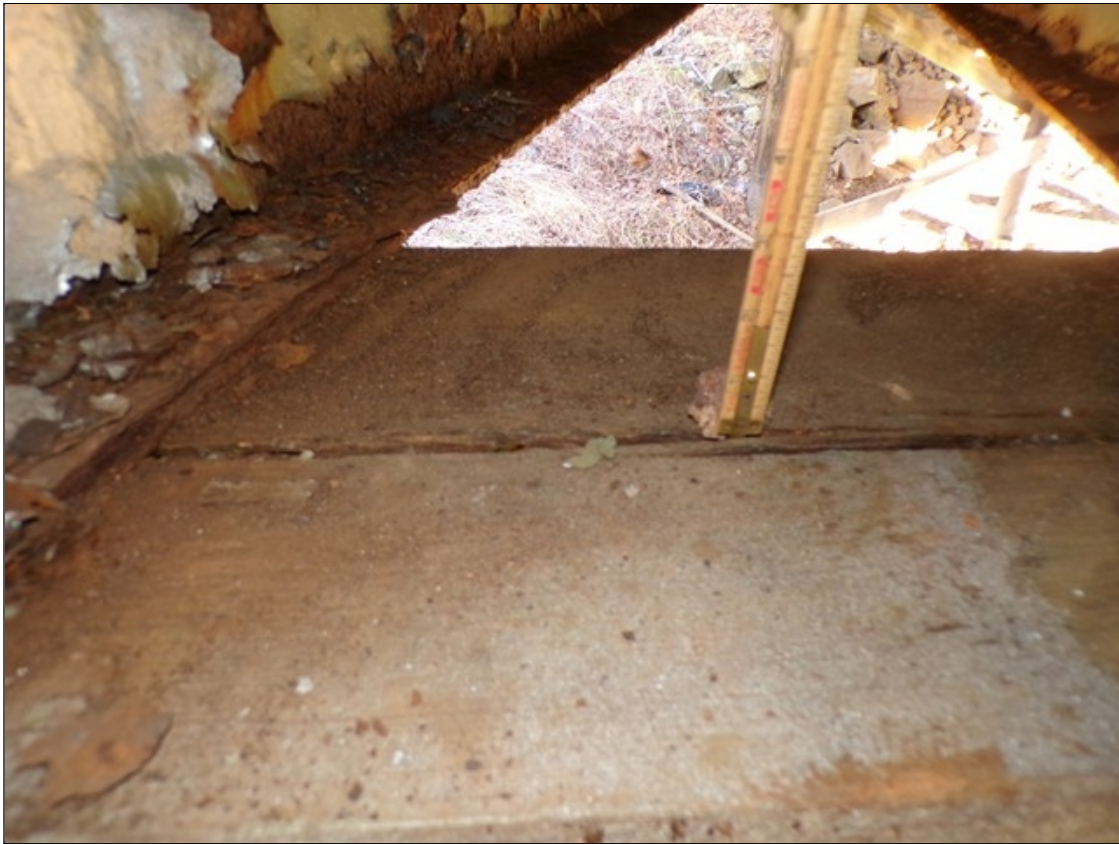
Span 2 Beam 1: (PAR) 4 FEET AND 5.5 FEET FROM BENT 1, TOP OF WEB, (WITH (2) AREAS UP TO 100% SECTION LOSS) 5 INCH LONG X 1/2 INCH HIGH

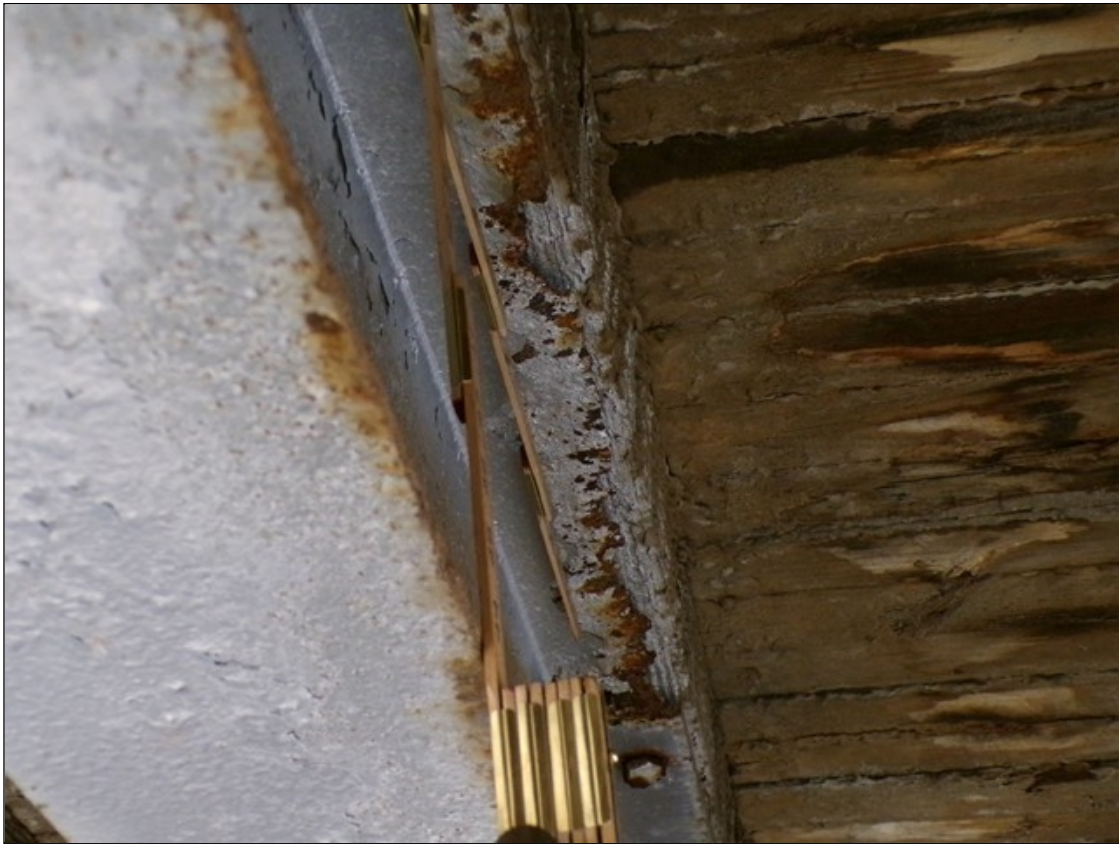
Span 1 Beam 3: (PAR) AT FAR END ABOVE REPAIR PLATE, TOP FLANGE TAPERED SECTION LOSS, 1/8 INCH AVERAGE REMAINING X FULL WIDTH X 8 FEET (WITH AREAS OF 100% SECTION LOSS)

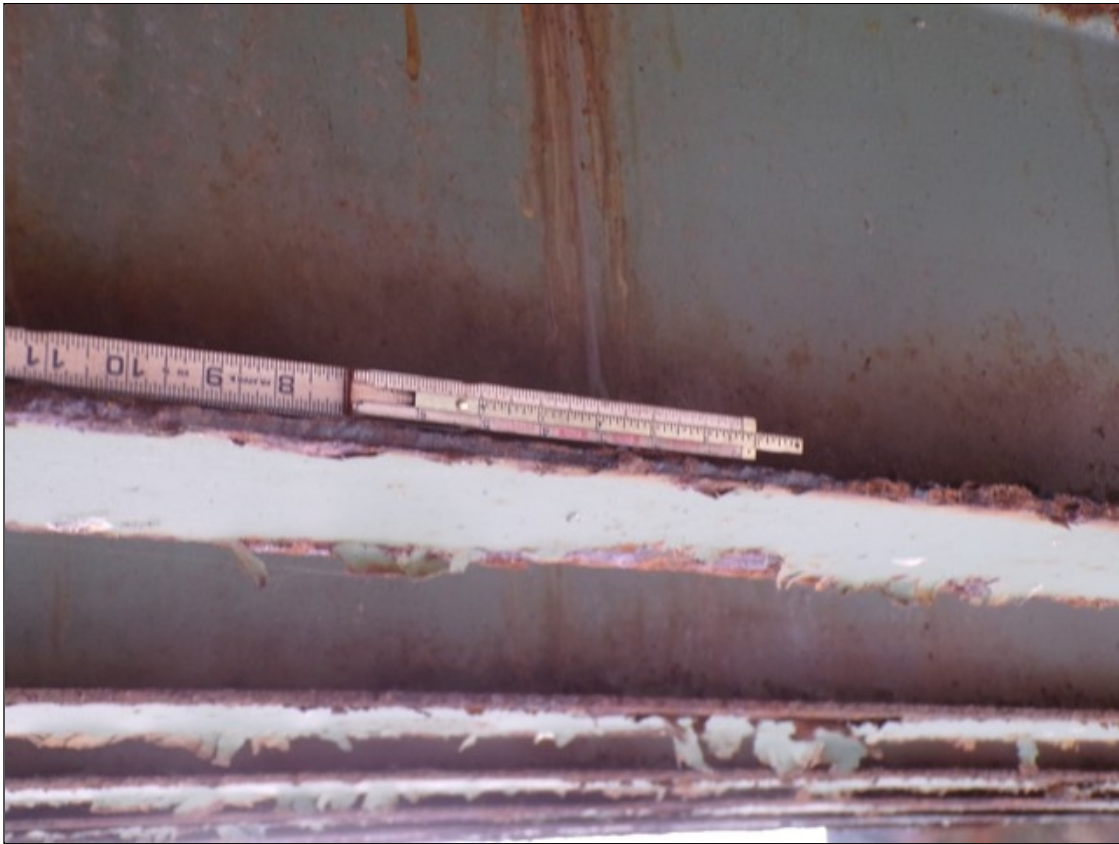
Span 1 Beam 6: (PAR) BEGINNING AT BENT 1, LEFT TOP FLANGE SECTION LOSS, 6 FEET LONG X 3 INCH WIDE X 0.14 INCH AVERAGE REMAINING WITH 18 INCH X 1 INCH AREA OF COMPLETE SECTION LOSS AND BOTTOM FLANGE CORROSION, 1 INCH WIDE X 2.3 INCH REMAINING

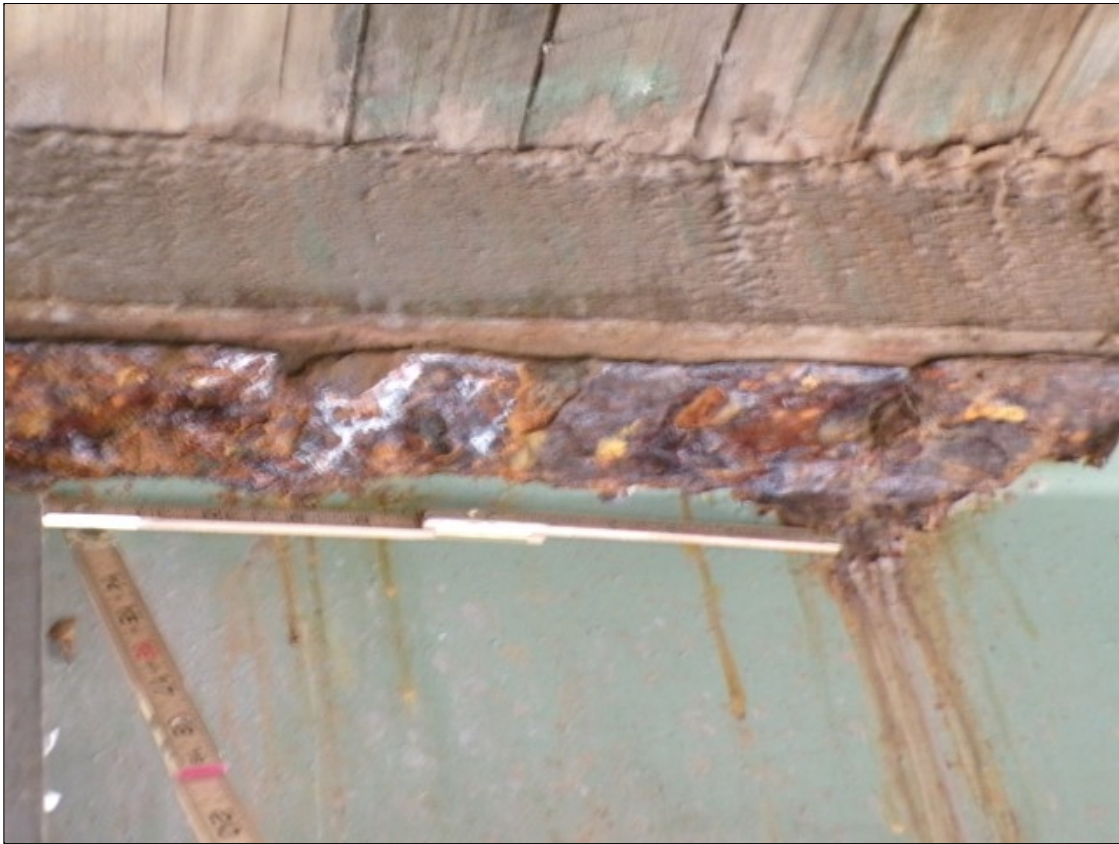
Span 2 Beam 6: (PAR) BEGINNING AT BENT 1, CORROSION WITH SECTION LOSS TO BOTTOM FLANGE (DOWN TO 0.2 INCH THICKNESS REMAINING) TO BOTH SIDES FOR 2 INCH WIDE X 17 FEET LONG
