NC DEPARTMENT OF TRANSPORTATION  
DIVISION OF HIGHWAYS  
STRUCTURE MANAGEMENT UNIT  
COUNTY: RUTHERFORD DIV: 13

## Structure Safety Inspection Report

BRIDGE NUMBER: 800239 BRIDGE NAME: \_\_\_\_\_ PREVIOUS BRIDGE NUMBER: \_\_\_\_\_

LATITUDE: 35.48940000 LONGITUDE: -81.99338000 ROUTE: SR1325 M.P.: 0.0

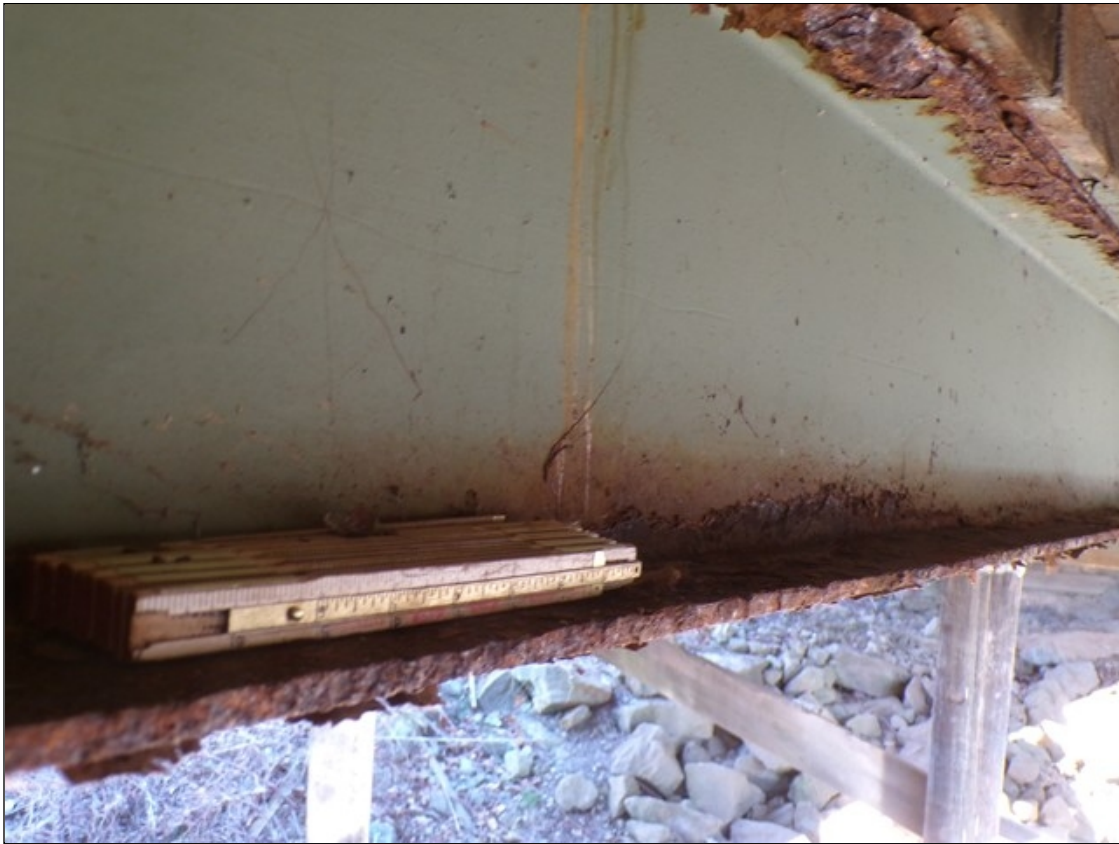
Span 2 Beam 6: (PAR) TOP FLANGE FULL LENGTH TAPERED CORROSION WITH SECTION LOSS DOWN TO 1/8 INCH THICKNESS REMAINING DOWN TO KNIFE'S EDGE FOR FULL WIDTH X FULL LENGTH, WITH 80% OF TOP FLANGE REDUCED TO 6 INCH WIDE

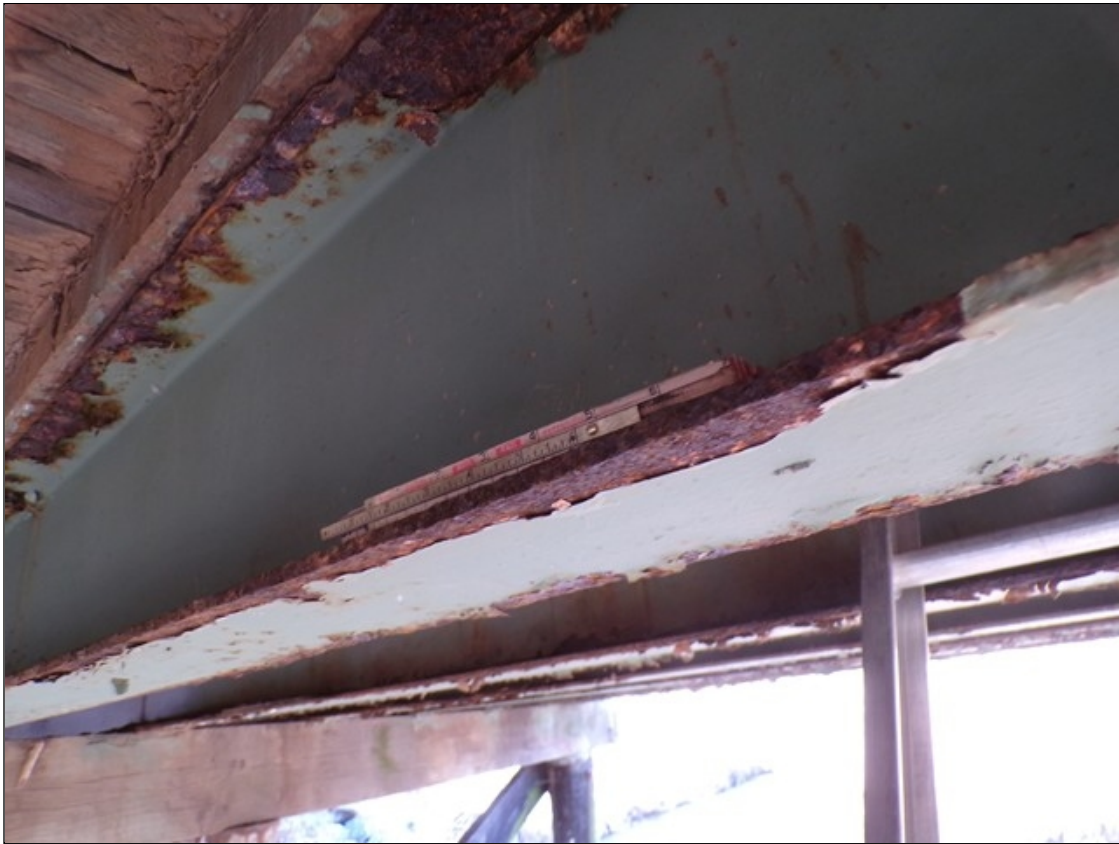
Span 2 Beam 7: (PAR) INTERMITTENT THROUGHOUT, CORROSION WITH SECTION LOSS TO BOTTOM FLANGE (DOWN TO 0.26 INCH THICKNESS REMAINING) TO BOTH SIDES FOR 2 INCH WIDE X 17 FEET LONG, AND UPPER AND LOWER WEB SECTION LOSS (DOWN TO 3/16 INCH THICKNESS REMAINING) FOR 2 INCH HIGH

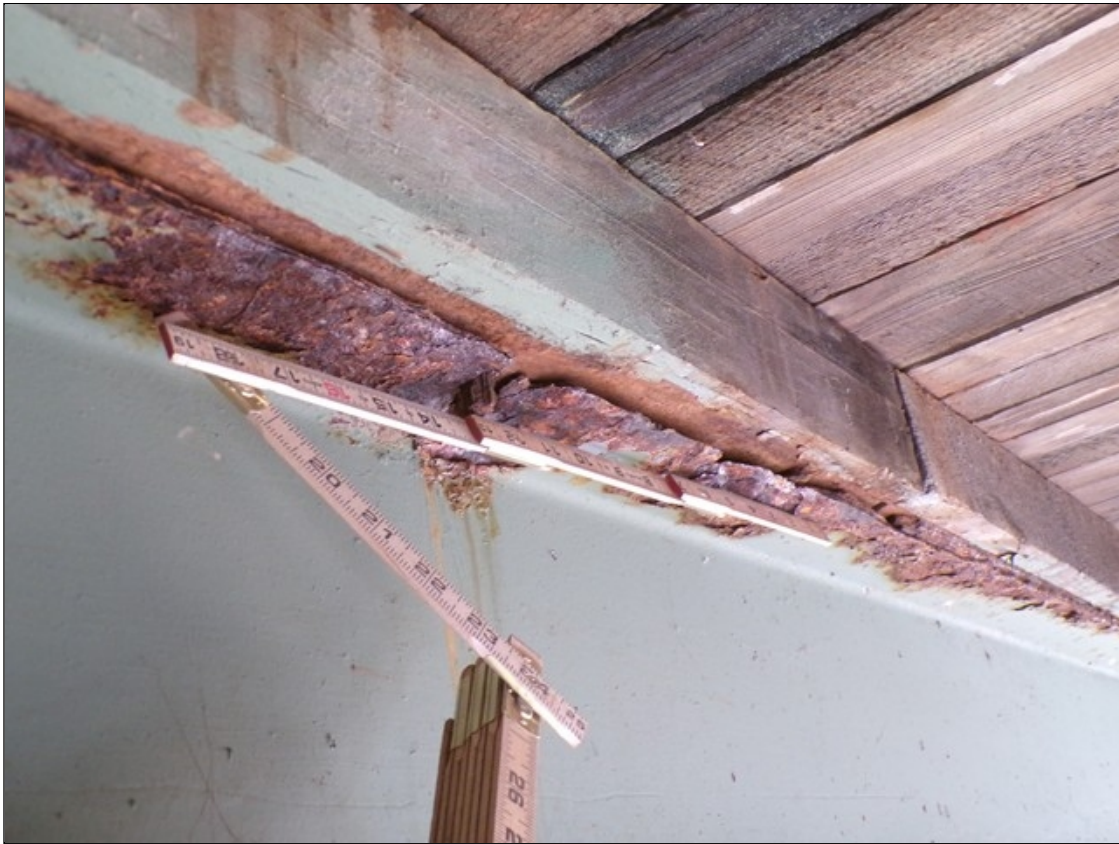
Span 2 Beam 7: (PAR) INTERMITTENT THROUGHOUT, CORROSION WITH SECTION LOSS TO BOTTOM FLANGE (DOWN TO 0.26 INCH THICKNESS REMAINING) TO BOTH SIDES FOR 2 INCH WIDE X 17 FEET LONG, AND UPPER AND LOWER WEB SECTION LOSS (DOWN TO 3/16 INCH THICKNESS REMAINING) FOR 2 INCH HIGH

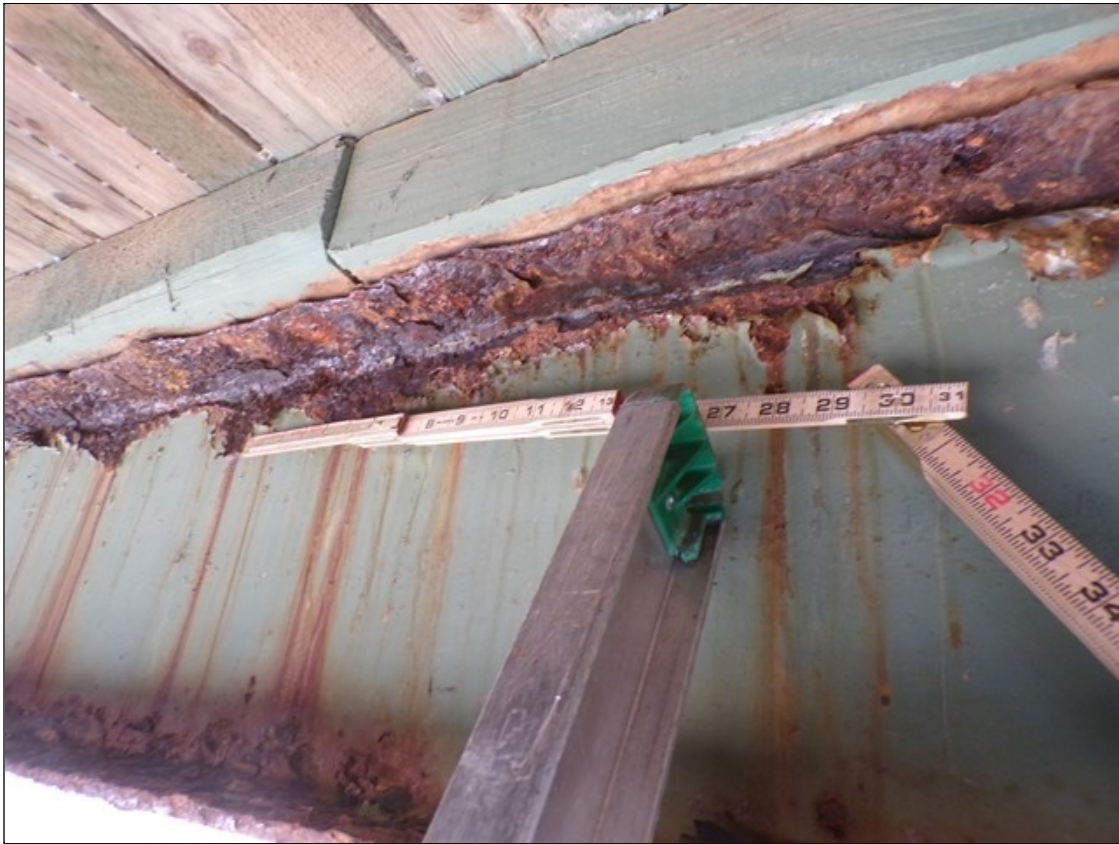
Span 2 Beam 7: (PAR) TOP FLANGE TAPERED CORROSION WITH SECTION LOSS, 1/8 INCH AVERAGE THICKNESS REMAINING DOWN TO KNIFE'S EDGE X FULL WIDTH X 17 FEET (WITH AREAS OF 100% SECTION LOSS 13 INCH LONG X 3/4 INCH WIDE)

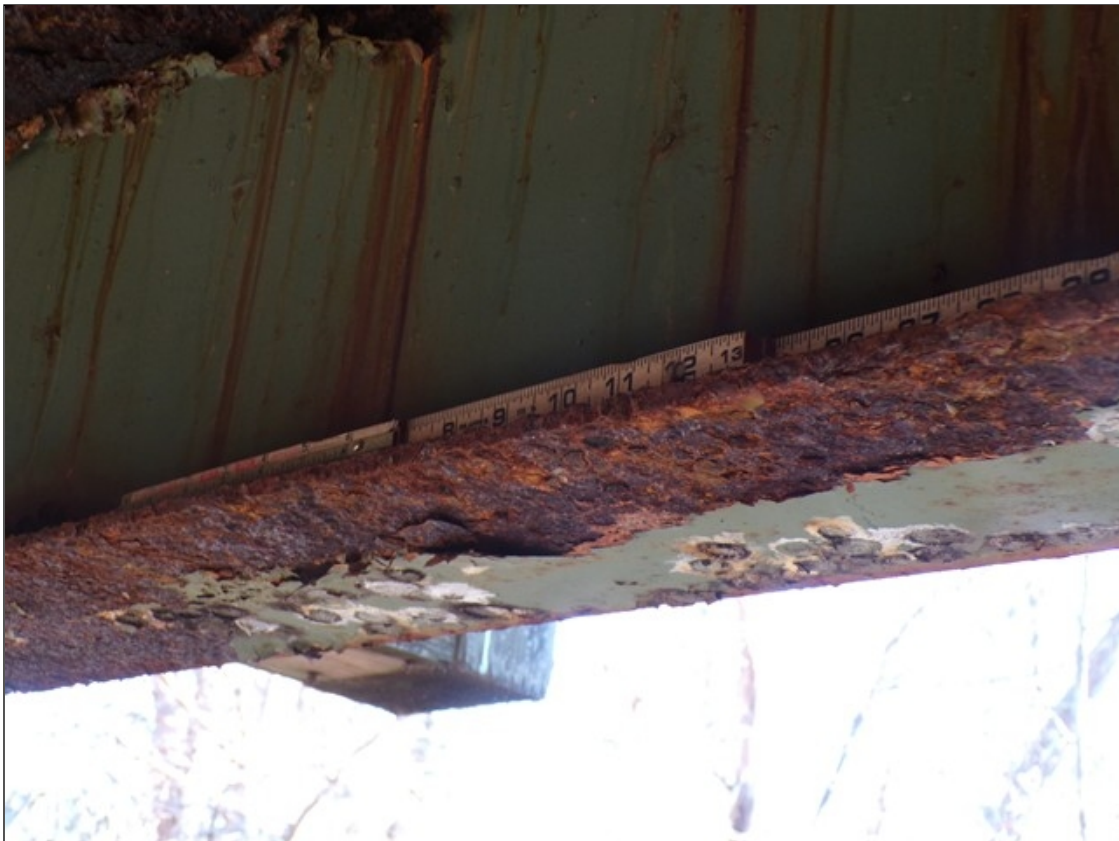
Span 2 Beam 10: (PAR) INTERMITTENT THROUGHOUT, CORROSION WITH SECTION LOSS, AT LOWER AND UPPER WEB, UP TO 4 INCH HIGH X DOWN TO 1/16 INCH THICKNESS REMAINING

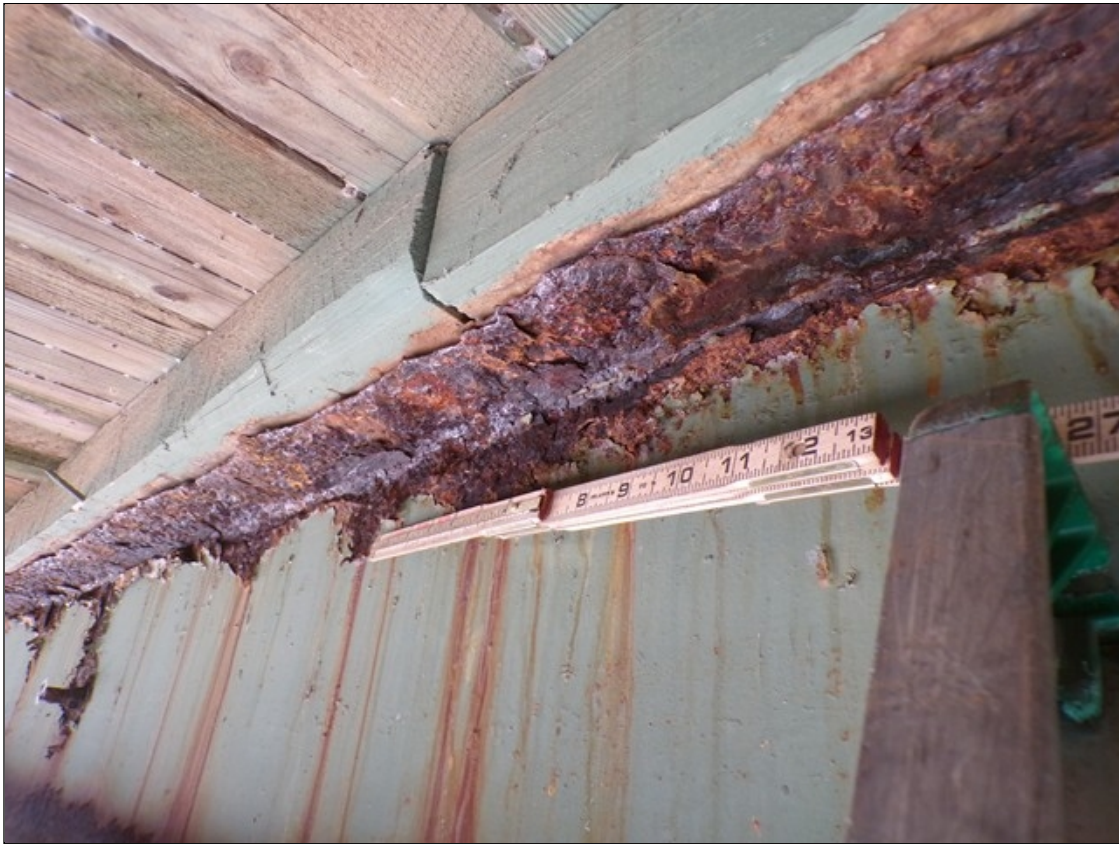
Span 2 Beam 10: (PAR) BOTTOM FLANGE FULL LENGTH CORROSION WITH SECTION LOSS (DOWN TO 0.19 INCH AVERAGE THICKNESS REMAINING) FOR FULL WIDTH

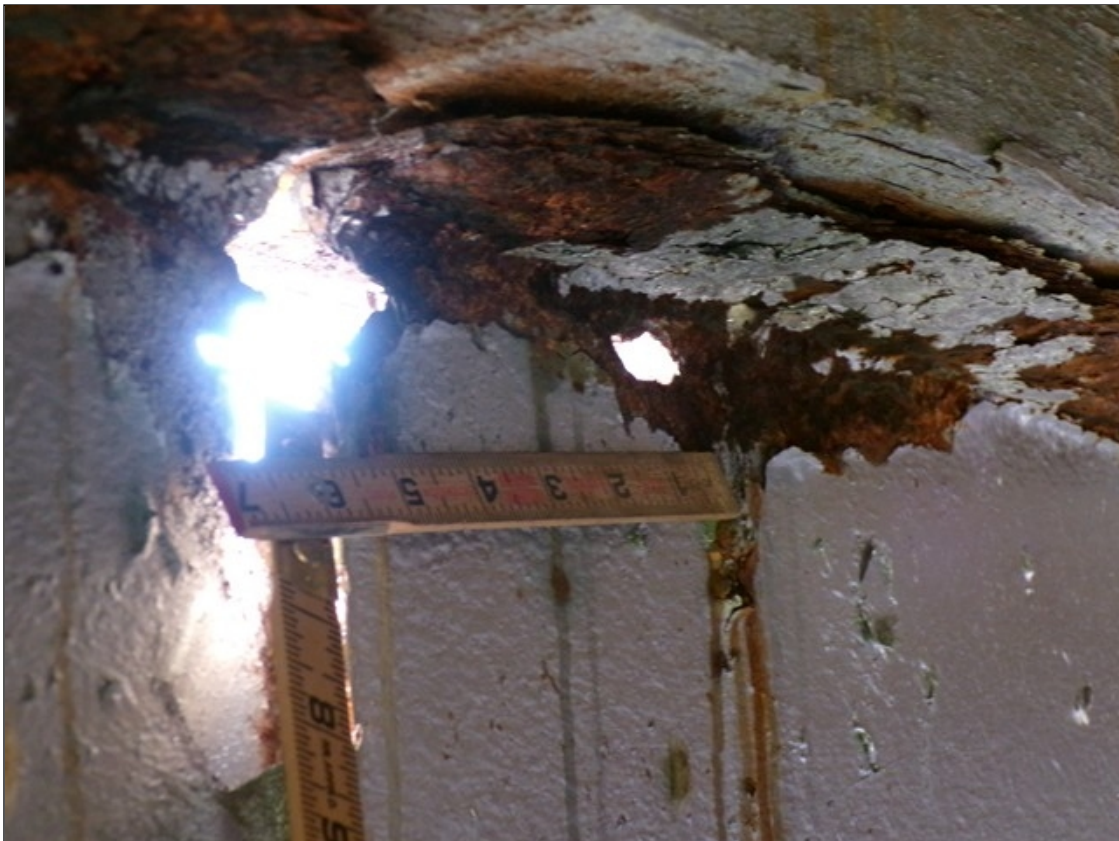
Span 1 Beam 10: (PAR) FAR END, TOP OF WEB, (2) AREAS OF 100% SECTION LOSS (UP TO 2 INCH HIGH X 2.5 INCH LONG)

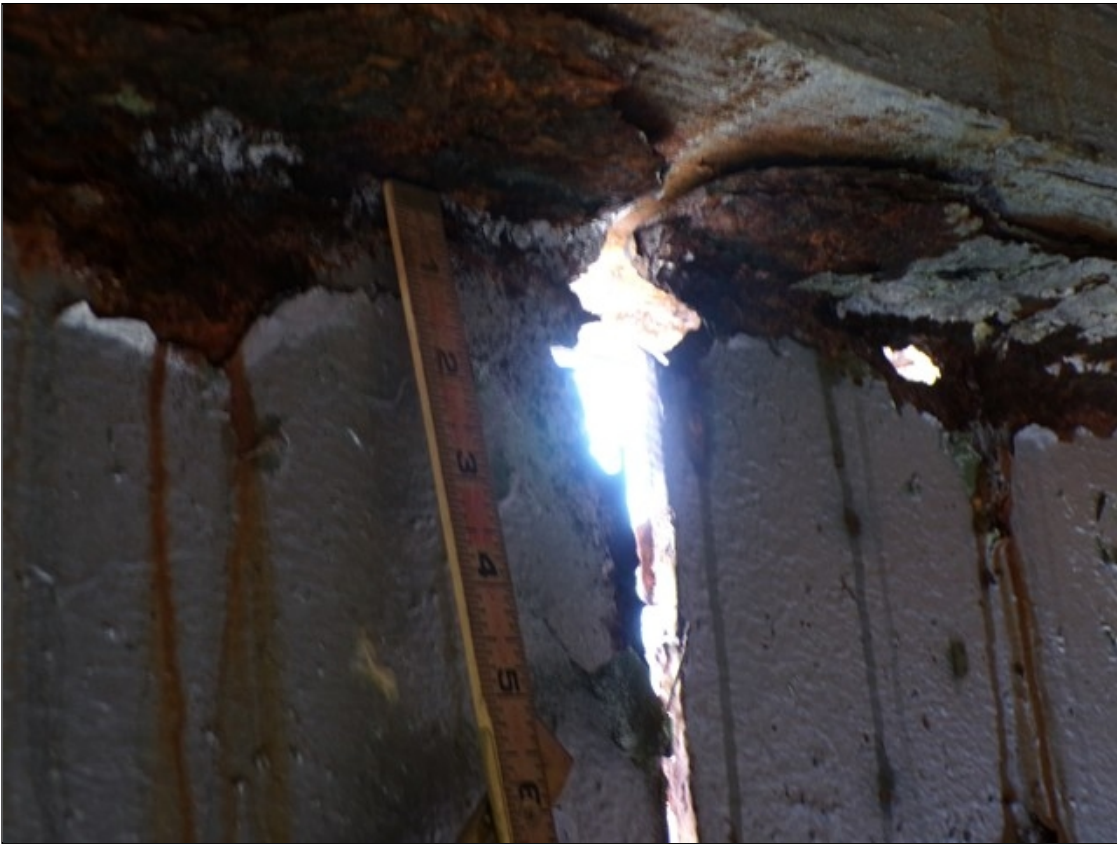
Span 2 Beam 10: 1 INCH X 2 1/2 INCH AREA OF 100% SECTION LOSS ON UPPER WEB AT BENT 1 (PAR)

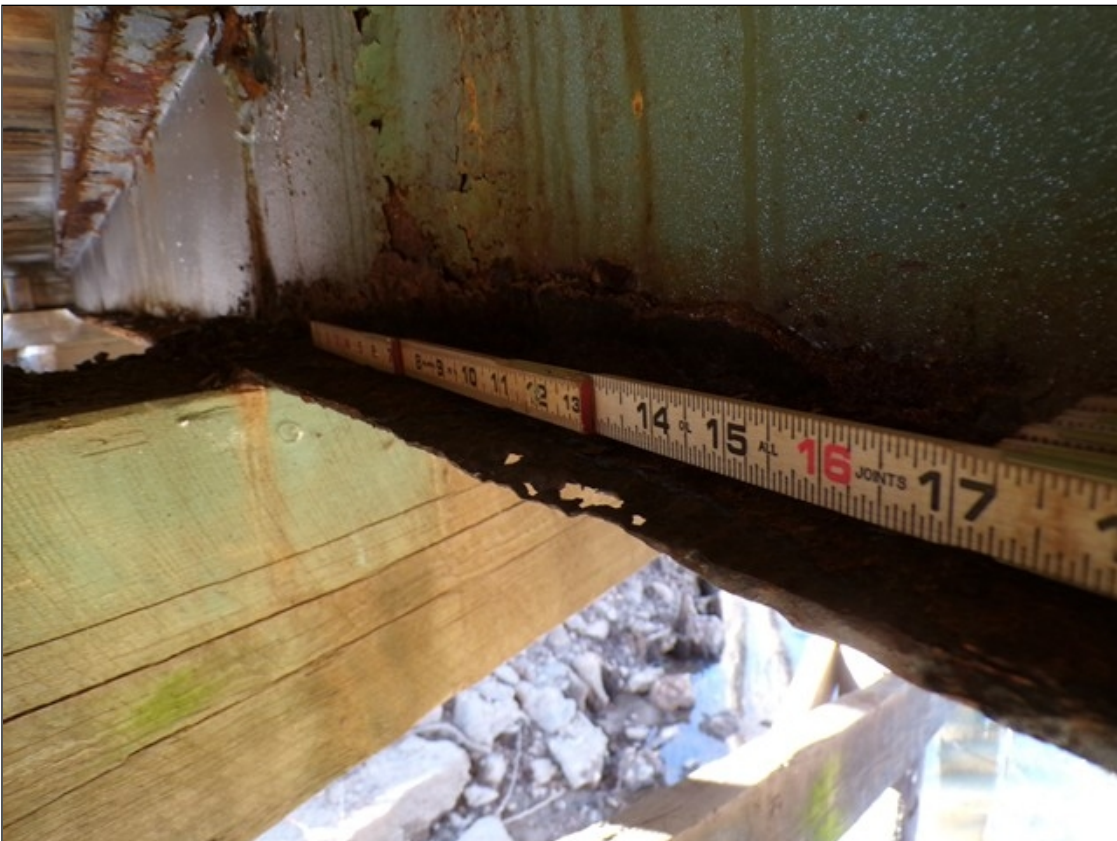
Span 2 Beam 9: 9 INCH X 1 INCH AREA OF SECTION LOSS WITH KNIFE EDGE REMAINING WITH 2 INCH X 1/2 INCH AREA OF 100% SECTION LOSS ON BOTH SIDES OF BOTTOM FLANGE, 1 FOOT FROM BENT 1 (PAR)

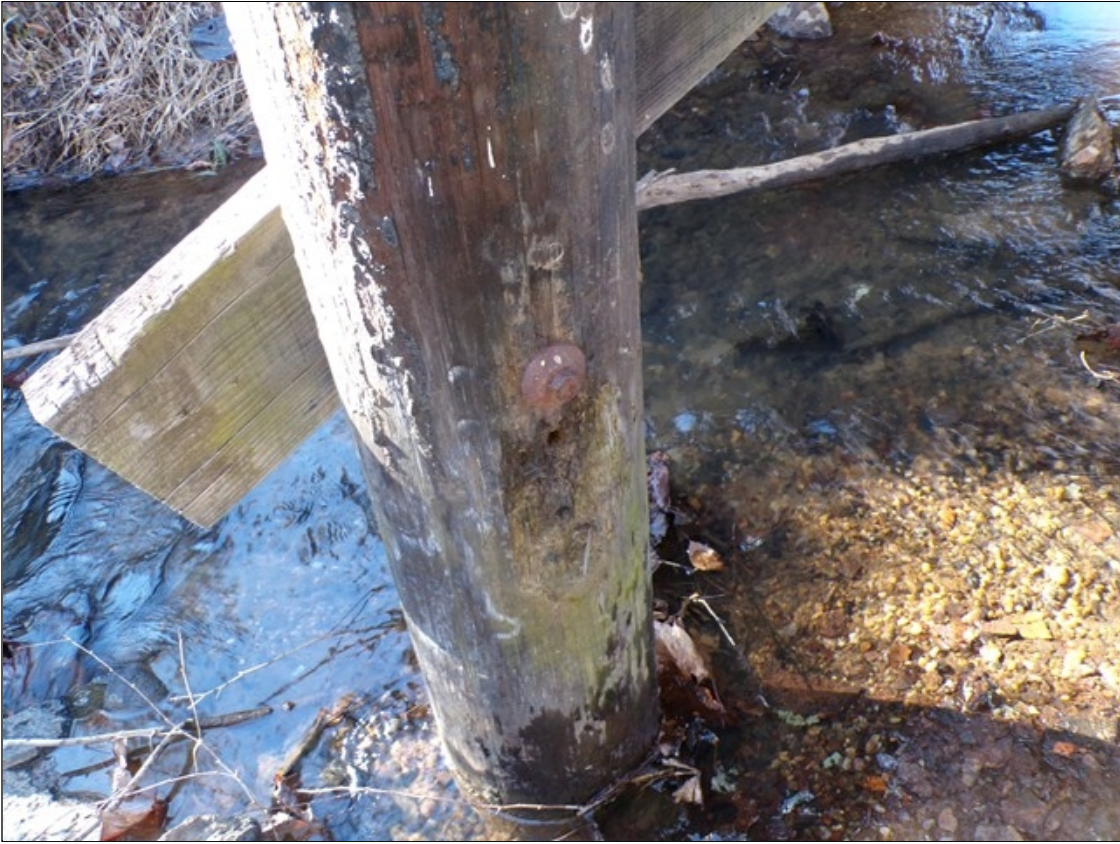
Bent 1 Pile 3: SECTION LOSS (UP TO 11 INCH HIGH X 7 INCH WIDE X 1 INCH DEEP) TO FAR SIDE 2 FEET FROM WATERLINE

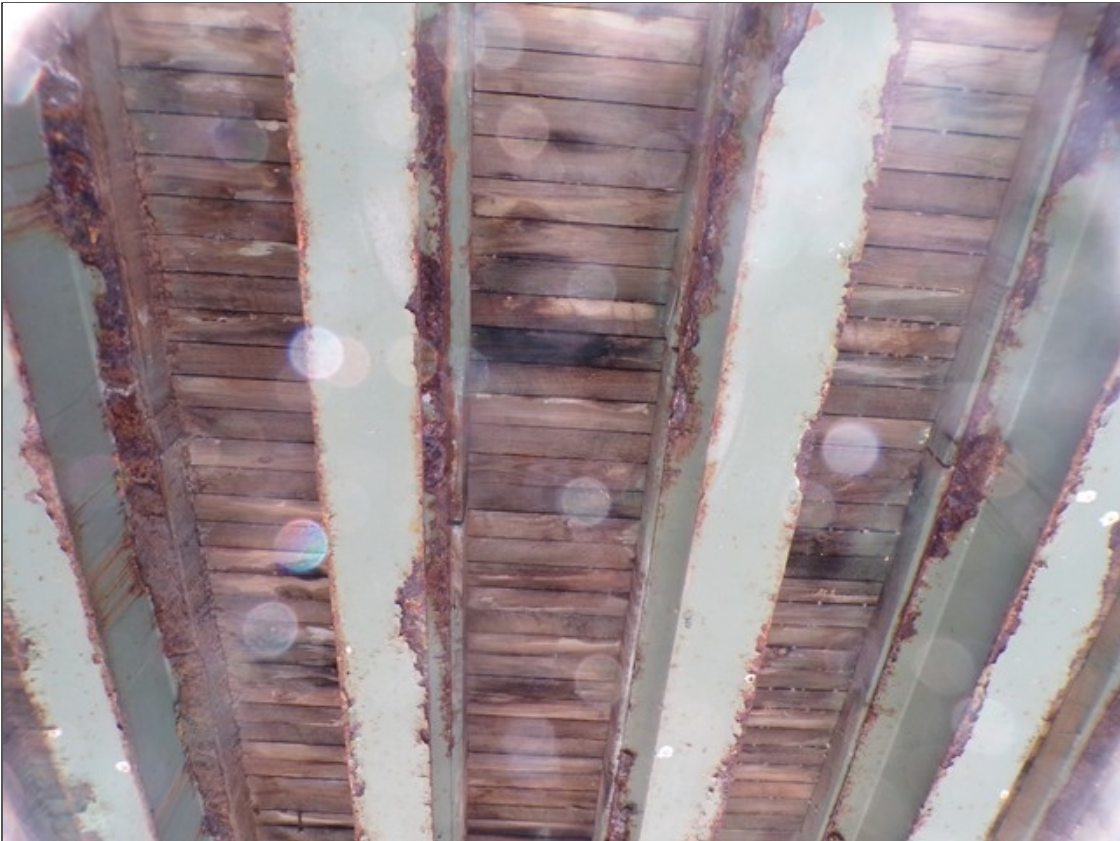
Span 2 Deck: THROUGHOUT BOTTOM OF DECK, SATURATION AND DECAY WITH WATER STAINING

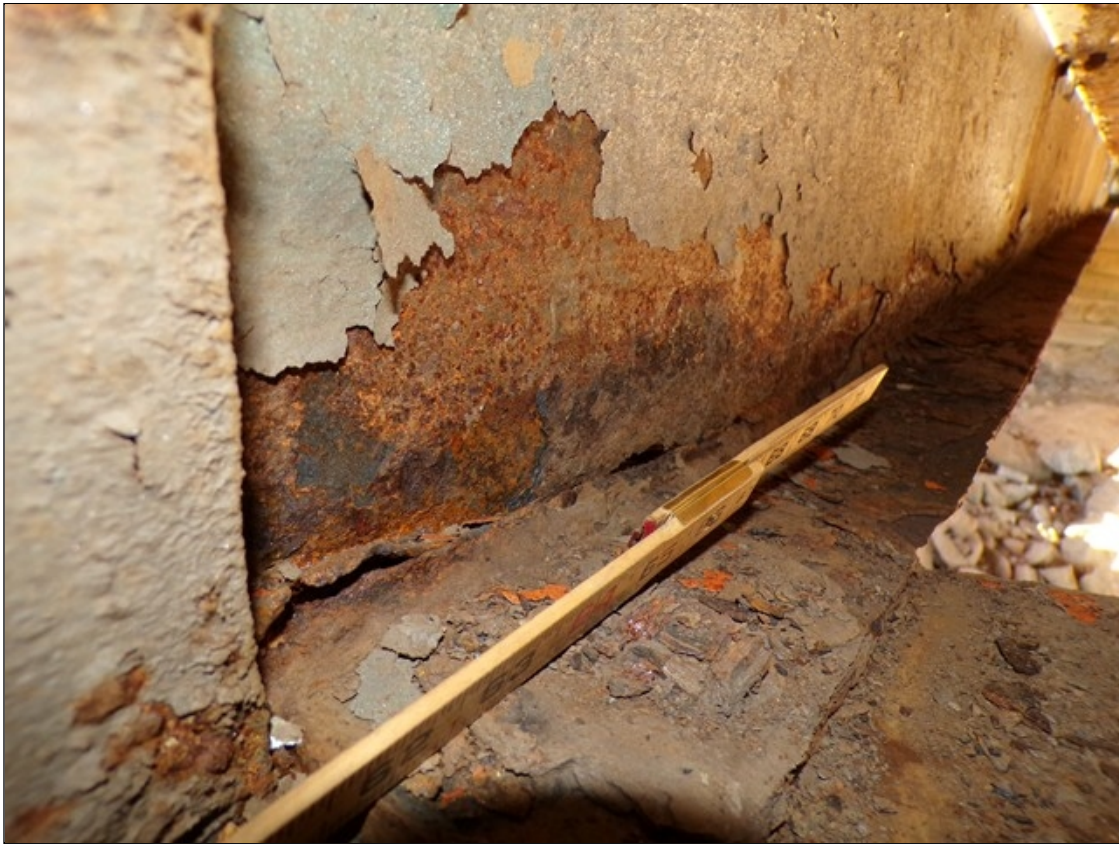
SPAN 3 Beam 4: (PAR) STARTING AT NEAR END, WEB CORROSION WITH SECTION LOSS, 15 FEET LONG DOWN TO 1/8 INCH REMAINING (WITH (2) AREAS OF 100% SECTION LOSS 2 INCH LONG X 1/2 INCH HIGH, 6 INCH FROM END) 15 INCH X FULL WIDTH DEFLECTION ON BOTTOM FLANGE WITH 11 INCH TEAR IN WEB AT BENT 2

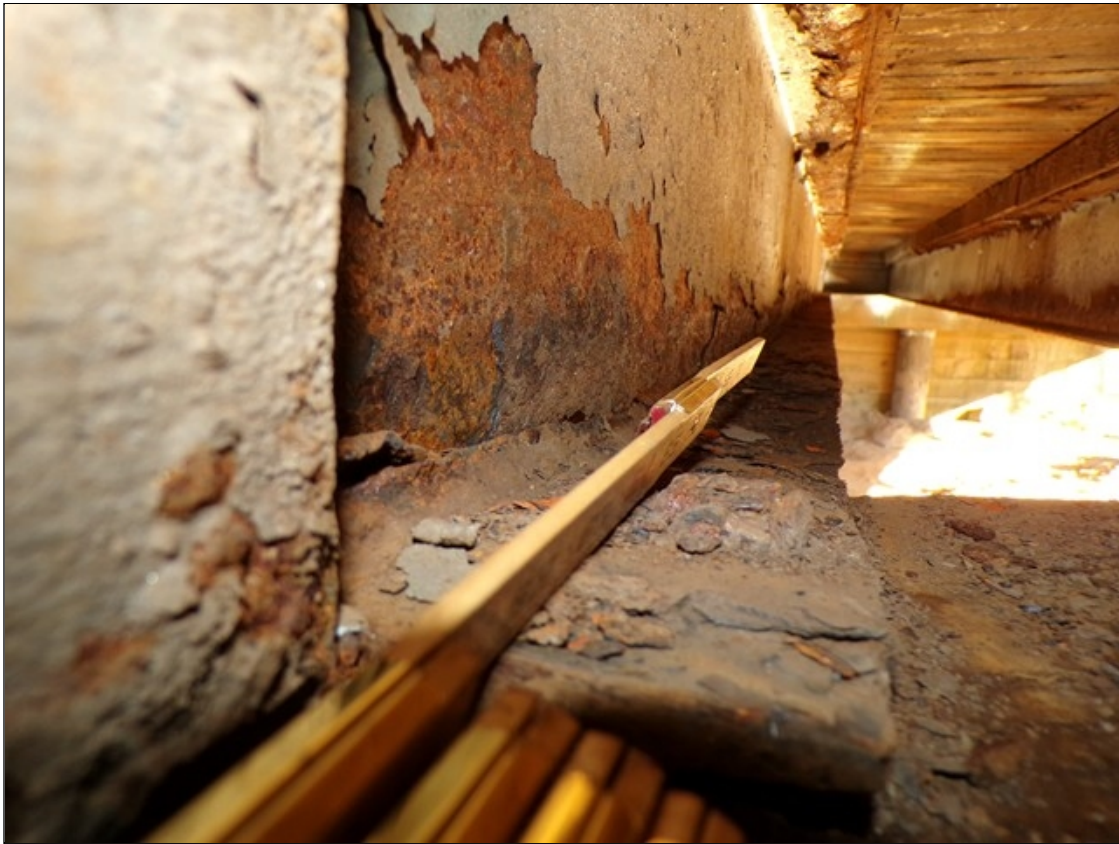
SPAN 3 Beam 4: (PAR) STARTING AT NEAR END, WEB CORROSION WITH SECTION LOSS, 15 FEET LONG DOWN TO 1/8 INCH REMAINING (WITH (2) AREAS OF 100% SECTION LOSS 2 INCH LONG X 1/2 INCH HIGH, 6 INCH FROM END) 15 INCH X FULL WIDTH DEFLECTION ON BOTTOM FLANGE WITH 11 INCH TEAR IN WEB AT BENT 2

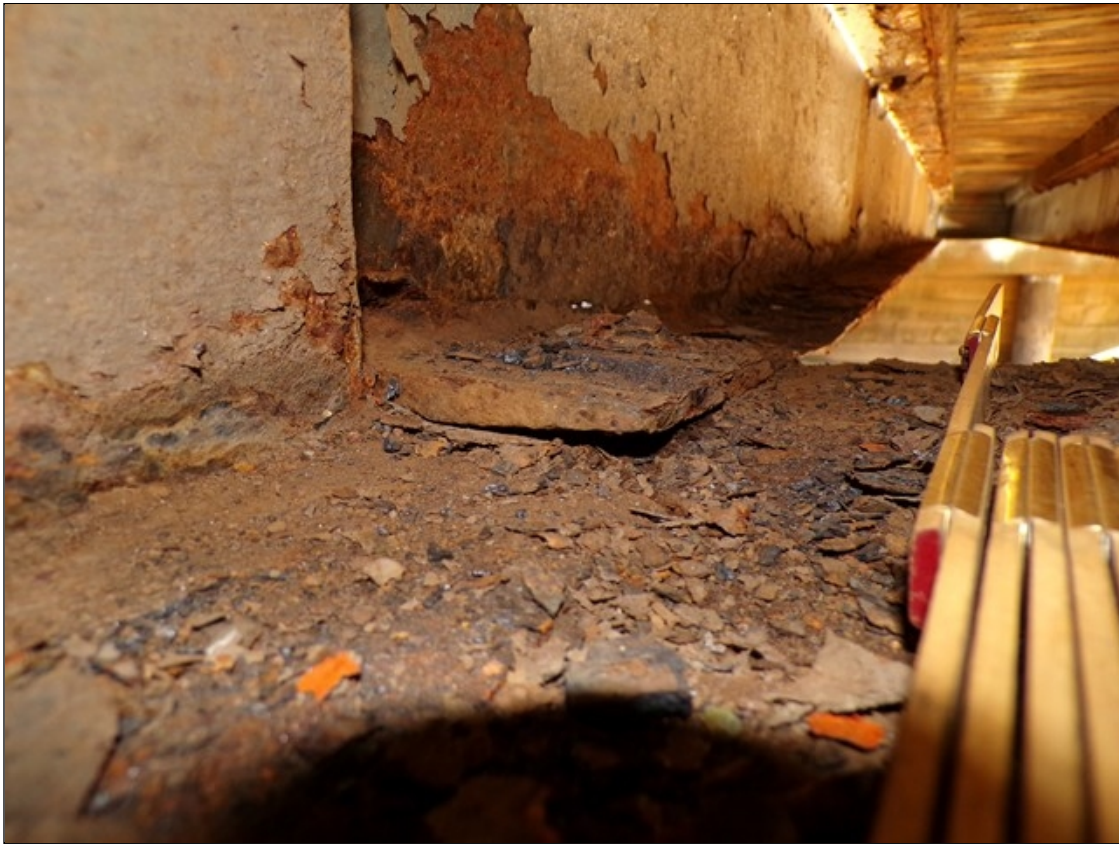
SPAN 3 Beam 4: (PAR) STARTING AT NEAR END, WEB CORROSION WITH SECTION LOSS, 15 FEET LONG DOWN TO 1/8 INCH REMAINING (WITH (2) AREAS OF 100% SECTION LOSS 2 INCH LONG X 1/2 INCH HIGH, 6 INCH FROM END) 15 INCH X FULL WIDTH DEFLECTION ON BOTTOM FLANGE WITH 11 INCH TEAR IN WEB AT BENT 2

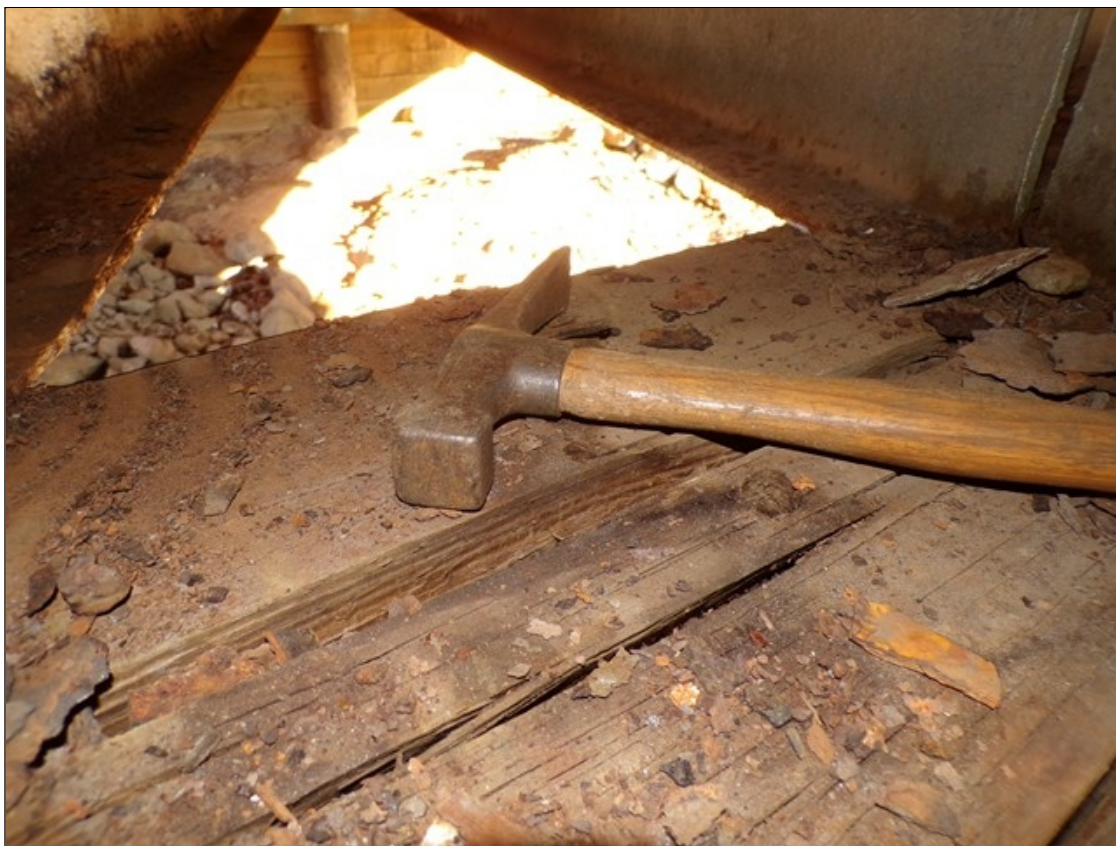
Bent 2 Cap 1: 10 FEET X 4 INCH AREA OF DECAY WITH 2 INCH DEEP SPLIT ON TOP OF CAP IN BAYS 3-5 (PAR)

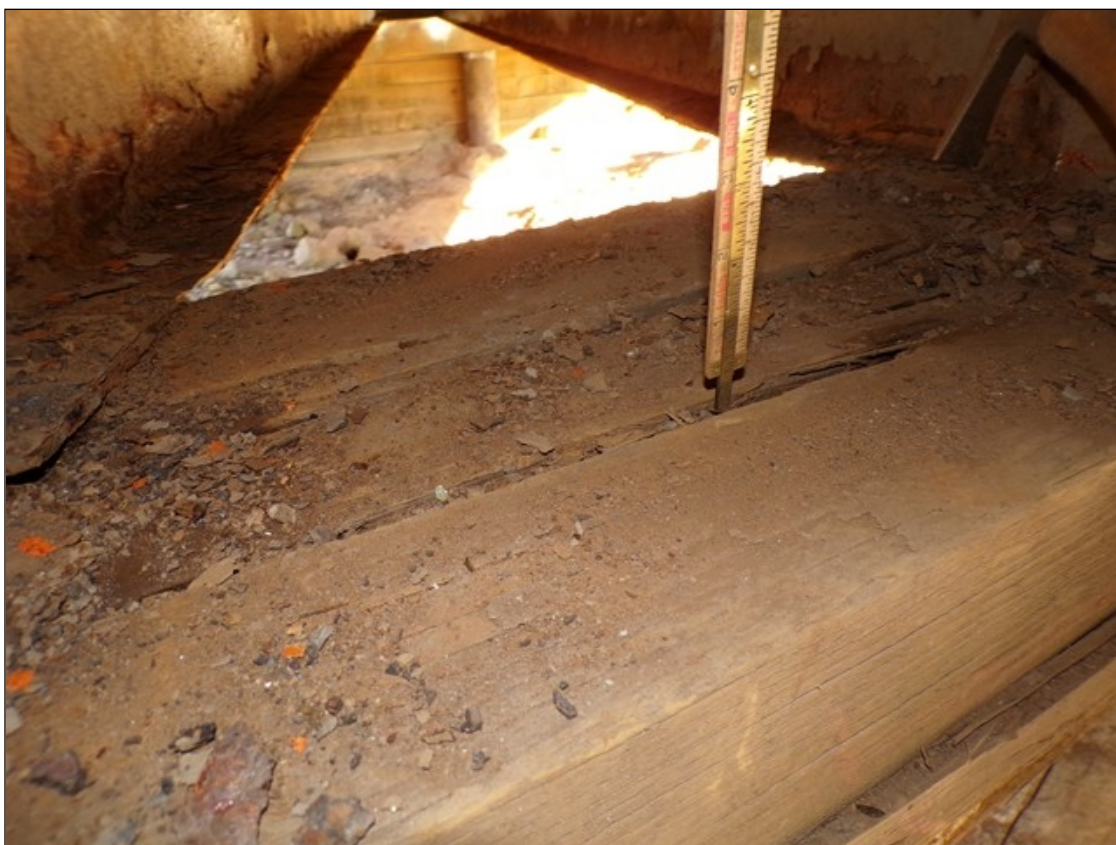
Bent 2 Cap 1: 10 FEET X 4 INCH AREA OF DECAY WITH 2 INCH DEEP SPLIT ON TOP OF CAP IN BAYS 3-5 (PAR)

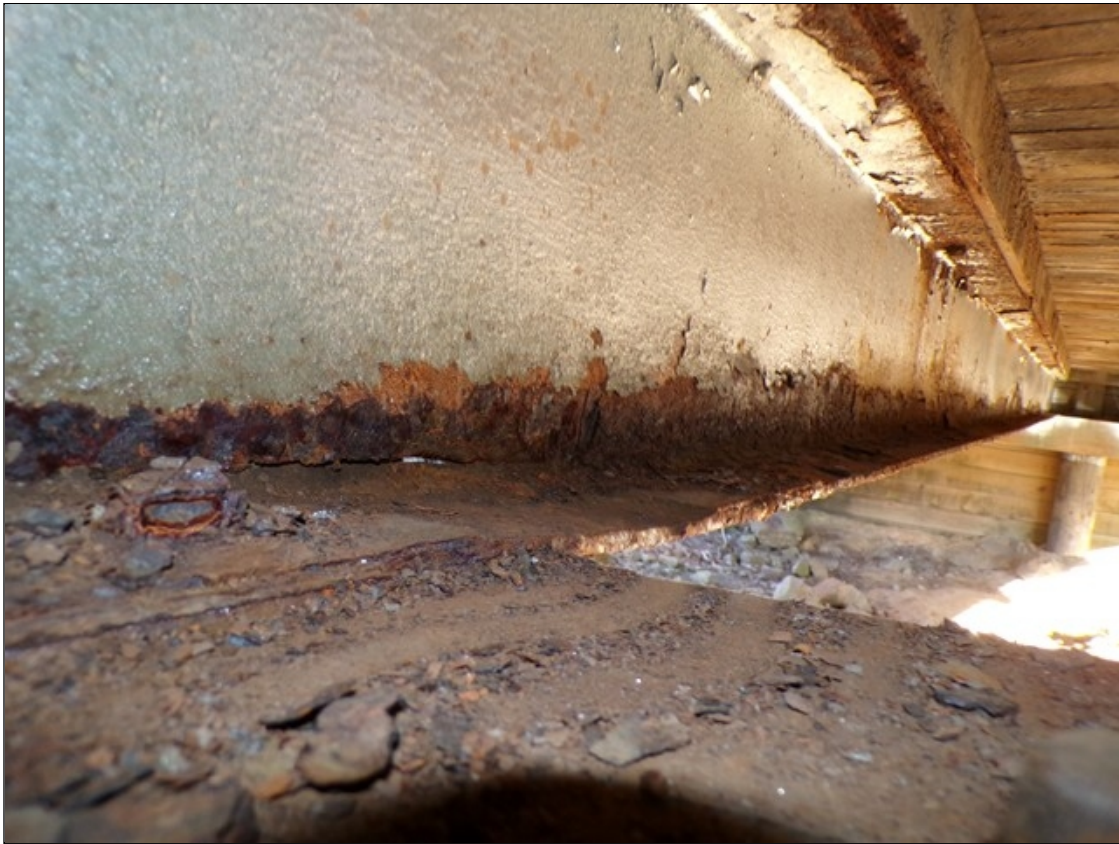
SPAN 3 Beam 5: 9 1/2 INCH TEAR ON WEB WITH 12 INCH DEFLECTION ON BOTTOM FLANGE AND WEB AT BENT 2 (PAR)

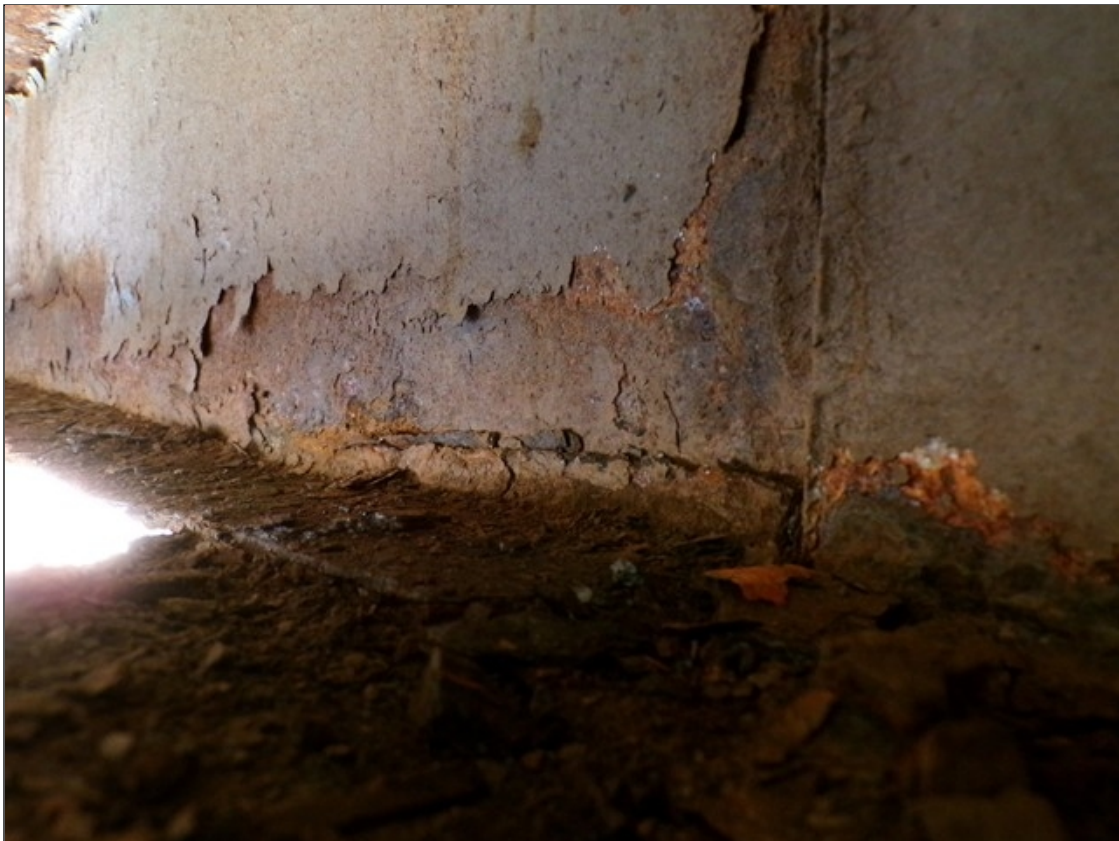
SPAN 3 Beam 5: 9 1/2 INCH TEAR ON WEB WITH 12 INCH DEFLECTION ON BOTTOM FLANGE AND WEB AT BENT 2 (PAR)

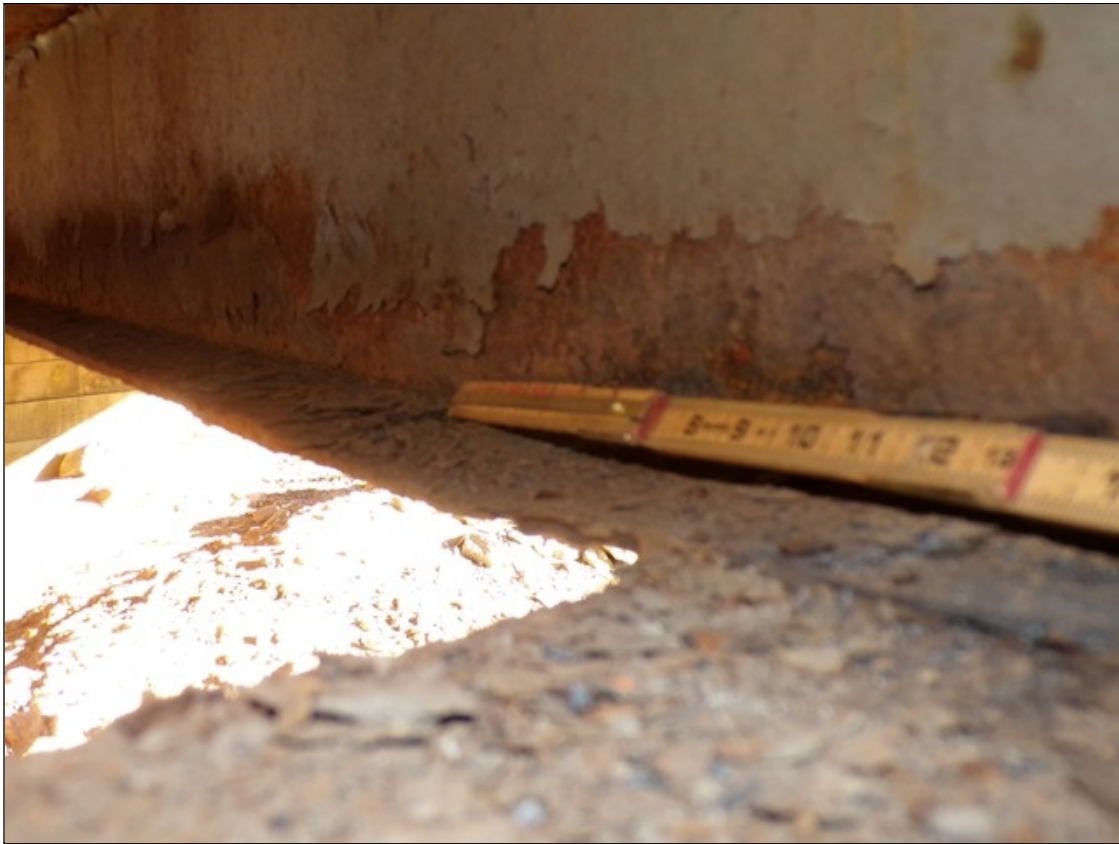
SPAN 3 Beam 5: 9 1/2 INCH TEAR ON WEB WITH 12 INCH DEFLECTION ON BOTTOM FLANGE AND WEB AT BENT 2 (PAR)
