PROJECT NO. **15BPR.164**  
**BEAUFORT** COUNTY  
TERMINAL: **AURORA**

STATE OF NORTH CAROLINA  
DEPARTMENT OF TRANSPORTATION  
RALEIGH

**LIFT BENT  
STEEL PILE  
REPAIR DETAILS**

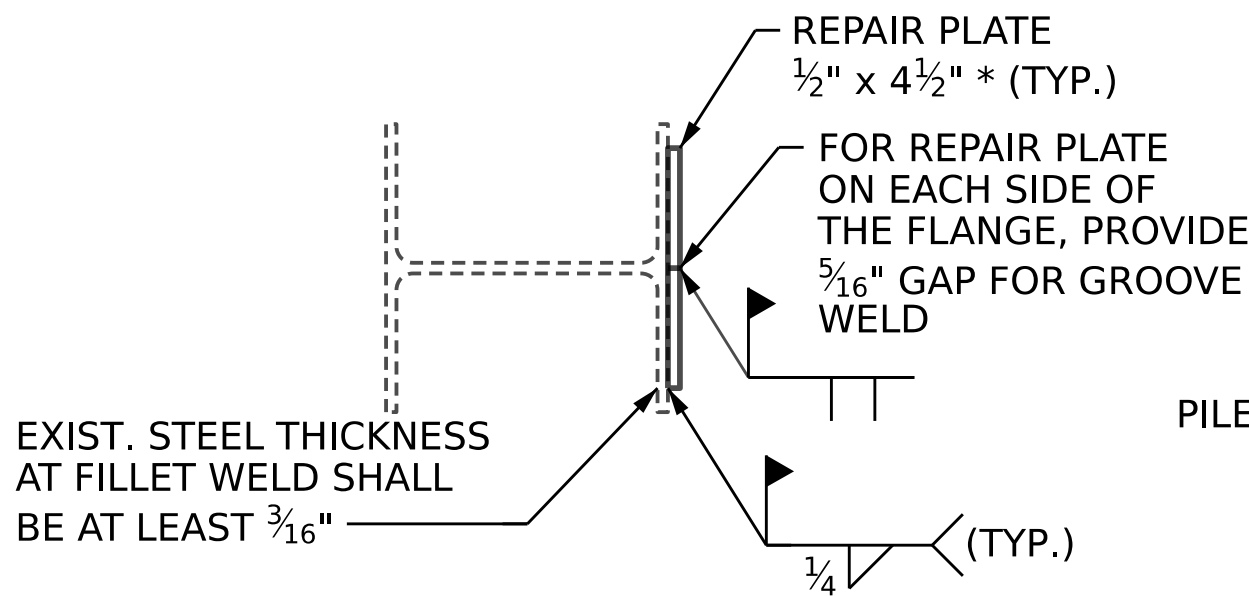
**SECTION A-A**

**HP12x53 STEEL PILE REPAIR DETAILS**

1. REMOVE LOOSE RUST AND MARINE GROWTH FROM THE EXISTING STEEL PILE TO OBTAIN A CLEAN, SOUND SURFACE PRIOR TO PERFORMING STEEL REPAIRS AND PILE JACKETING, USING APPROVED MECHANICAL MEANS OR HIGH-PRESSURE WATER BLASTING. IF ADDITIONAL SECTION LOSS GREATER THAN 33% IS FOUND TO THE PILE FLANGES, NOTIFY THE ENGINEER.

2. TACK WELD NEW REPAIR PLATE INTO THE PROPER LOCATION. ENSURE REPAIR PLATE EXTENDS A MINIMUM OF 4" INCHES BEYOND THE DETERIORATED SECTION OF THE PILE FLANGE.

3. WELD NEW REPAIR PLATES. IF A NEW PLATE IS IN CONTACT WITH AN EXISTING REPAIR PLATE, BUTT WELD THE INTERFACE BETWEEN THE TWO PLATES.
4. FOR ANY REPAIRS NOT ENCAPSULATED BY PILE JACKET, PAINT THE EXPOSED STEEL AND CONNECTION COMPONENTS IN THE REPAIR AREA IN ACCORDANCE WITH SECTION 442-12 OF THE STANDARD SPECIFICATIONS, USING PAINT SYSTEM 4 FROM NCDOT'S STRUCTURAL STEEL SHOP COATINGS PROGRAM DOCUMENT, WITH TOPCOAT COLOR MATCHED TO THE EXISTING TOPCOAT COLOR.

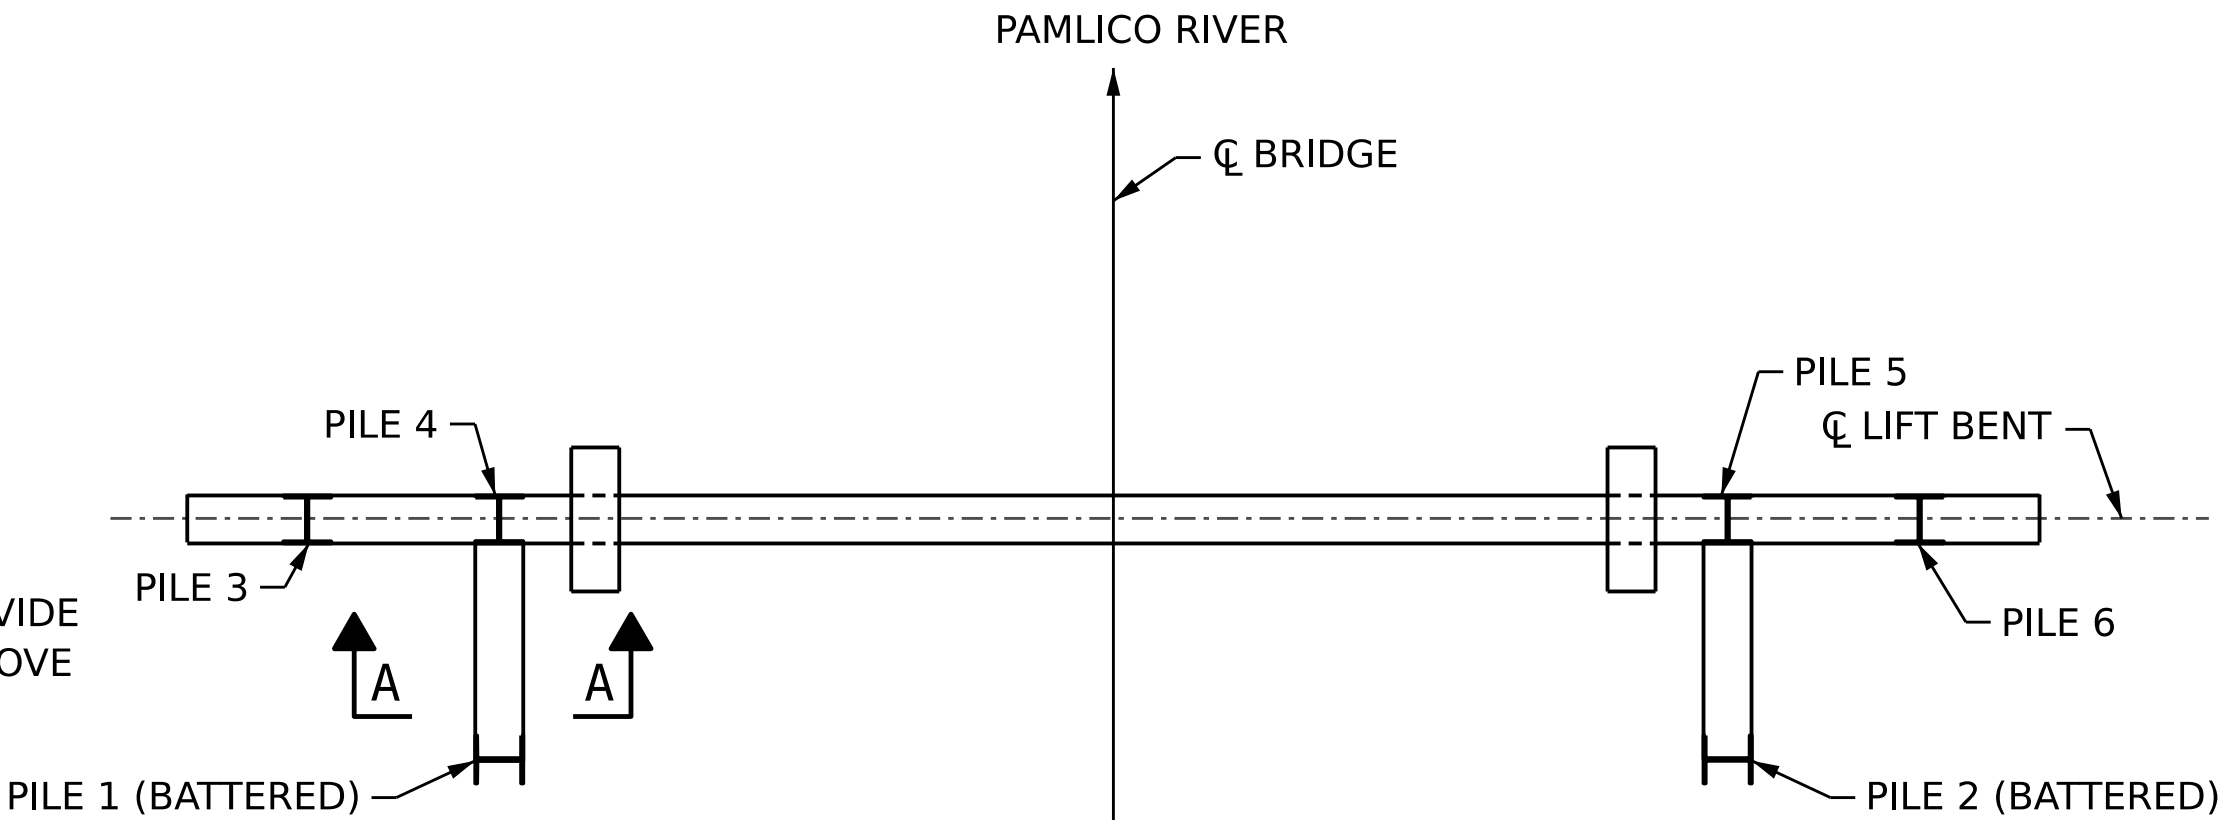
**PLAN OF LIFT BENT**

| ESTIMATED STEEL PILE REPAIR QUANTITIES | | | | |
|---|---|---|---|---|
| LIFT BENT | 2 | WELDED PLATE REPAIR | AT SW FLANGE WATERLINE | 26 |
| | 3 | WELDED PLATE REPAIR | BETWEEN BRACING & WATER LINE | 87 |
| | 4 | WELDED PLATE REPAIR | AT SW FLANGE WATERLINE | 72 |
| | 5 | WELDED PLATE REPAIR | AT SE FLANGE WATERLINE | 57 |
| | 6 | WELDED PLATE REPAIR | BETWEEN BRACING & WATERLINE | 41 |
| | P1-P3 | WELDED PLATE REPAIR | HORIZONTAL BRACING MEMBER REPAIR | 87 |
