PROJECT NO. **15BPR.164**  
**BEAUFORT** COUNTY  
TERMINAL: **BAYVIEW**

STATE OF NORTH CAROLINA  
DEPARTMENT OF TRANSPORTATION  
RALEIGH

**STEEL BEAM CRACK  
REPAIR DETAILS**

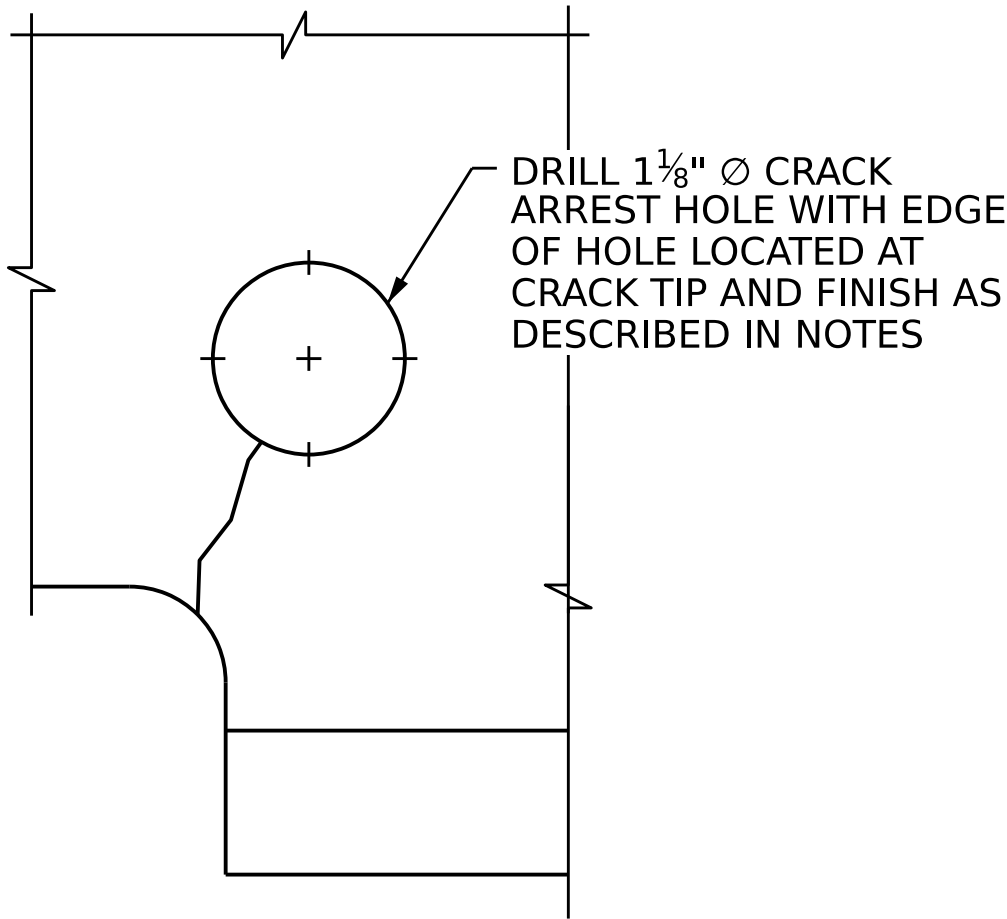
**DETAIL "A"**

IMAGES SHOW TWO EXAMPLES OF CRACKS NEEDING REPAIR. SEE "STEEL BEAM CRACK REPAIR LOCATION TABLE" FOR ALL CRACK REPAIR LOCATIONS.

1. LOCATE THE CRACK TIP USING MAGNETIC PARTICLE TESTING (MT) OR DYE-PENETRANT TESTING (PT). INSPECT BOTH SIDES OF THE PLATE TO ENSURE THE TIP IS NOT MISSED.

2. POSITION MAGNETIC BASED DRILL AS SHOWN RELATIVE TO THE AS-LOCATED CRACK TIP.
3. DRILL HOLE WITH ANNULAR CUTTER.
4. CHECK DRILLED PLATE AND REMOVED CORE FOR EVIDENCE OF CRACK TIP.

5. FOLLOWING REMOVAL OF THE CORE, REINSPECT THE EDGE OF THE DRILLED HOLE USING MT OR PT TO ENSURE THE CRACK TIP DOES NOT REMAIN.
6. SAND THE EDGES OF THE DRILLED HOLE USING AN 80 TO 100 GRIT FLAP WHEEL WITH AN ANGLE GRINDER ON THE EXTERIOR EDGES AND AN 80 TO 100 GRIT FLAP WHEEL WITH DIE GRINDER ON THE INTERIOR EDGES.

7. CLEAN AND PREPARE THE REPAIR AREA FOR FINISHING.
8. INSTALL 1-INCH DIA. BOLT WITH WASHER ON EACH WEB FACE.
9. PAINT THE EXPOSED STEEL AND CONNECTION COMPONENTS IN THE REPAIR AREA IN ACCORDANCE WITH SECTION 442-12 OF THE STANDARD SPECIFICATIONS, USING PAINT SYSTEM 4 FROM NCDOT'S STRUCTURAL STEEL SHOP COATINGS PROGRAM DOCUMENT, WITH TOPCOAT COLOR MATCHED TO THE EXISTING TOPCOAT COLOR.
