**HP12x53 STEEL PILE REPAIR DETAILS**

PROJECT NO. **15BPR.164**  
**BEAUFORT** COUNTY  
TERMINAL: **BAYVIEW**

STATE OF NORTH CAROLINA  
DEPARTMENT OF TRANSPORTATION  
RALEIGH

**STEEL PILE  
REPAIR DETAILS**

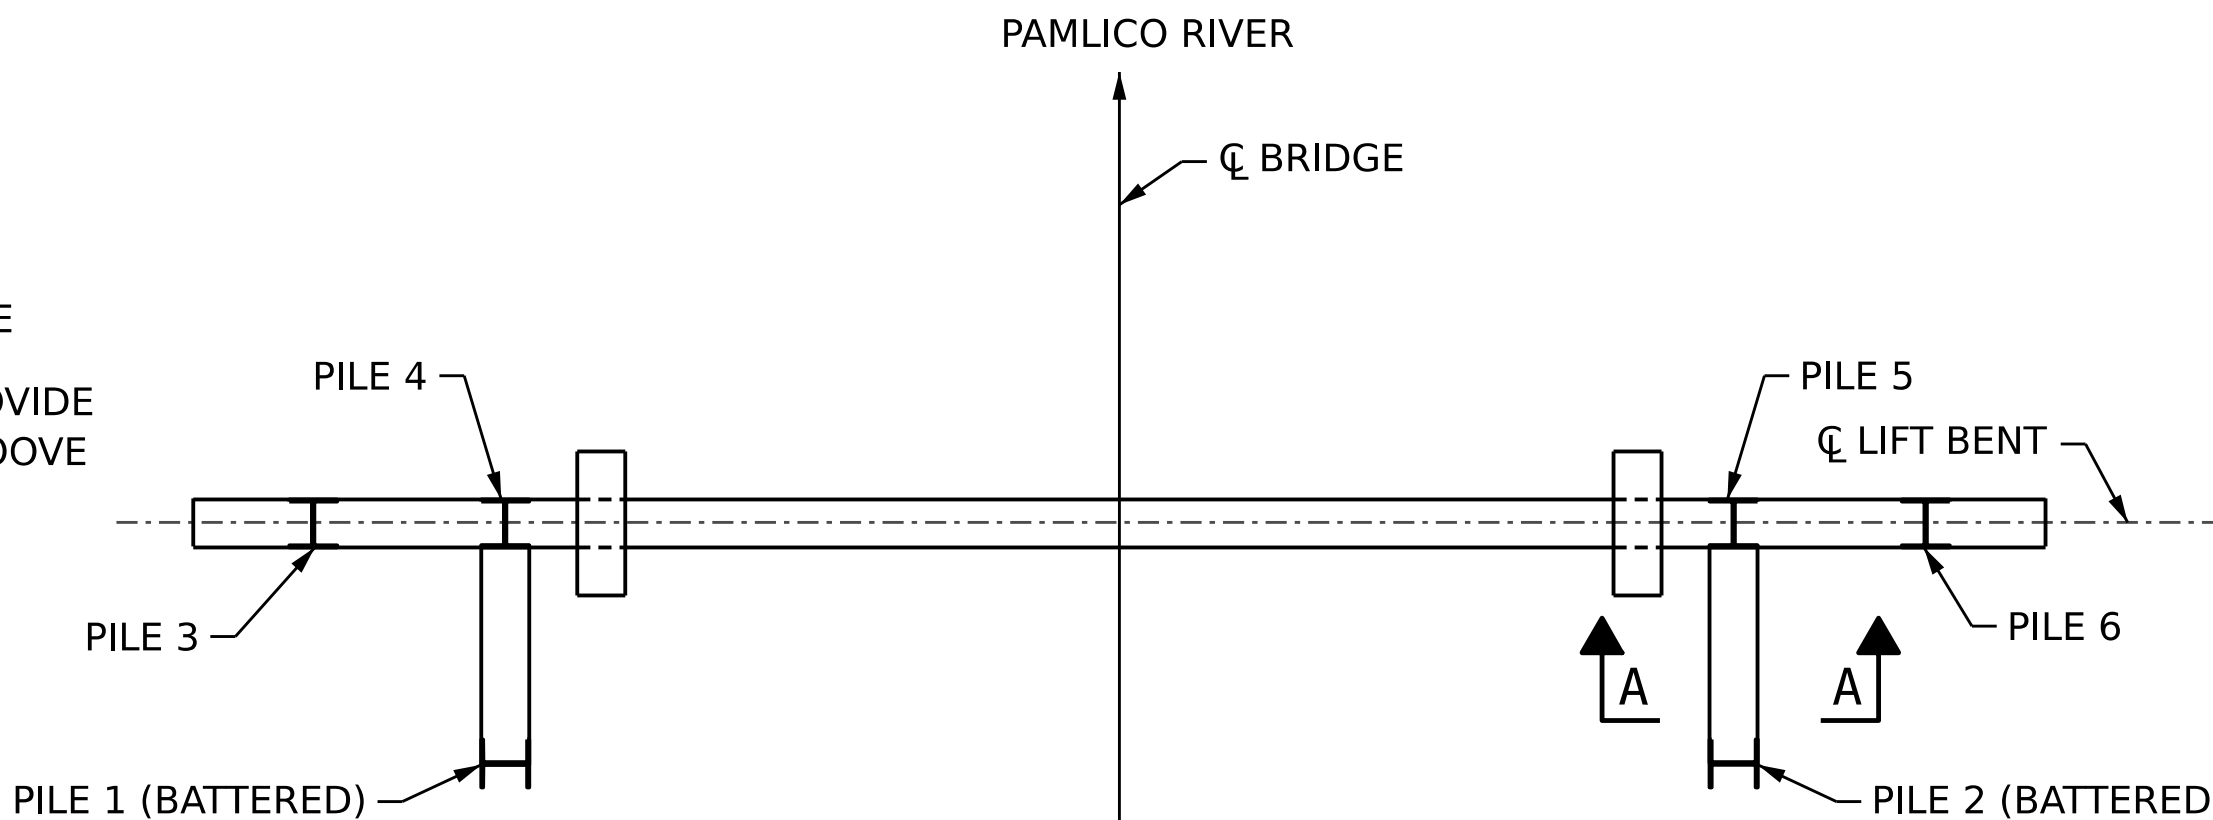
**PLAN OF LIFT BENT**

| ESTIMATED STEEL PILE REPAIR QUANTITIES | | | | |
|---|---|---|---|---|
| LIFT BENT | 2 | WELDED PLATE REPAIR | BETWEEN BRACING & WATER LINE | 87 |
| | 4 | WELDED PLATE REPAIR | BETWEEN BRACING & WATERLINE | 87 |
| | P2-P5 | WELDED PLATE REPAIR | HORIZONTAL BRACING MEMBER REPAIR | 72 |
