PROJECT NO. **15BPR.164**  
**BEAUFORT** COUNTY  
TERMINAL: **AURORA**

STATE OF NORTH CAROLINA  
DEPARTMENT OF TRANSPORTATION  
RALEIGH

## **STEEL BEAM CRACK REPAIR DETAILS**

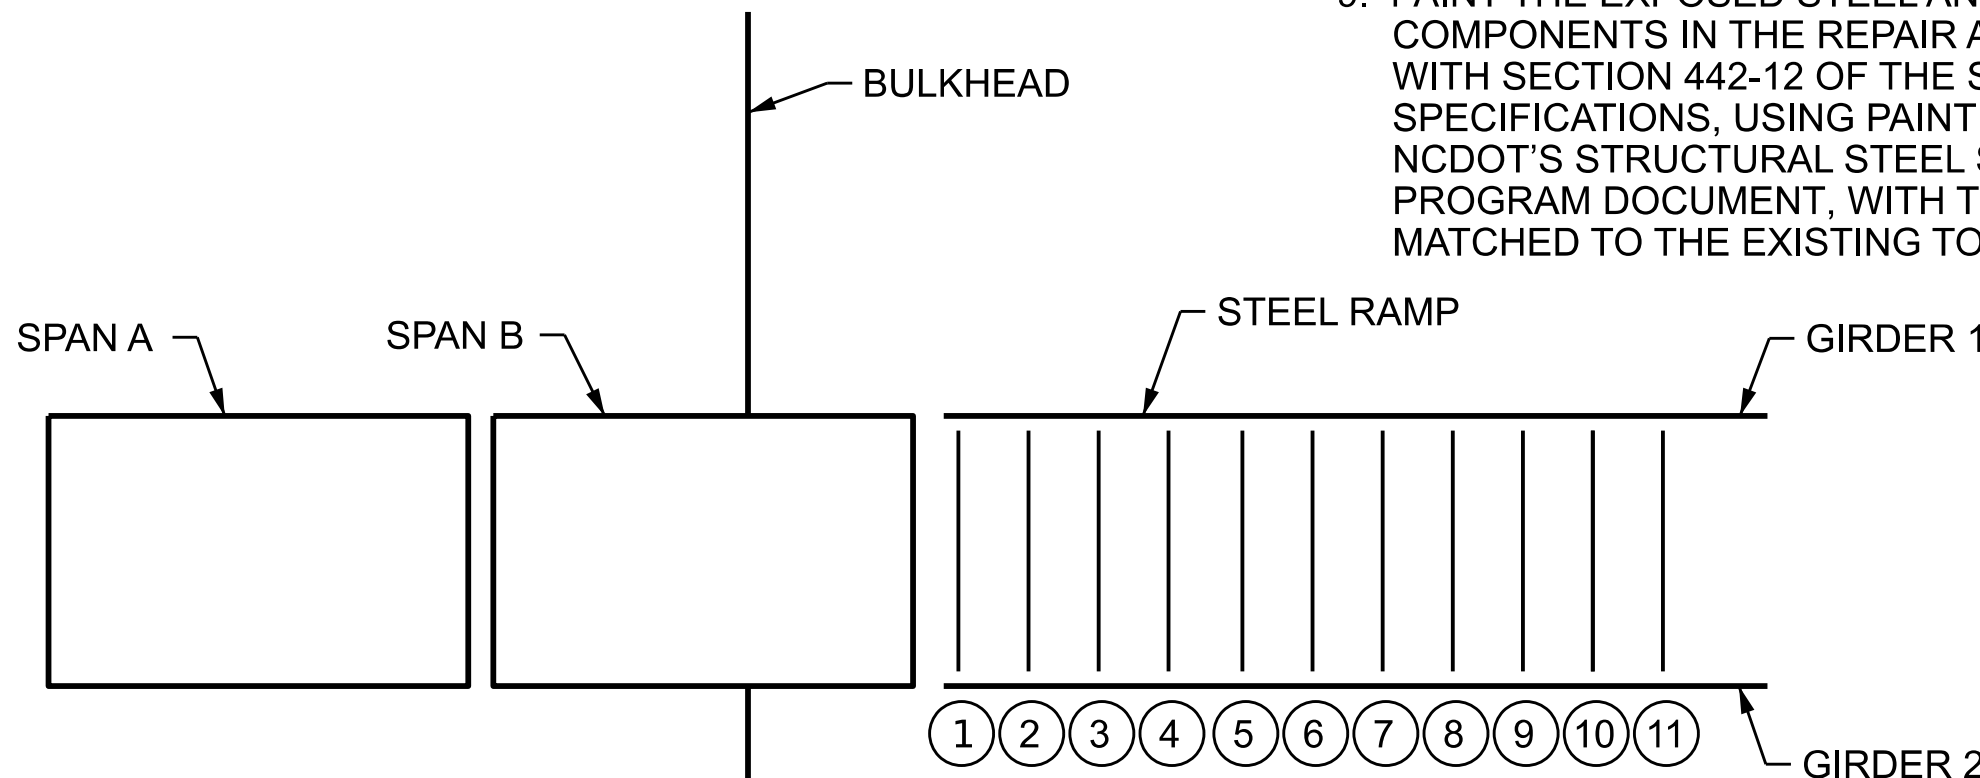
### **PLAN LAYOUT**

| STEEL BEAM CRACK REPAIR LOCATION TABLE | | |
| NO. | GIRDER NO. | FLOORBEAM NO. |
| 1 | GIRDER 1 | FLOORBEAM 1 |
| 2 | GIRDER 1 | FLOORBEAM 4 |
| 3 | GIRDER 1 | FLOORBEAM 11 (X2) |
| 4 | GIRDER 2 | FLOORBEAM 1 |
| 5 | GIRDER 2 | FLOORBEAM 9 |
| 6 | GIRDER 2 | FLOORBEAM 11 |
