HP12x53 STEEL PILE REPAIR DETAILS

PROJECT NO. **15BPR.164**  
**BEAUFORT** COUNTY  
TERMINAL: **AURORA**

| STATE OF NORTH CAROLINA<br>DEPARTMENT OF TRANSPORTATION<br>RALEIGH | | | | | |
|---|---|---|---|---|---|
| BENT 1<br>STEEL PILE<br>REPAIR DETAILS | | | | | |
| SHEET NO. S1-05 | | | | | TOTAL SHEETS 34 |

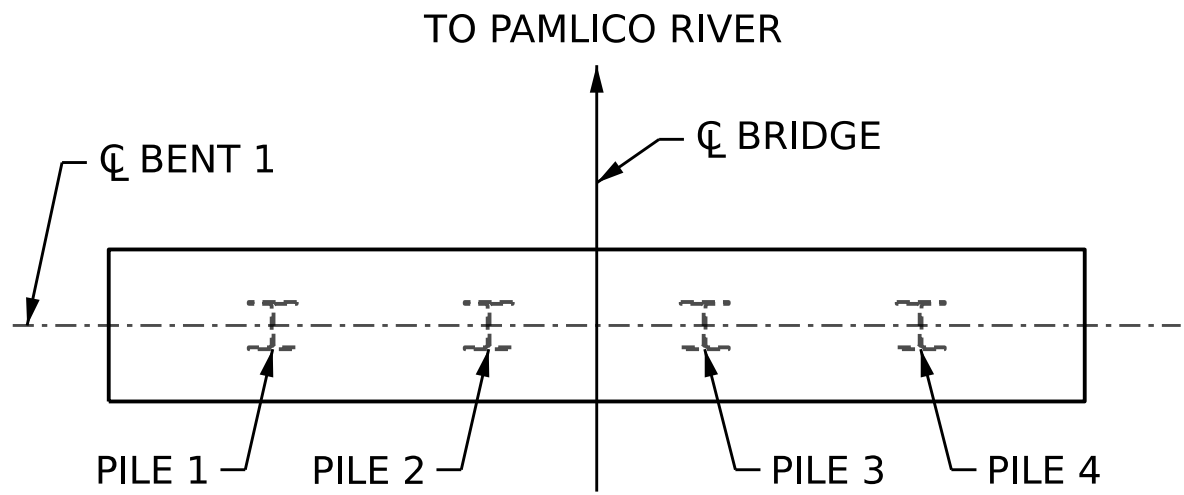
PLAN OF BENT 1

| ESTIMATED STEEL PILE REPAIR QUANTITIES | | | | |
|---|---|---|---|---|
| 1 | 1 | WELDED PLATE REPAIR | FULL HEIGHT OF EXPOSED PILE | 67 |
| | 2 | WELDED PLATE REPAIR | FULL HEIGHT OF EXPOSED PILE | 82 |
| | 3 | WELDED PLATE REPAIR | FULL HEIGHT OF EXPOSED PILE | 67 |
| | 4 | WELDED PLATE REPAIR | FULL HEIGHT OF EXPOSED PILE | 82 |
