PROJECT NO. **15BPR.164**  
**BEAUFORT** COUNTY  
TERMINAL: **AURORA**

STATE OF NORTH CAROLINA  
DEPARTMENT OF TRANSPORTATION  
RALEIGH

**BENT 2  
STEEL PILE  
REPAIR DETAILS**

| REVISIONS | | | | | | SHEET NO.<br>S1-06 |

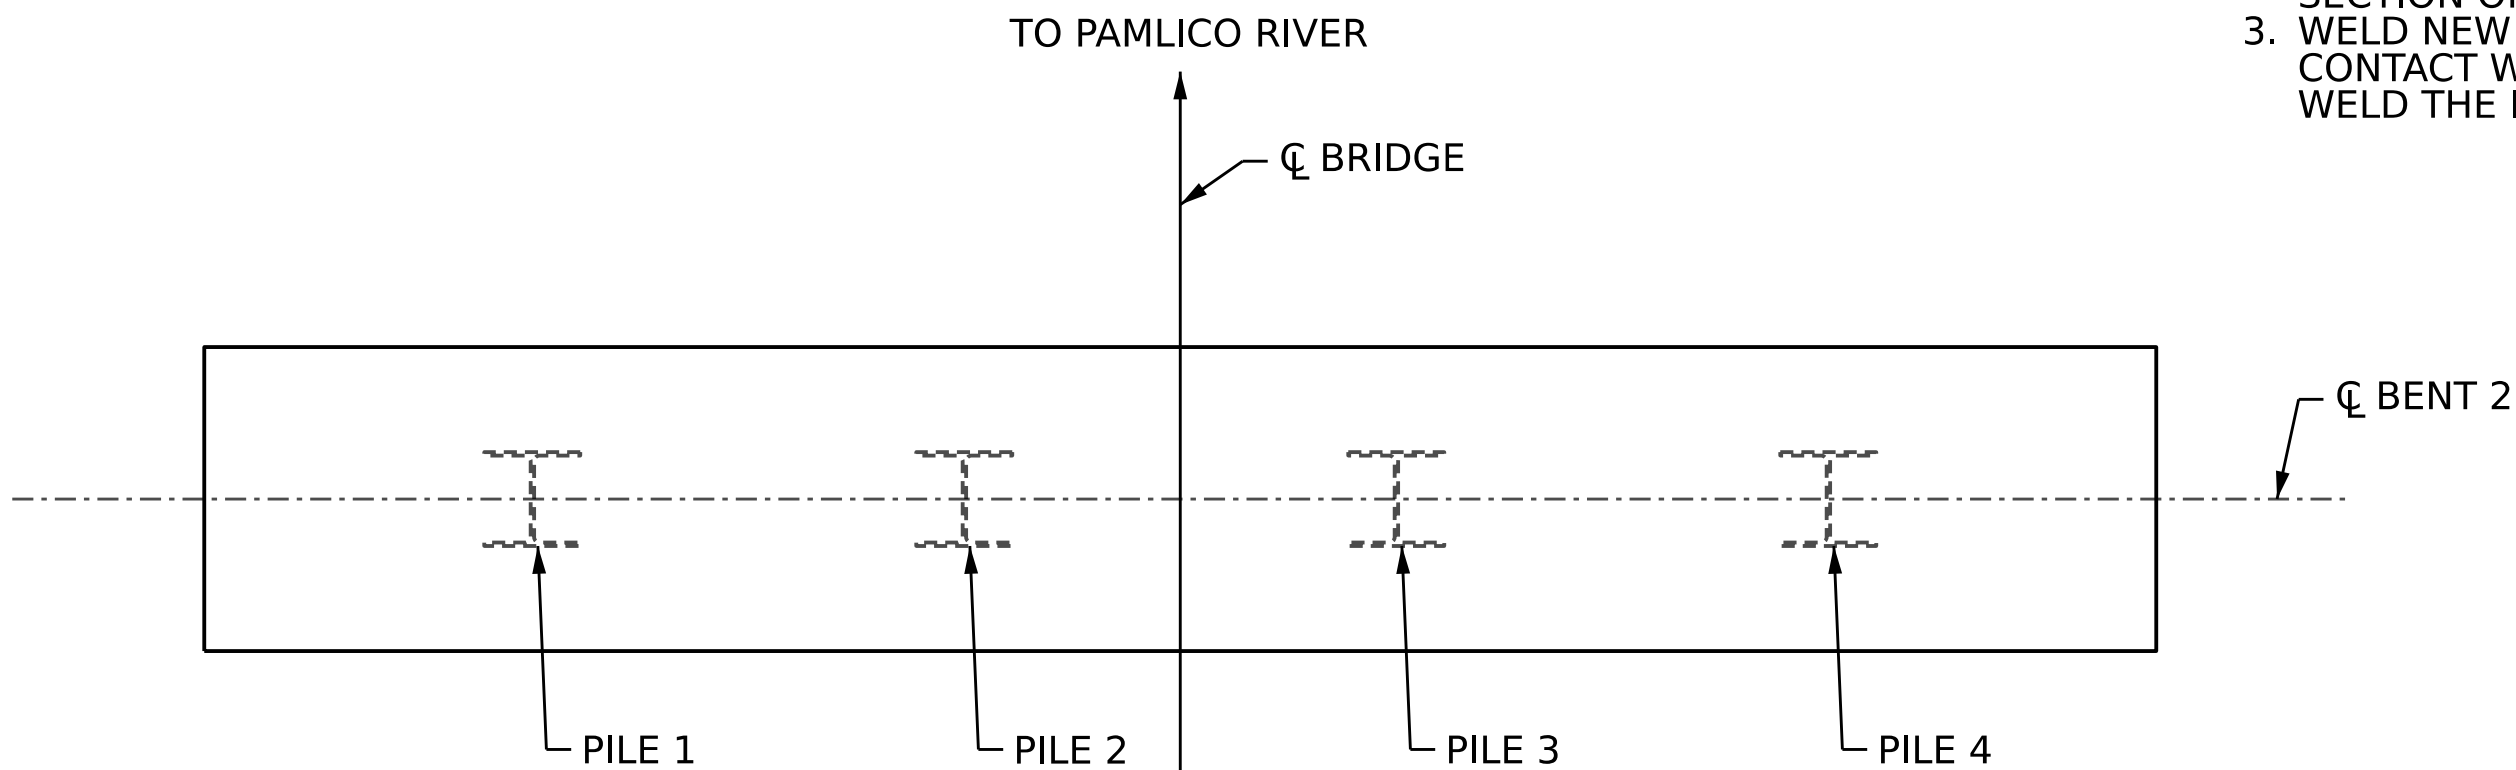
PLAN OF BENT 2

| ESTIMATED STEEL PILE REPAIR QUANTITIES | | | | QUANTITY (LBS.) |
|---|---|---|---|---|
| 2 | 1 | WELDED PLATE REPAIR | ABOVE & BELOW EXISTING REPAIR PLATE, AT WATERLINE | 87 |
| | 2 | WELDED PLATE REPAIR | ABOVE & BELOW EXISTING REPAIR PLATE | 87 |
| | 3 | WELDED PLATE REPAIR | ABOVE & BELOW EXISTING REPAIR PLATE, AT WATERLINE | 72 |
| | 4 | WELDED PLATE REPAIR | ABOVE & BELOW EXISTING REPAIR PLATE | 72 |
